**DATE:** September 11, 2017  
**TO:** Blue Bird Owners  
**SUBJECT:** Recall R17YY, Vision Chassis Mounted Battery Box Supports

**NHTSA Recall Number: 17V-100 School Bus**  
**NHTSA Recall Number: 17V-101 Non-School Bus**

**Subject: RECALL R17YY, Vision Chassis Mounted Battery Box Supports**

## VISION CHASSIS MOUNTED BATTERY BOX SUPPORT

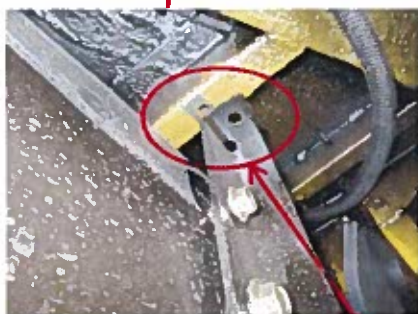
1. Park bus on level surface, apply parking brake, turn off ignition key, and chock wheels.
2. Disconnect batteries.
3. Inspect front brace for loose or missing fasteners on the front battery box-to-floor brace. See Illustration on Page 2.
4. Inspect for cracks on the front battery box-to-body floor brace, front battery box frame mounting bracket, and rear battery box frame mounting brackets for cracks at bolt holes and in the bend.
5. Per the Battery Configuration in the bus and the inspection results, perform the appropriate repair per the matrix on Page 3.

Example shown of front brace missing fasteners at floor and loose at battery box attachment.

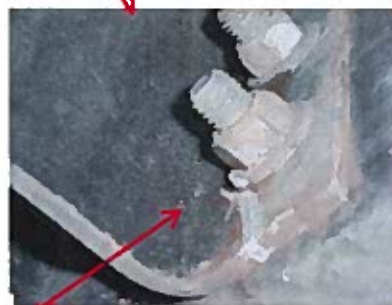
Crack may be in vertical bend.

Example shown of vertical crack at lower hole. Cracks may be vertical or horizontal to one or more holes.

| | | <u>Choose Bus Battery Option</u> | |
|---|---|---|---|
| <u>Inspection Results</u> | NO cracks or missing or loose fasteners or history of loose fasteners | Repair A | Repair B |
| | <b>Front battery box-to-body floor brace-</b> History of loose fasteners or inspection shows missing or loose fasteners or any cracks | Repair B | Repair B |
| | <b>Front battery box frame mounting bracket CRACKS-</b> at <u>one</u> bolt hole or in the bends of bracket | Repair C | Repair C |
| | <b>Front and Rear battery box frame mounting bracket CRACKS-</b> at <u>more than one</u> bolt hole or bend of either bracket | Repair D | Repair D |

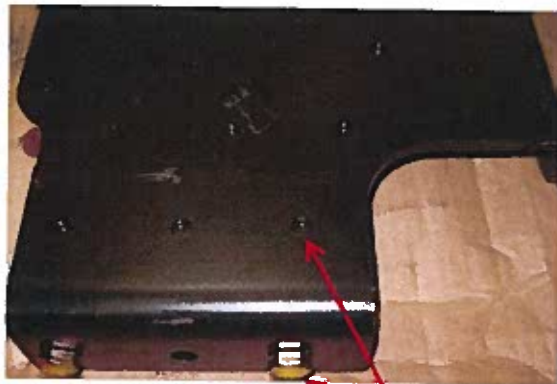
Temporary install two 1/2 inch capscrews with standard nuts and tighten. Drill six 3/8 inch diameter holes using the reinforcement as guide.

2. On the bench, assembly install new high strength steel front frame battery bracket 10049663 and front (LH) reinforcement bracket 10054519 together with two (2) 1/2 inch capscrews 00803239 and standard nuts (not included in kit) and tighten nuts.

3. Using the front (LH) reinforcement bracket 10054519 as a guide, drill six (6) 3/8 inch diameter holes.
4. Install six (6) 3/8 inch capscrews 00559195, flat washers 01107085, and flange locknuts 00543934. Install one (1) 1/4 inch capscrew 00870477, flat washer 01991108, and locknut 02001345. Leave all fasteners loose; do not torque until assembly has been installed on the chassis.

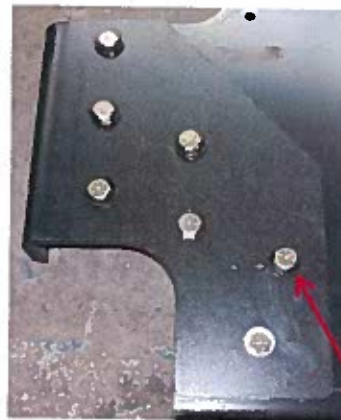
Install all the fasteners attaching the reinforcement to the front frame battery bracket and leave loose until installed onto chassis frame.
