**SUBJECT:** Recall R17YY, Vision Chassis Mounted Battery Box Supports

**IMPORTANT SAFETY RECALL NOTICE**

## VISION CHASSIS MOUNTED BATTERY BOX SUPPORT

The chassis mounted battery box support brackets may develop cracks or fracture and could allow the battery box to separate from the chassis and fall.

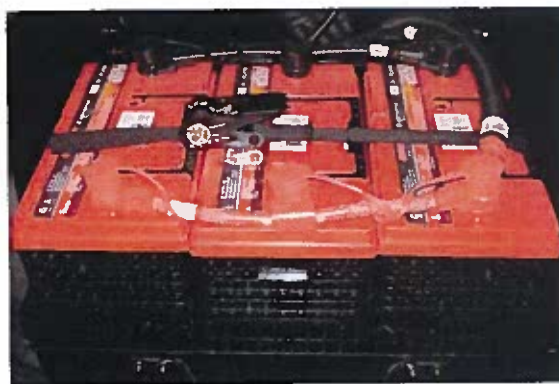
THREE ODYSSEY BATTERIES

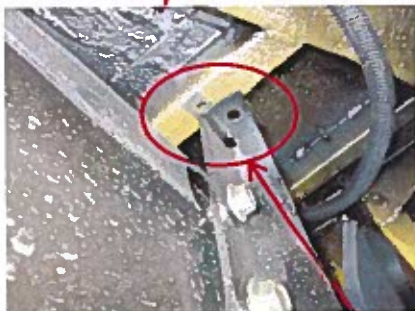
Example shown of front brace missing fasteners at floor and loose at battery box attachment.

Inspect for loose front brace and cracked support brackets. From matrix in instructions, select the correct repair for your bus which includes removing braces, and may include adding reinforcements or replacing front or front and rear support brackets.

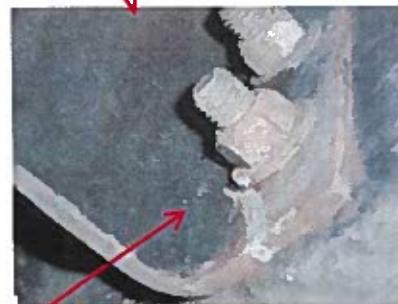
Crack may be in vertical bend.

Example shown of vertical crack at lower hole. Cracks may be vertical or horizontal to one or more holes.

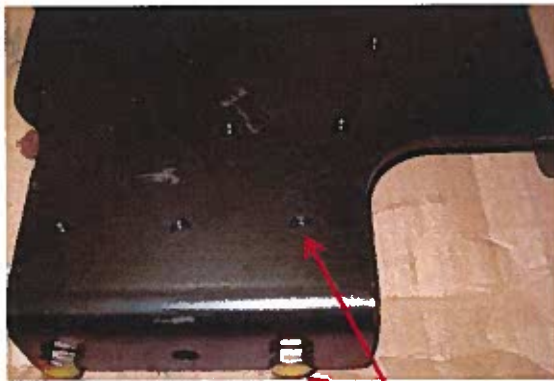
#### BENCH ASSEMBLY

Temporary install two 1/2 inch capscrews with standard nuts and tighten. Drill six 3/8 inch diameter holes using the reinforcement as guide.

2. On the bench, assembly install new high strength steel front frame battery bracket 10049663 and front (LH) reinforcement bracket 10054519 together with two (2) 1/2 inch capscrews 00803239 and standard nuts (not included in kit) and tighten nuts.

3. Using the front (LH) reinforcement bracket 10054519 as a guide, drill six (6) 3/8 inch diameter holes.
4. Install six (6) 3/8 inch capscrews 00559195, flat washers 01107085, and flange locknuts 00543934. Install one (1) 1/4 inch capscrew 00870477, flat washer 01991108, and locknut 02001345. Leave all fasteners loose; do not torque until assembly has been installed on the chassis.

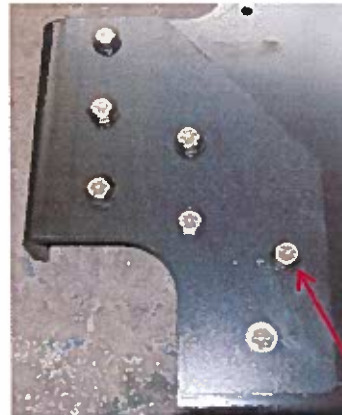
Install all the fasteners attaching the reinforcement to the front frame battery bracket and leave loose until installed onto chassis frame.
