**R17YY**

**SUBJECT:** Recall R17YY, Vision Chassis Mounted Battery Box Supports

## VISION CHASSIS MOUNTED BATTERY BOX SUPPORT

The chassis mounted battery box support brackets may develop cracks or fracture and could allow the battery box to separate from the chassis and fall.

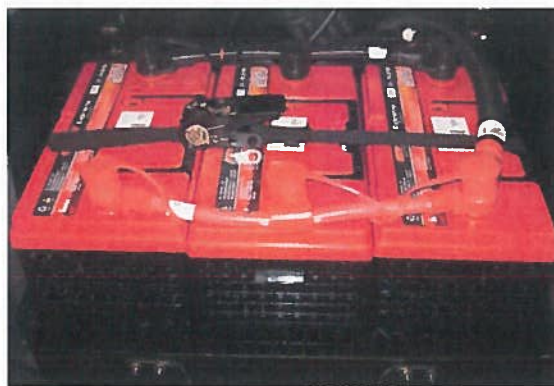
THREE ODYSSEY BATTERIES

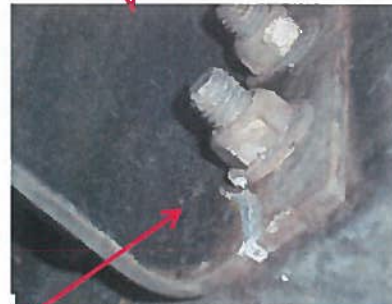
Crack may be in vertical bend.

Example shown of vertical crack at lower hole. Cracks may be vertical or horizontal to one or more holes.

| | | <u>Choose Bus Battery Option</u> | |
|---|---|---|---|
| | <b>Front battery box frame mounting bracket CRACKS-</b> at <u>one</u> bolt hole or in the bends of bracket | Repair C | Repair C |
| | <b>Front and Rear battery box frame mounting bracket CRACKS-</b> at <u>more than one</u> bolt hole or bend of either bracket | Repair D | Repair D |

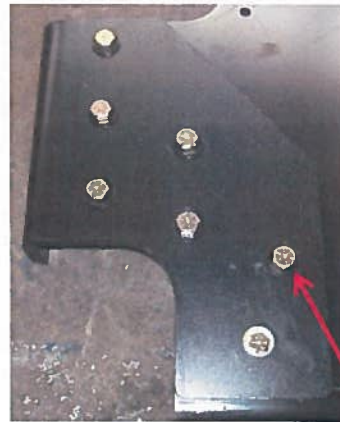
Install all the fasteners attaching the reinforcement to the front frame battery bracket and leave loose until installed onto chassis frame.
