F/CMVSS Noncompliance Recall

17239 Front Head Restraint Removable After Tablet Holder Installed

Reference Number: N172095270

Release Date: June 2017
Revision: 00

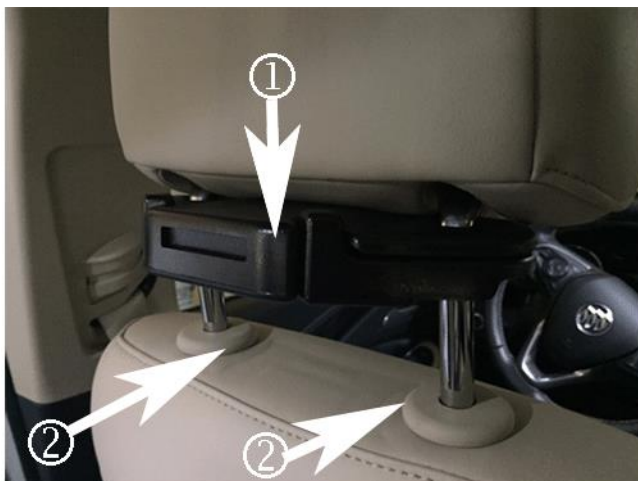
4825302

1. Push the head restraint release button on the headrest and raise the head restraint. If a tablet type device is installed in the tablet holder, remove and store the tablet in a safe environment.
2. Lift the tablet holder (1).

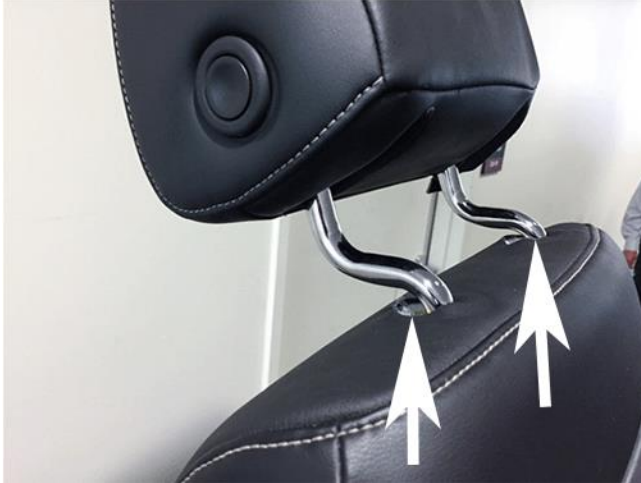
4825303

3. Determine if the head restraint guide bezels (2) are present.
 - If the head restraint guide bezels are present proceed to step four below.
 - If the bezels are not present, proceed to step seven below.
4. Lower the seat back rearward to gain space between the head restraint and the roof. Ensure sure that the cushion is locked in place on the posts and will not move and then, pulling vertically on the head restraint assembly, remove the head restraint from the seat back. If the head restraint will not come out of the seatback, refer to *Front Seat Head Restraint Guide Replacement* in SI. Leave the tablet holder on the head restraint posts.

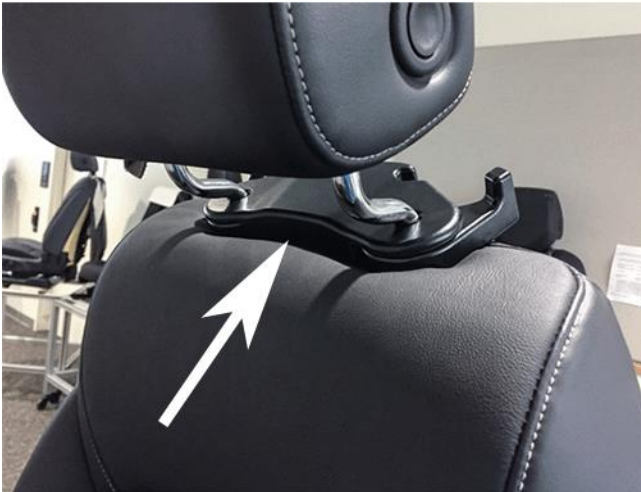
4825307

5. With the head restraint removed, remove the two bezels. Store the bezels in the vehicle glove box for future use.
