Bulletin Type.....: Safety Recall

Bulletin No.....: TS-S123 (Rev01)

**Bulletin Name.....: Tag Axle Air Bellow Protection
Cover**

Vehicle Model.....: TS45

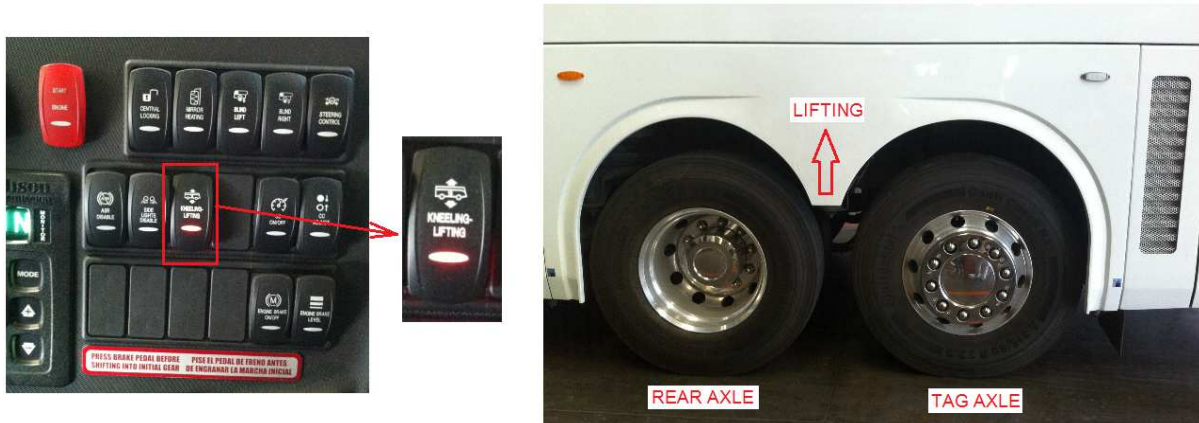
- a- Before starting the operation lift the vehicle by pushing the kneeling/lifting button placed on dashboard, see in Figure -1. Thus enough space will be achieved for the following processes (**See Figure-1**)

Figure -1: Kneeling/lifting operation

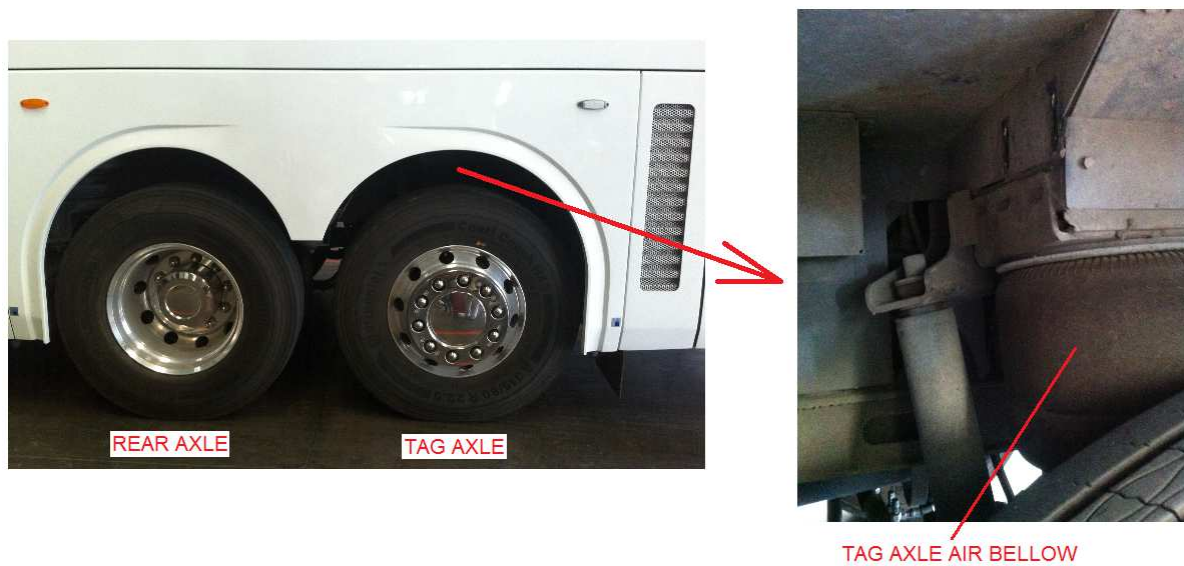
Figure - 2:

- b- Location of the tag axle air bellow at road side

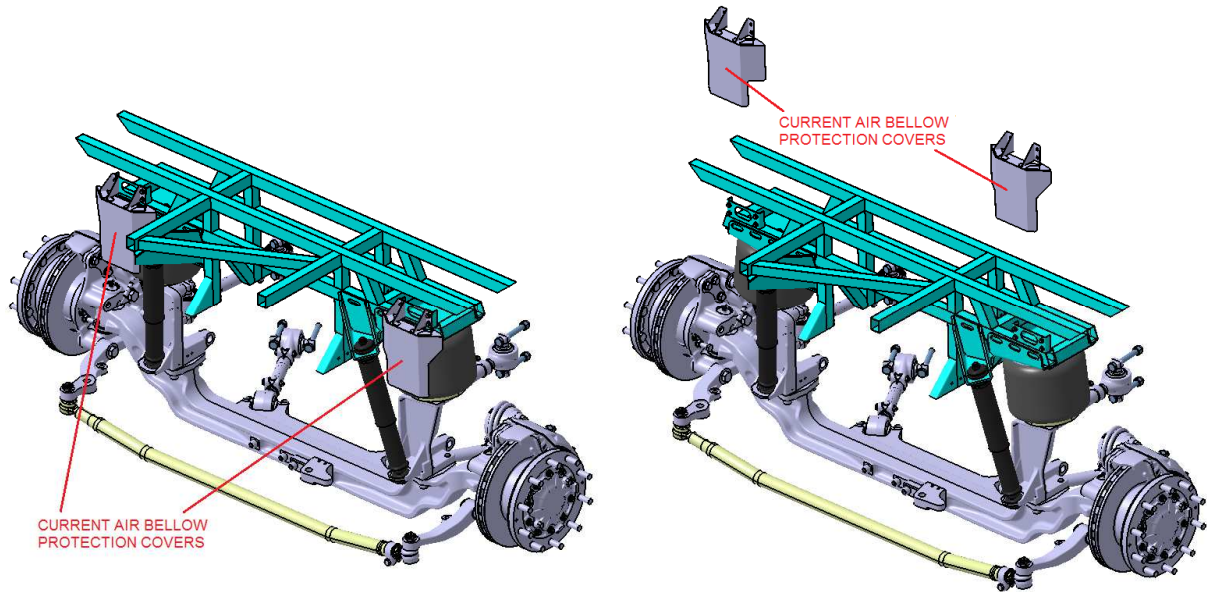
Figure - 3

If current air bellow protection covers still exist on the vehicle, remove them by loosening the bolts, (**See Figure-3**)

Figure - 3: Removal of existing air bellow protection covers of tag axle

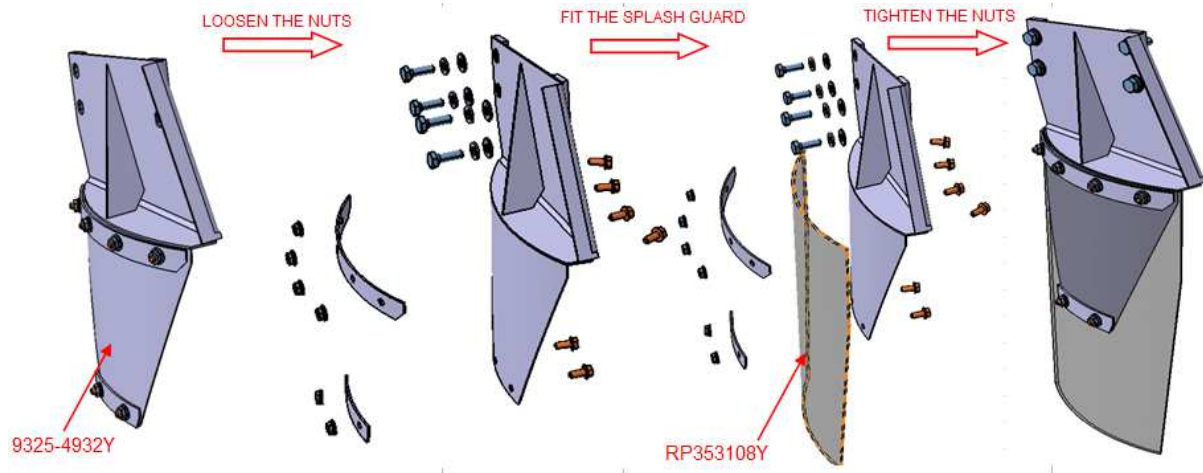
Figure – 4

Note: Same subassembly process is also valid for the air bellow protection cover at right side

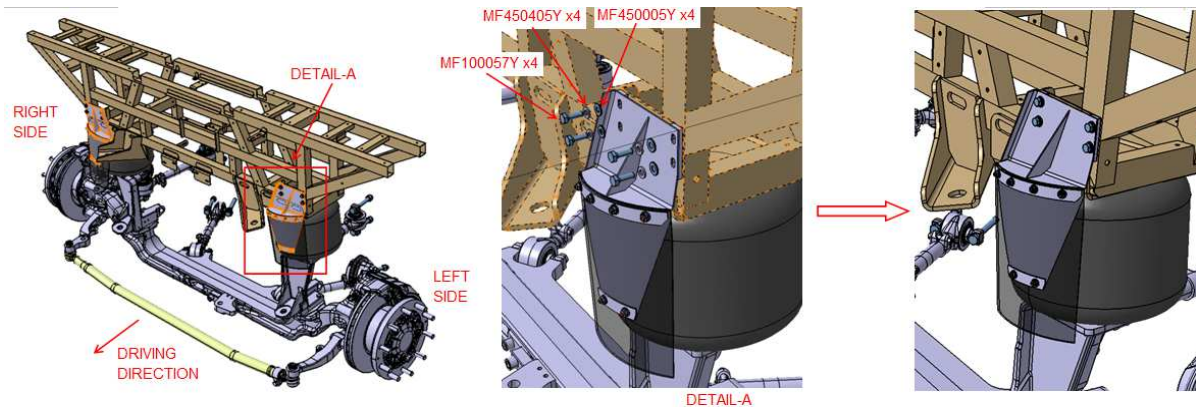
Install both air bellow protection covers to the vehicle, see in **Figure-5** and **Figure-6**.

Figure - 5: Fix the protection cover at left side by the bolts given in DETAIL -A (tightening torque is 8 lbft).

Note: Same installation process is also valid for the one at right side
