PREVOST

**SAFETY
RECALL**

SR17-31B

DATE :	May 2018	SECTION :	23 ACCESSORIES
SUBJECT:	2½ lb AND 5 lb FIRE EXTINGUISHER REPLACEMENT

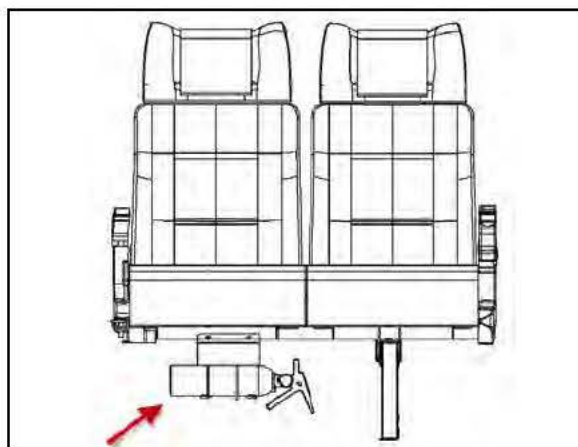
FIGURE 1

1. Locate all the existing 2½ lb fire extinguishers on the vehicle (Figure 1).

All vehicles should have at least two fire extinguishers. There is one on the left side of the aisle and one on the right side of the aisle. Check the vehicle configuration for the exact amount of fire extinguishers.

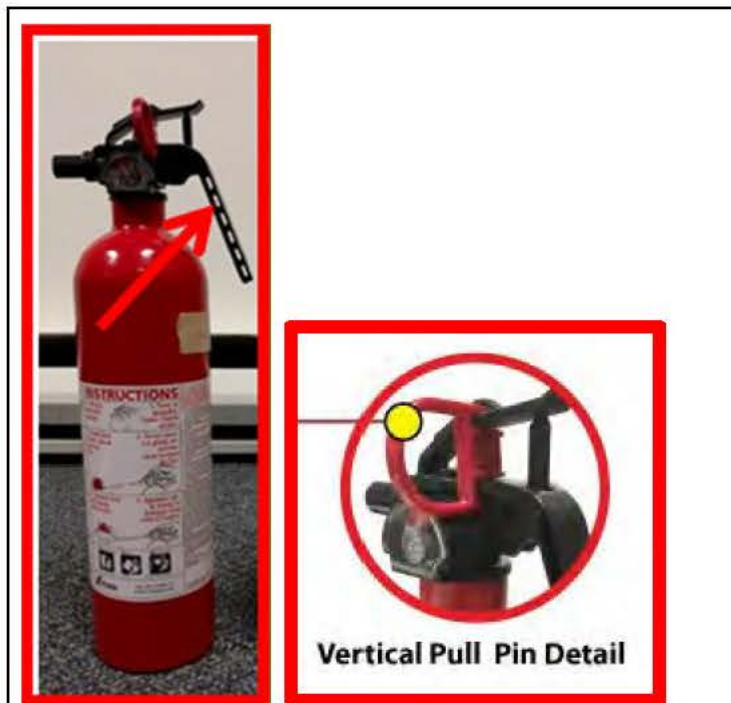
FIGURE 2: RECALLED EXTINGUISHER TYPE

On vehicles affected by this recall, all 2½ lb fire extinguishers (p/n 901360) equipped with a straight plastic handle and vertical pull pin have to be replaced by fire extinguishers equipped with a metal handle and metal pull pin.

2. Replace all existing 2½ lb fire extinguishers with straight plastic handle and vertical pull pin (Figure 2) with the new 2½ lb fire extinguishers with the metal handle and metal pull pin (Figure 3).

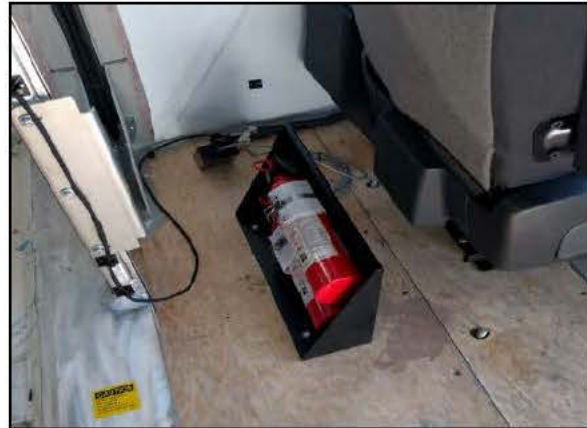
FIGURE 5 shows a typical installation when the vehicle is delivered to the converter partner. Location of the fire extinguishers might be different.

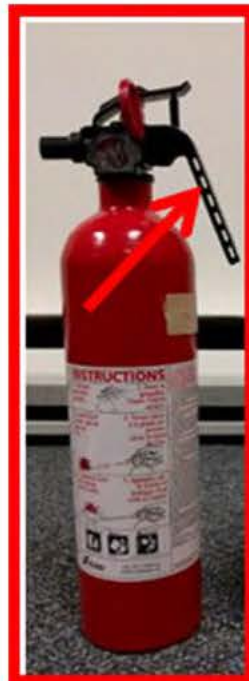
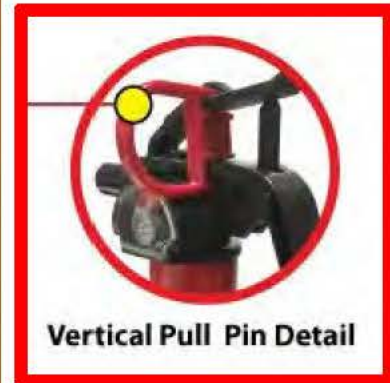
FIGURE 6: RECALLED EXTINGUISHER TYPE

On vehicles affected by this recall, all 2½ lb fire extinguishers (p/n 901360) equipped with a straight plastic handle and vertical pull pin have to be replaced by fire extinguishers equipped with a metal handle and a metal pull pin.

2. Replace all existing 2½ lb fire extinguishers with straight plastic handle and vertical pull pin (Figure 6) with the new 2½ lb fire extinguishers with the metal handle and metal pull pin (Figure 7).

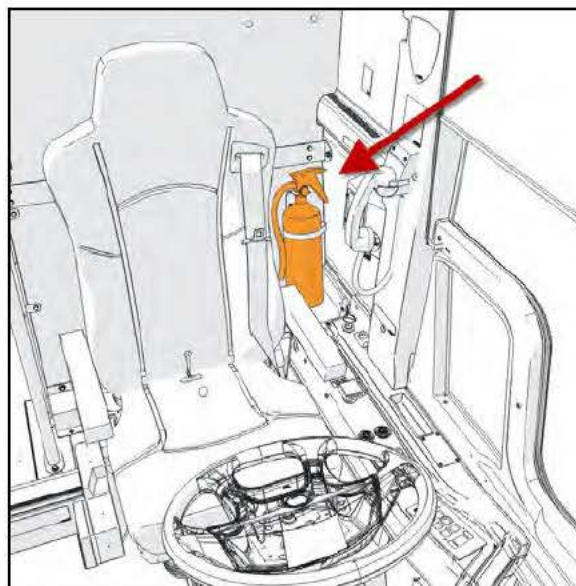
FIGURE 9

1. Locate the existing 5-lb fire extinguisher behind the driver's seat of the vehicle.

Figure 9 shows the installation when the vehicle was delivered. Location of the fire extinguisher might be different.

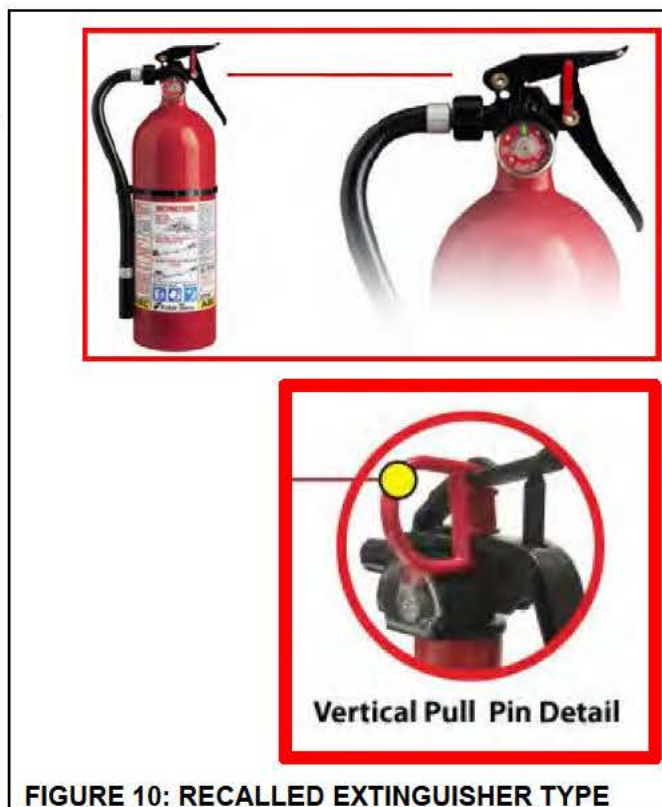
2. Check the handle and pull pin on the existing fire extinguisher.
3. If the extinguisher is equipped with a plastic handle and vertical pull pin (Figure 10), move to step 4, otherwise the bulletin is complete.

4. Replace existing 5 lb fire extinguisher with the plastic handle and vertical pull pin (Figure 10) with the new 5 lb fire extinguisher with the metal handle and metal pull pin (Figure 12).
5. Bulletin is complete for this vehicle model.

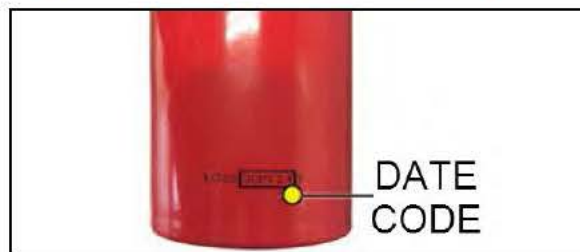
Figure 11 shows the location of the 10-digit date code on the side of the cylinder. Digits 5 through 9 represent the day and year.

All fire extinguishers with the date code XXXX29715X (October 24, 2015) or later have to be replaced.
