CONDITION OF CONCERN

Previous Recall 0516J – Fuel Leak at Fuel Pump Rings:

Recall 1017E – Fuel Leak at Fuel Pump Discharge Pipe:

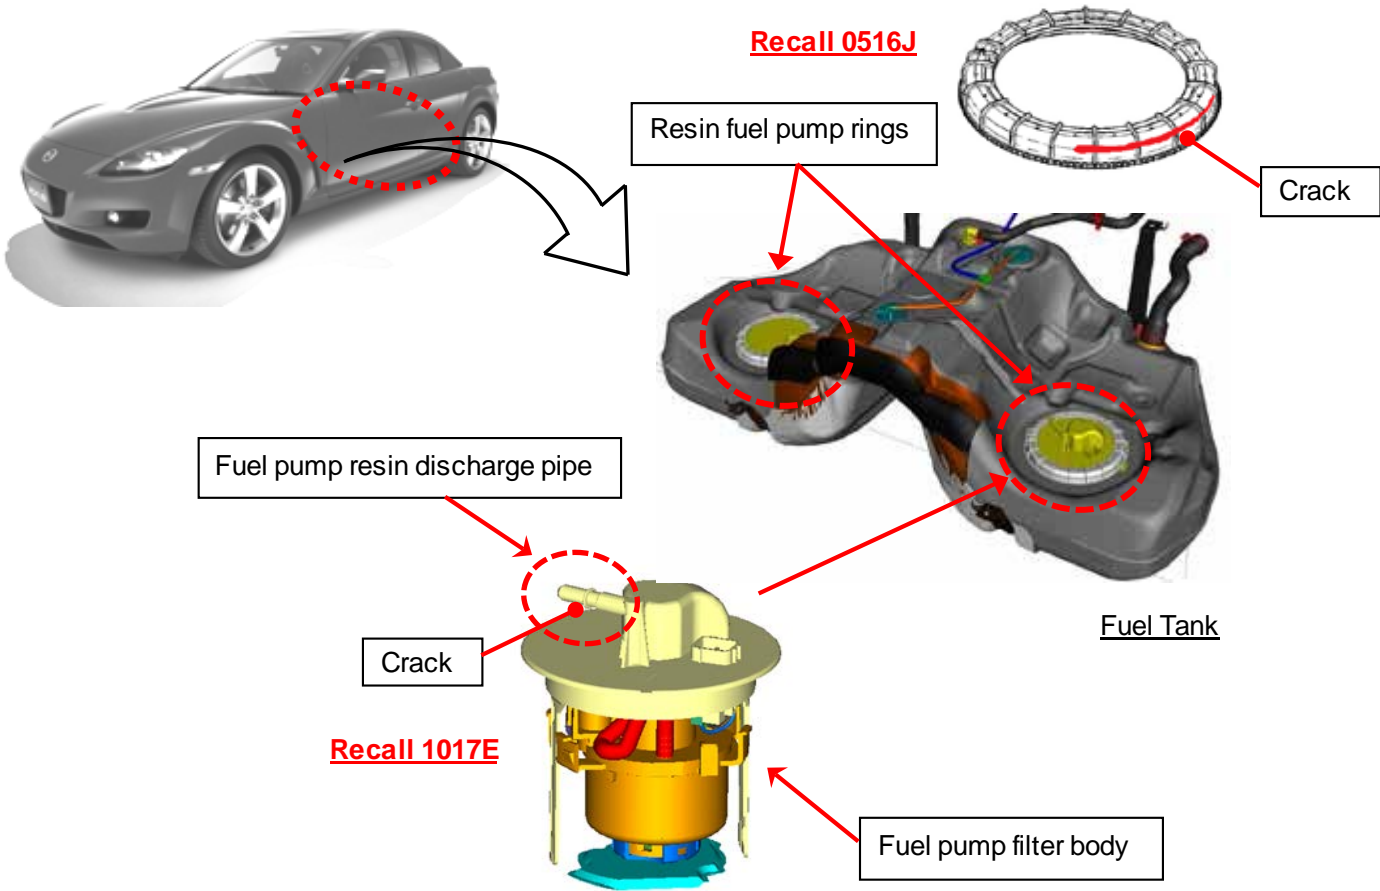
Due to insufficient heat insulating performance, the resin fuel pump rings, which are located on the top surface of the fuel tank, may deteriorate by heat from the engine and exhaust pipes. Continuous use of the vehicle may allow the deterioration to progress, leading to a crack in the fuel pump rings and subsequent fuel leak, which may increase a risk of fire.

Due to insufficient durability of the resin discharge pipe of fuel pump, the discharge pipe may deteriorate, affected by the pressure of fuel inside the pipe and by heat from the engine and exhaust pipe. Continuous use of the vehicle may allow the deterioration of discharge pipe to progress, leading to a crack in the discharge pipe and subsequent fuel leak, which may increase a risk of fire.
