Inspection Criteria for Gooseneck Cracking

TRAIL KING Industries, Inc.

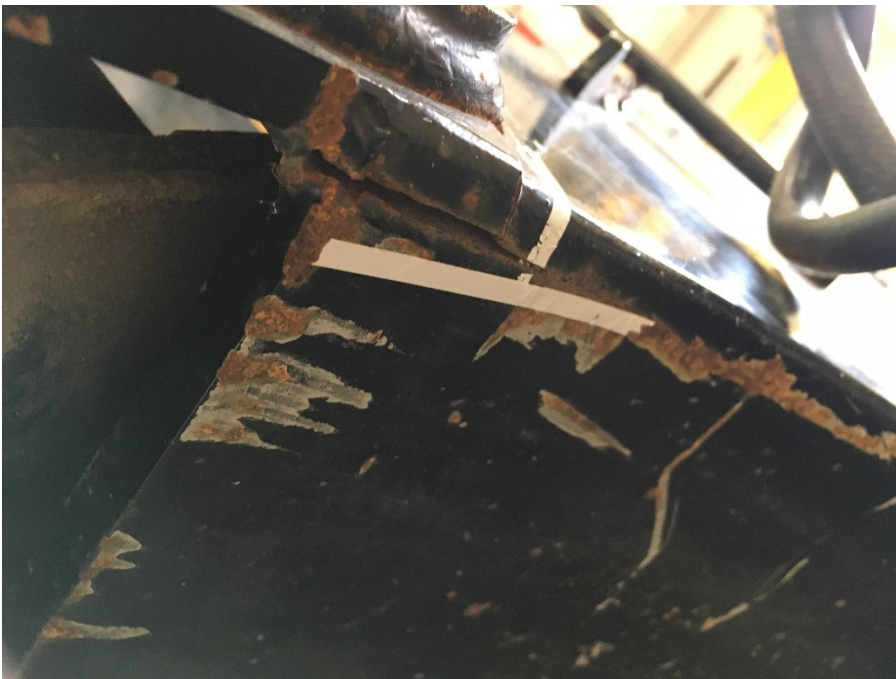
Picture shown below shows cracking from inside.
