SUBJECT: Safety Recall 18S02 - DO NOT DRIVE VEHICLES - Supplement #4

Certain 2006 Model Year Ranger Vehicles

Driver and Passenger Airbag Inflator Replacement Higher Risk Vehicles

CERTAIN 2006 RANGER VEHICLES — DRIVER AND PASSENGER AIRBAG INFLATOR REPLACEMENT

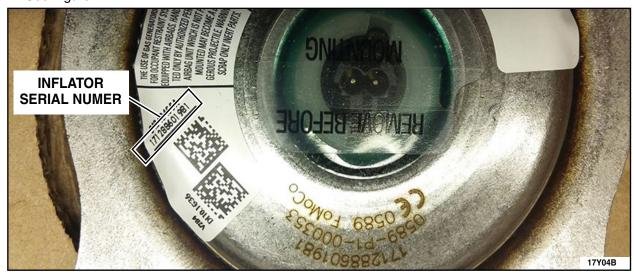
FIGURE 2

Record the 12 character serial number of the new driver airbag inflator on the repair order. See Figure 2.

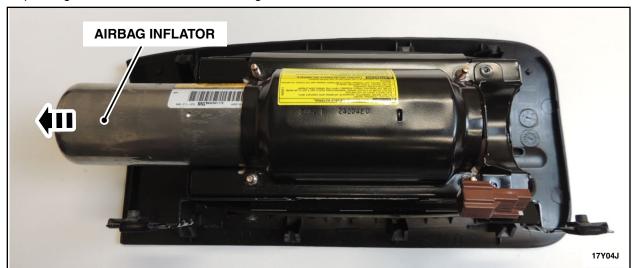
FIGURE 9

7. With an assistant holding the airbag assembly, remove the inflator from the airbag assembly by pushing outward on the inflator. See Figure 9.

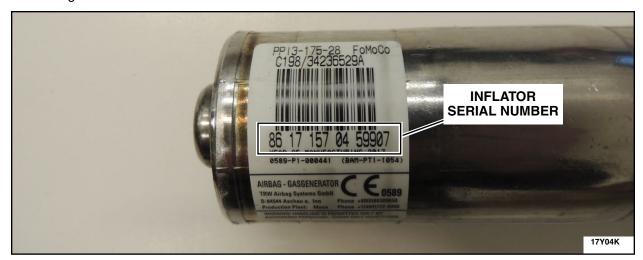
FIGURE 11

Record the 14 character serial number of the *new* passenger airbag inflator on the repair order. See Figure 11.
