SUBJECT: **NEW VEHICLE DEMONSTRATION / DELIVERY HOLD - Safety Recall 18S24**
- Supplement #3
 Certain 2012-2015 Model Year Focus Electric and 2013-2015 Model Year C-MAX Energi and Fusion Energi Vehicles
 Convenience Charge Cord Replacement

NEW VEHICLE DEMONSTRATION / DELIVERY HOLD -**Safety Recall 18S24 – Supplement #3**

2012-2015 FOCUS ELECTRIC TECHNICAL INFORMATION

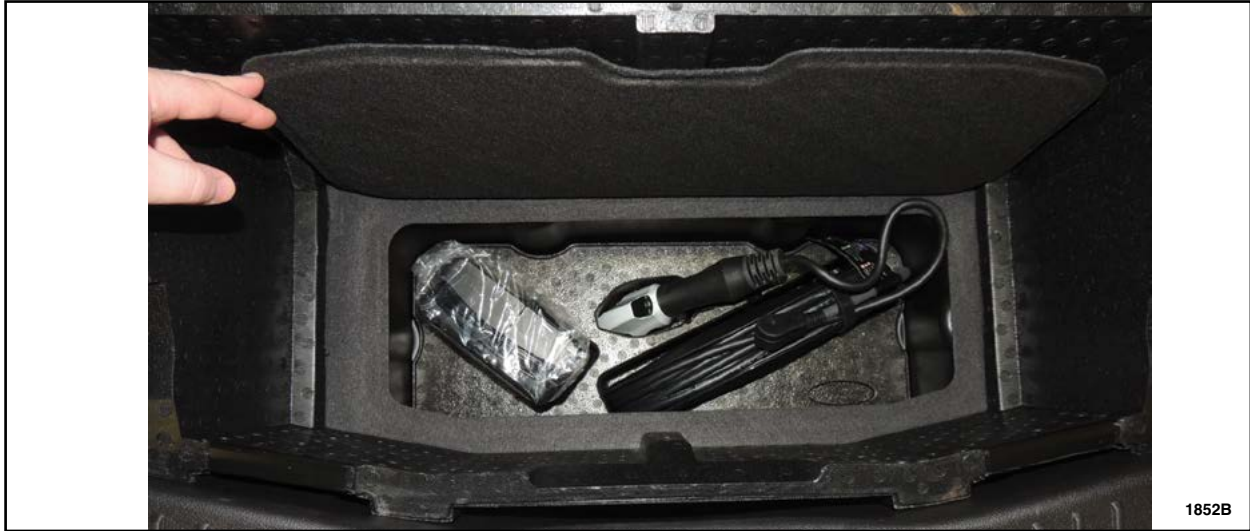
FIGURE 2

2. Open the convenience charge cord cover. See Figure 2

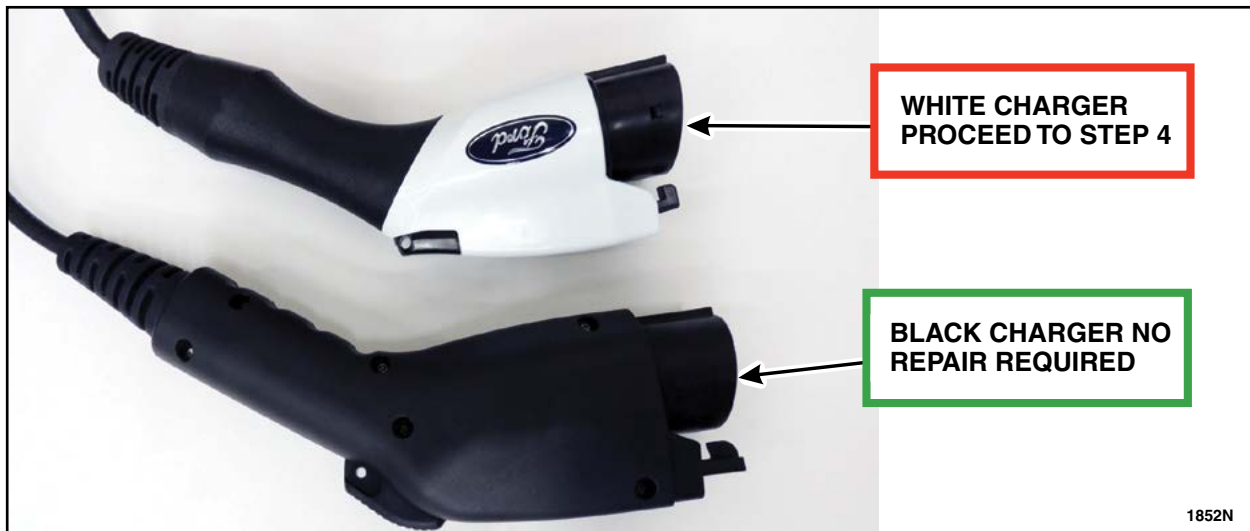
FIGURE 3

3. Inspect convenience charge cord. See Figure 3.

- White Charger - Proceed to Step 4 to inspect part number.
- Black Charger - No repair required.

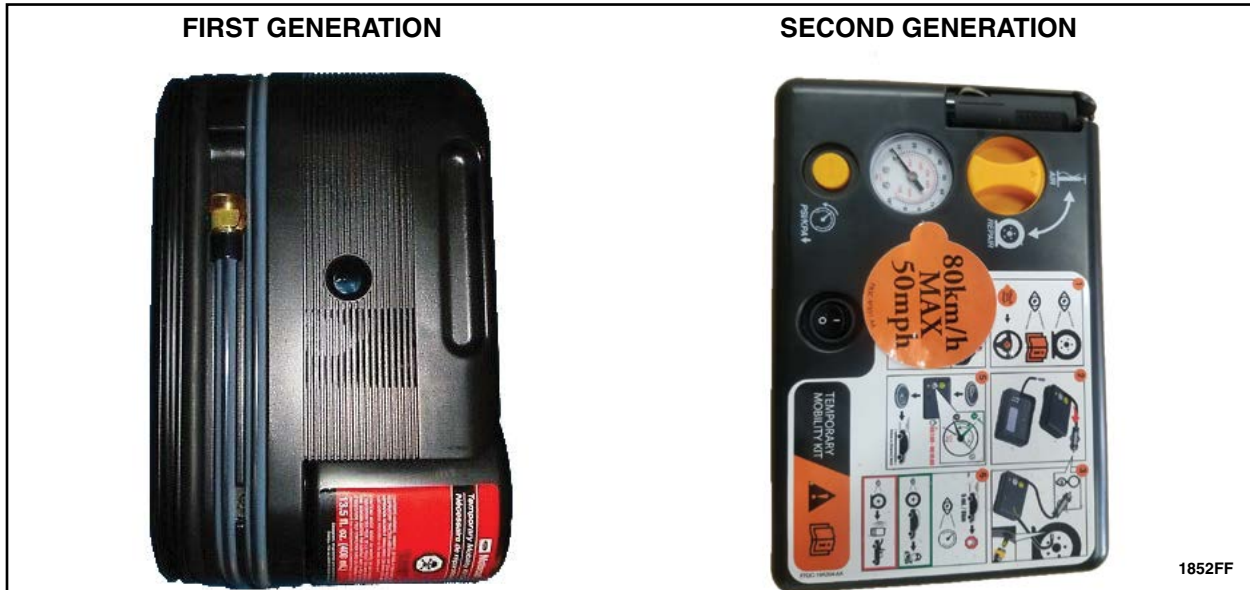
FIGURE 6

5. Identify if the tire mobility kit is a first or second generation model. See Figure 6.

- First Generation mobility kit - Proceed to Step 6.
- Second Generation mobility kit - Proceed to Step 11.

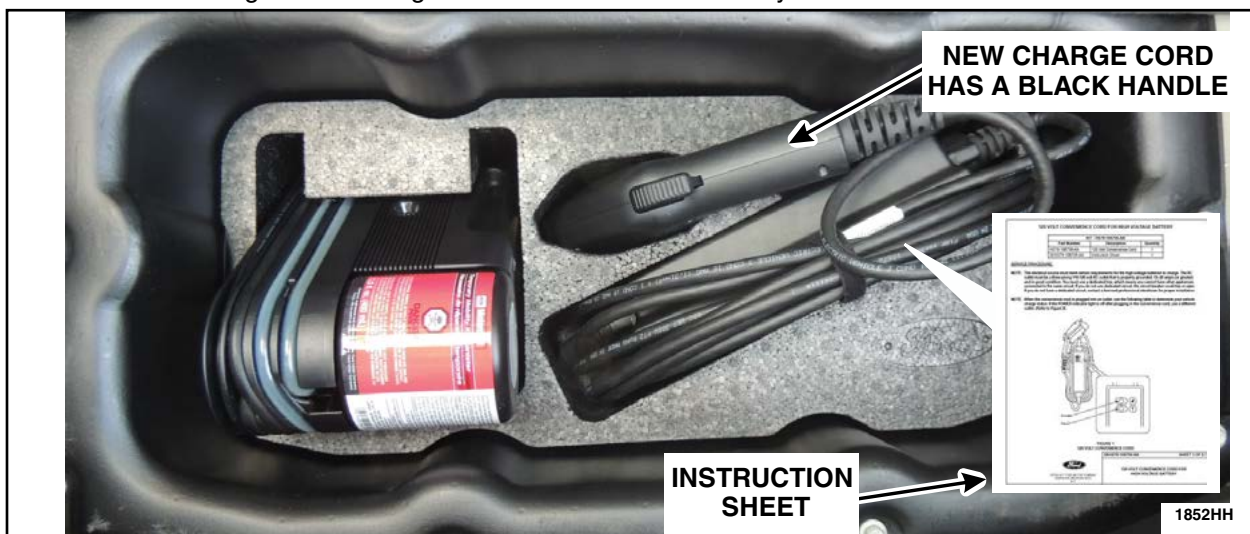
FIGURE 7

6. For vehicles with the first generation tire mobility kit, remove the convenience charge cord and install the new convenience charge cord into the existing foam insert.

NOTE: The new convenience charge cord may be wrapped end to end around the power supply as shown in Figure 7 avoiding interference to the tire mobility kit.

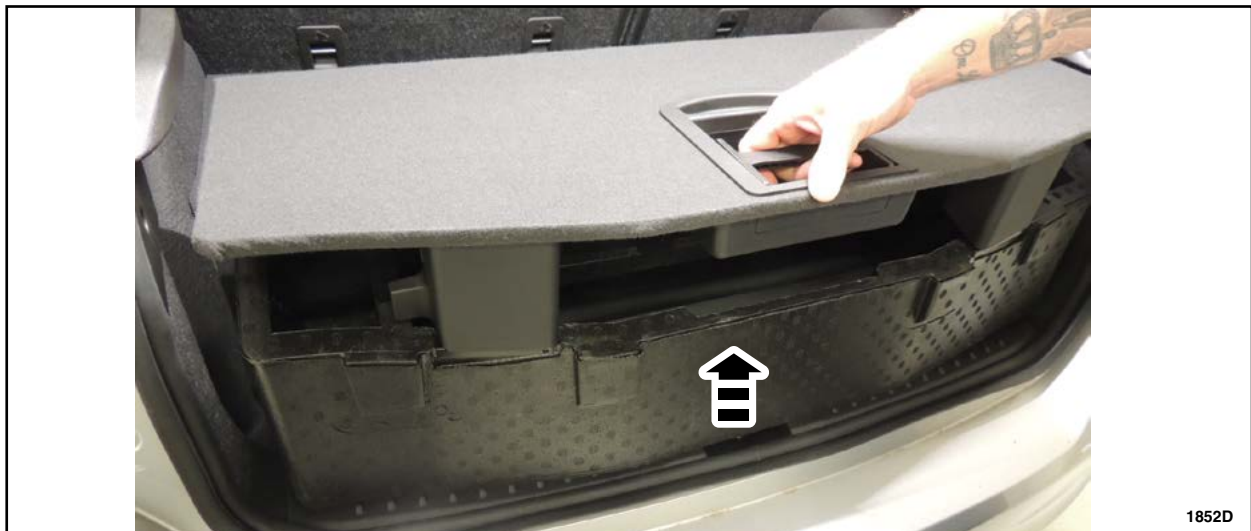
FIGURE 9

10. Discard the foam insert from the new service kit if re-using 1st generation mobility kit. This completes the repair.
11. For vehicles with the second generation mobility kit, remove the load space storage compartment. See Figure 9.

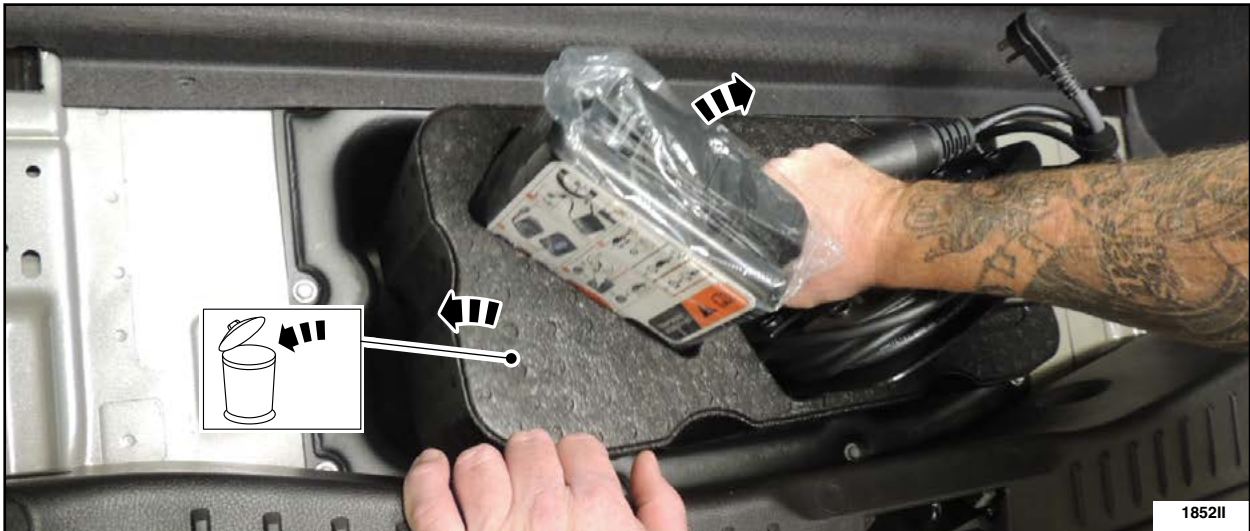
FIGURE 11

13. Remove the convenience charge cord and the foam insert. Discard the removed foam insert. See Figure 11.

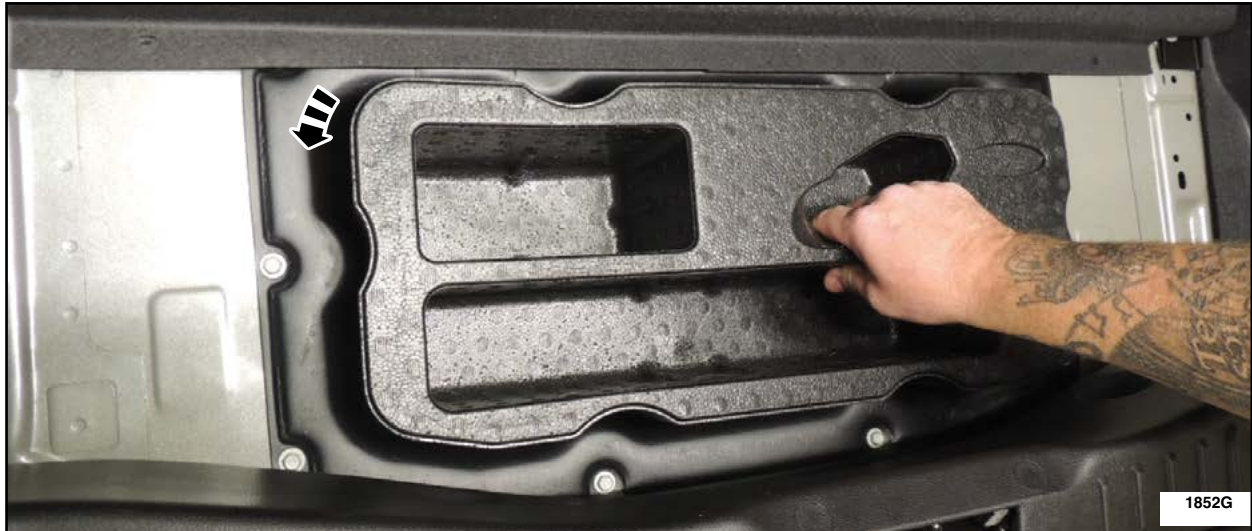
FIGURE 12

14. Install the *new* convenience charge cord foam insert. See Figure 12.

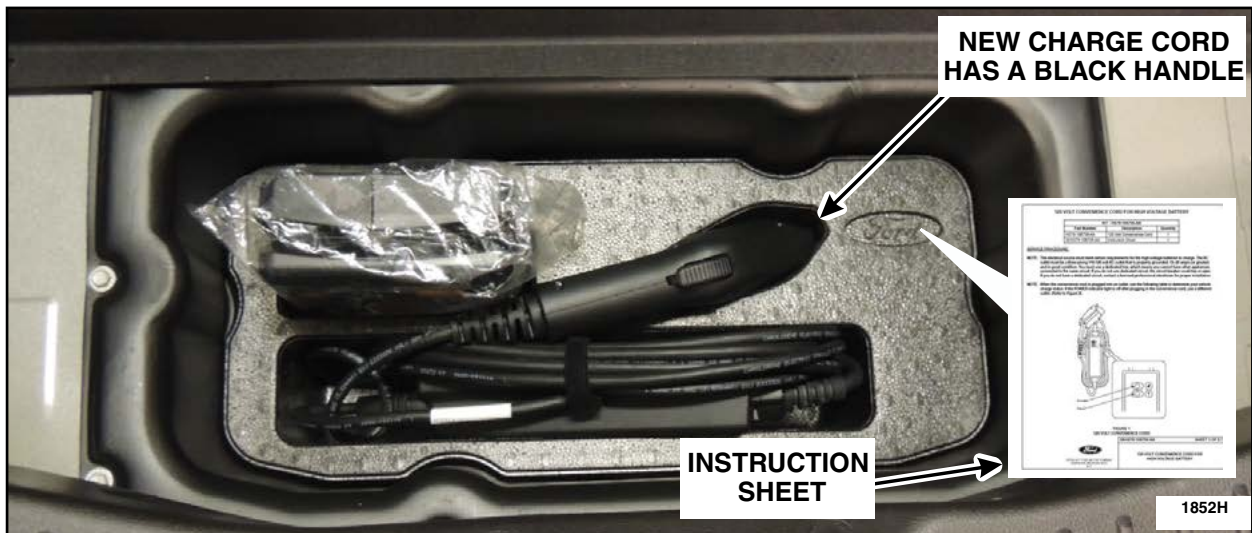
FIGURE 13

15. Transfer the tire mobility kit, install the *new* convenience charge cord into the *new* foam insert with the customer instruction sheet. See Figure 13.

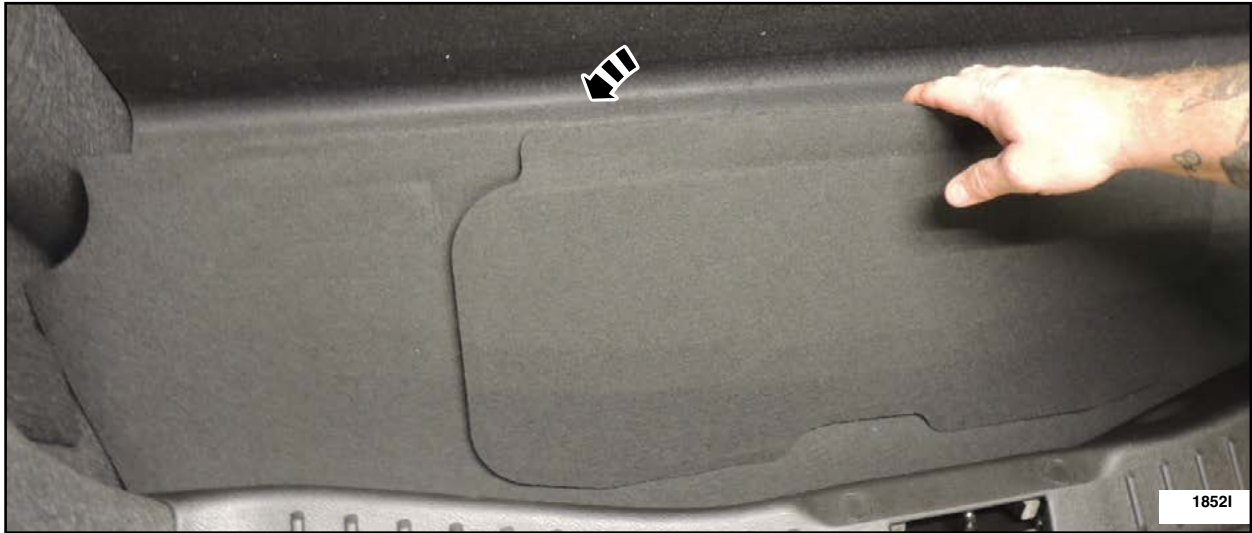
FIGURE 14

16. Install the convenience charge cord cover. See Figure 14.

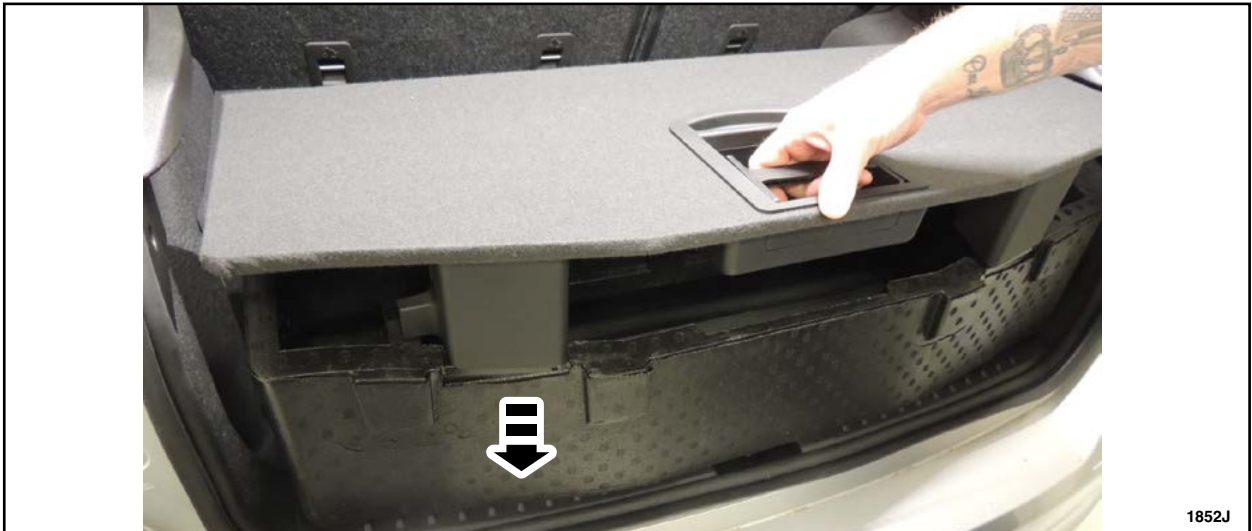
FIGURE 15

17. Install the load space storage compartment and close the liftgate. See Figure 15.

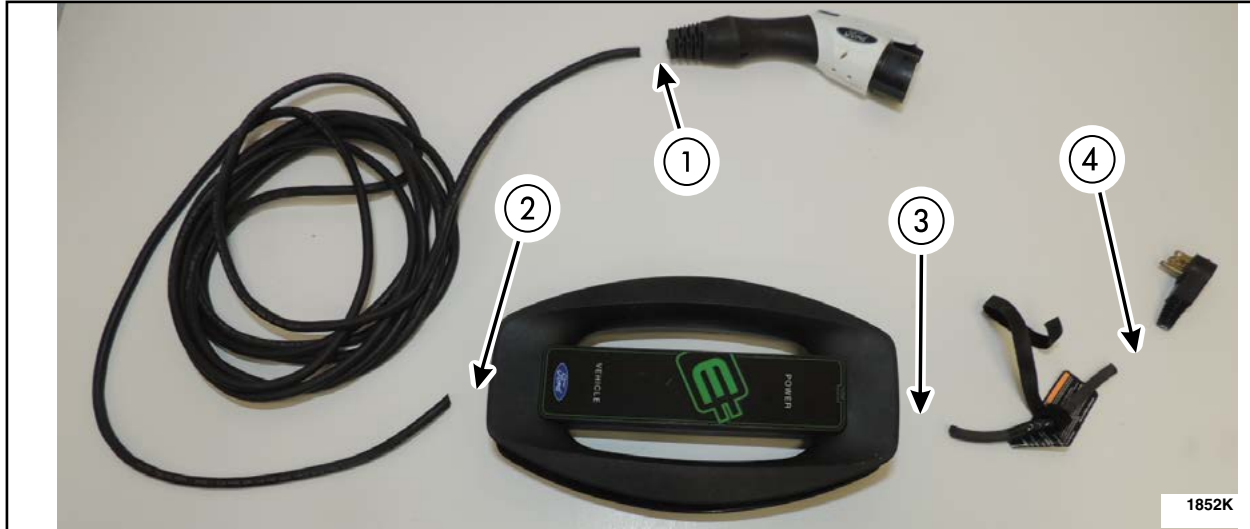
FIGURE 16

18. Destroy the old convenience charge cord so it cannot be reused. Cut the convenience charge cord in the areas shown. A minimum of 4 cuts as shown in Figure 16. This completes the repair.

! **IMPORTANT:** All replaced charge cords must be destroyed as described.

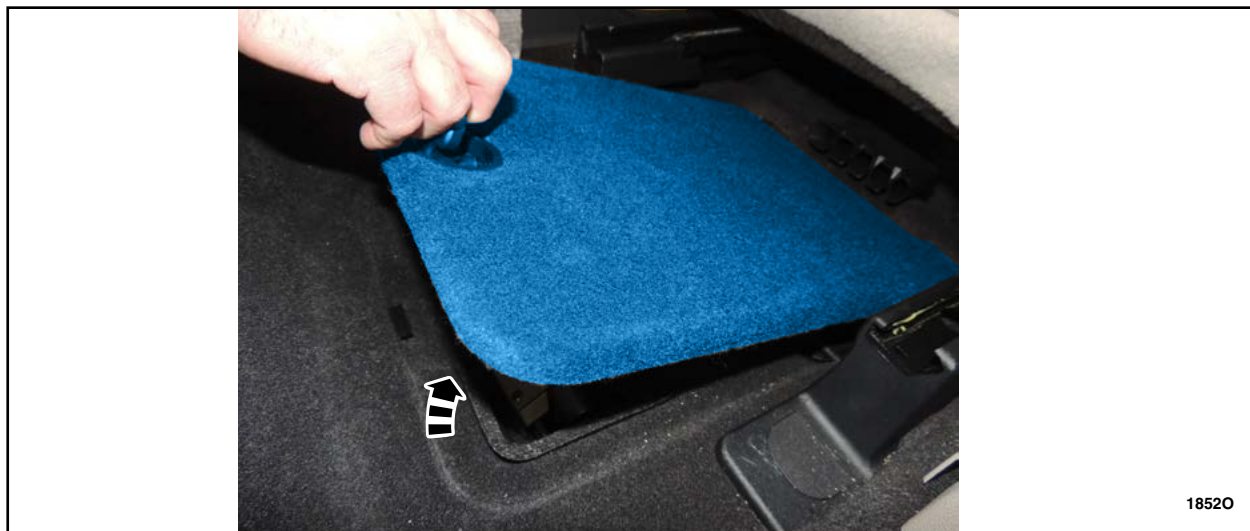
FIGURE 1

1. Open the driver side door and position the driver seat fully forward.
2. Remove the convenience charge cord storage cover behind the driver's seat. See Figure 1

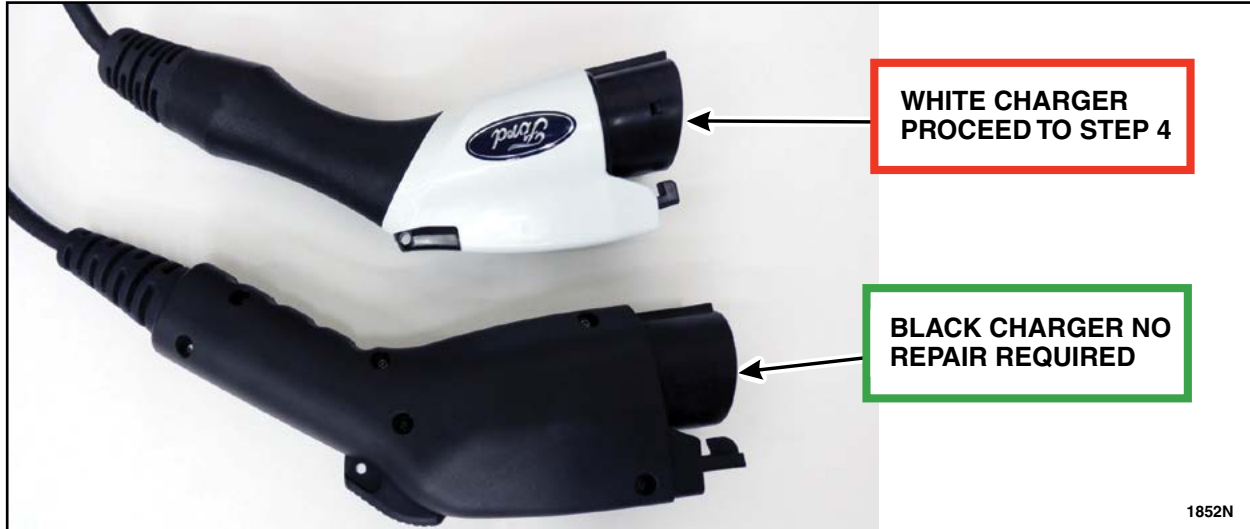
FIGURE 2

3. Inspect convenience charge cord. See Figure 2.

- White Charger - Proceed to Step 4 to inspect part number.
- Black Charger - No repair required.

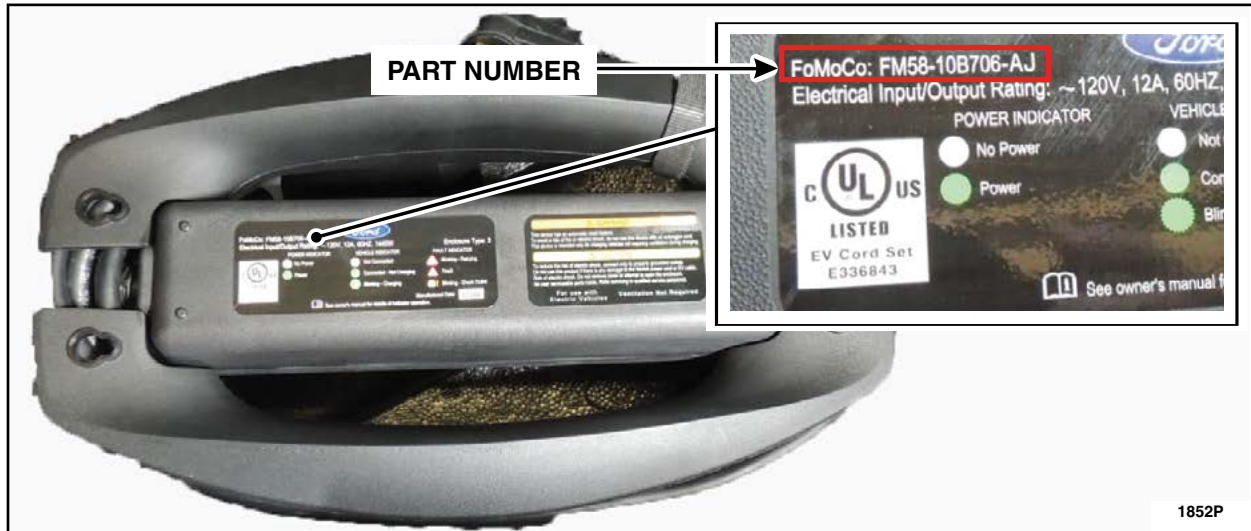
FIGURE 3

4. For **White** chargers, inspect convenience charge cord part number against the table below.
See Figure 3 and 4.

<p>DOES NOT PASS Recalled Part Numbers</p> <ul style="list-style-type: none">FM58-10B706-AAFM58-10B706-ABFM58-10B706-ACFM58-10B706-ADFM58-10B706-AEFM58-10B706-AF	<p>PASS</p> <p>All Other Part Numbers, No Repair Required</p>
---	--

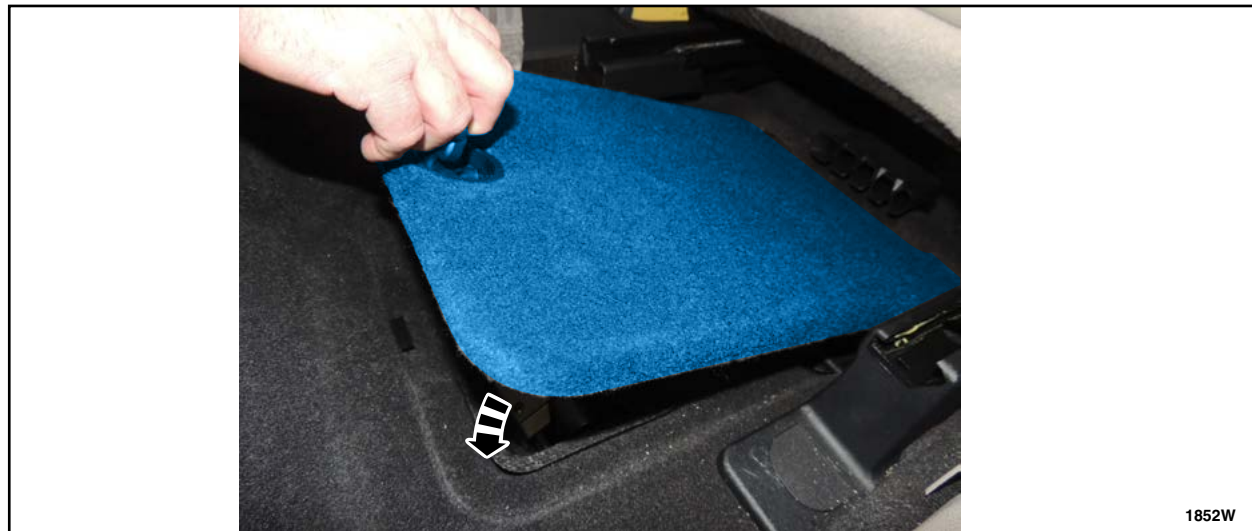
FIGURE 6

6. Install the convenience charge cord storage cover. See Figure 6.

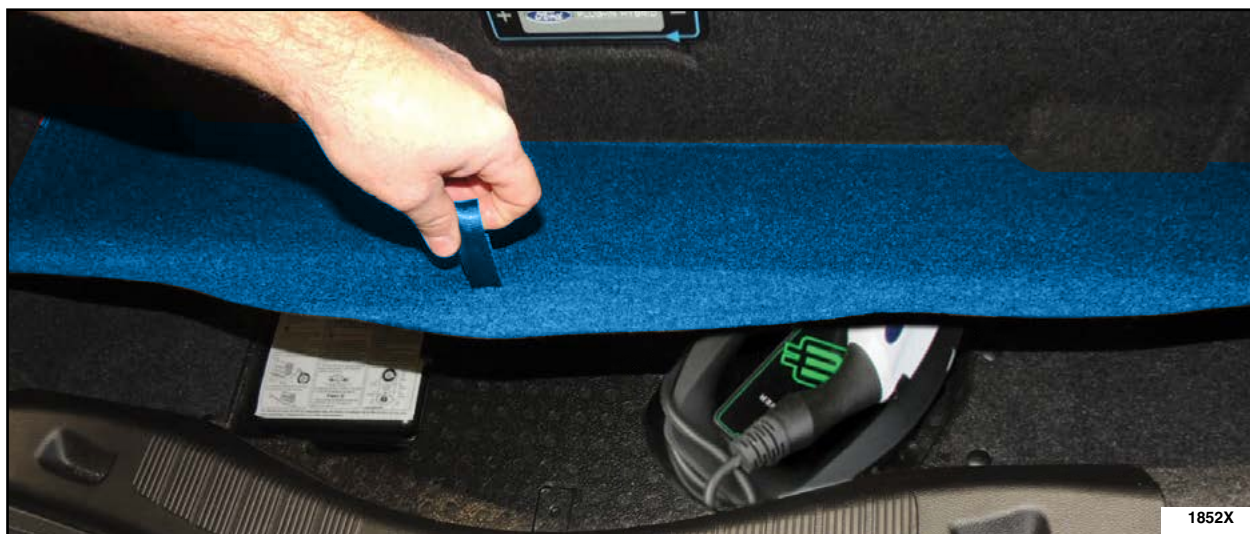
FIGURE 1

1. Open the trunk and the load space storage compartment lid. See Figure 1.

10. Install the load space storage compartment cover by reversing step 1 and close the trunk.
See Figure 1.
11. Destroy the old convenience charge cord so it cannot be reused. Cut the convenience charge cord in the areas shown. A minimum of 4 cuts as shown in Figure 9. This completes the repair.

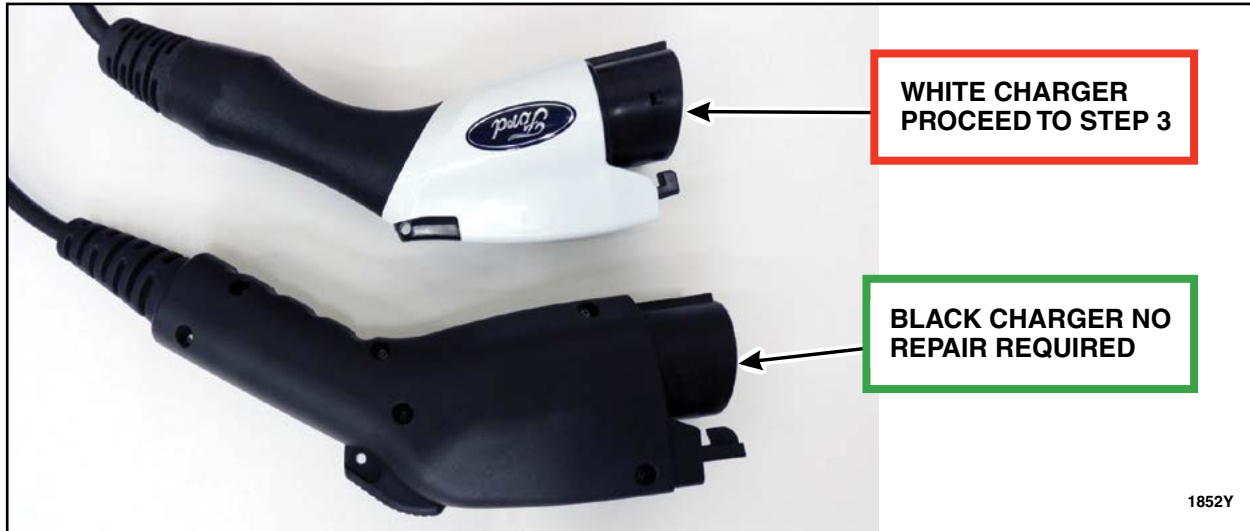
FIGURE 2

2. Remove and inspect convenience charge cord. See Figure 2.

- White Charger - Proceed to Step 3 to inspect part number.
- Black Charger - No repair required.

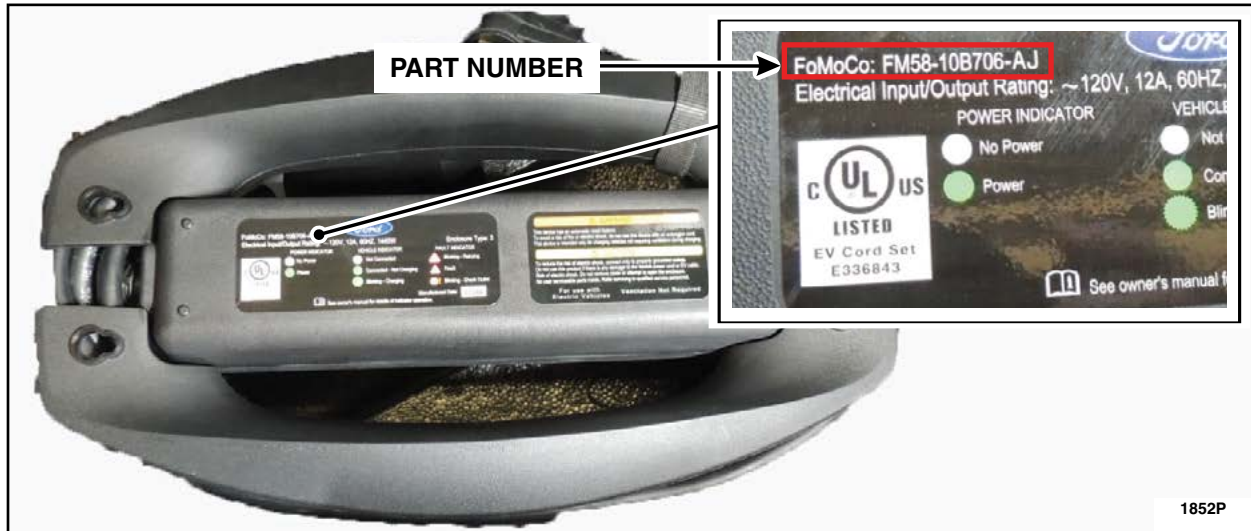
FIGURE 3

3. For **White** chargers, inspect convenience charge cord part number against the table below.
See Figure 3 and 4.

DOES NOT PASS Recalled Part Numbers	PASS All Other Part Numbers, No Repair Required
FM58-10B706-AA	
FM58-10B706-AB	
FM58-10B706-AC	
FM58-10B706-AD	
FM58-10B706-AE	
FM58-10B706-AF
