Dear Nissan Titan owner:

Reason for Recall
Motivo del Retiro

Installation Instructions

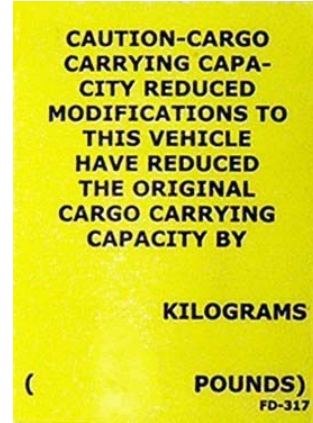
Figure 1

1. Park the vehicle in a safe place with the ignition OFF, the parking brake ON, and the automatic transmission in "P".
2. Open the driver's door.
3. Check if your vehicle already has a Load Carrying Capacity Modification label (see Figure 1).
4. See Figures 2-4 below for appropriate label placement on your vehicle, specific to your Titan model.

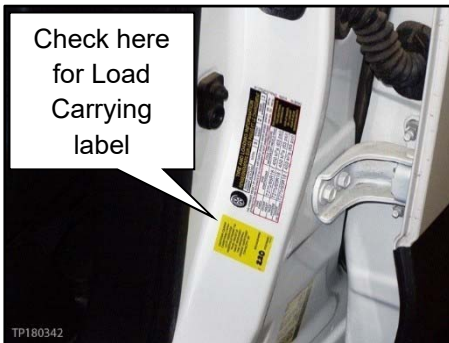
Figure 2 (Crew Cab)

Crew Cab (Figure 2) and Single Cab (Figure 3)

If present, the Load Carrying Capacity Modification label will be located **below** the existing Tire and Loading Information label on the driver's side B pillar (driver door jamb).

5. Does the vehicle already have a Load Carrying Capacity Modification label?
 - **YES**, No further action is required. Discard the supplied label.
 - **NO**, Continue to Step 6.
6. Clean the area where the label will be placed with mild soap and water.
7. Completely dry the area.
8. Peel the new Load Carrying Capacity Modification label from the backing sheet and affix to within 1 inch of the Tire and Loading label. See Figures 2-4 for appropriate label placement for your vehicle.

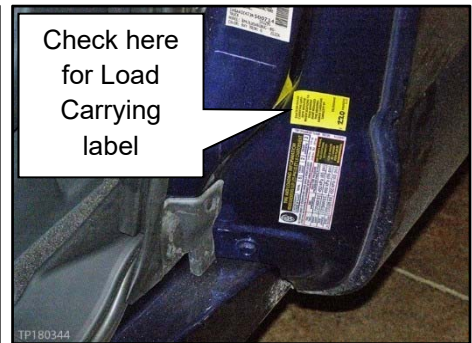
Figure 4 (King Cab)

King Cab (Figure 4)

If present, the Load Carrying Capacity Modification label will be located **above** the existing Tire and Loading Information label on the driver's side rear passenger door.
