Revised (2) May 2019

Dealer Service Instructions for:

Safety Recall U03 / NHTSA 18V-021 Passenger Airbag Inflator

The front passenger airbag inflator (PAB) on about 328,000 of the above vehicles may contain propellant that degraded after prolonged exposure to high absolute humidity, high temperatures and high temperature cycling. Activation of an inflator with degraded propellant, in a vehicle crash where the PAB is designed to deploy, may result in an inflator explosion. An inflator explosion may cause metal fragments to pass through the air bag and into the vehicle interior at high speed, which may result in injury or death to vehicle occupants.

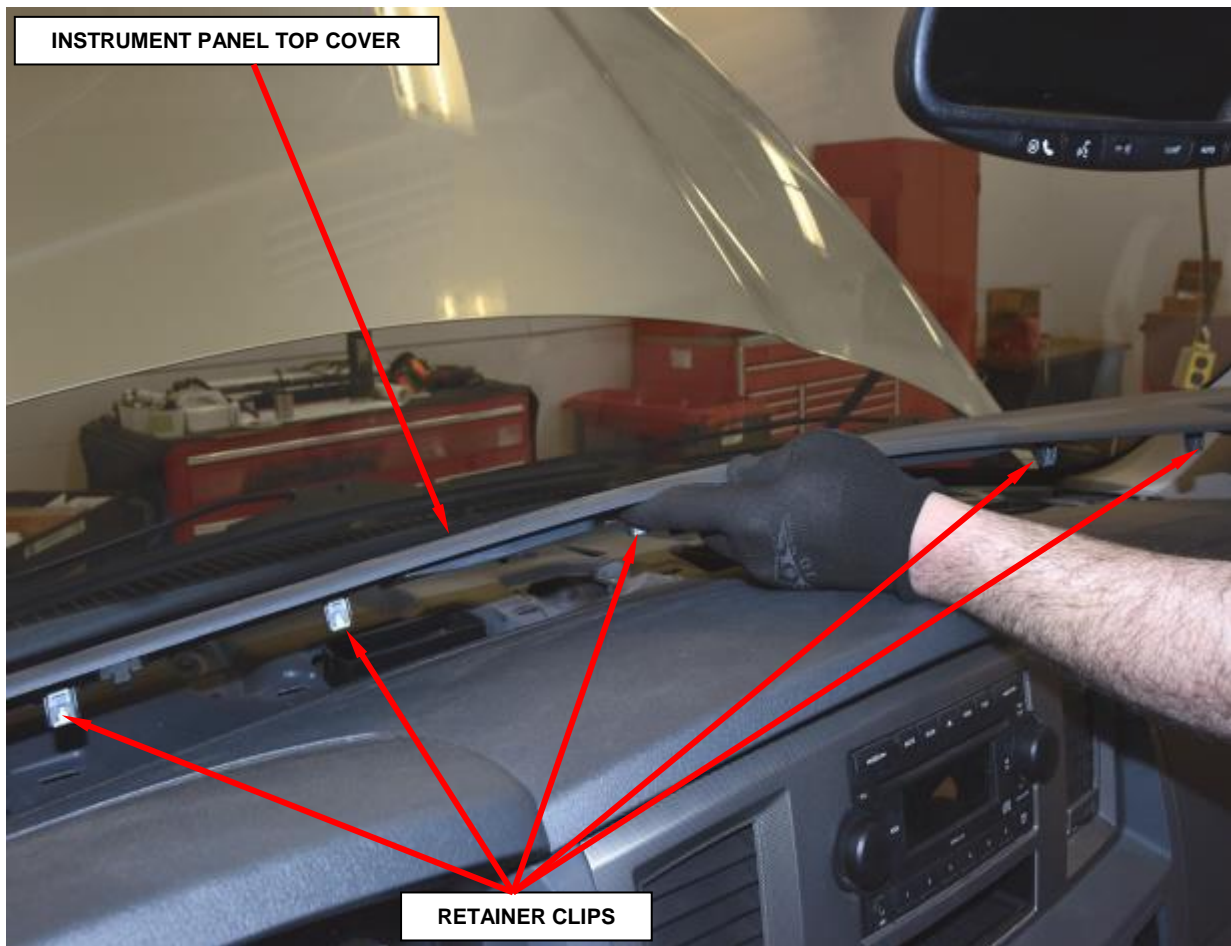
Figure 1 - Instrument Panel Top Cover

2. Using a trim stick C-4755 or equivalent, disengage the eight retainer clips that secure the rear of the instrument panel top cover to the top of the instrument panel (Figure 1).
3. Pull the instrument panel top cover rearward to release the five retainer clips that secure the front of the instrument panel top cover to the top of the instrument panel and remove the cover.

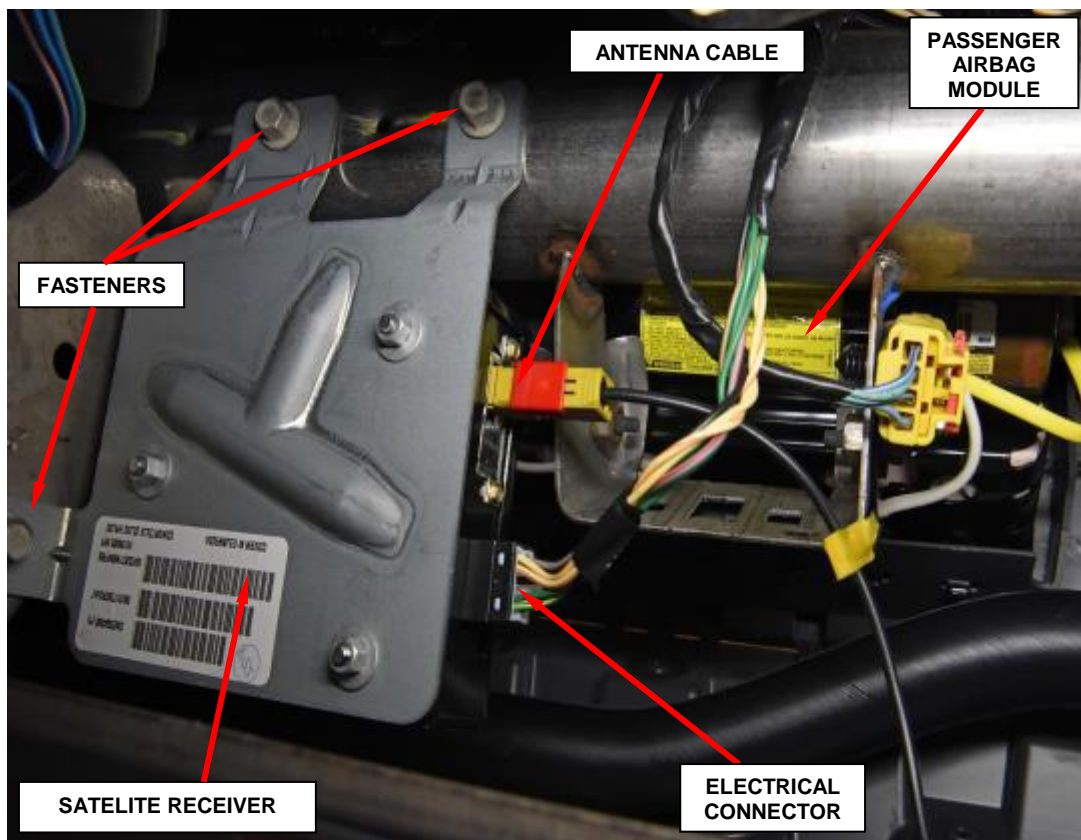
**Figure 2 – Satellite Receiver (if equipped)
(View through glove box opening)**

4. Remove the glove box from the instrument panel.
5. Disconnect the antenna cable and electrical connector, if equipped (Figure 2).
6. Remove the three mounting fasteners securing the receiver to the bracket if equipped (Figure 2).
7. Remove the satellite receiver, if equipped (Figure 2).

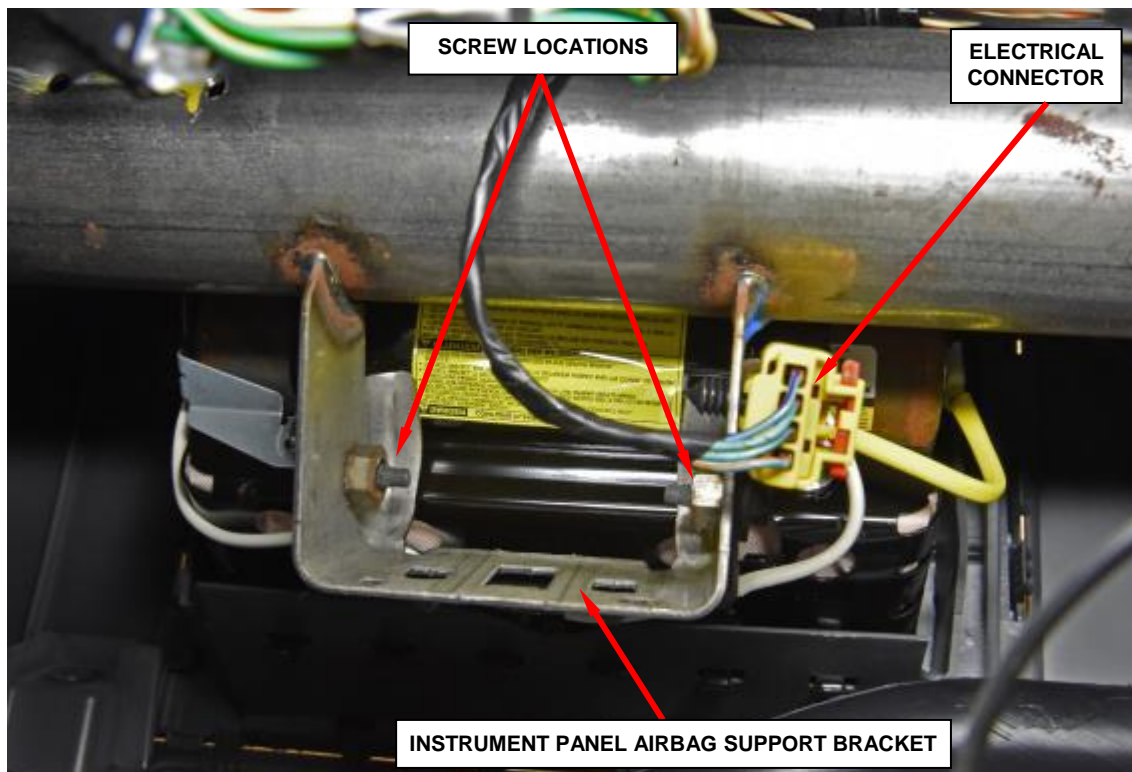
Figure 3 – Airbag Module (View through glove box opening)

8. Reach up into the instrument panel between the upper glove box opening reinforcement and the cross car beam to access and disconnect the instrument panel wire electrical connector from the airbag inflator pigtail wire connector on the right side of the instrument panel airbag support bracket (Figure 3). To disconnect the connector:
 - a. Slide the red Connector Position Assurance (CPA) lock on the top of the connector toward the side of the connector.
 - b. Depress the connector latch tab and pull the two halves of the connector straight away from each other.
9. Remove and save the two screws that secure the passenger airbag lower bracket to the instrument panel airbag support bracket (Figure 3).
10. Disengage the airbag inflator pigtail wire connector from the instrument panel airbag support bracket (Figure 3).

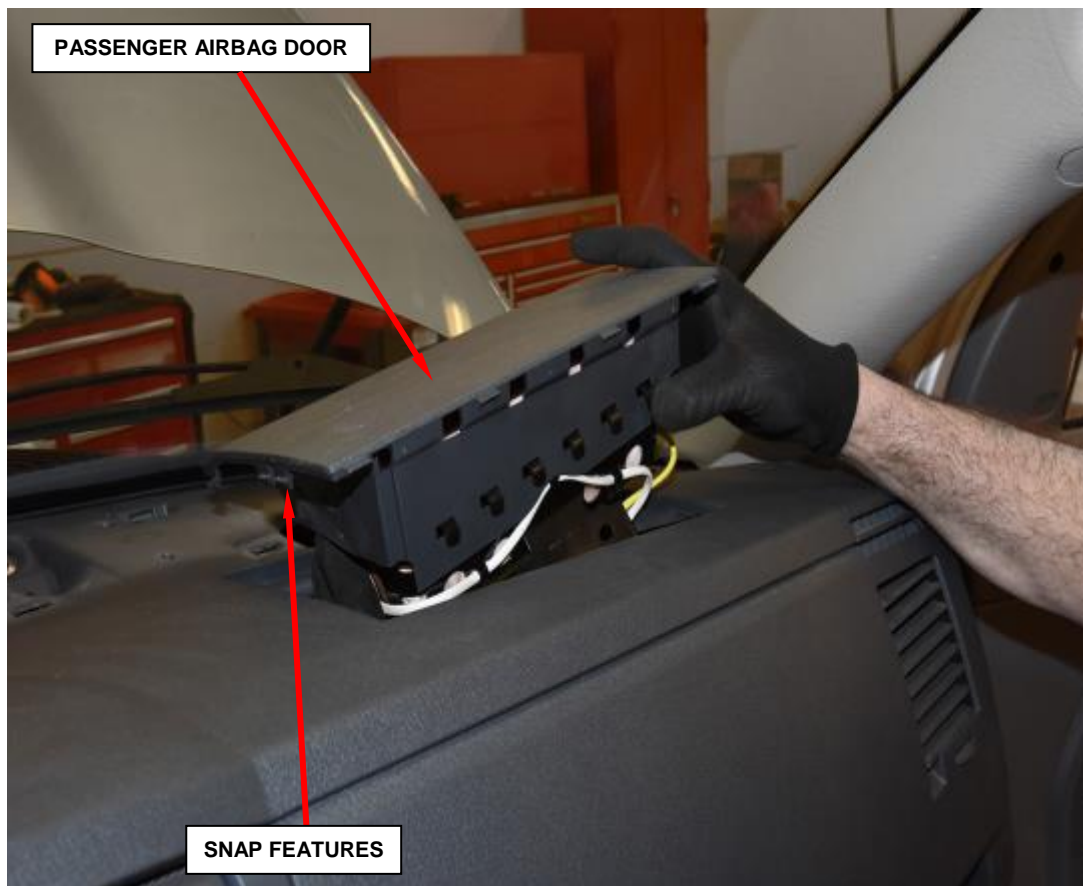
**Figure 4 – Passenger Airbag Removal**

12. Remove the passenger airbag and airbag door from the instrument panel as a unit.

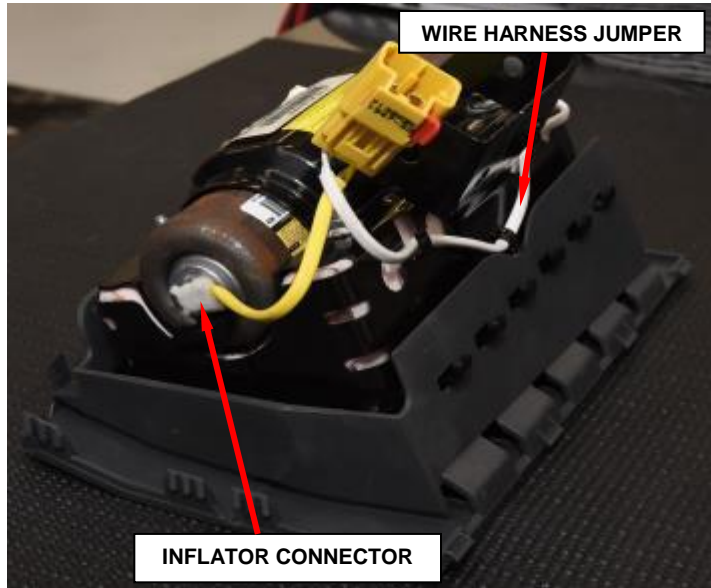
Figure 5 – Inflator Connector

b. Disconnect the single yellow wire inflator connector from the end of the inflator using pliers (Figure 5).

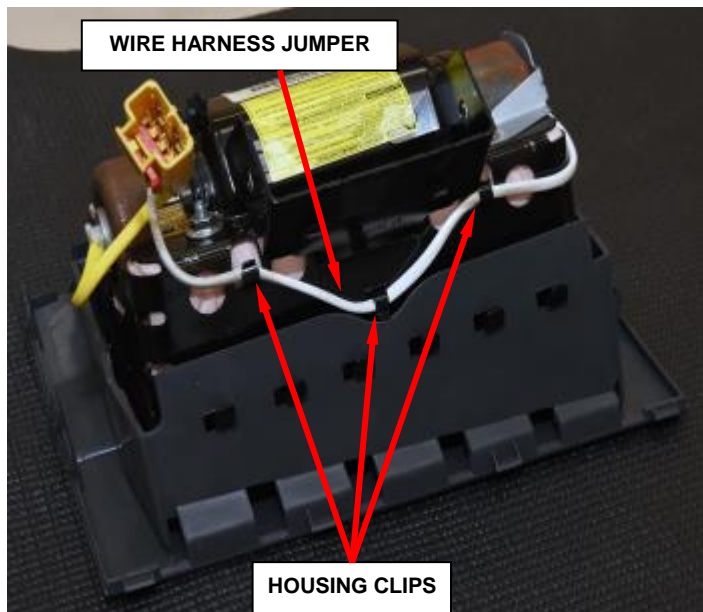
Figure 6 – Wire Harness Jumper

c. Disengage the wire harness jumper from the housing clips in three places (Figure 6).

- o. Install the stopper plate to the airbag module (Figure 7).
- p. Install the four **NEW** mounting nuts to the airbag module and tighten to 53 in. lbs. (6 N·m) (Figure 7).
- q. Connect the single yellow wire inflator connector to the end of the inflator after removing the protective tape from the end of the inflator (Figure 5).
- r. Engage the wire harness jumper under the housing clips in three places (Figure 6).
- s. Retrofit is complete.

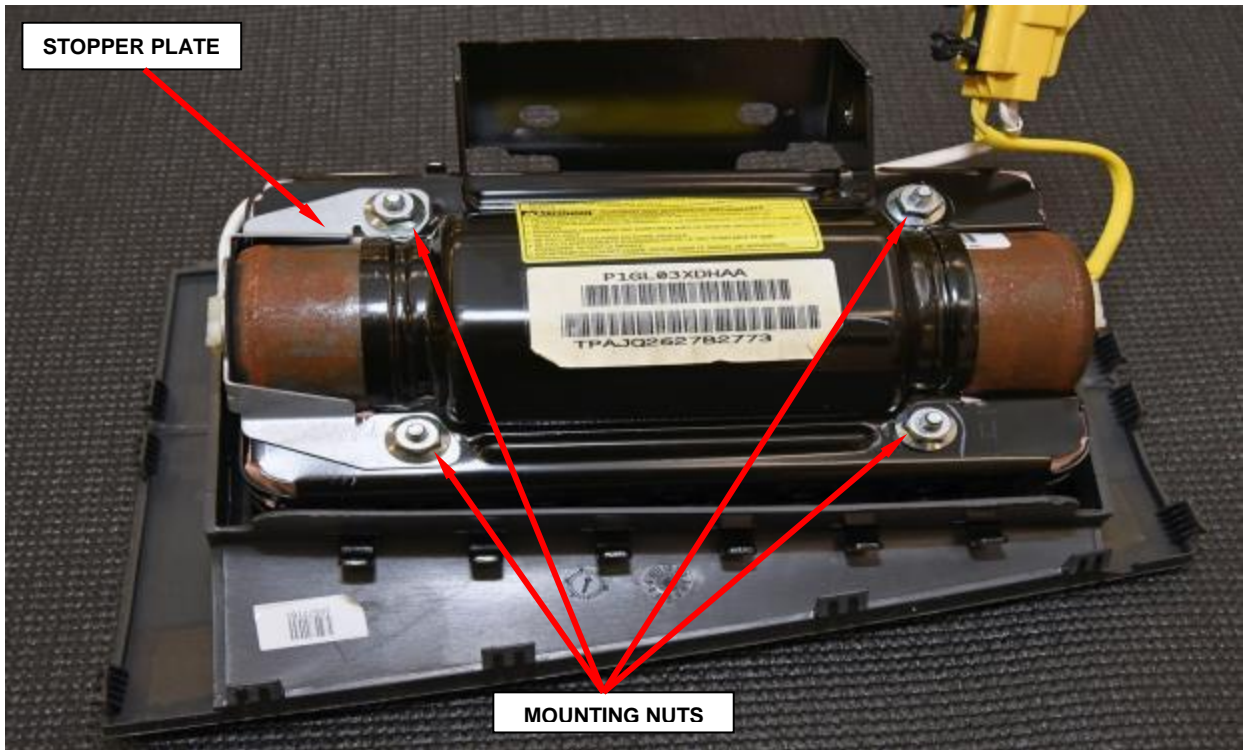
Figure 7 – Mounting Nuts and Stopper Plate

- d. Remove and **discard** the four mounting nuts and remove and save the stopper plate from the passenger airbag module (Figure 7).

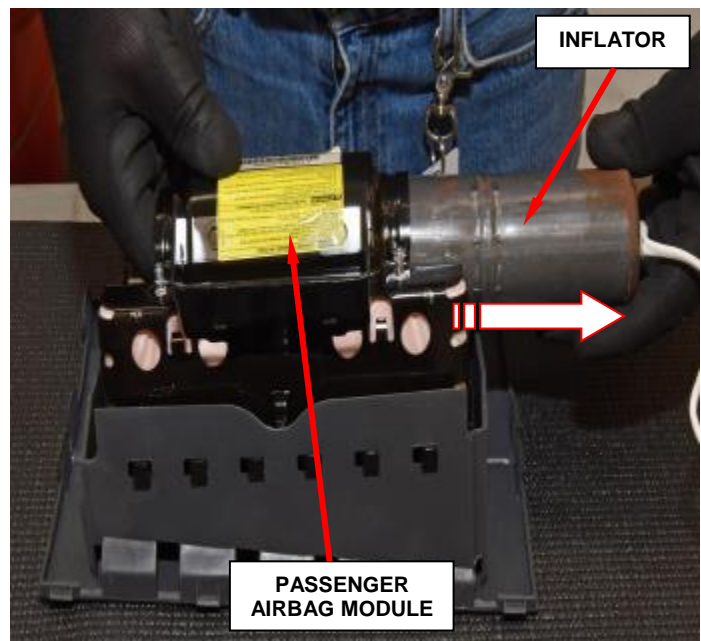
Figure 8 – Inflator Removal

- e. Slide the inflator out of the passenger airbag module (Figure 8).

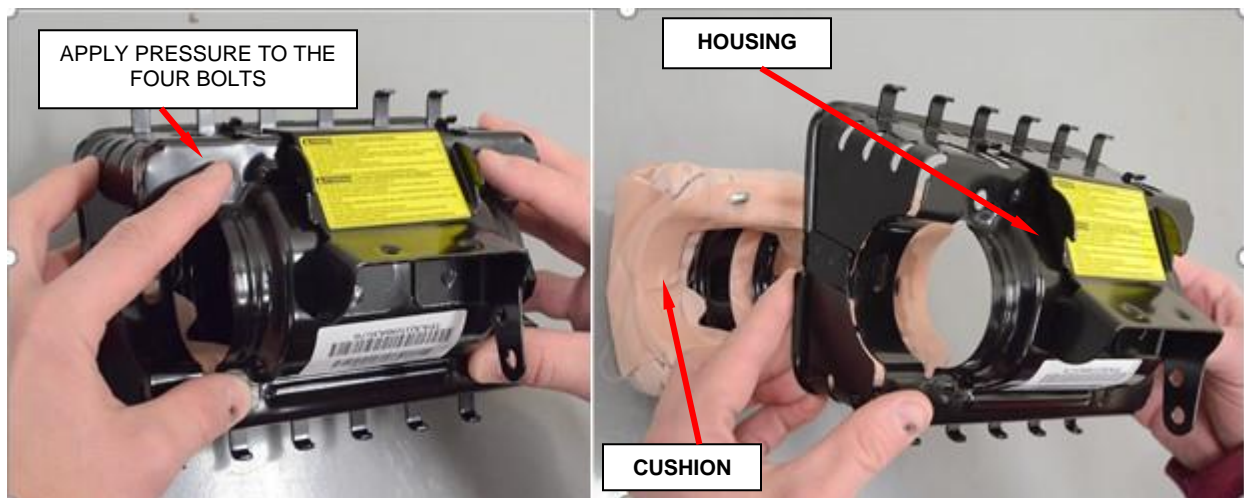
Figure 9 – Remove Airbag Cushion from Housing

g. Remove airbag cushion from housing by applying pressure to the bolts, set cushion aside (Figure 9).

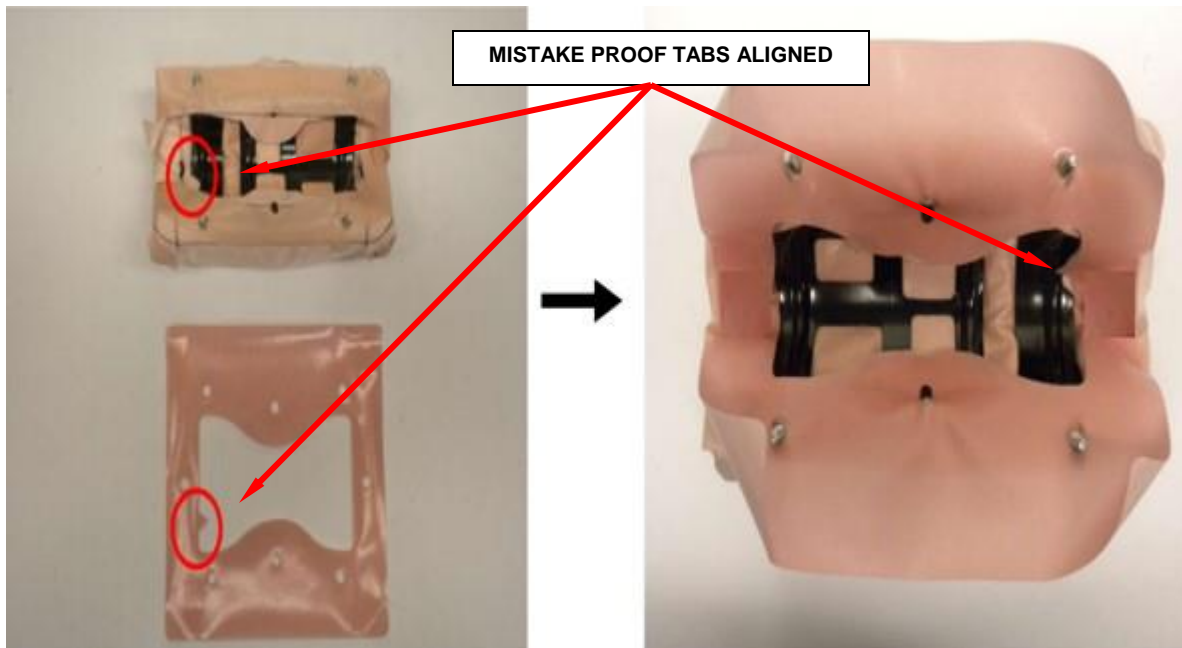
Figure 10 - Fabric Gasket to Cushion (Glossy Side Up)

- h. Place the fabric gasket, glossy side up, onto cushion. Mistake-proof tab should be aligned to the tab on the cushion (Figure 10).

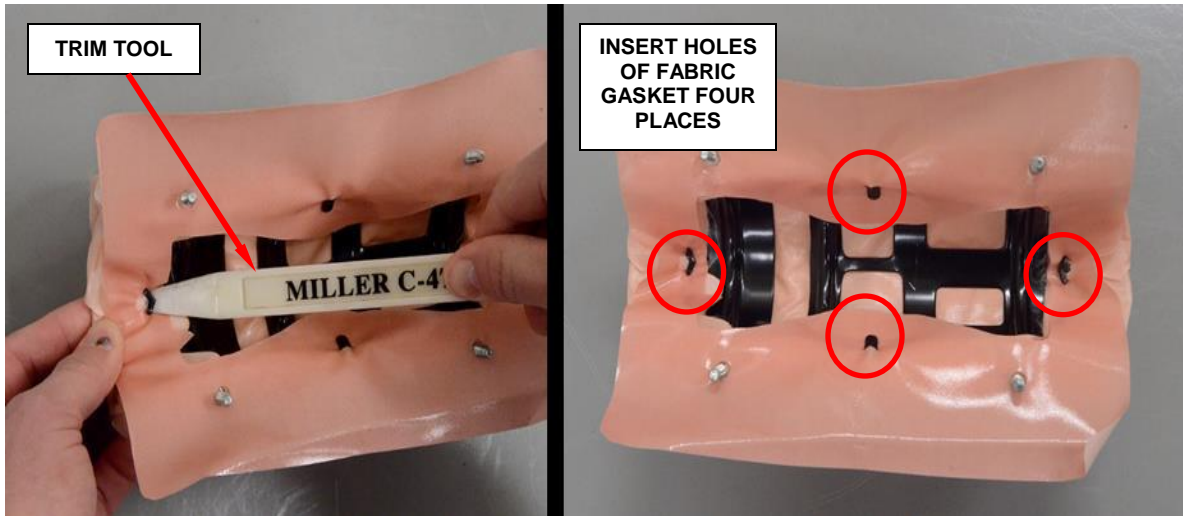
Figure 11 – Fabric Gasket

- i. With the help of a trim tool insert the holes of fabric gasket, four places (Figure 11).

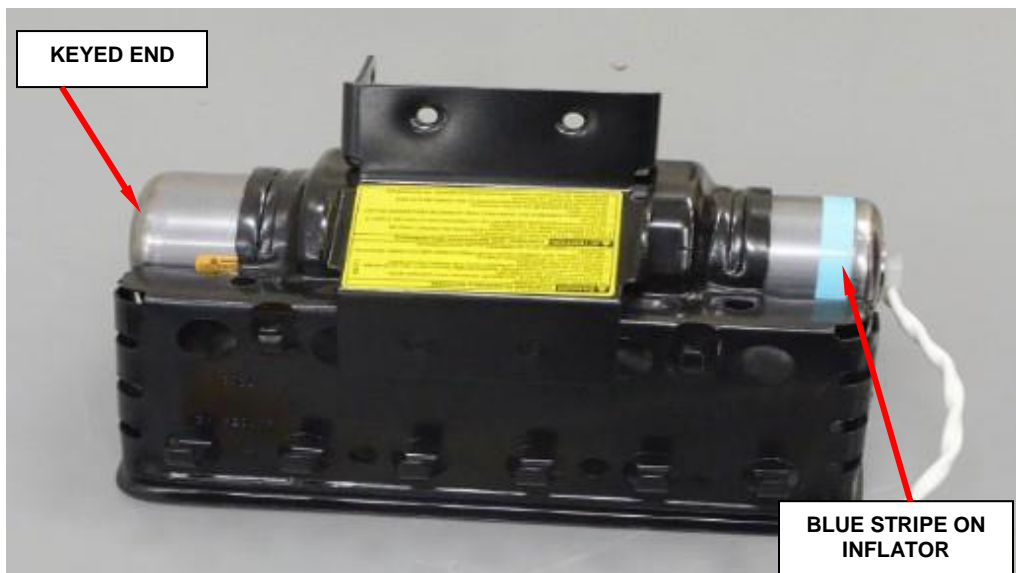
Figure 12 – Insert Inflator

- j. Slide **new** inflator into housing. The keyed end is inserted first, therefore the blue stripe on the inflator will be located at the open end, as shown (Figure 12).

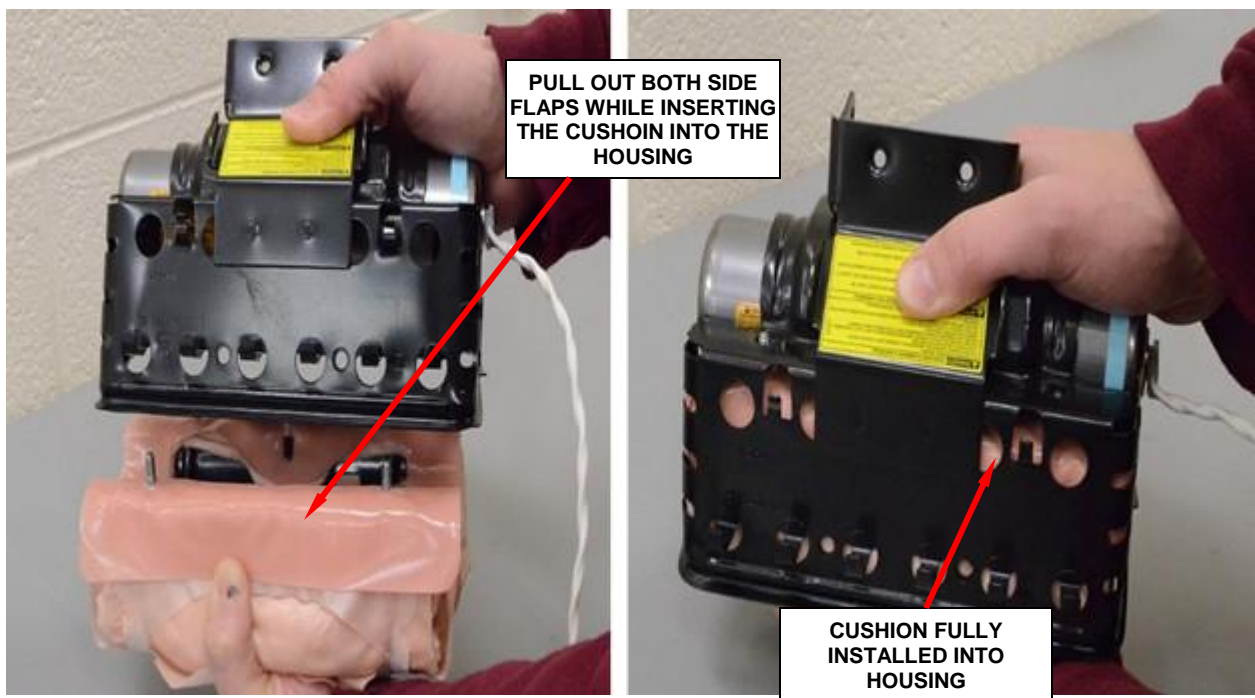
Figure 13 - Side Flaps Must Be Held Out

NOTE: The spacing between the bolts is different on both sides, thus mistake-proof.

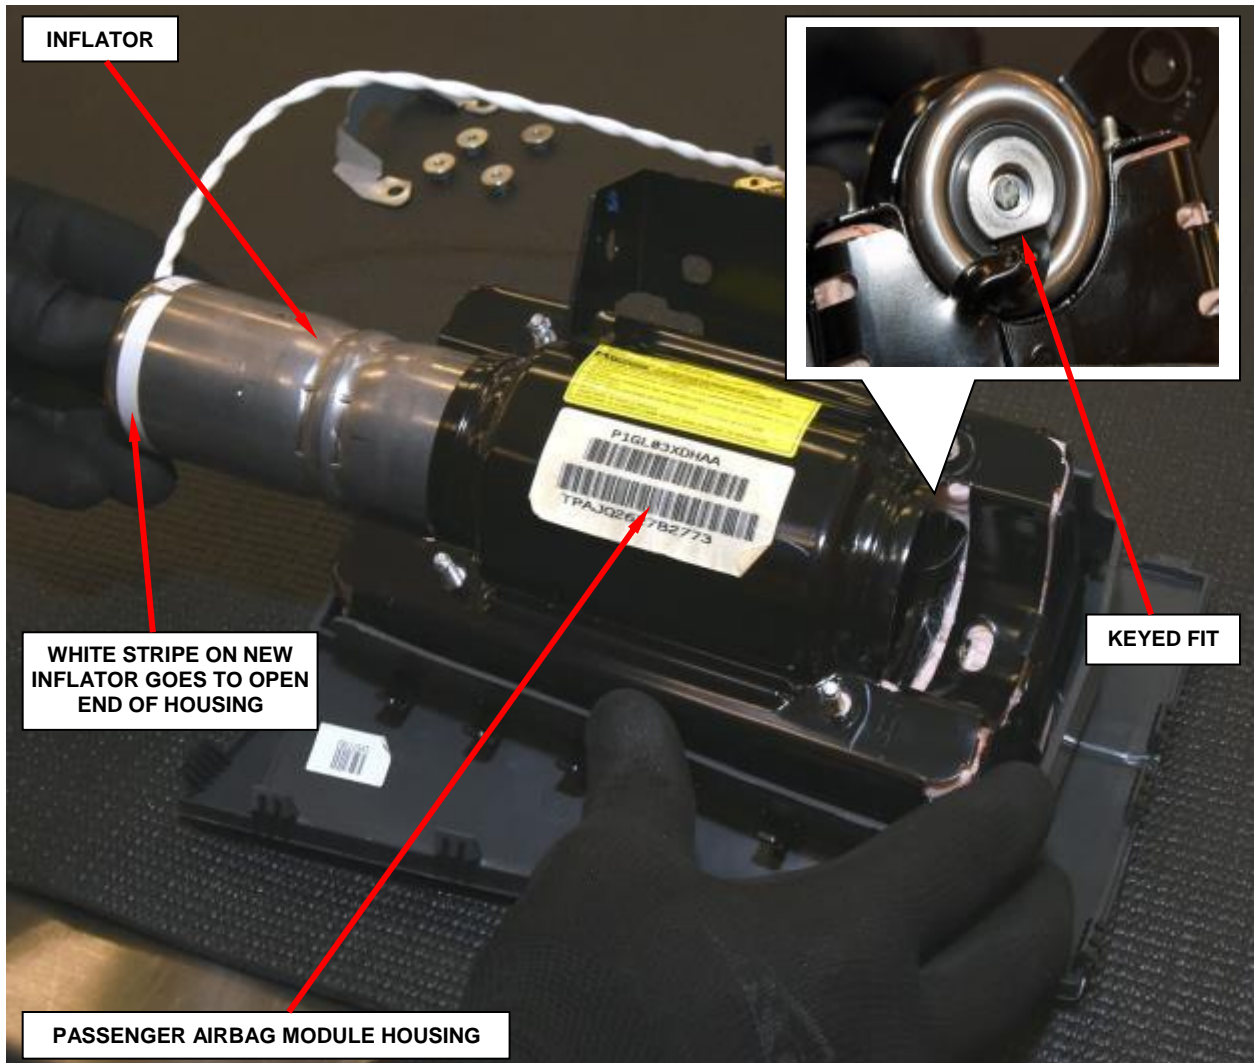
Figure 14 - Passenger Inflator Installation

NOTE: The inflator is keyed to fit into the housing (Figure 14).

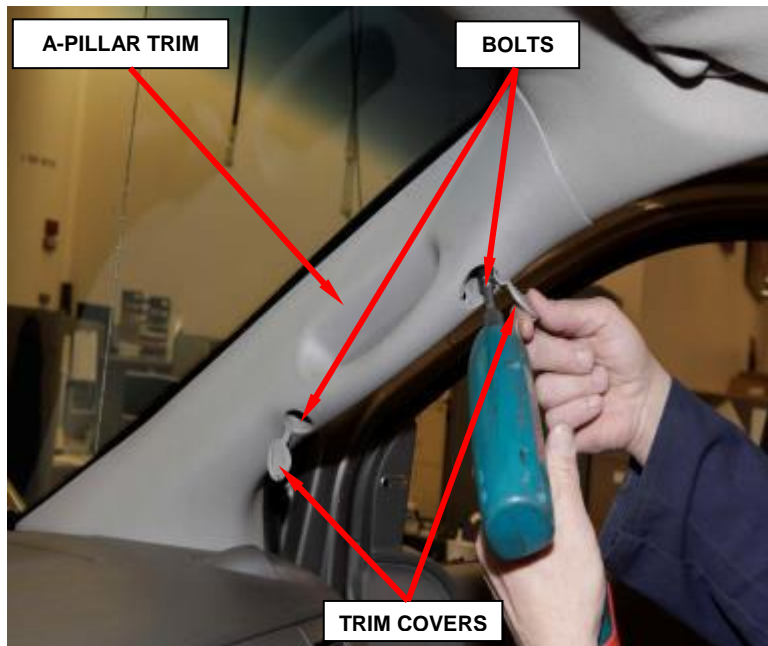
Figure 15 – Passenger Side A-Pillar Trim

2. Use the following steps to remove the defroster grille from the top of the instrument panel.
 - a. Using a trim stick, remove the driver side A-pillar trim.
 - b. Open the trim covers in the passenger side A-pillar grab handle and remove and save the two bolts (Figure 15).
 - c. Remove the passenger side A-pillar trim.
 - d. Using a trim stick, remove the instrument panel defroster grille (Figure 16).
 - e. Disconnect the sun sensor electrical connector from the center of the instrument panel defroster grille.

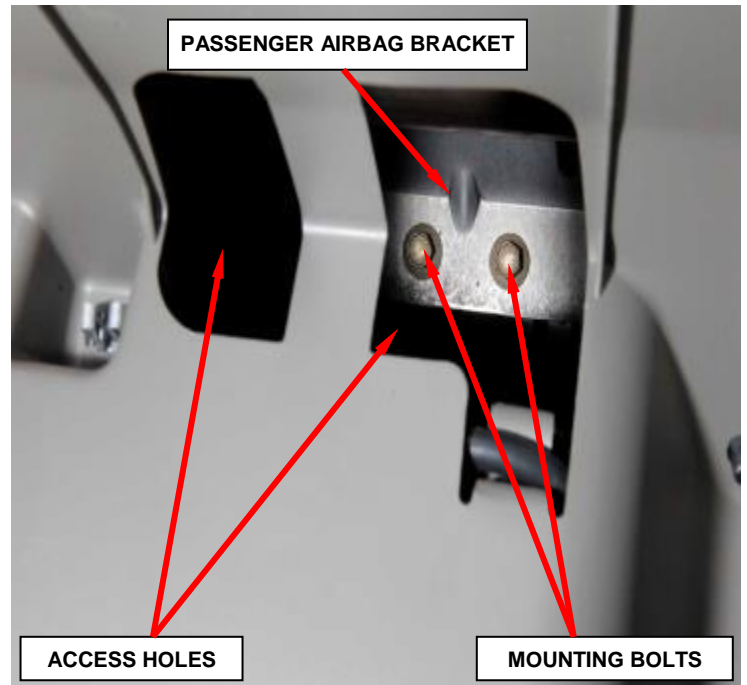
Figure 17 – Airbag Mounting Screws and Bracket

3. Use the following steps to remove the glove box.
 - a. Release the two glove box stops and lower the glove box downward past the stops.
 - b. Disengage the glove box hinges from the instrument panel and remove the glove box.
4. Reach up into the instrument panel glove box opening and through the access holes to remove and save the two mounting bolts that secure the passenger airbag bracket to the instrument panel support structure (Figure 17) (Figure 18).

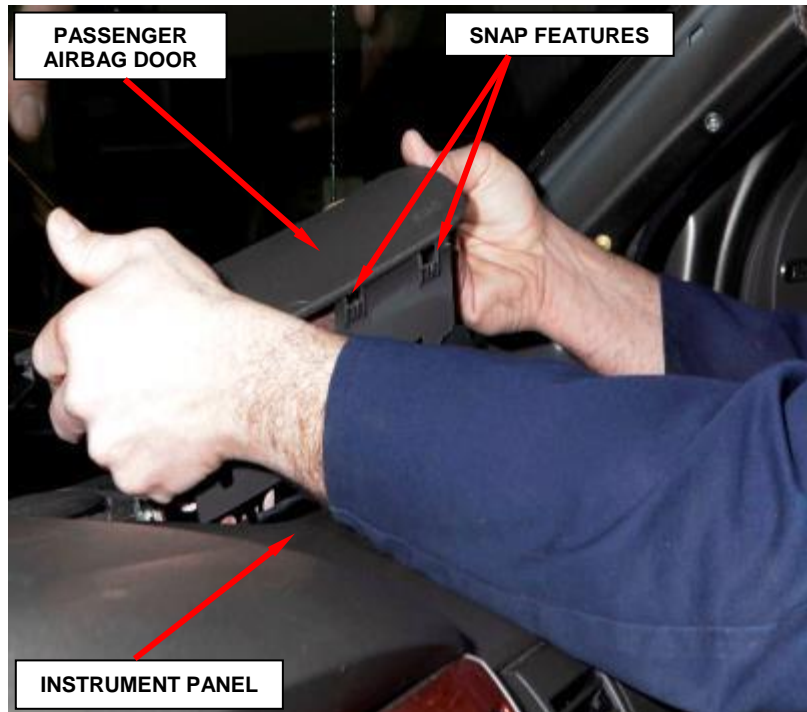
Figure 19 – Passenger Airbag Door

5. Using a trim stick or another suitable wide flat bladed tool, gently pry the forward and side edges of the passenger airbag door away from the top of the instrument panel far enough to disengage the snap features on the airbag door from the receptacles in the instrument panel top pad (Figure 19).

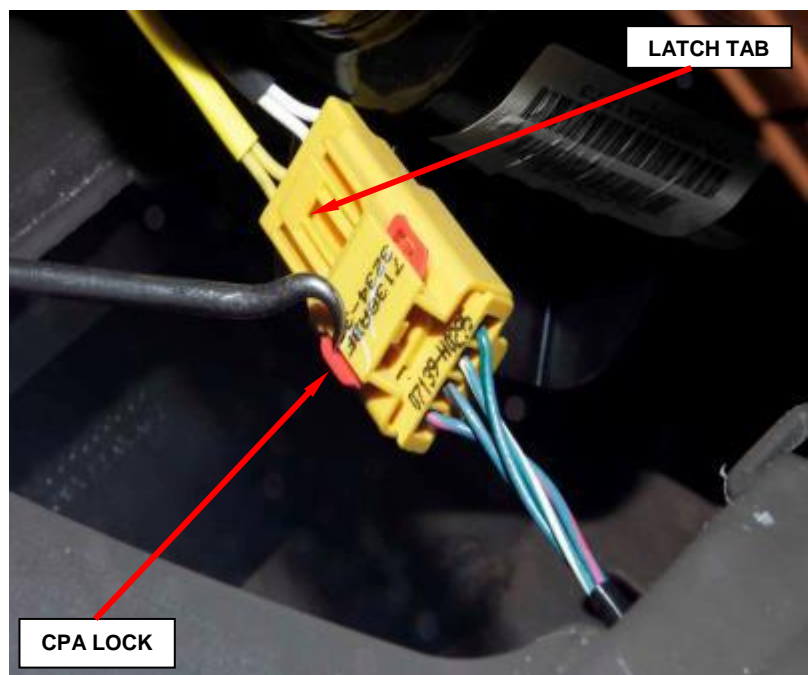
Figure 20 – Airbag Inflator Pigtail Connector

- a. Slide the red Connector Position Assurance (CPA) lock on the connector toward the side of the connector (Figure 20).
- b. Depress the connector latch tab and pull the two halves of the connector straight away from each other.

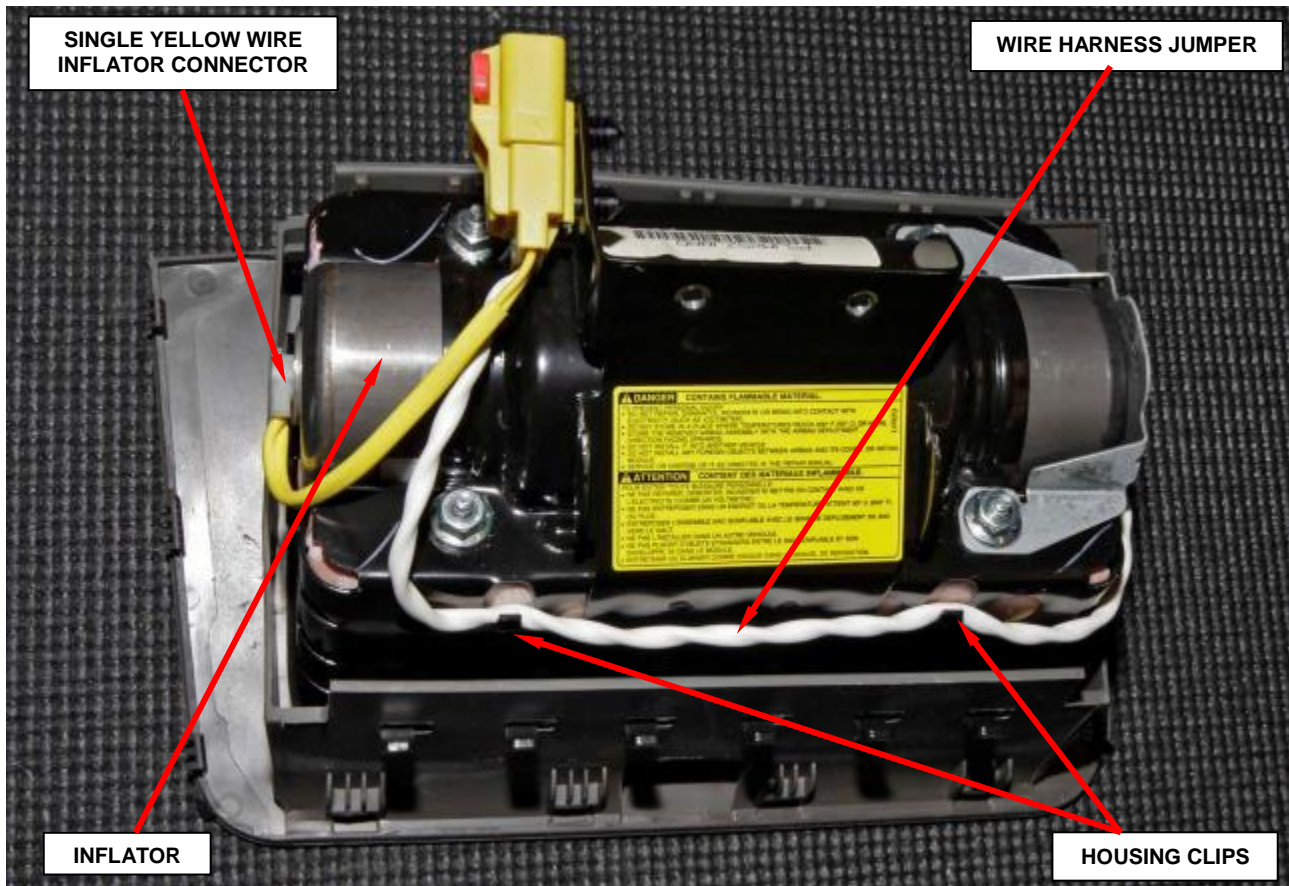
Figure 21 – Passenger Airbag Assembly

7. Remove the passenger airbag and airbag door from the instrument panel as a unit.
8. Use the following procedure to retrofit the passenger airbag assembly.
 - a. Place the passenger airbag assembly on a soft surface to prevent damage using the foam block provided with the inflator kit.
 - b. Disengage the wire harness jumper from the housing clips in two places (Figure 21).
 - c. Disconnect the single yellow wire inflator connector from the end of the inflator (Figure 21).

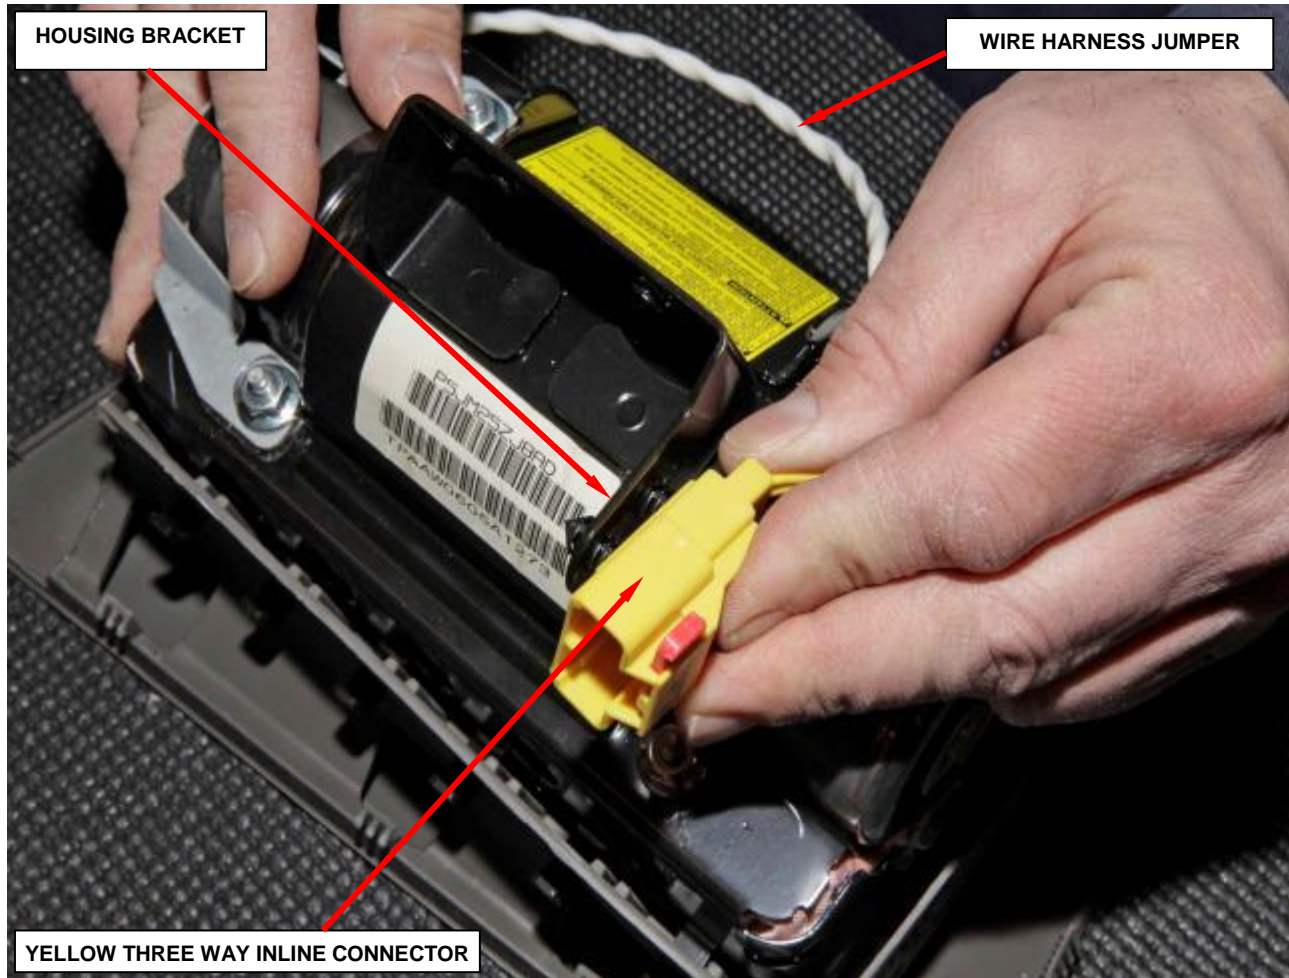
Figure 22 – Inflator Connectors

- d. Release the yellow three way inline connector from the housing bracket (Figure 22).

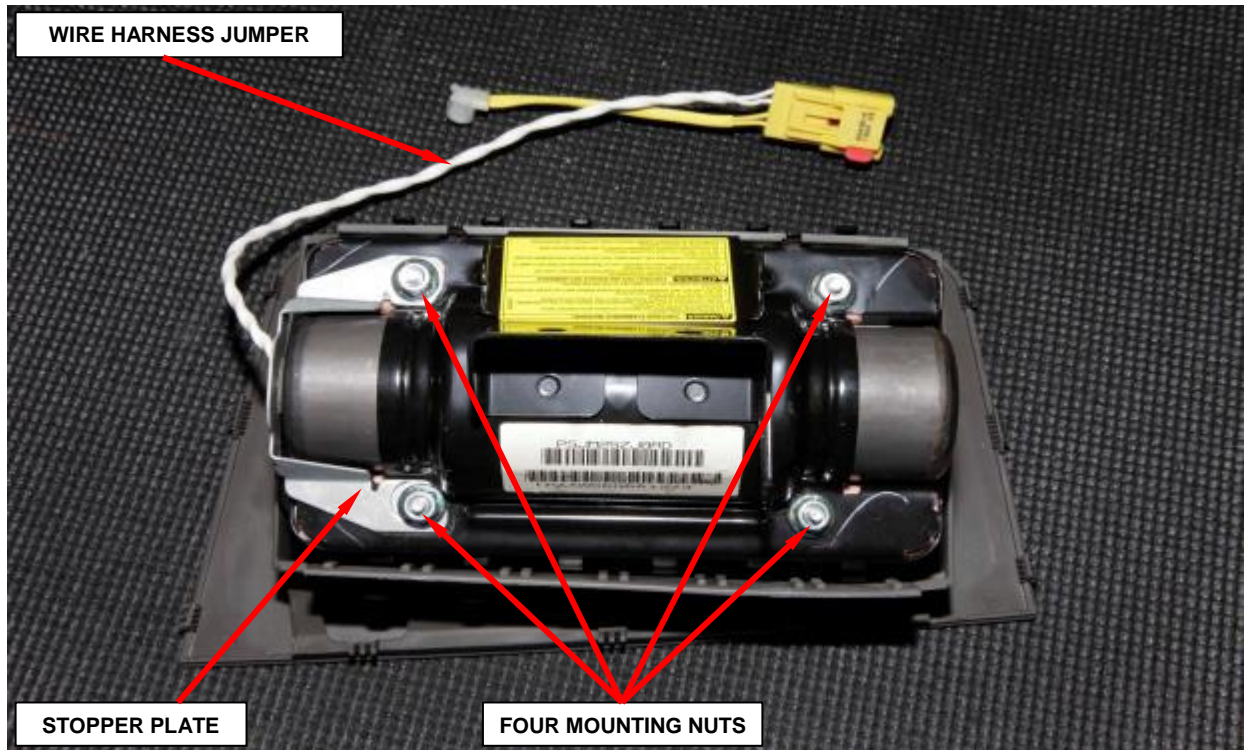
Figure 23 – Mounting Nuts and Stopper Plate

- e. Remove and **discard** the four mounting nuts and remove and save the stopper plate from the housing (Figure 23)
- f. Slide the inflator out of the housing (Figure 24).

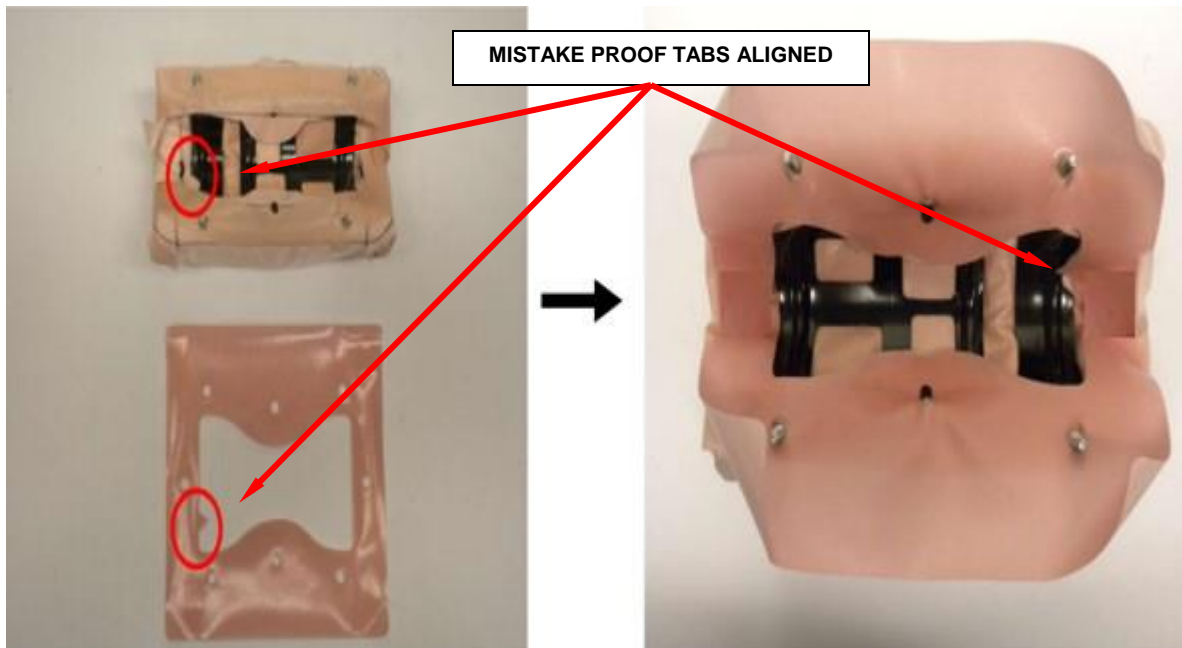
Figure 26 - Fabric Gasket to Cushion (Glossy Side Up)

- i. Place the fabric gasket, glossy side up, onto cushion. Mistake-proof tab should be aligned to the tab on the cushion (Figure 26).

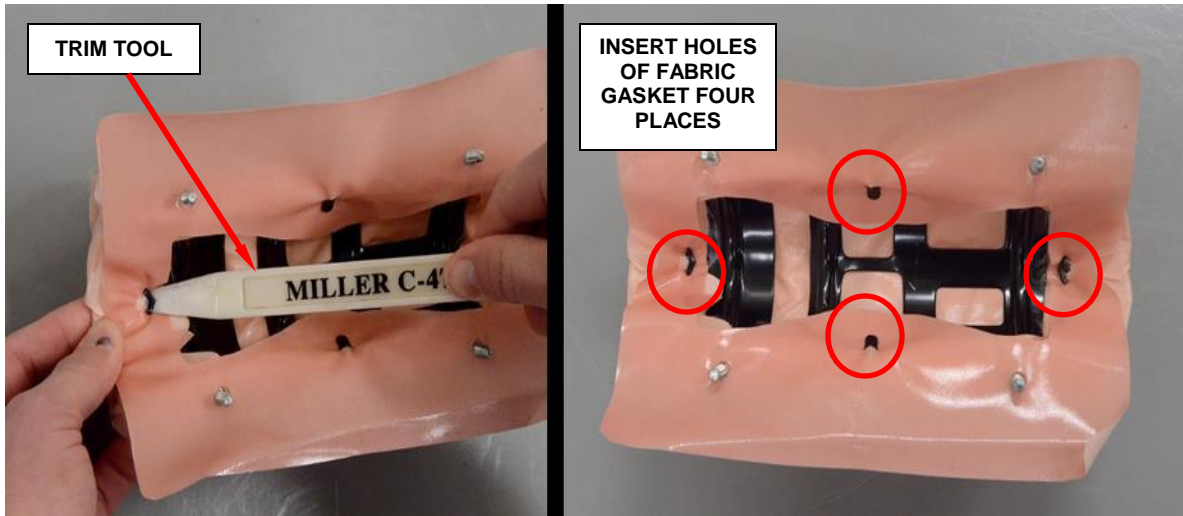
Figure 27 – Fabric Gasket

- j. With the help of a trim tool insert the holes of fabric gasket, four places (Figure 27).

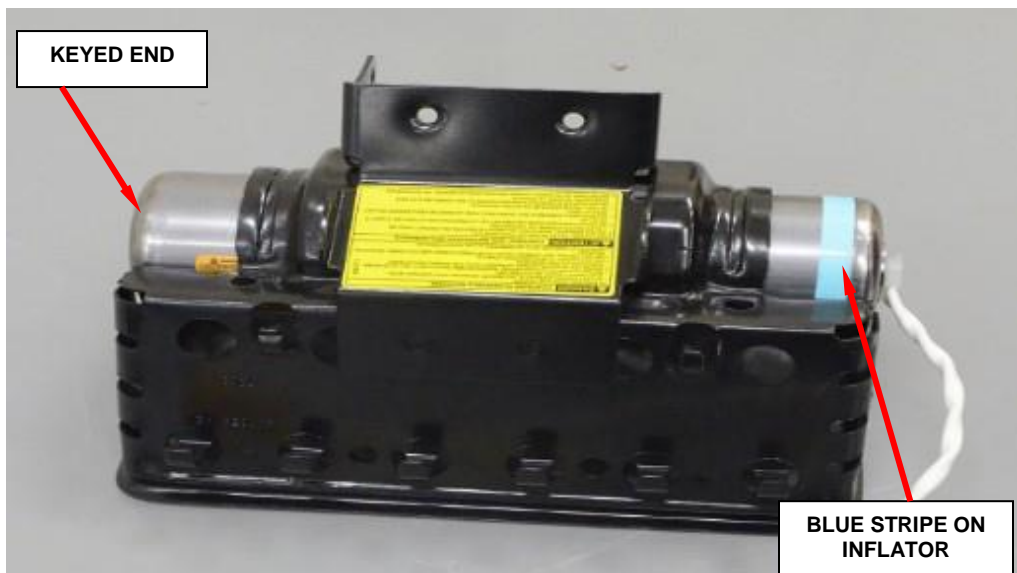
Figure 28 – Insert Inflator

- k. Slide **new** inflator into housing. The keyed end is inserted first, therefore the blue stripe on the inflator will be located at the open end, as shown (Figure 28).

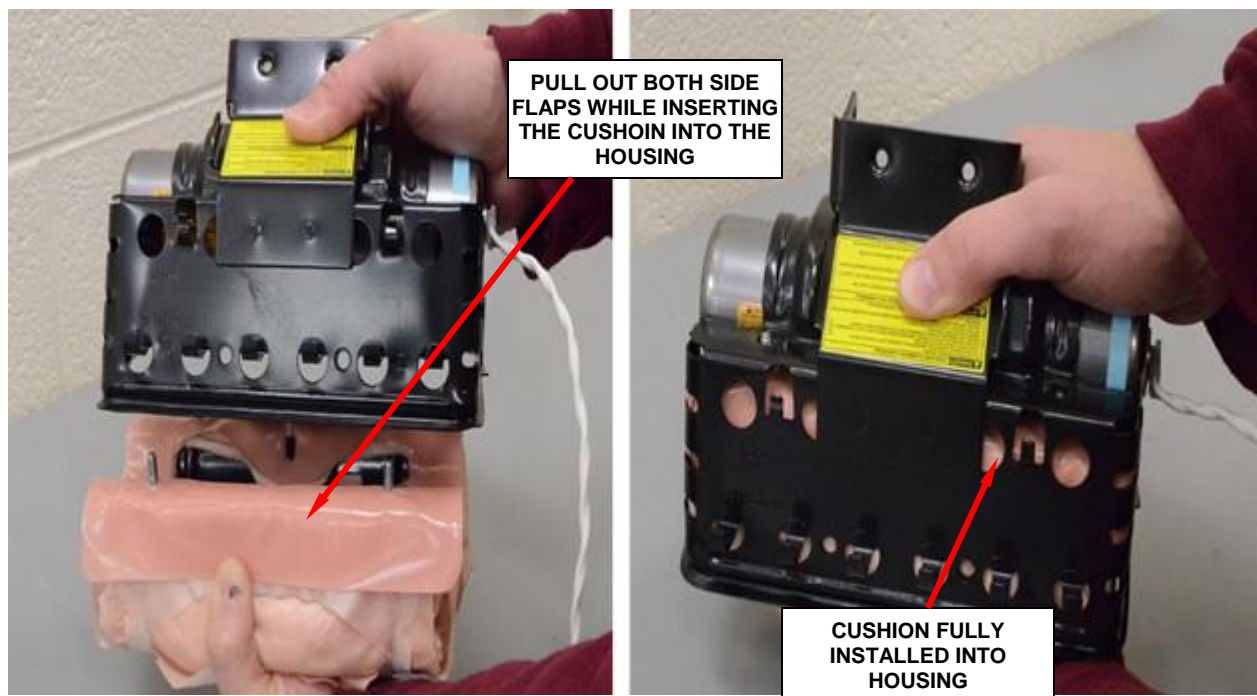
Figure 29 - Side Flaps Must Be Held Out

1. Insert the cushion, pulling out both side flaps (Figure 29).

NOTE: The spacing between the bolts is different on both sides, thus mistake-proof.

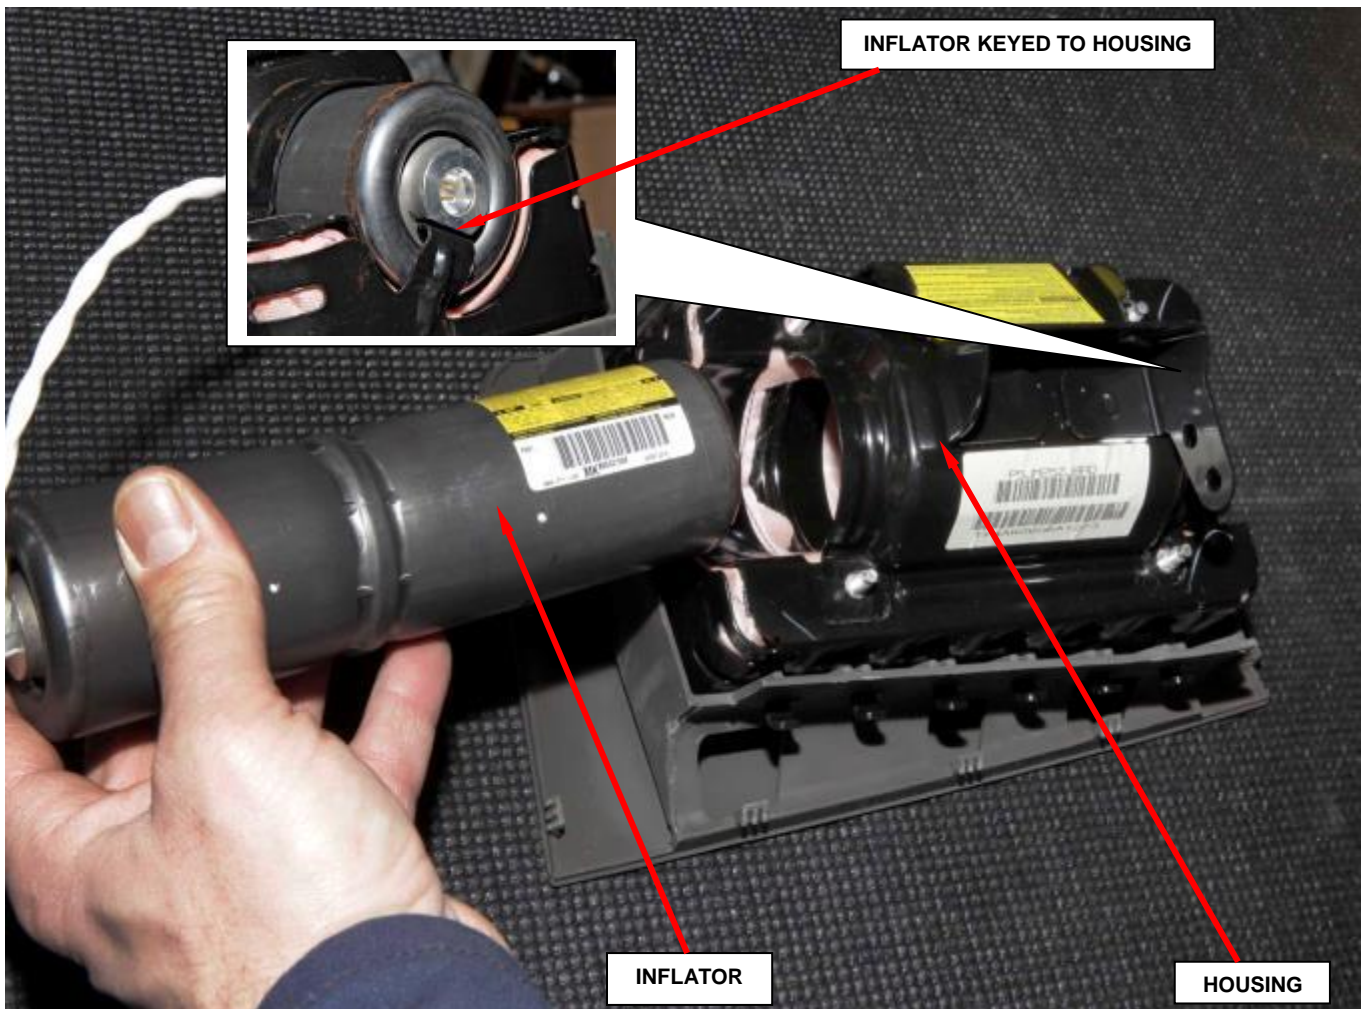
Figure 30 – Inflator Installation

NOTE: The inflator is keyed to fit into the housing.
