Revised (2) May 2019

Dealer Service Instructions for:

Safety Recall U03 / NHTSA 18V-021 Passenger Airbag Inflator

The front passenger airbag inflator (PAB) on about 328,000 of the above vehicles may contain propellant that degraded after prolonged exposure to high absolute humidity, high temperatures and high temperature cycling. Activation of an inflator with degraded propellant, in a vehicle crash where the PAB is designed to deploy, may result in an inflator explosion. An inflator explosion may cause metal fragments to pass through the air bag and into the vehicle interior at high speed, which may result in injury or death to vehicle occupants.

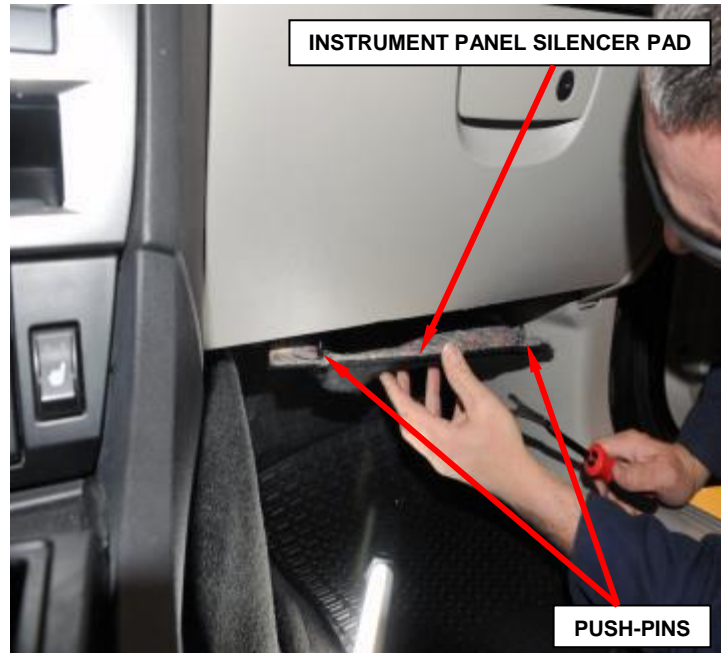
Figure 31 - Instrument Panel Silencer

2. Use the following steps to remove the right side instrument panel silencer pad.
 - a. Remove and save the two push-pins that secure the instrument panel silencer to the instrument panel (Figure 31).
 - b. Pull the right side silencer pad rearward to disengage it from the brackets located near the dash panel.
 - c. Remove the right side silencer pad from the vehicle.

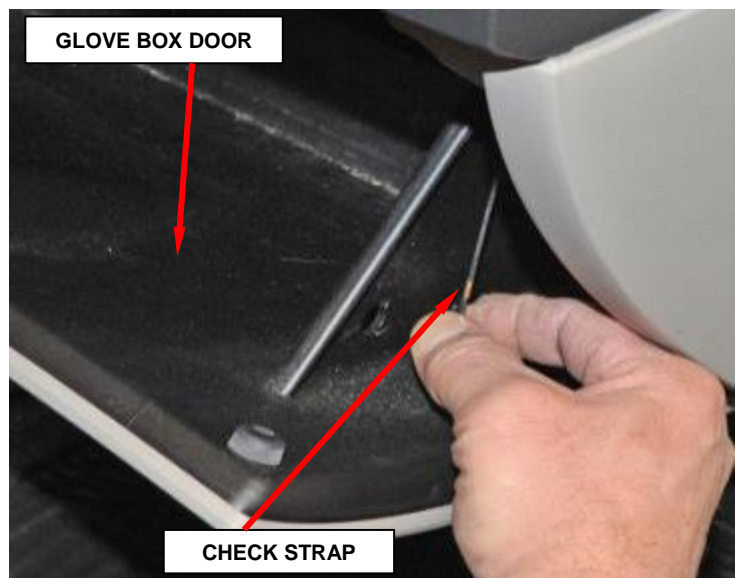
Figure 32 – Check Strap

3. Use the following steps to remove the glove box.
 - a. Remove the check strap from the right side of the glove box (Figure 32).
 - b. Release the two glove box stops and lower the glove box downward past the stops.
 - c. Disengage the glove box hinges from the instrument panel and remove the glove box.

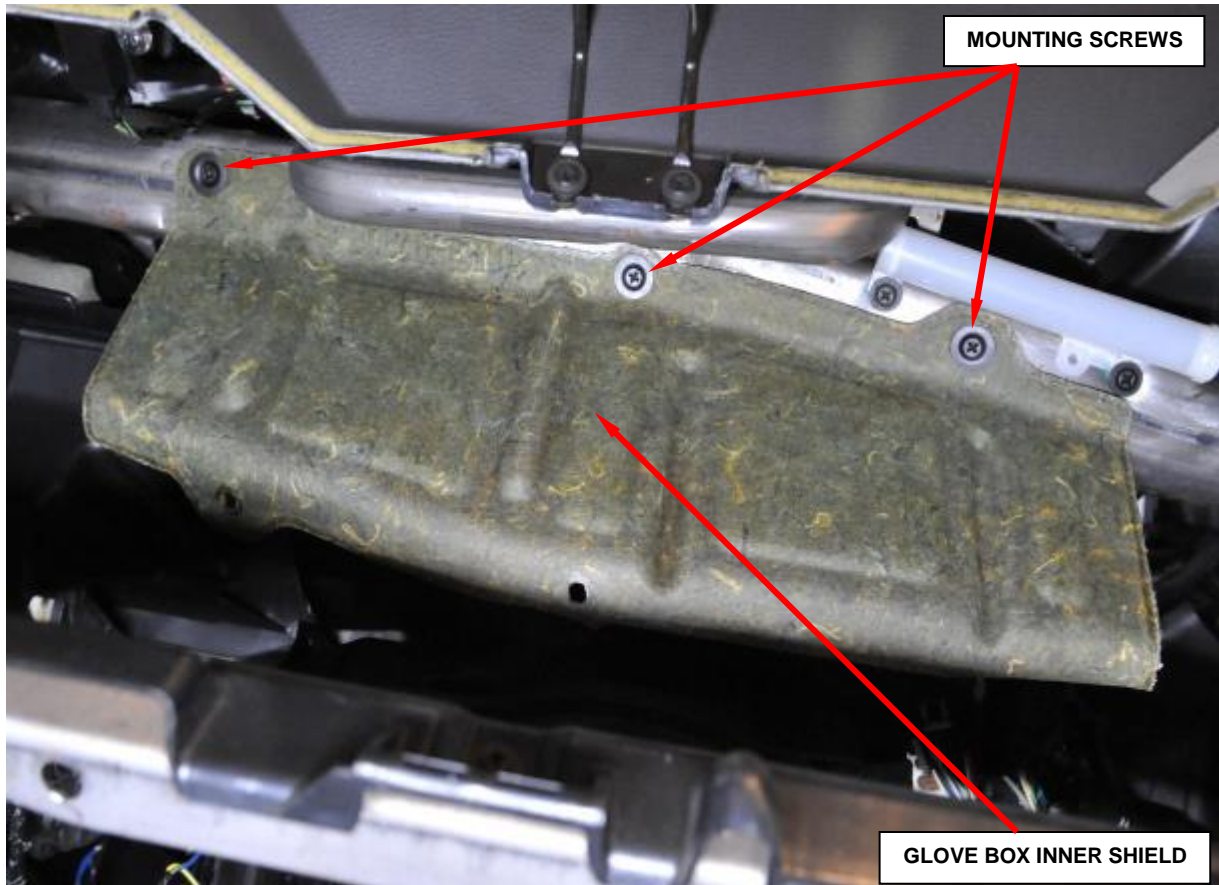
Figure 33 – Inner Glove Box Shield

4. Remove and save the three mounting screws to the inner glove box shield, if equipped (Figure 33).

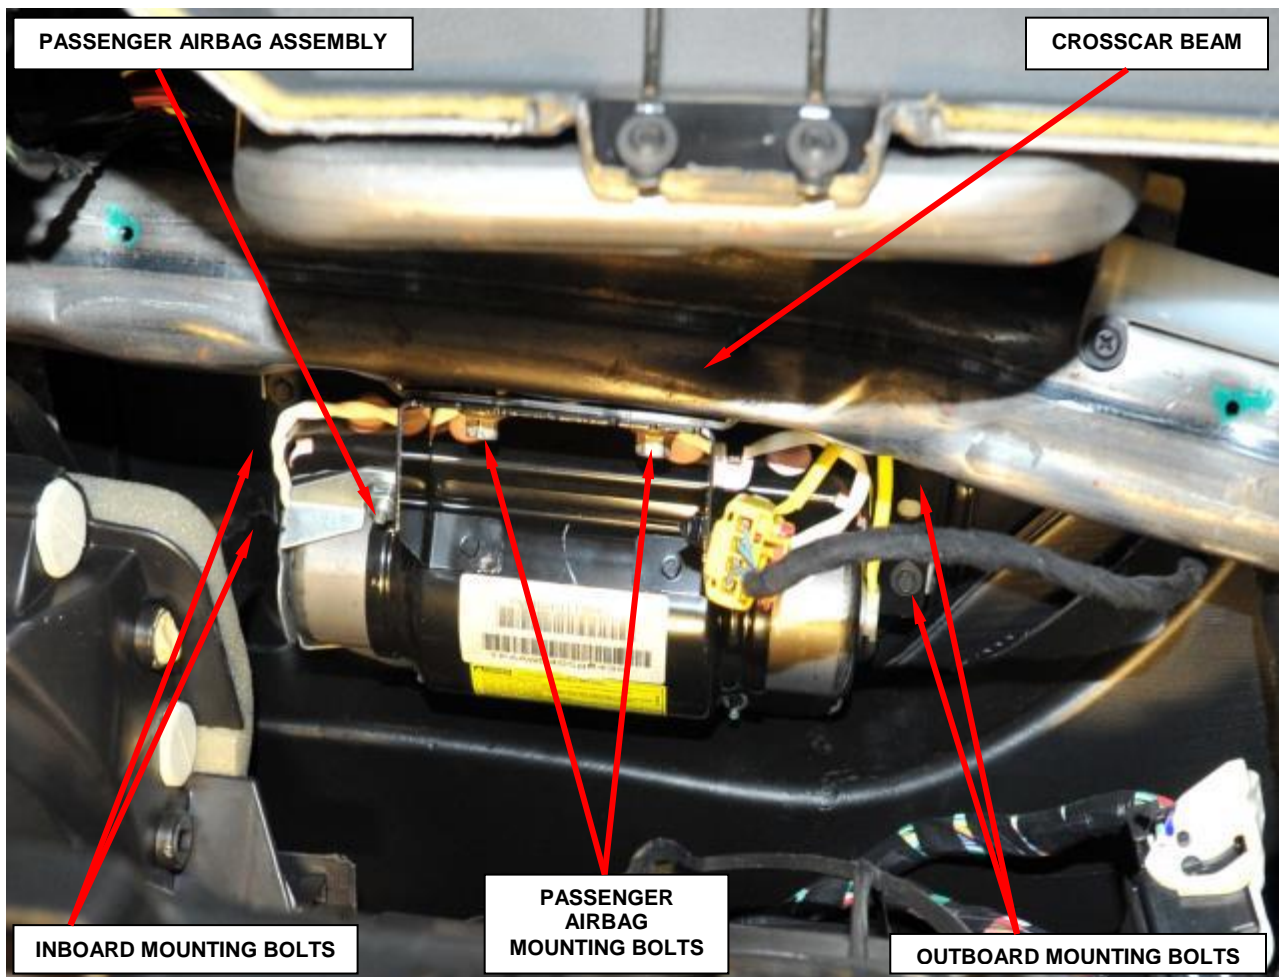
Figure 34 – Passenger Airbag Mounting Locations

5. Remove and save the two inboard mounting bolts to the passenger airbag assembly just below the distribution duct and to the left of the distribution housing (Figure 34).
6. Remove and save the two outboard mounting bolts to the passenger airbag assembly just below the distribution duct (Figure 34).
7. Remove and save the two passenger airbag assembly mounting bolts to the crosscar beam (Figure 34).

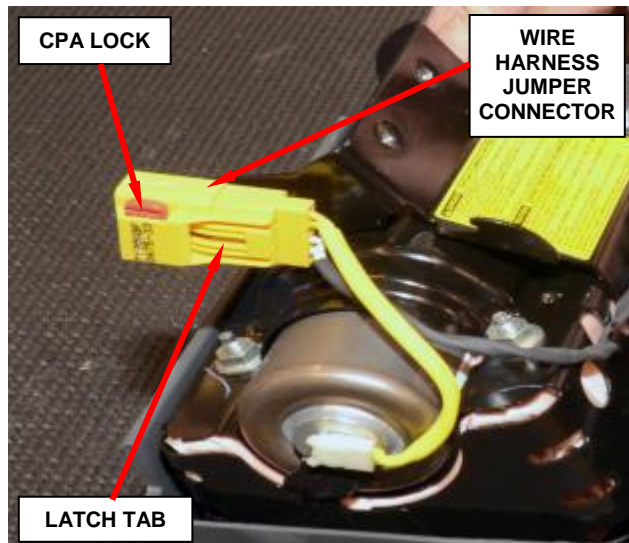
Figure 35 – Wire Harness Jumper

8. Pull the passenger airbag assembly out of the instrument panel far enough to access and disconnect the instrument panel wire harness connector from the wire harness jumper connector on the right side of the airbag mounting bracket.
 - a. Slide the red Connector Position Assurance (CPA) lock on the connector toward the side of the connector (Figure 35).
 - b. Depress the connector latch tab and pull the two halves of the connector straight away from each other.

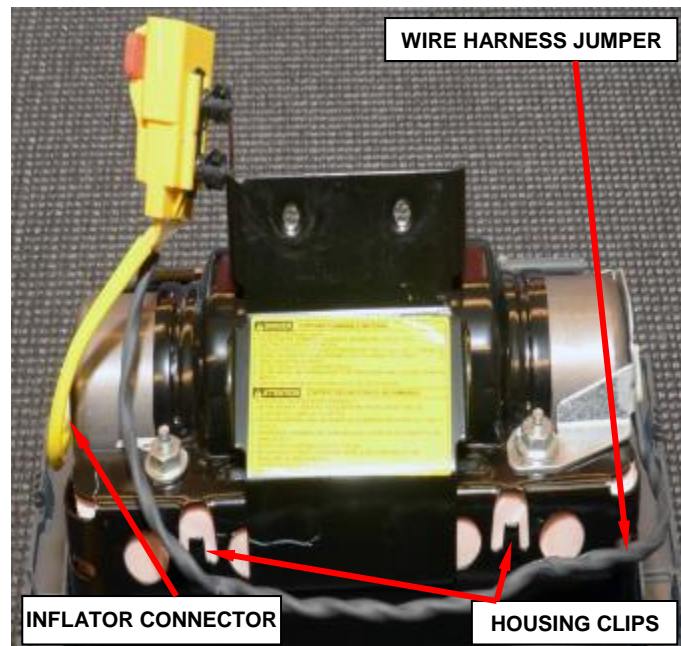
Figure 36 – Wire Harness Jumper

- b. Disengage the wire harness jumper from the housing clips in two places (Figure 36).
 - c. Disconnect the single yellow wire inflator connector from the end of the inflator using pliers (Figure 36).

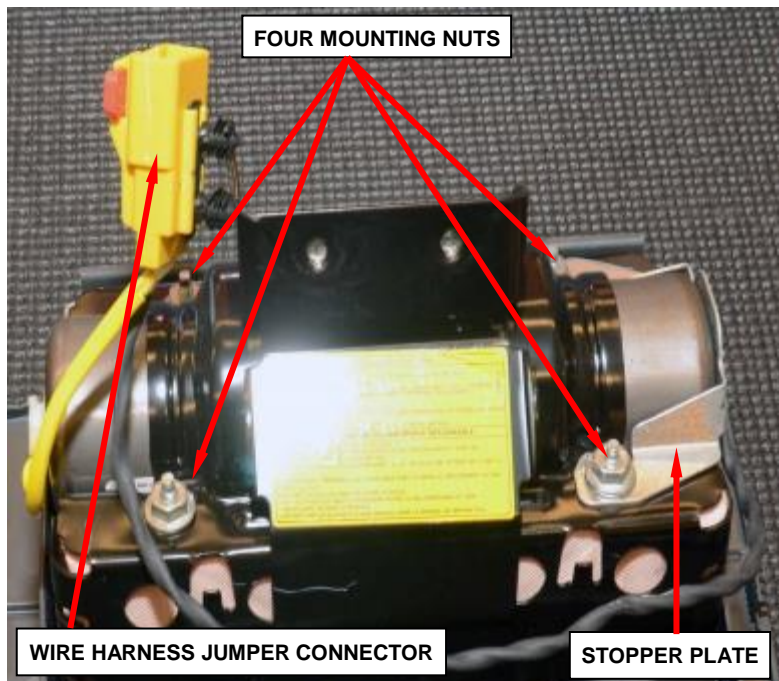
**Figure 37 – Airbag Module**

- d. Remove the yellow three way wire harness jumper connector from the housing bracket (Figure 37).
- e. Remove and **discard** the four mounting nuts, then remove the stopper plate from the passenger airbag module (Figure 37).
- f. Slide the inflator out of the passenger airbag module (Figure 43).

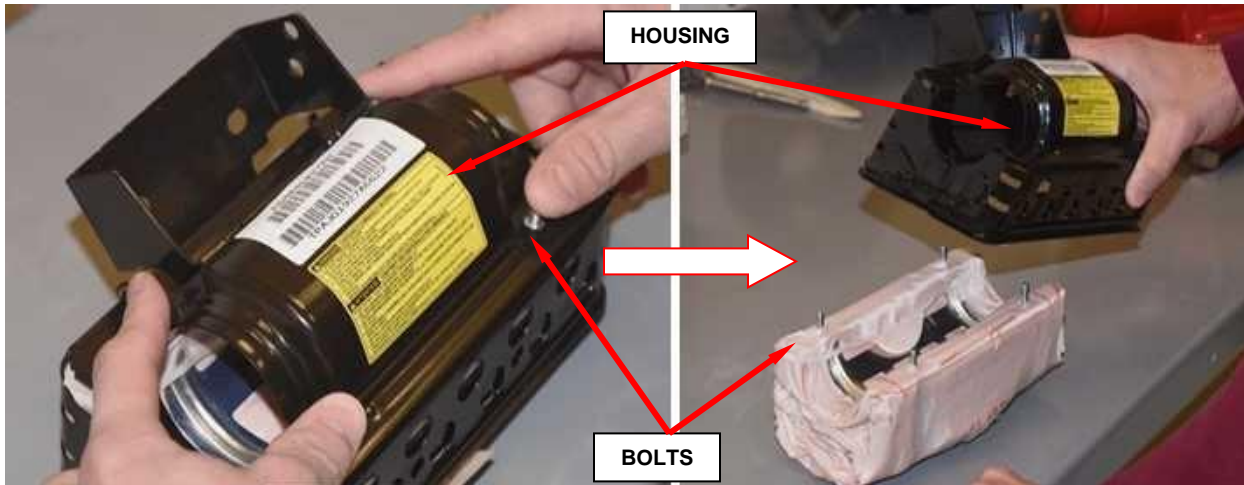
Figure 38 - Remove Airbag Cushion from Housing

- g. Remove airbag cushion from housing by applying pressure to the bolts, set cushion aside (Figure 38).

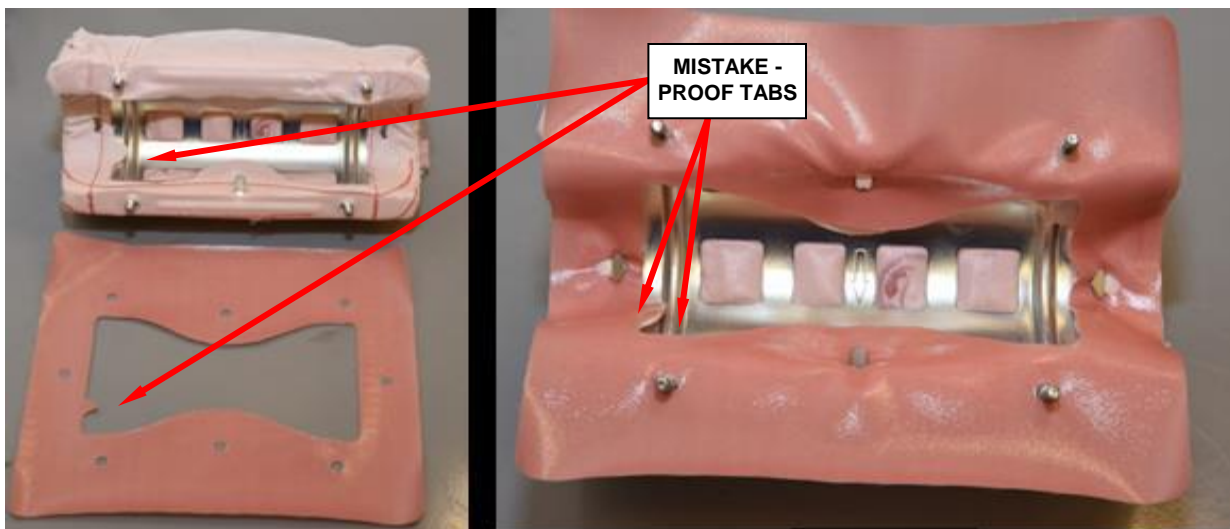
Figure 39 – Fabric Gasket to Cushion

- h. Place the fabric gasket, glossy side up, onto cushion. Mistake-proof tab should be aligned to the tab on the cushion (Figure 39).

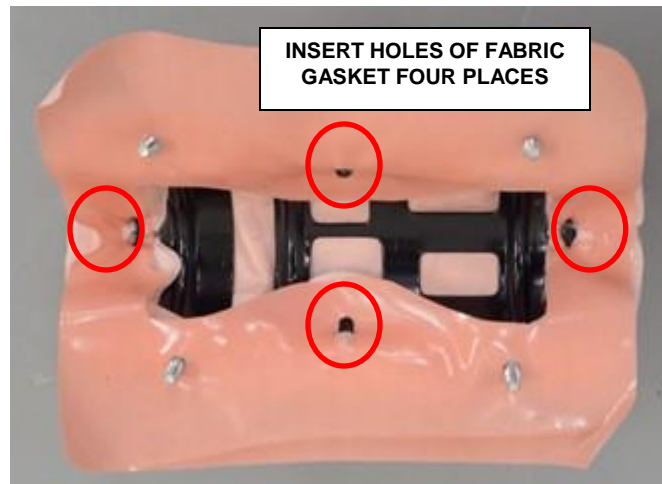
Figure 40 – Fabric Gasket

- i. With the help of a trim tool insert the holes of fabric gasket, four places (Figure 40).

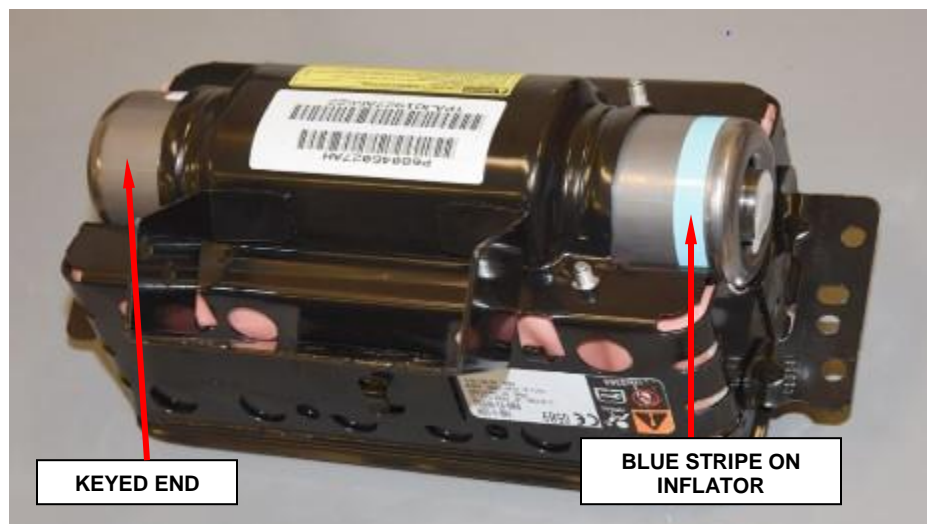
Figure 41 – Insert Inflator (Shown with Cushion Installed)

- j. Slide **new** inflator into housing. The keyed end is inserted first, therefore the blue stripe on the inflator will be located at the open end, as shown (Figure 41).

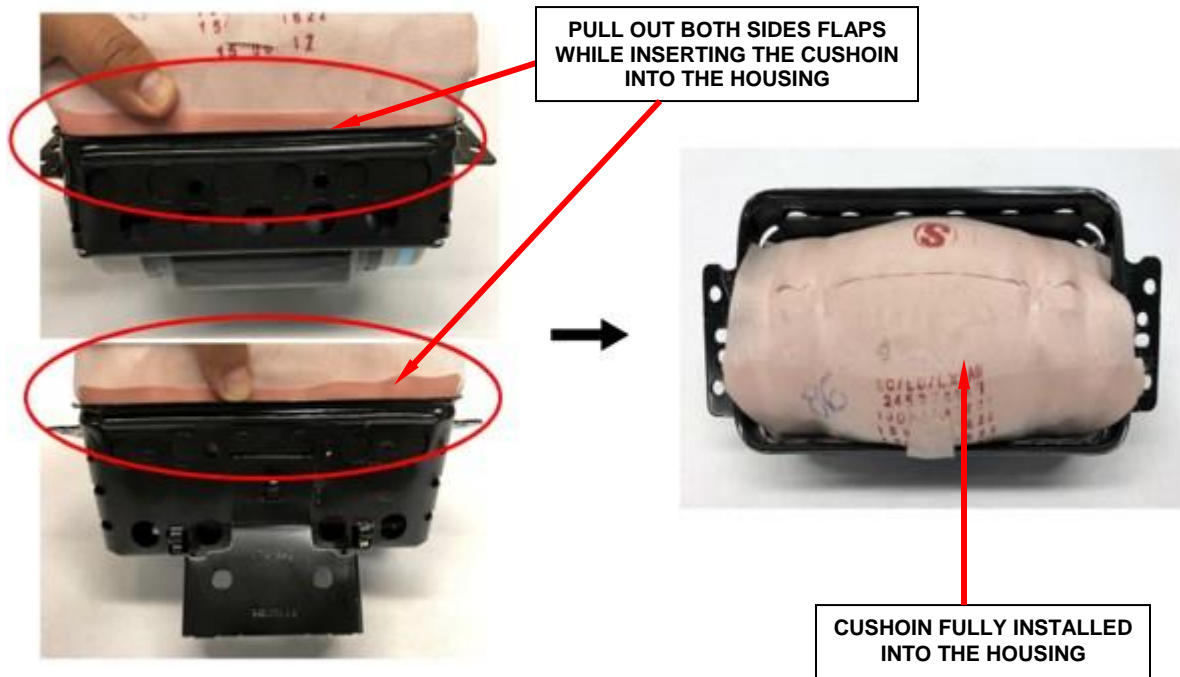
Figure 42 – Side Flaps Must Be Held Out

k. Insert the cushion, pulling out both side flaps (Figure 42).

NOTE: The spacing between the bolts is different on both sides, thus mistake-proof.

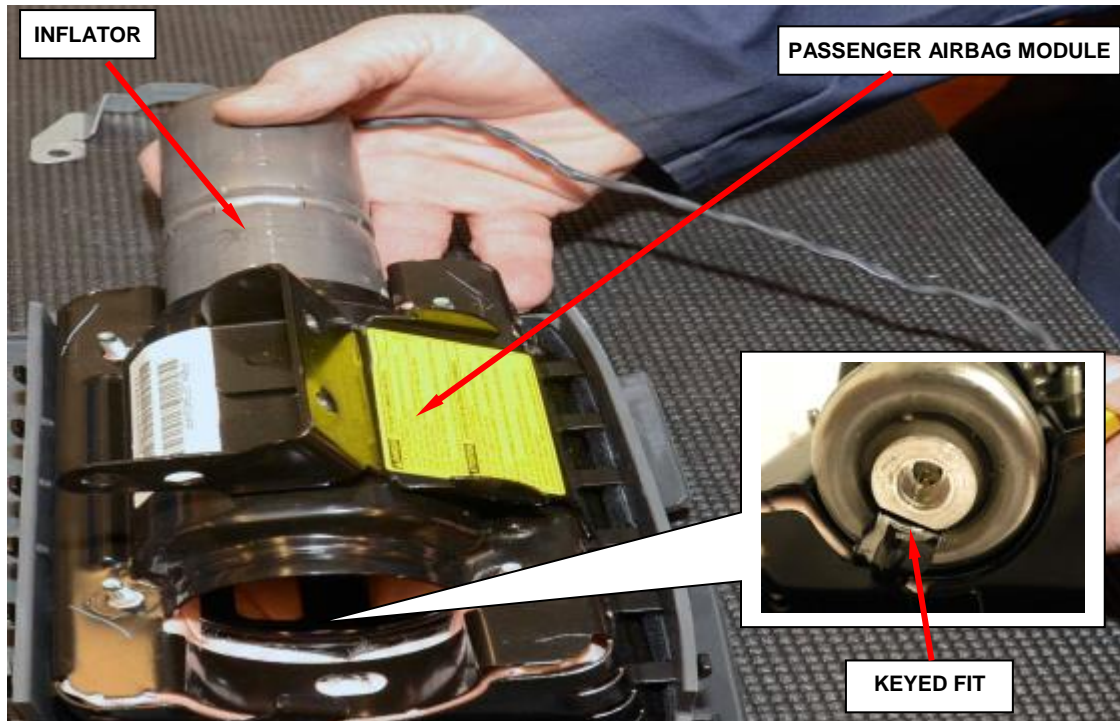
Figure 43 – Passenger Airbag Inflator to Housing

NOTE: The inflator is keyed to fit into the housing (Figure 43).

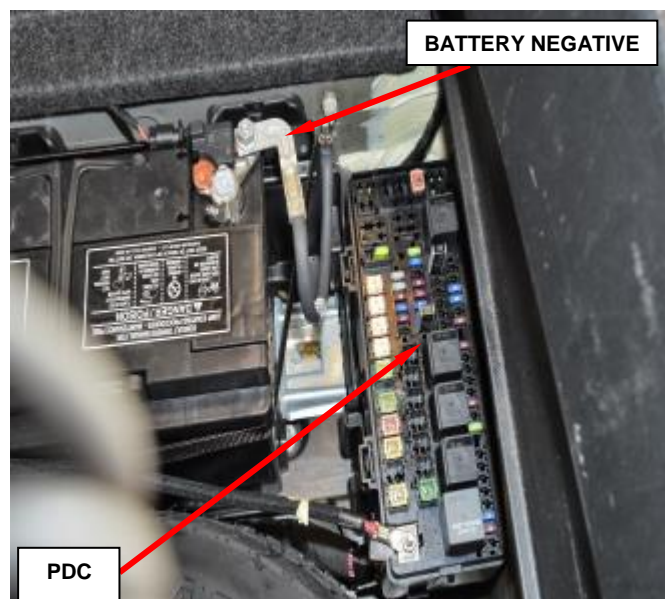
Figure 44 – Battery Negative

1. Disconnect and isolate the battery negative cable then remove the two Airbag Module fuses from the Power Distribution Center (PDC), see the PDC cover for the fuse locations. Wait two minutes for the system capacitor to discharge before further service (Figure 44).

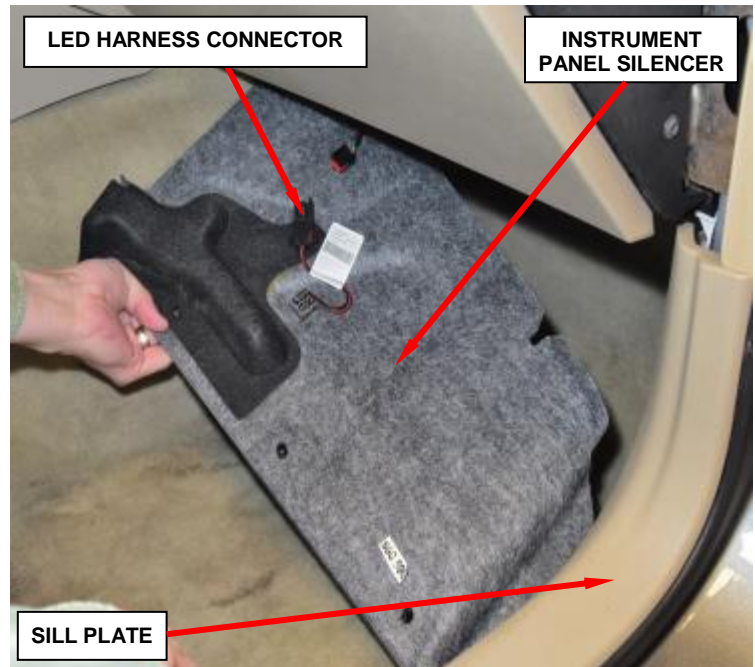
Figure 45 – Instrument Panel Silencer

2. Use the following steps to remove the glove box from the instrument panel.
 - a. Remove the right side instrument panel end cap.
 - b. Remove the right side sill plate (Figure 45).
 - c. Remove the three pushpins that secure the instrument panel silencer to the instrument panel (Figure 45).
 - d. Disconnect the harness connector(s) and remove the right side instrument panel silencer (Figure 45).
 - e. Open the glove box door.
 - f. Remove the two side screws from the glove box compartment (Figure 46).
 - g. Remove the six screws from the glove box compartment (Figure 46).
 - h. Disconnect the wiring harness connectors and remove the glove box compartment.

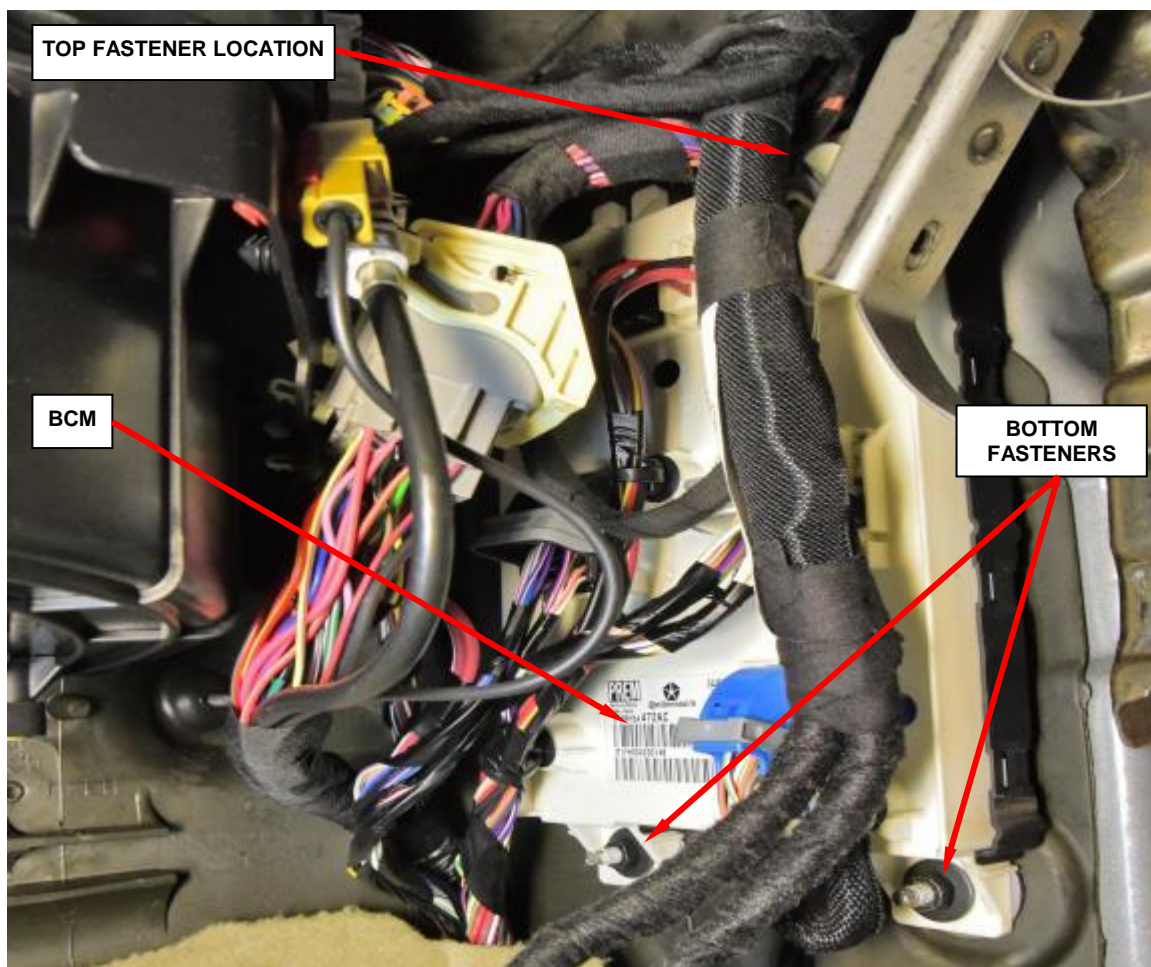
**Figure 47 – Body Control Module**

3. Disconnect all of the electrical connectors from the Body Control Module (BCM) receptacles.
4. Remove and save the two fasteners at the bottom of the BCM (Figure 47).
5. Loosen the top fastener. This fastener only has to be loosened to allow removal of the BCM. It does not need to be completely removed in order to remove the module (Figure 47).
6. Pull the module away from the side bulk head and down and remove and save the module.

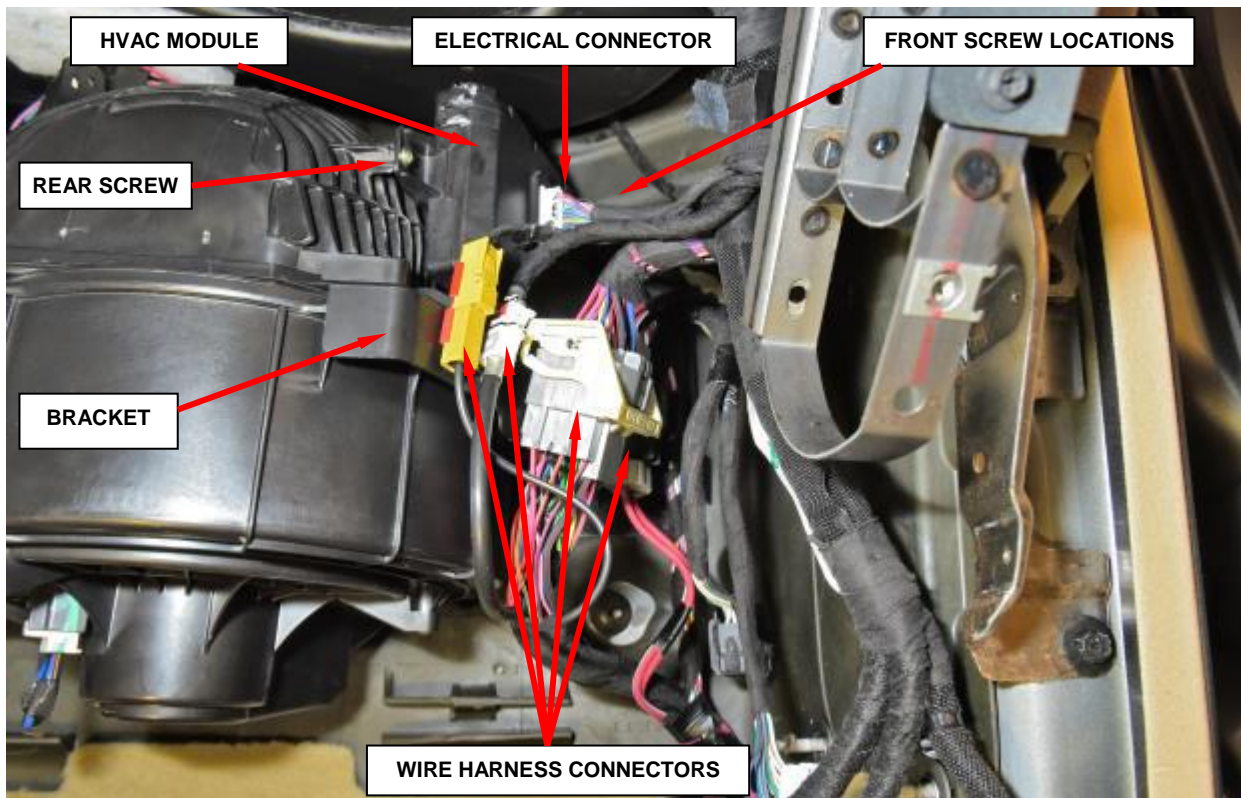
Figure 48 – HVAC Module

8. Release the wire harness connectors from the bracket (Figure 48).
9. Loosen the two screws that secure the front of the HVAC module to the air inlet housing (Figure 48).
10. Remove the one screw that secures the rear of the HVAC module to the air inlet housing (Figure 48).
11. Slide the HVAC module rearward to disengage the module from the two front retaining screws and remove the module.

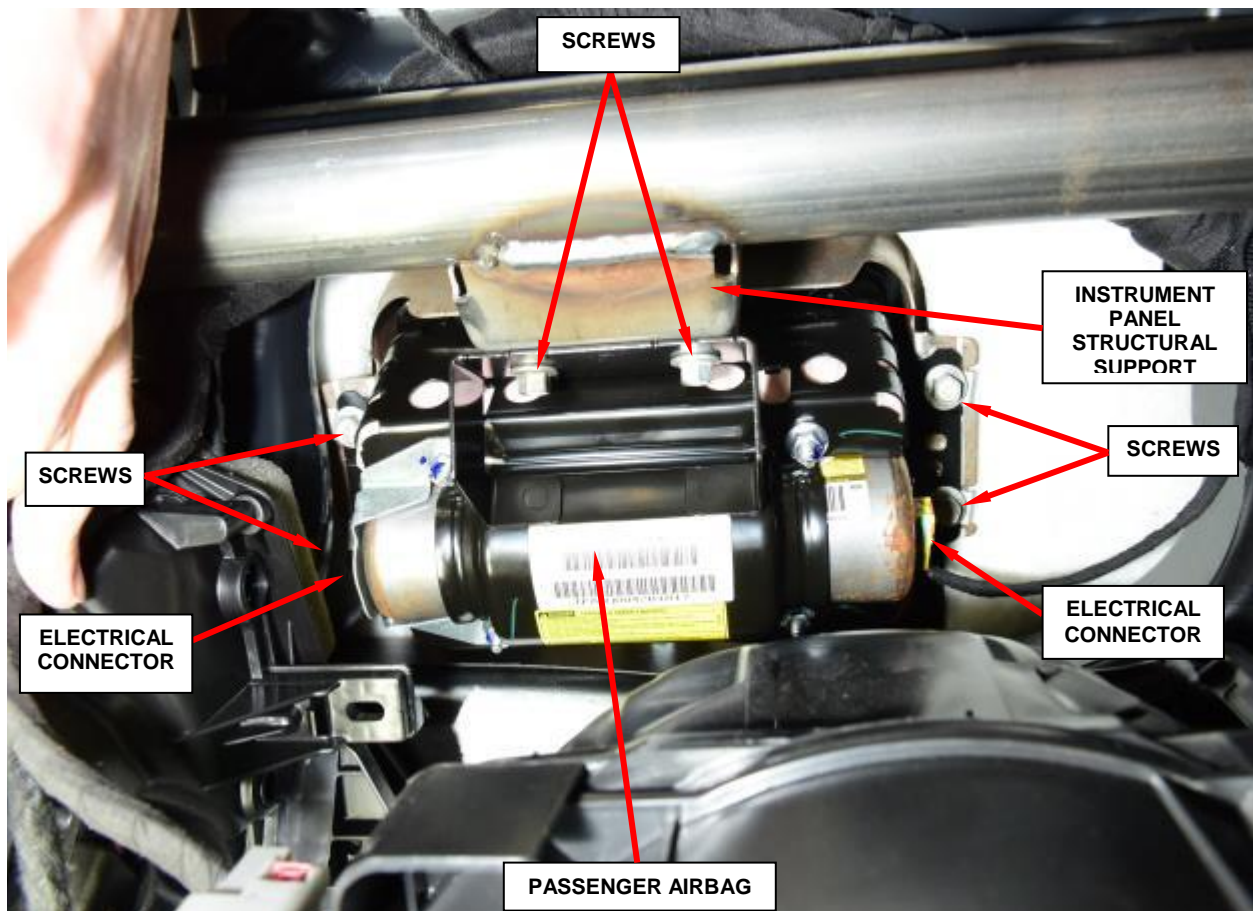
**Figure 49 – Passenger Airbag**

12. Reach through the instrument panel glove box opening to access and disconnect the two instrument panel electrical connectors from the two Passenger Airbag (PAB) initiators, one at each side of the PAB inflator canister (Figure 49).
13. Reach through the instrument panel glove box opening to access and remove and save the two screws that secure the PAB lower bracket to the instrument panel structural support (Figure 49).
14. Remove and save the four screws that secure the two upper PAB mounting brackets to the U-nuts on each side of the PAB retainer or chute on the underside of the instrument panel cover (Figure 49).

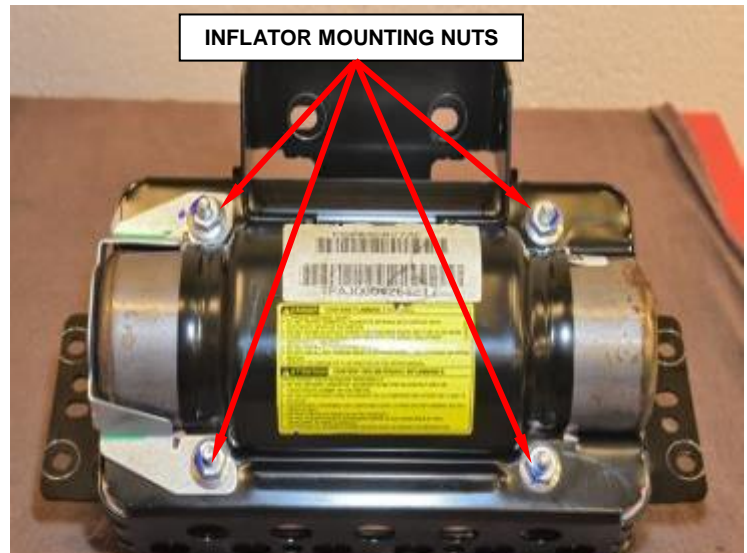
Figure 50 – Mounting Nuts

15. Remove the PAB from the instrument panel cover.
16. Use the following procedure to retrofit the passenger side airbag assembly.
 - a. Place the passenger airbag assembly on a soft surface to prevent damage.
 - b. Remove and **discard** the four inflator mounting nuts (Figure 50).
 - c. Remove and save stopper plate from housing (Figure 51).
 - If using replacement inflator kit CBXZS434AB or AC (GuNi), continue with Step d.
 - If using replacement inflator kit CBXZS434AA, continue with Step k.

- m. Position the stopper plate to the airbag housing (Figure 51).
- n. Install the four **NEW** mounting nuts to the airbag housing and tighten to 53 in. lbs. (6 N·m) (Figure 50).

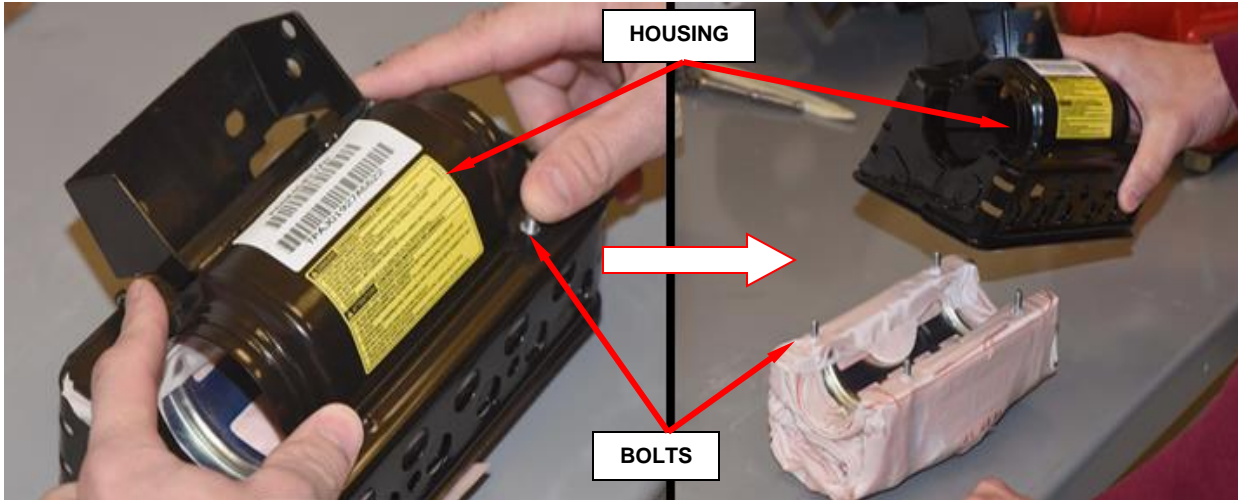
Figure 52 - Remove Airbag Cushion from Housing

- d. Slide inflator out of the housing.
- e. Remove airbag cushion from housing by applying pressure to the bolts, set cushion aside (Figure 52).

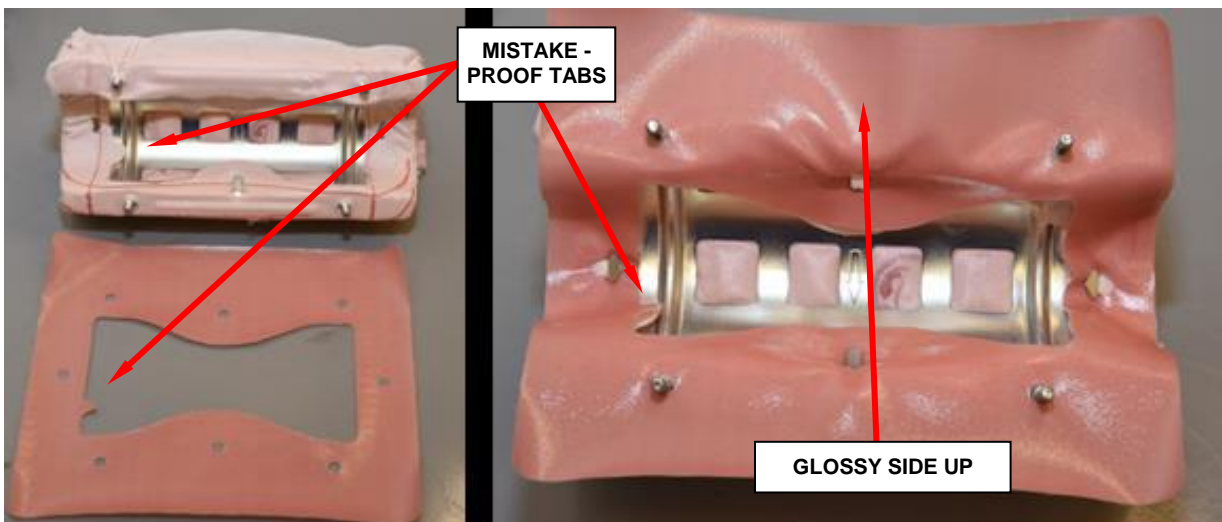
Figure 53 – Fabric Gasket to Cushion

- f. Place the fabric gasket, glossy side up, onto cushion. Mistake-proof tab should be aligned to the tab on the cushion (Figure 53).

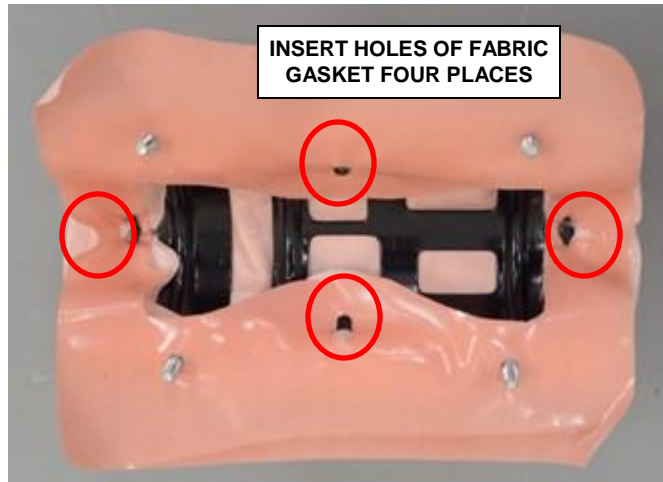
Figure 54 – Fabric Gasket

g. With the help of a trim tool insert the holes of fabric gasket, four places (Figure 54).

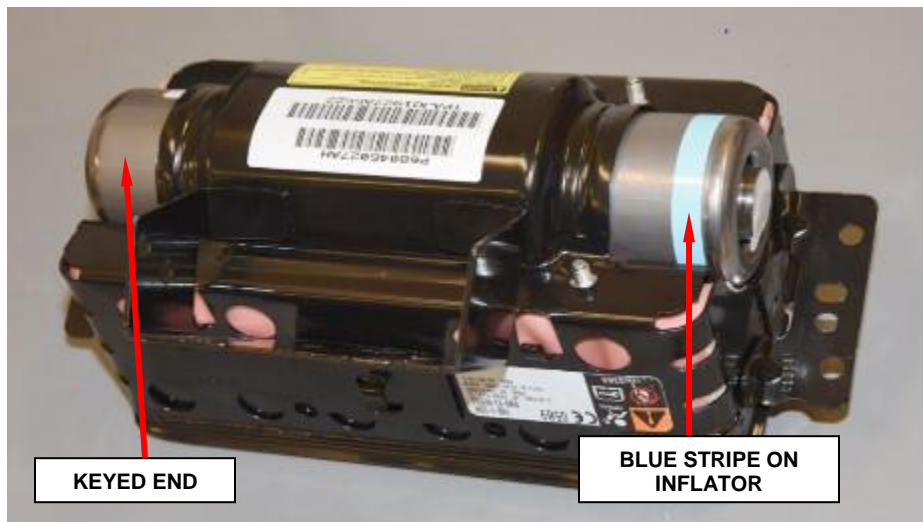
Figure 55 – Insert Inflator (Shown with Cushion Installed)

h. Slide **new** inflator into housing. The keyed end is inserted first, therefore the blue stripe on the inflator will be located at the open end, as shown (Figure 55).

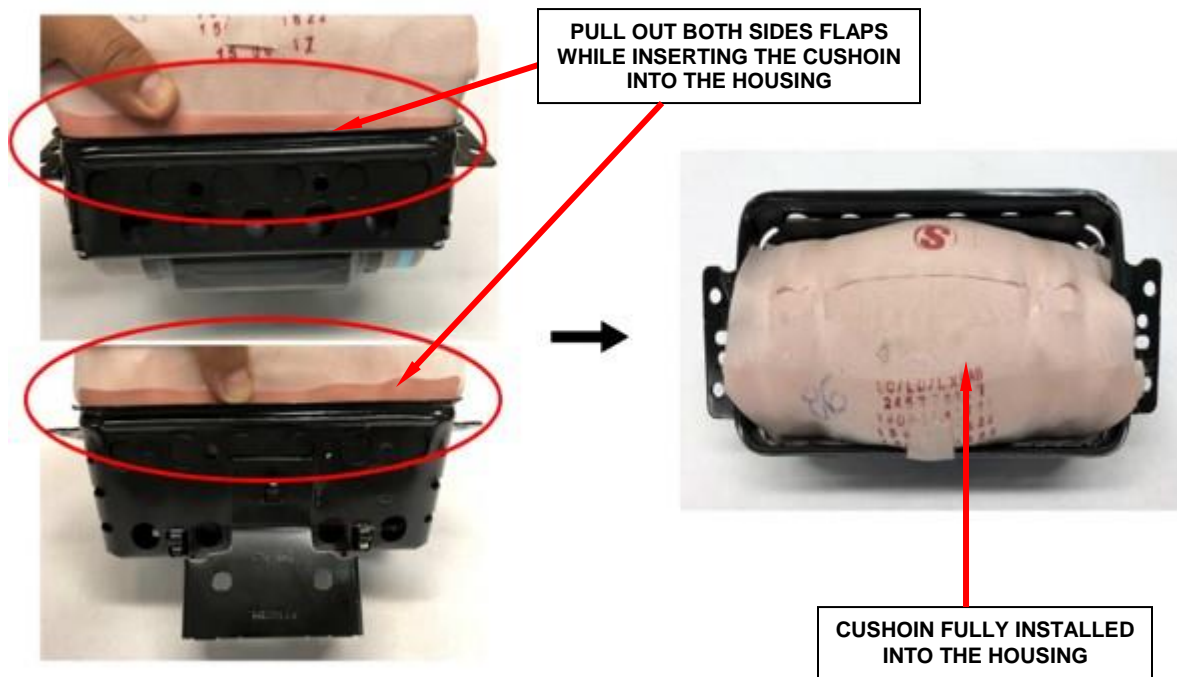
Figure 56 – Side Flaps Must Be Held Out

- i. Insert the cushion, pulling out both side flaps (Figure 56).

NOTE: The spacing between the bolts is different on both sides, thus mistake-proof.

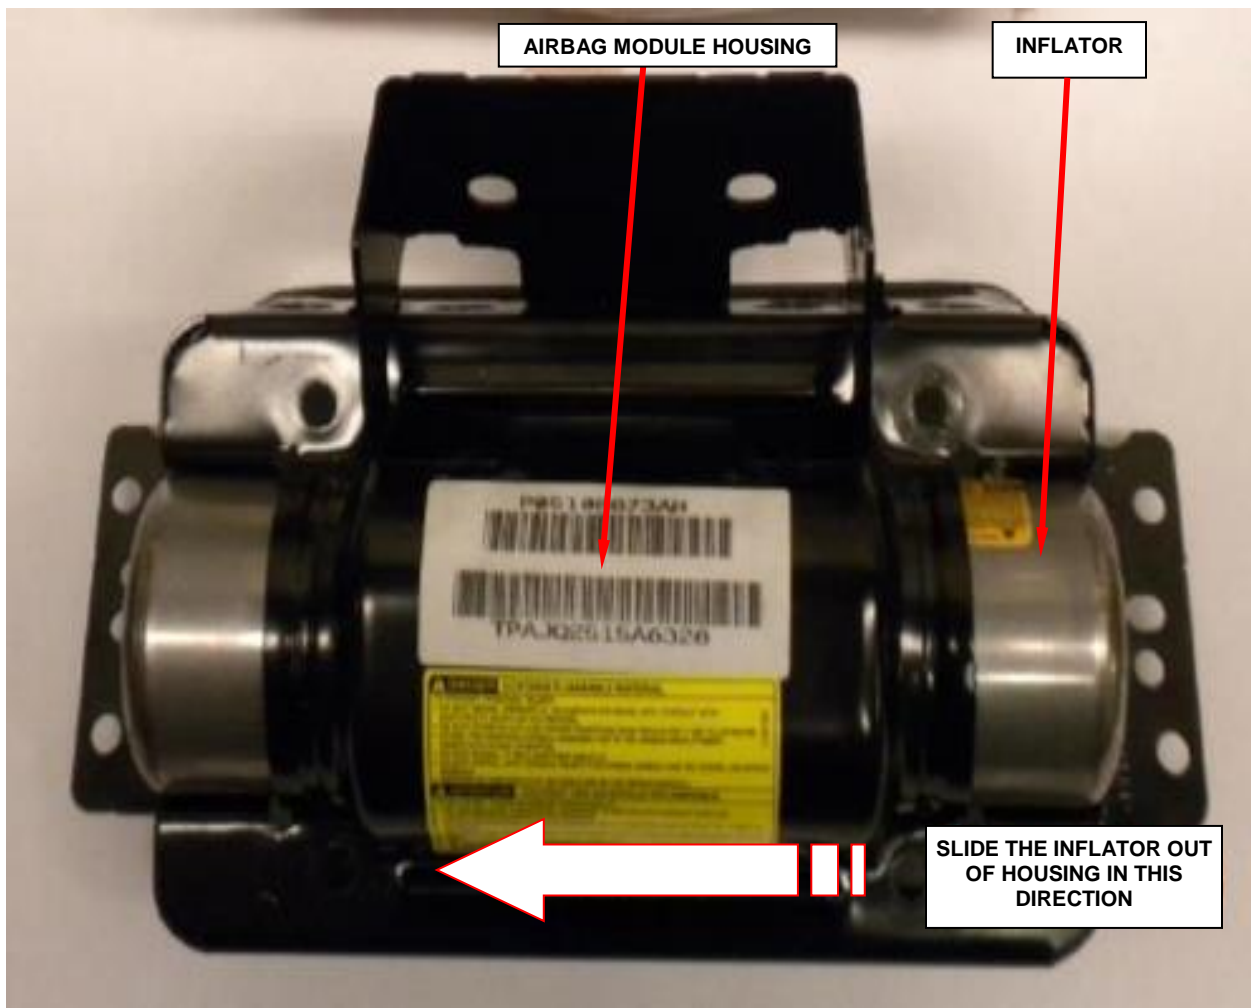
Figure 57 – Remove Airbag Inflator

- k. Slide the inflator out of the passenger airbag module housing (Figure 57).

IMPORTANT: Do NOT discard old inflator. Follow the parts return policy and instructions at the beginning of this document.

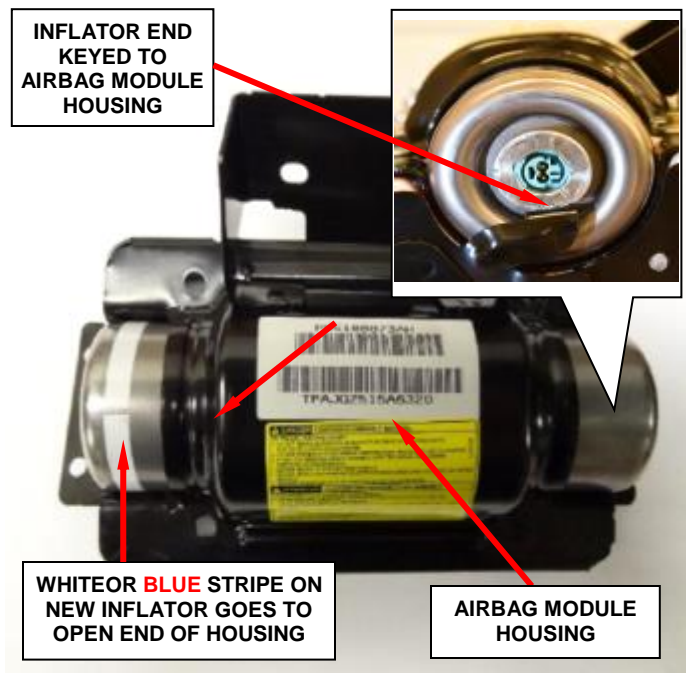
Figure 58 – Install New Inflator to Housing

- l. Slide the **NEW** inflator into the passenger airbag module housing. The keyed end is inserted first; therefore, the white stripe on the **NEW** inflator will be located at the open end (Figure 58).

NOTE: The inflator’s key **MUST** line up with the housing’s key.

NOTE: The inflator’s key **MUST** line up with the housing’s key (Figure 58).

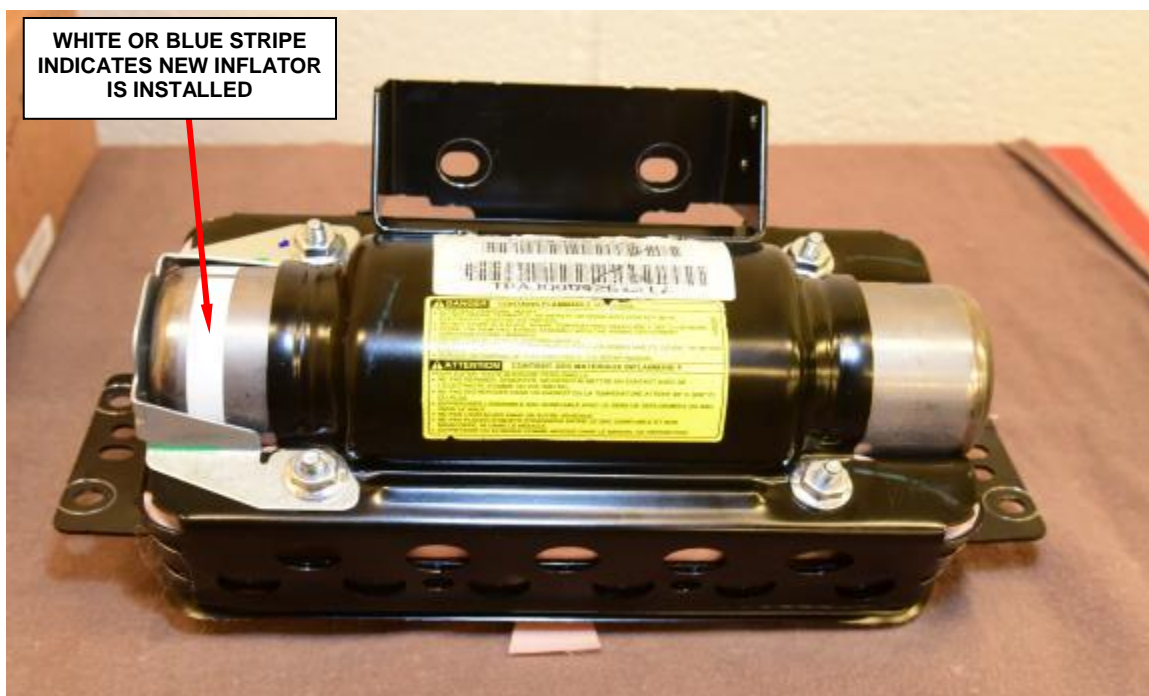
Figure 59 – Retrofit Complete

- o. Passenger airbag retrofit is complete (Figure 59).

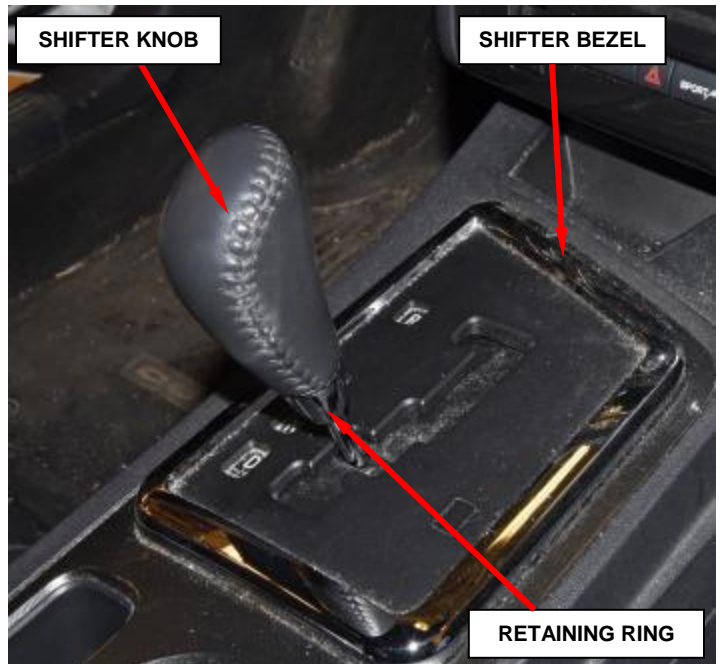
Figure 60 – Shifter Knob

7. Using a small flat bladed tool or equivalent, separate the retaining ring and slide down the shifter shaft (Figure 60).
8. Pull up on the shifter knob and remove from the shifter shaft (Figure 60).
9. Remove the shifter bezel and/or shifter boot (Figure 60).

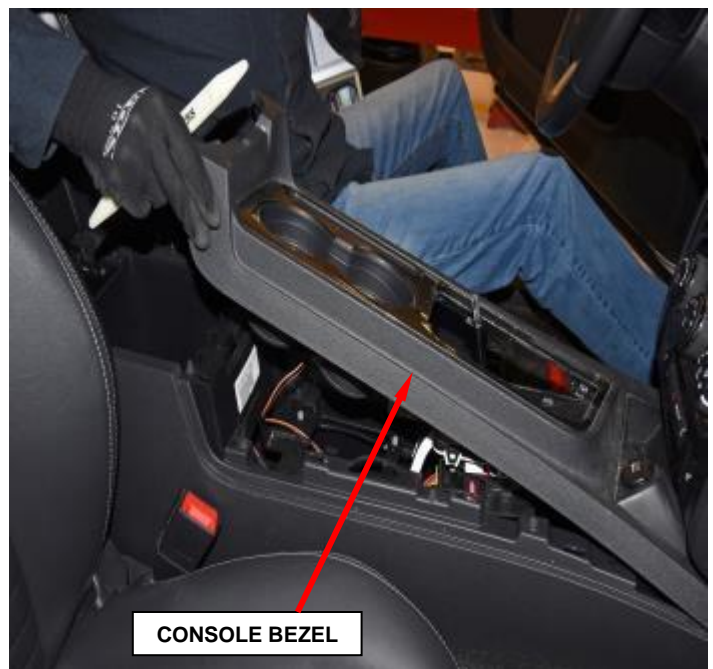
Figure 61 - Console Bezel

10. Open the lid of the console rear bin and remove the mat from the rear bin.
11. Using a trim stick, unsnap the console bezel from the console (Figure 61).
12. Disconnect the electrical connectors and remove the bezel.
