Revised (2) May 2019

Dealer Service Instructions for:

Safety Recall U03 / NHTSA 18V-021 Passenger Airbag Inflator

The front passenger airbag inflator (PAB) on about 328,000 of the above vehicles may contain propellant that degraded after prolonged exposure to high absolute humidity, high temperatures and high temperature cycling. Activation of an inflator with degraded propellant, in a vehicle crash where the PAB is designed to deploy, may result in an inflator explosion. An inflator explosion may cause metal fragments to pass through the air bag and into the vehicle interior at high speed, which may result in injury or death to vehicle occupants.

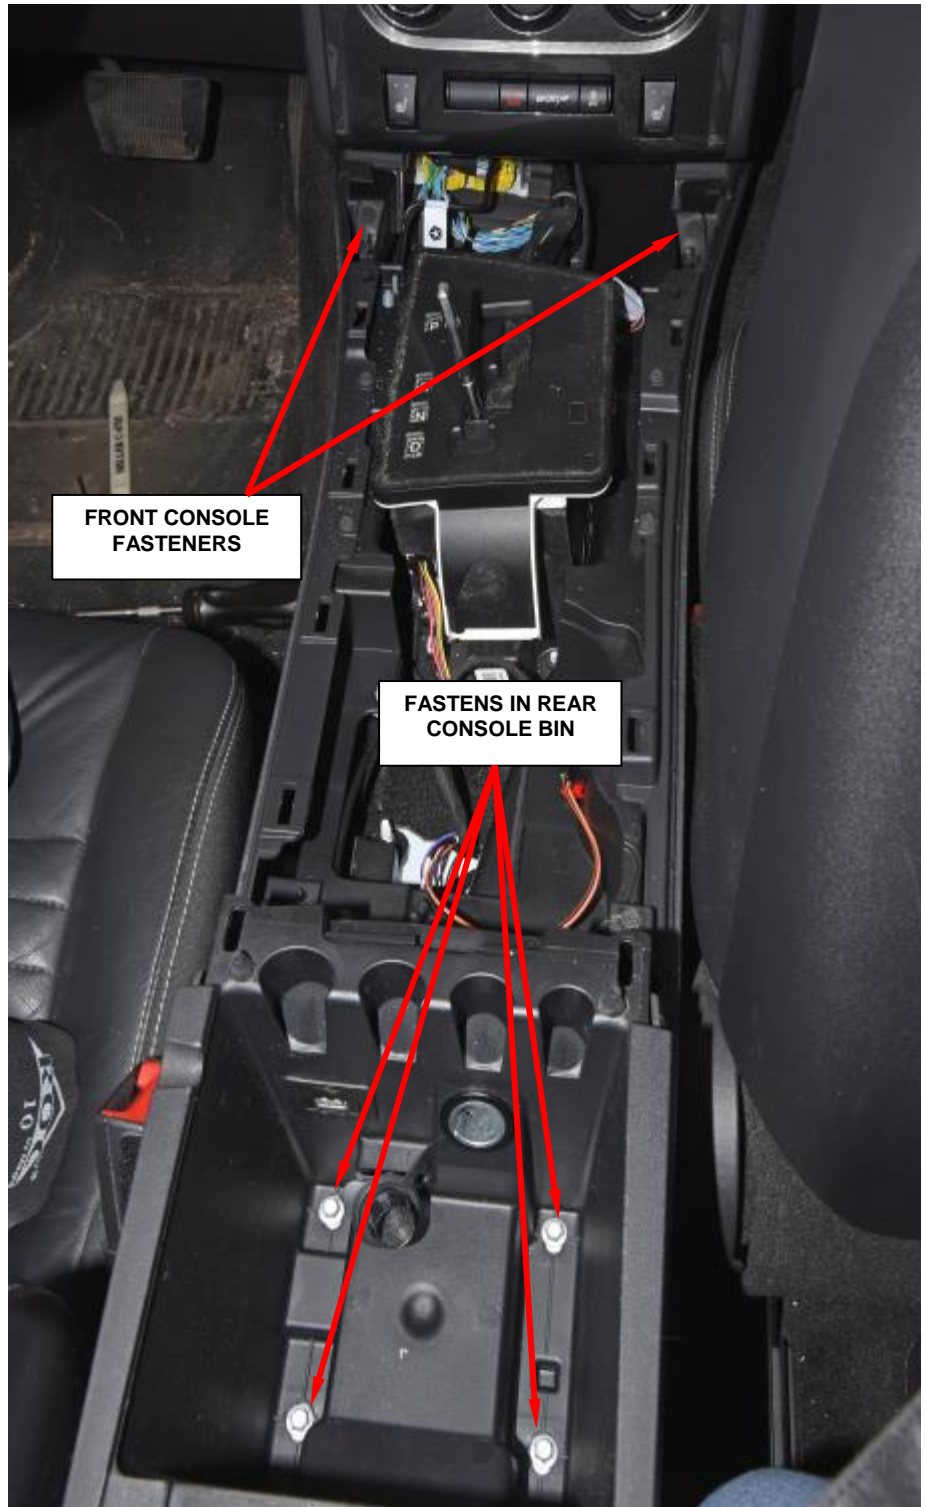
Figure 62 – Floor Console

13. Remove the four fasteners from the rear bin that secure the console to the floor panel transmission tunnel (Figure 62).

14. Remove the two fasteners that secure the front of the console to the instrument panel (Figure 62).

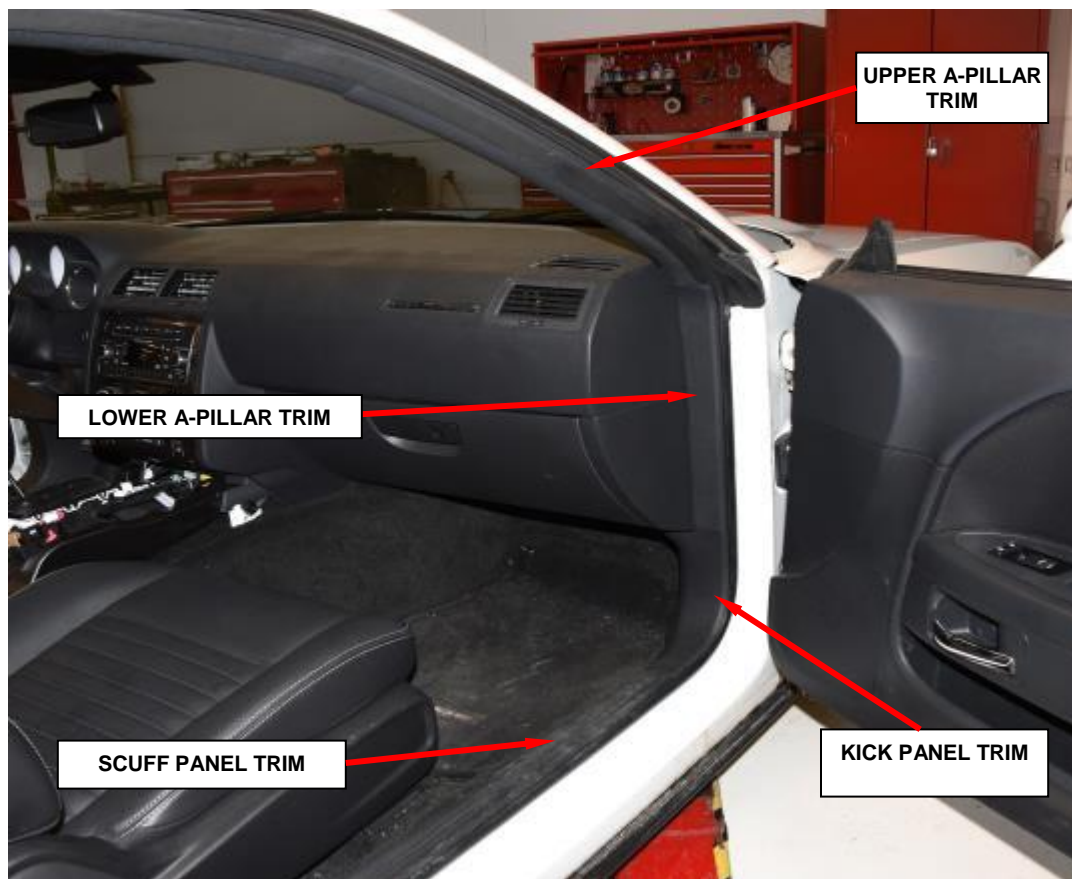
Figure 63 – Door Opening Trim (Right Side Shown, Left Side Similar)

17. Using a trim stick C-4755 or equivalent, remove the right and left side lower A-pillar trim (Figure 63).
18. Using a trim stick C-4755 or equivalent, release the right and left side upper A-pillar trim then release the airbag tether and remove the trim (Figure 53).
19. Using a trim stick C-4755 or equivalent, remove the right and left side scuff panel trim (Figure 63).
20. Using a trim stick C-4755 or equivalent, remove the right and left side kick panel trim (Figure 63).

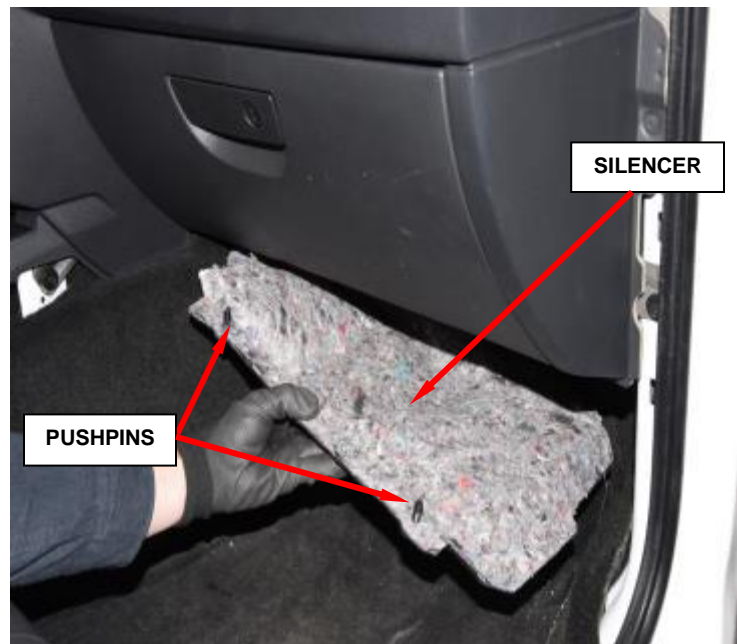
Figure 64 – Passenger Side Silencer

21. Remove the two pushpins that secure the passenger side instrument panel silencer to the instrument panel bracket (Figure 64).
22. Pull the passenger side instrument panel silencer rearward to disengage it from the brackets located near the dash panel.
23. Remove the passenger side instrument panel silencer from the vehicle.
24. Open the glove box bin.
25. Remove the support strap and retainer assembly from the outboard end of the bin (Figure 65).
26. Push in on both sides of glove box bin to disengage the glove box stops and lower the bin.
27. Pivot the glove box bin downward and disengage the glove box hinge hooks from the instrument panel hinge brackets located at each end of the bin (Figure 65).
28. Remove the glove box bin from the vehicle.

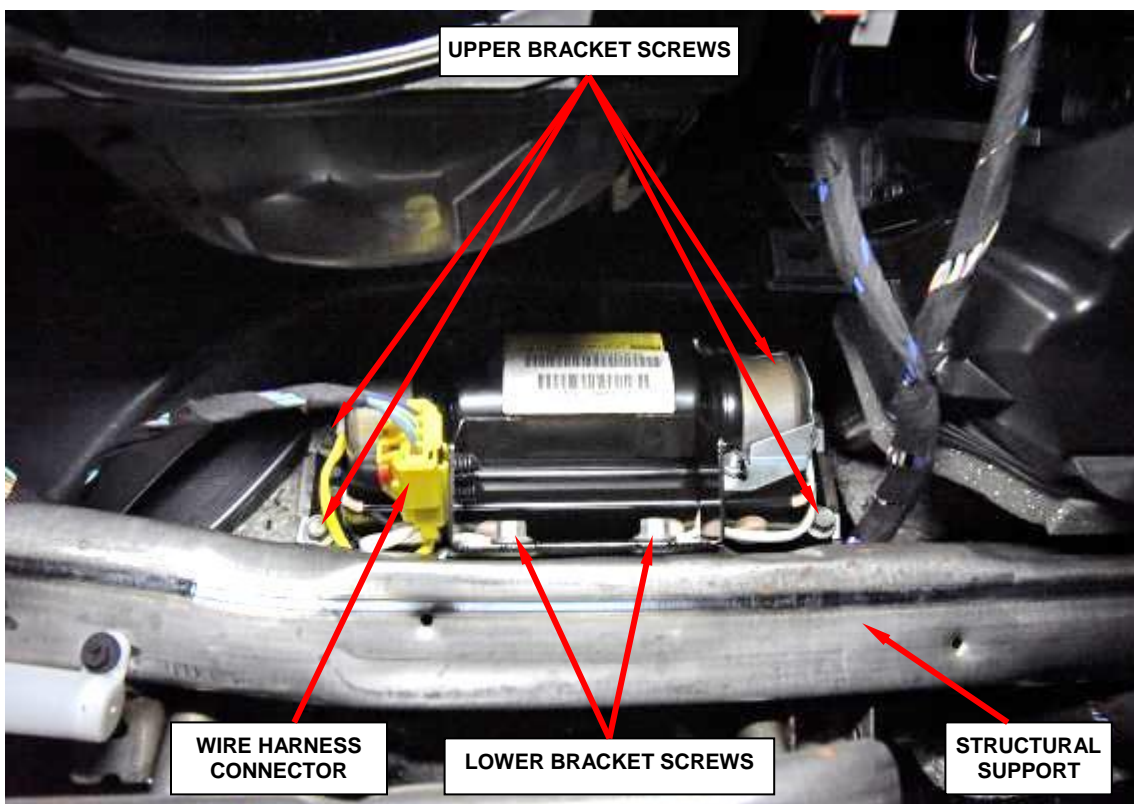
Figure 66 – PAB Housing, Inflator and Cushion to be Removed a Unit (View through Glove Box Opening)

29. Disconnect the instrument panel wire harness connector from the PAB pigtail wire connector (Figure 66).
30. Remove the two screws that secure the PAB lower bracket to the instrument panel structural support (Figure 66).
31. Remove the four screws that secure the PAB upper brackets to the sides of the PAB retainer or chute on the underside of the instrument panel cover (Figure 66).
32. Allow the PAB housing, inflator and cushion as a unit to remain on the underside of the instrument panel cover until **Step 36**. **Do not pry or force the unit from the vehicle at this time.**

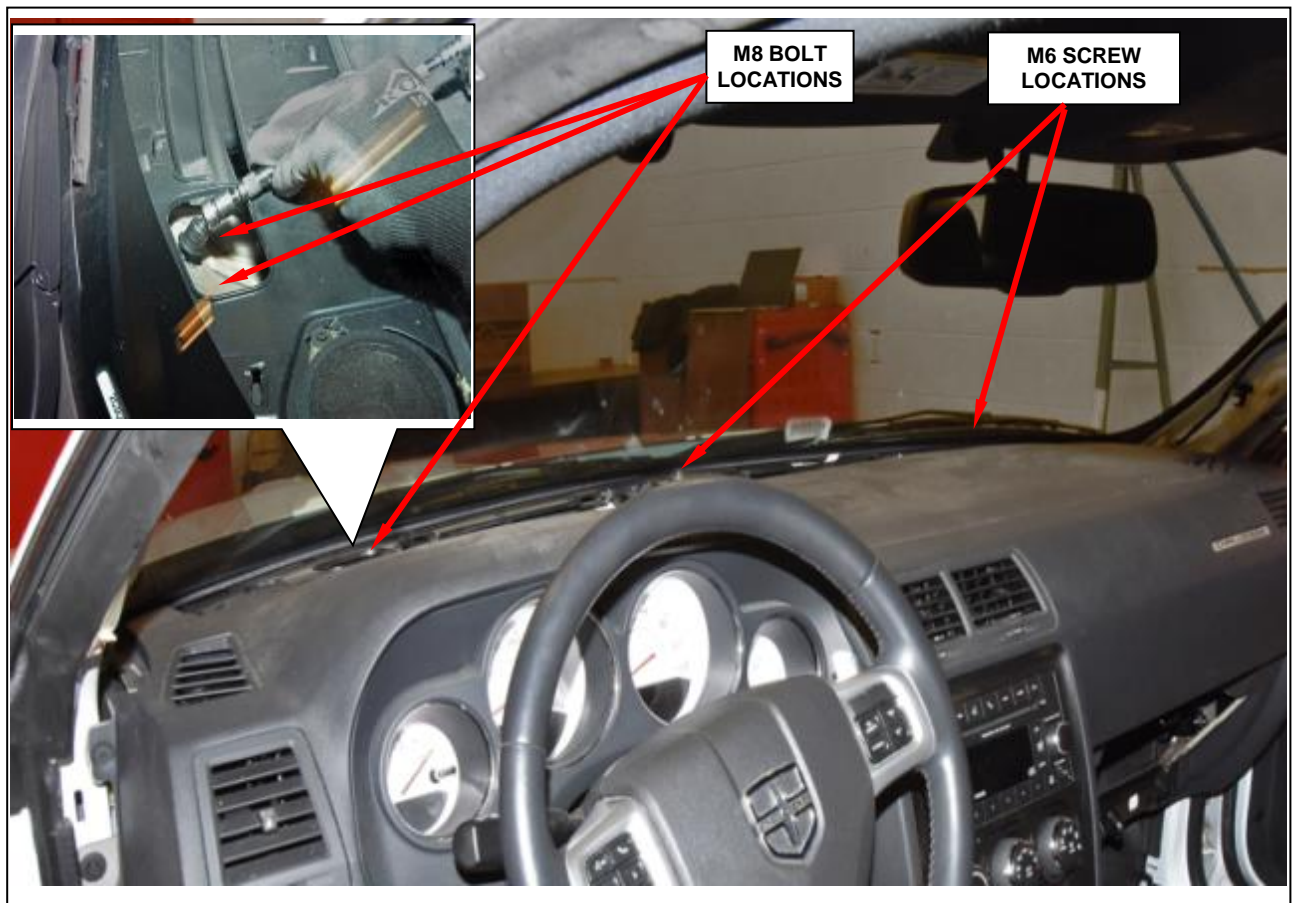
Figure 67 – Top Instrument Panel Fasteners

33. Remove the defroster grille to access the instrument panel top retaining bolts then remove and save the two M8 bolts and two M6 screws (Figure 67).

WARNING: Metal retaining clips may remain in the instrument panel. Remove the clips from the panel and install them on the defroster grille before grille installation.

CAUTION: Use extreme care to avoid damage to the windshield when removing the top four fasteners.

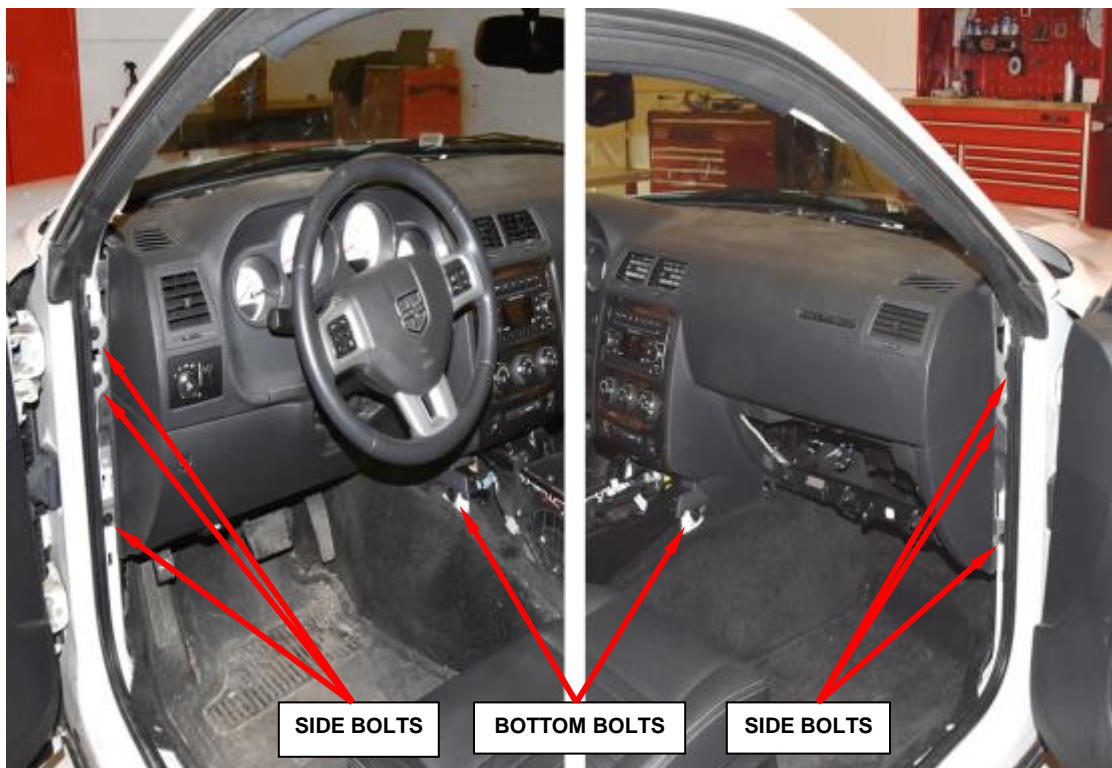
Figure 68 – Side and Bottom Retaining Bolts

34. Remove and save the instrument panel side support bolts (Figure 68).
35. Remove and save the bolts that secure the bottom of the instrument panel (Figure 68).

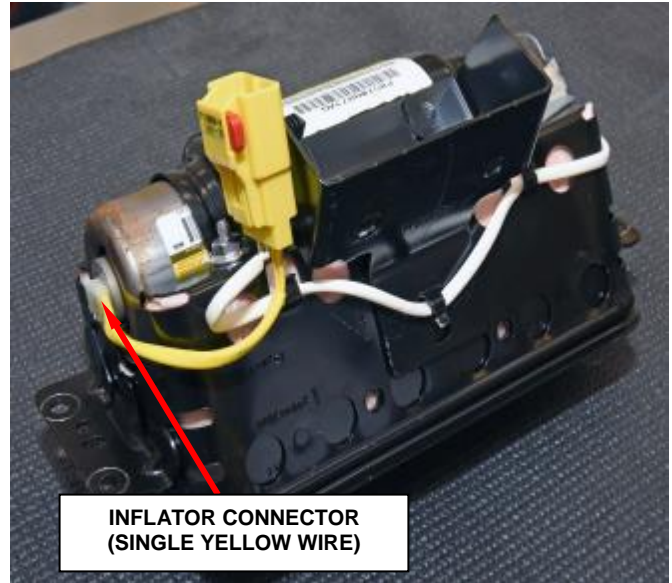
Figure 69 – Inflator Connector

b. Use pliers to grasp the single yellow wire inflator connector then wiggle as you pull up until it is disconnected from the inflator (Figure 69).

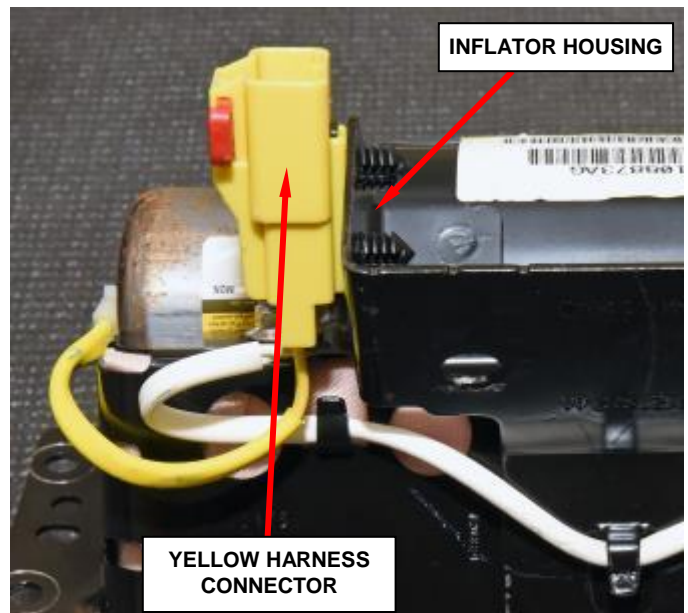
Figure 70 – Wire Harness Connector

c. Release the yellow wire harness connector from the inflator housing bracket (Figure 70).

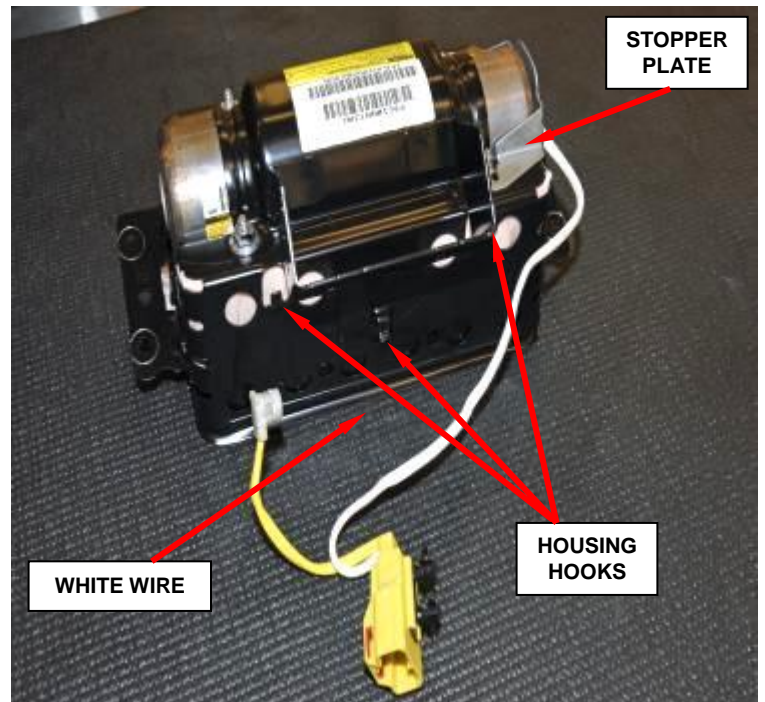
Figure 71 – White Wire Harness

- d. Release the white wire from the three housing hooks (Figure 71).

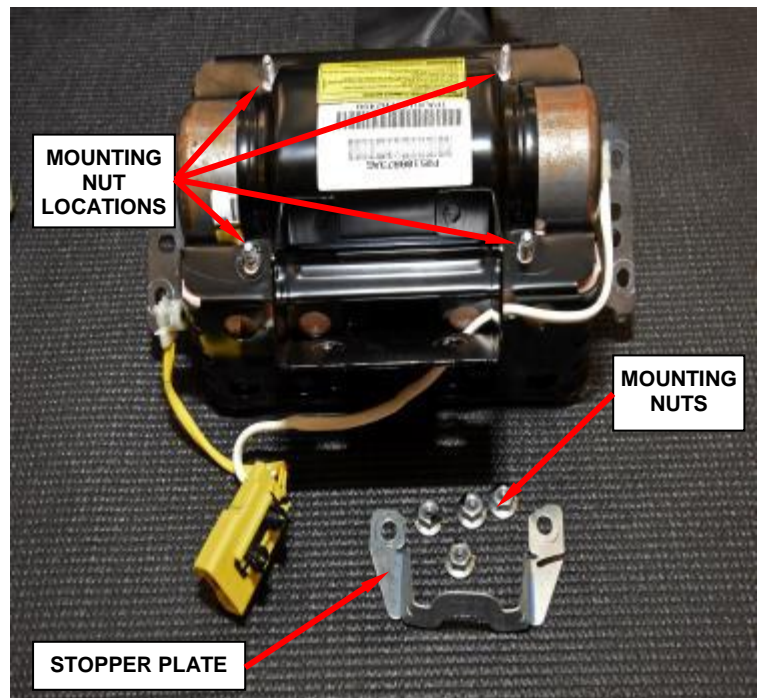
Figure 72 – Mounting Nuts and Stopper Plate

- e. Remove and **discard** the four inflator mounting nuts (Figure 72).

- f. Remove and save stopper plate from housing (Figures 71 and 72).

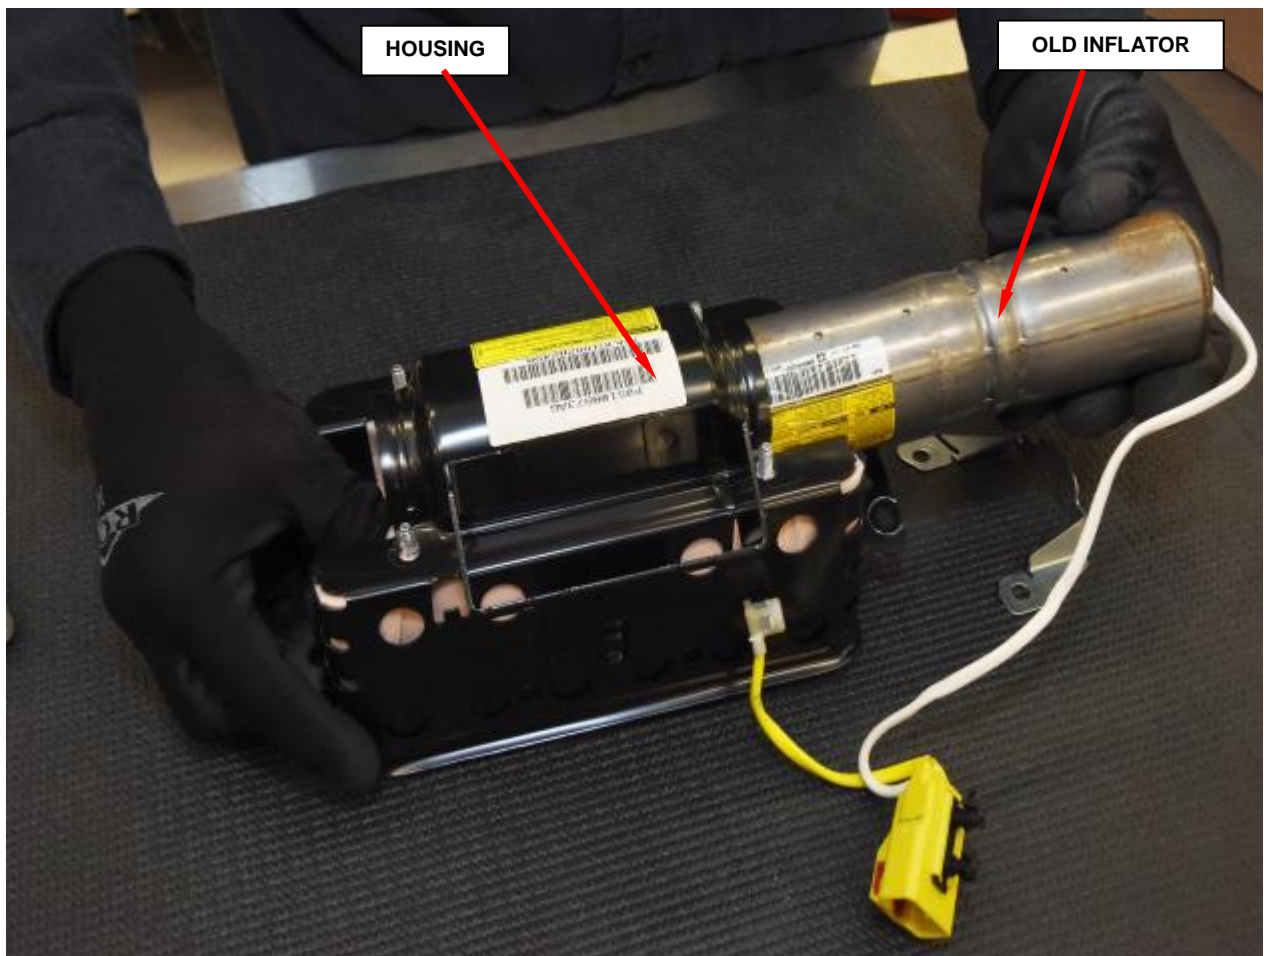
Figure 73 – Passenger Airbag Inflator Removal

- g. Slide the inflator out of the housing (Figure 73).

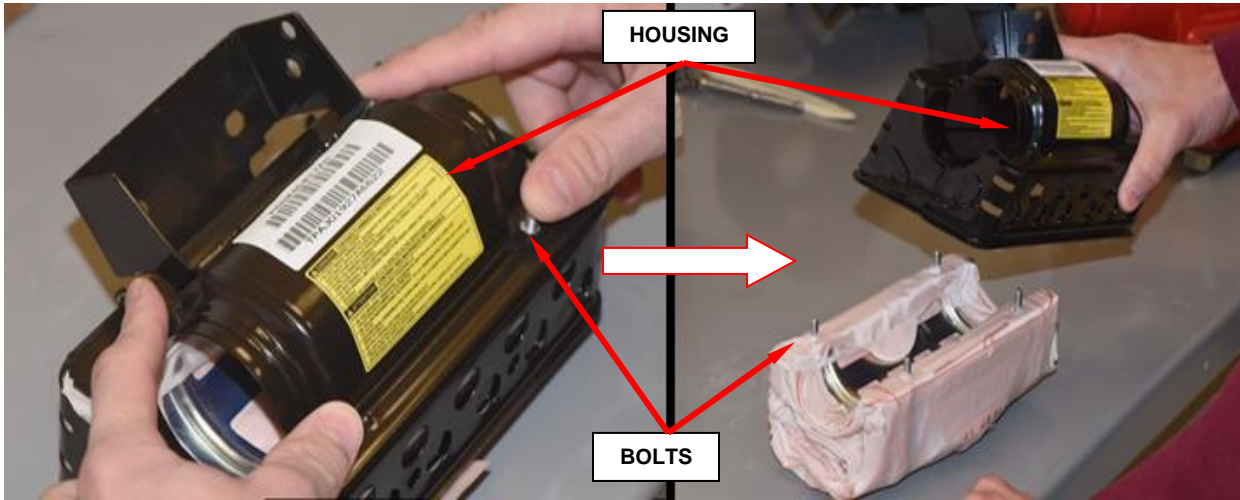
Figure 74 - Remove Airbag Cushion from Housing

- h. Remove airbag cushion from housing by applying pressure to the bolts, set cushion aside (Figure 74).

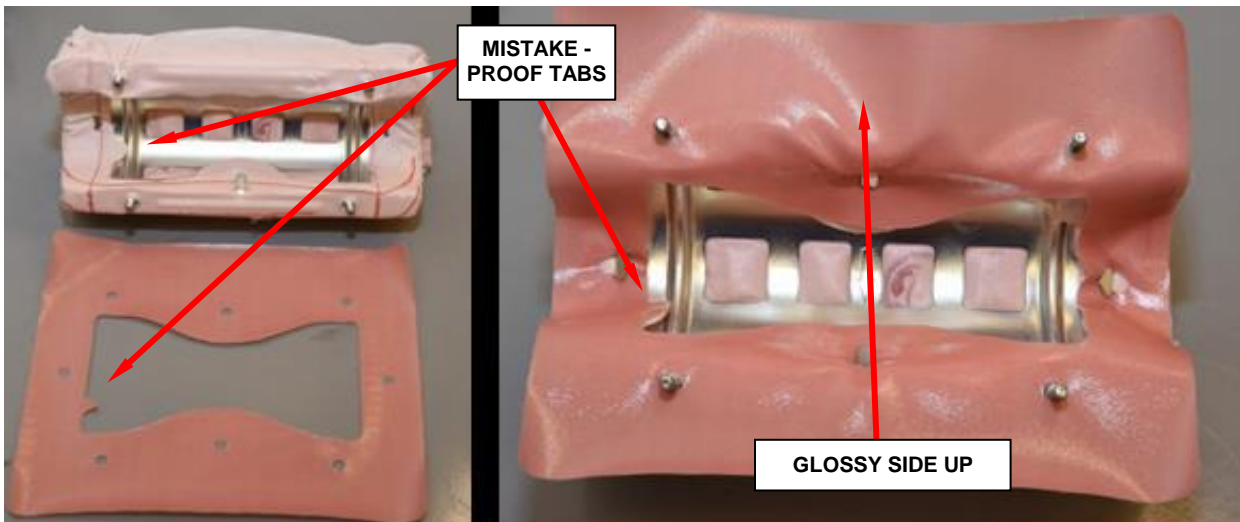
Figure 75 – Fabric Gasket to Cushion

- i. Place the fabric gasket, glossy side up, onto cushion. Mistake-proof tab should be aligned to the tab on the cushion (Figure 75).

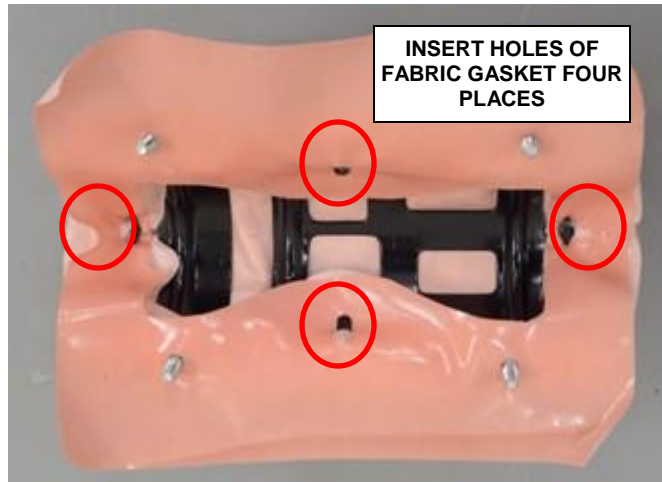
Figure 76 – Fabric Gasket

- j. With the help of a trim tool insert the holes of fabric gasket, four places (Figure 76).

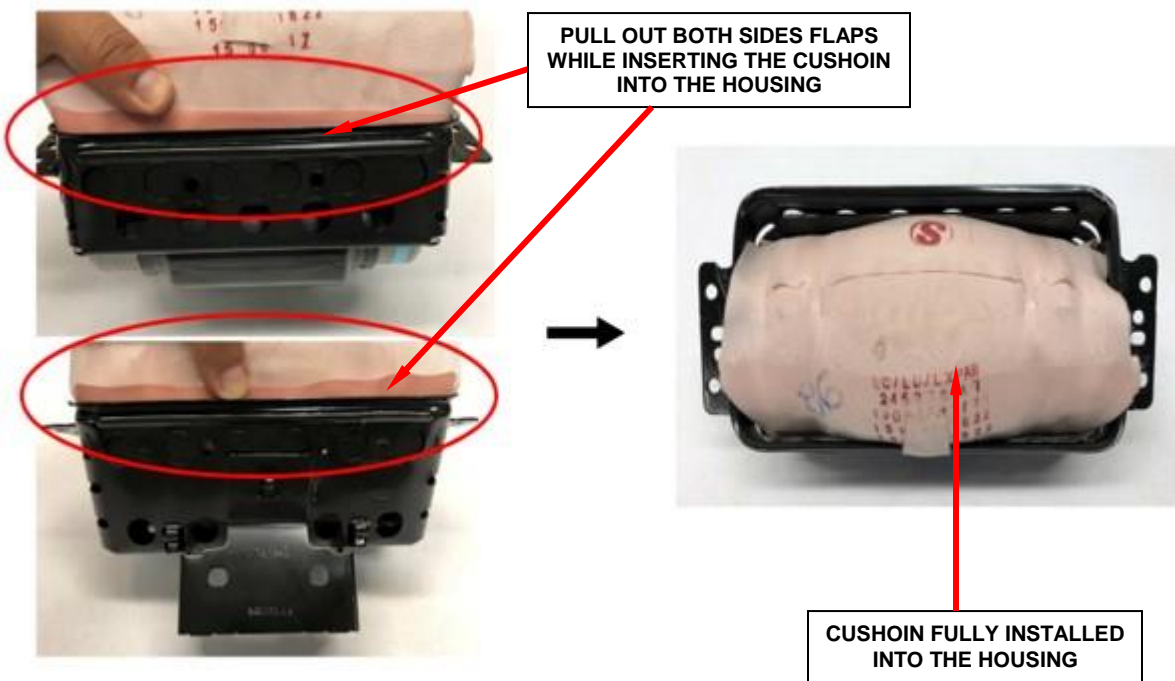
Figure 78 – Side Flaps Must Be Held Out

1. Insert the cushion, pulling out both side flaps (Figure 78).

NOTE: The spacing between the bolts is different on both sides, thus mistake-proof.

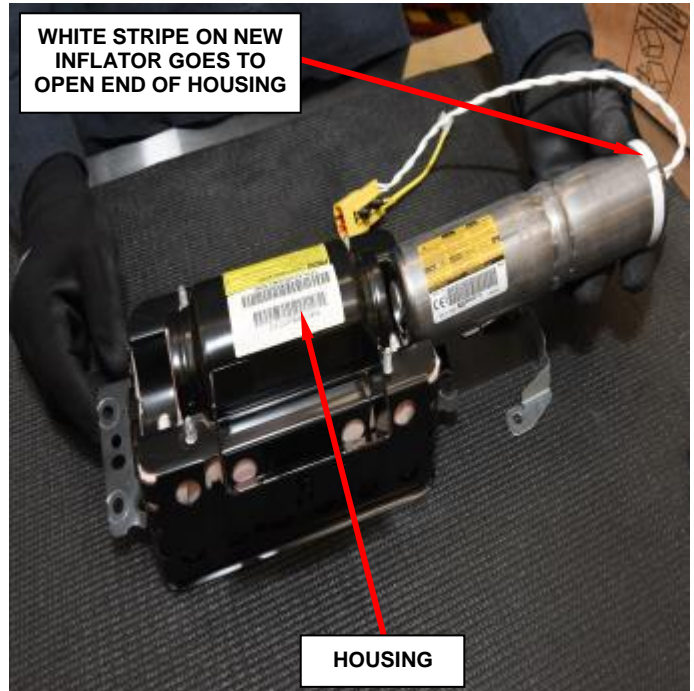
Figure 79 – Install New Inflator to Housing

- n. Slide the **NEW** inflator into the passenger airbag module housing. The keyed end is inserted first; therefore, the white stripe on the **NEW** inflator will be located at the open end (Figures 79 and 80).

NOTE: The inflator's key **MUST** line up with the housing's key.

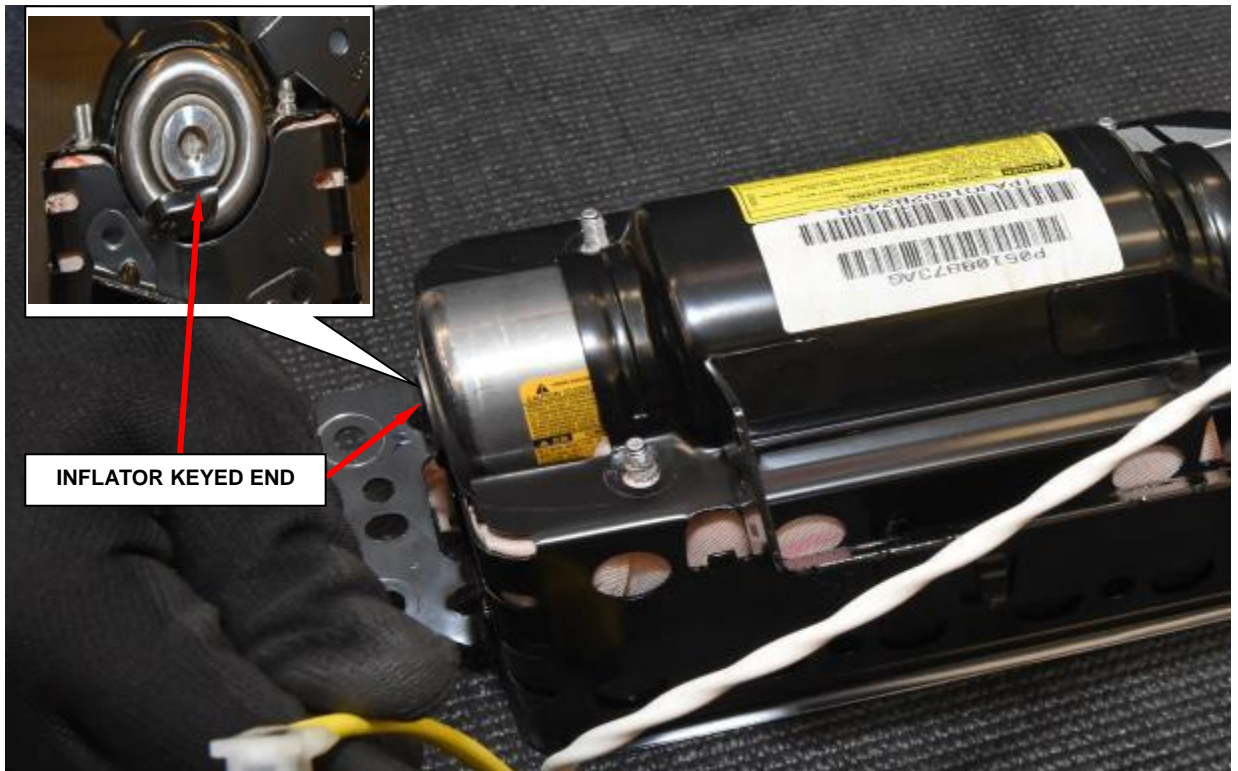
Figure 80 – Inflator End Position

NOTE: The inflator’s key **MUST** line up with the housing’s key (Figure 80).

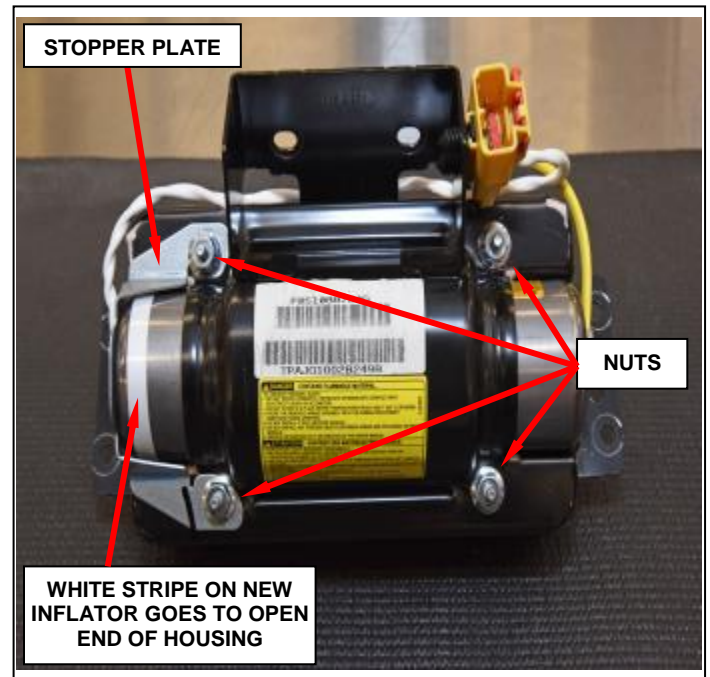
Figure 81 – Stopper Plate and Nuts

o. Position the stopper plate to the airbag housing (Figure 81).

p. Install the four **NEW** mounting nuts to the airbag housing and tighten to 53 in. lbs. (6 N·m) (Figure 81).

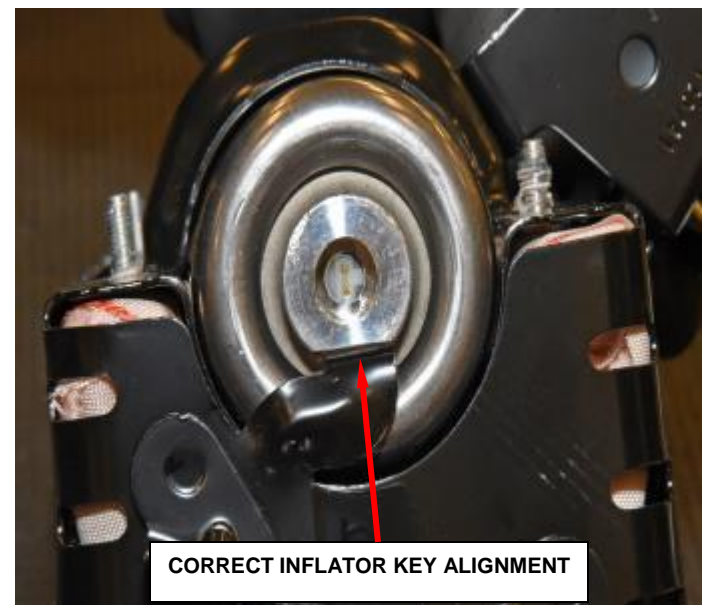
Figure 82 – Check for Inflator Key Alignment

q. Ensure that the inflator’s key is still lined up with the housing’s key (Figure 82).

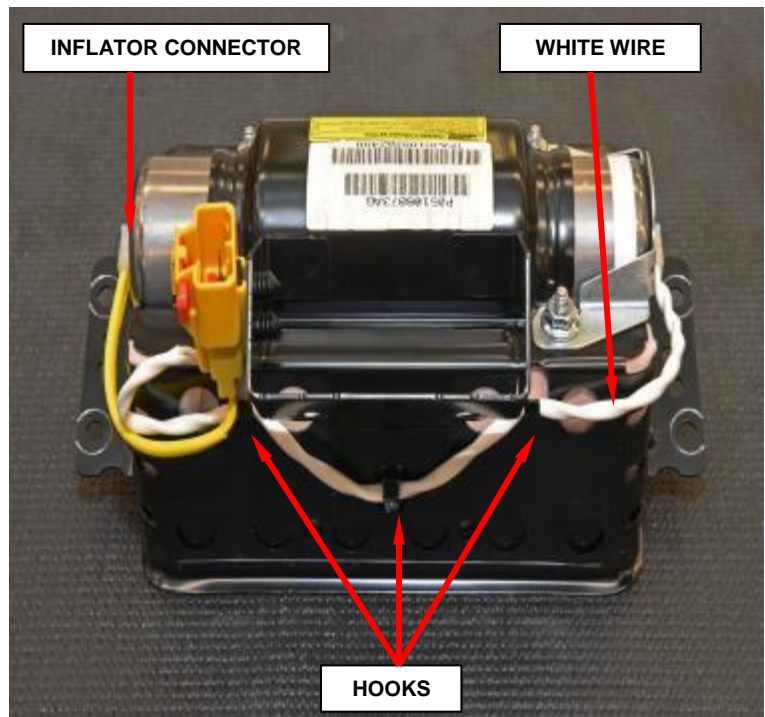
Figure 83 – Retrofit Complete

- r. Attach the white wire to the three hooks on the housing (Figure 83).
- s. Install the yellow three way inline connector to the airbag housing bracket.

- t. Connect the single yellow wire inflator connector to the end of the inflator after removing the protective tape from the end of the inflator (Figure 83).
- u. Passenger airbag retrofit is complete (Figure 83).

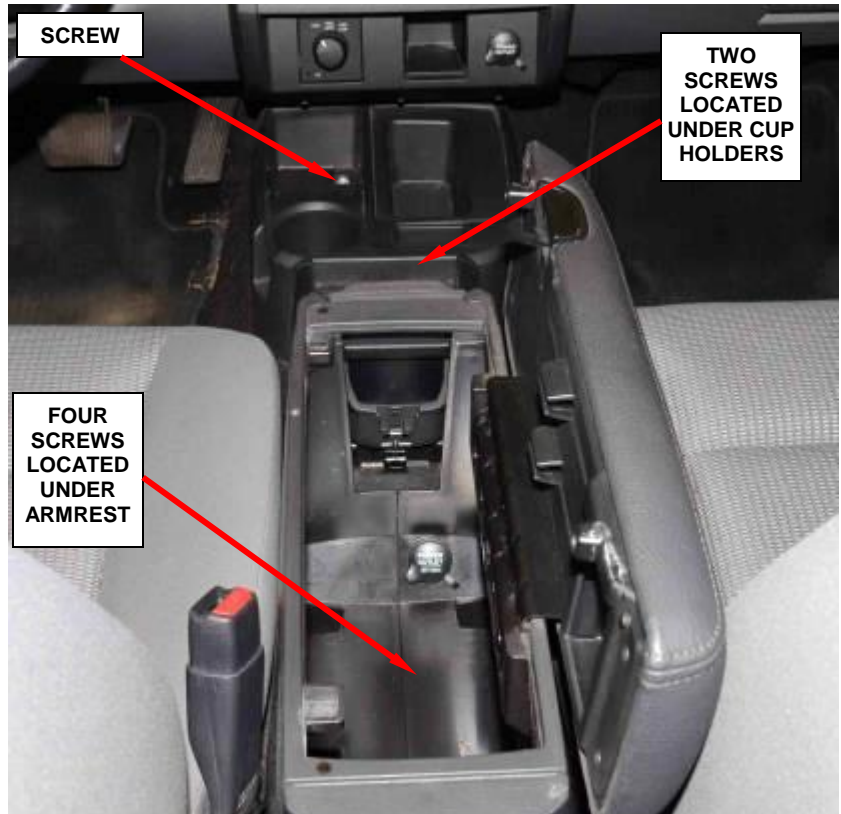
Figure 84 - Floor Console (ATX Shown)

- a. Remove the rubber liner.
- b. Remove the cup holder.
- c. Remove the tray.
- d. Remove the screws that secure the floor console to the floor panel (Figure 84).
- e. Disconnect the console assembly wire harness connector located underneath the floor console and remove the floor console from the vehicle.

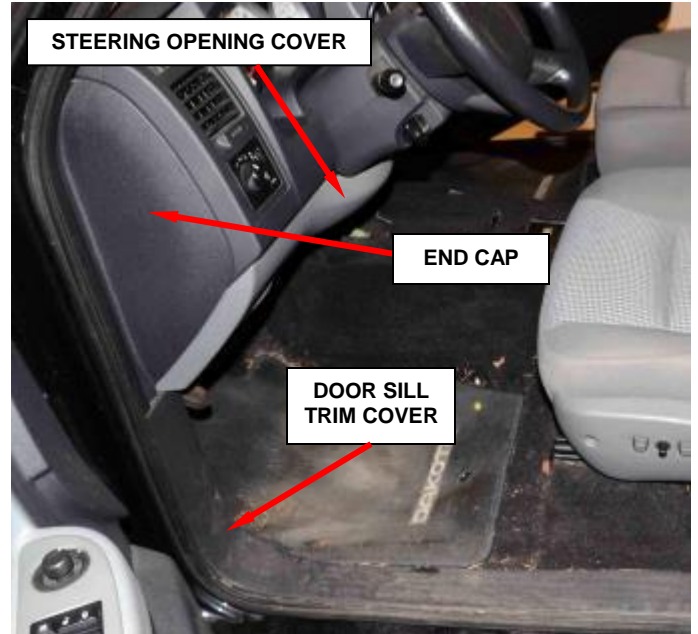
**Figure 85 – Door Sill Trim
(Driver Side Shown)**

3. Remove the driver and passenger side door sill trim cover (Figure 85).
4. Remove the driver and passenger side instrument panel end caps (Figure 85).

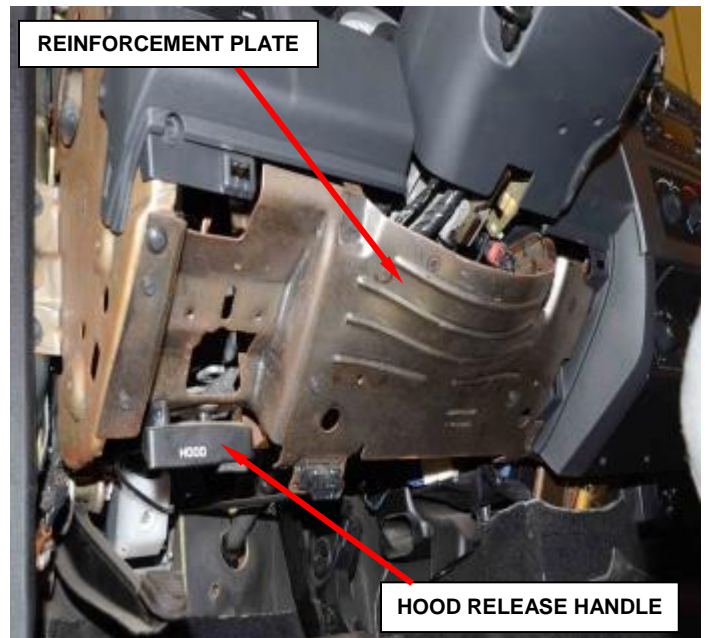
**Figure 86 – Steering Column Reinforcement
Plate**

5. Remove the steering column opening cover and disconnect the parking brake linkage (Figure 86).
6. Remove the steering column reinforcement plate (Figure 86).
7. Remove the two hood release handle screws and position the handle to the side (Figure 86).

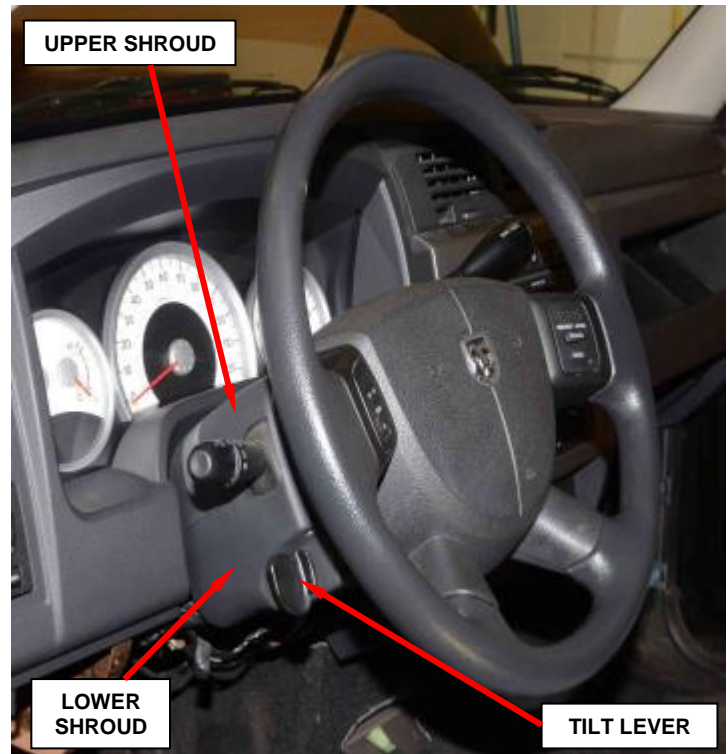
Figure 87 – Steering Column Shrouds

9. Remove the steering column tilt lever knob (Figure 87).

10. Remove the three screws from the lower steering column shroud and remove the upper and lower shrouds (Figure 87).

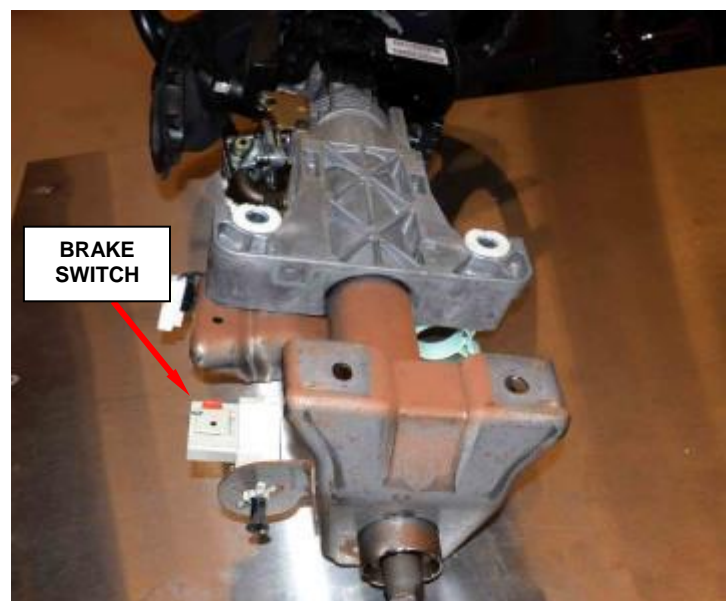
Figure 88 - Brake Switch Connector (Column out of Vehicle for Photographic Purposes)

11. Disconnect the brake switch electrical connector (Figure 88).

WARNING: During installation depress the brake pedal while loading the steering column to the studs or damage may occur to the brake pedal switch.

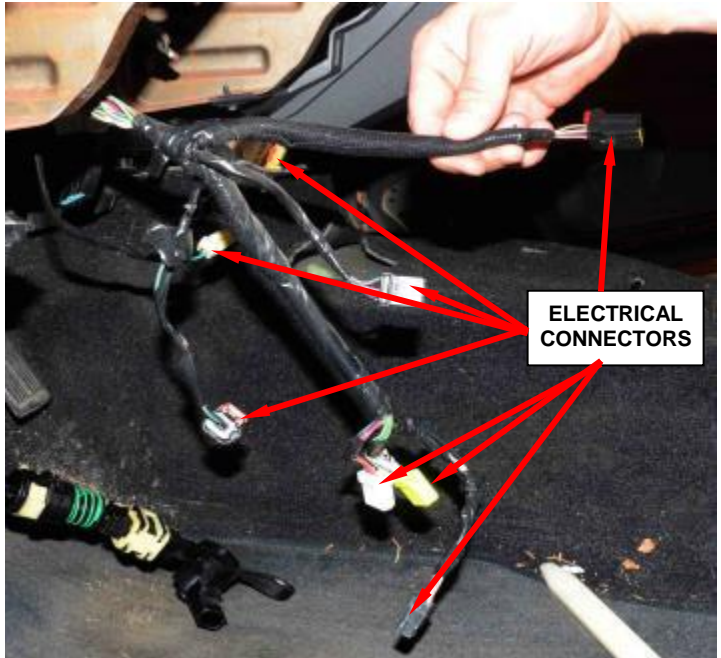
Figure 89 – Column Electrical Connectors

12. Disconnect the wiring harness electrical connectors from the column (Figure 89).
 - a. Disconnect the accelerator position sensor electrical connector (Figure 91).

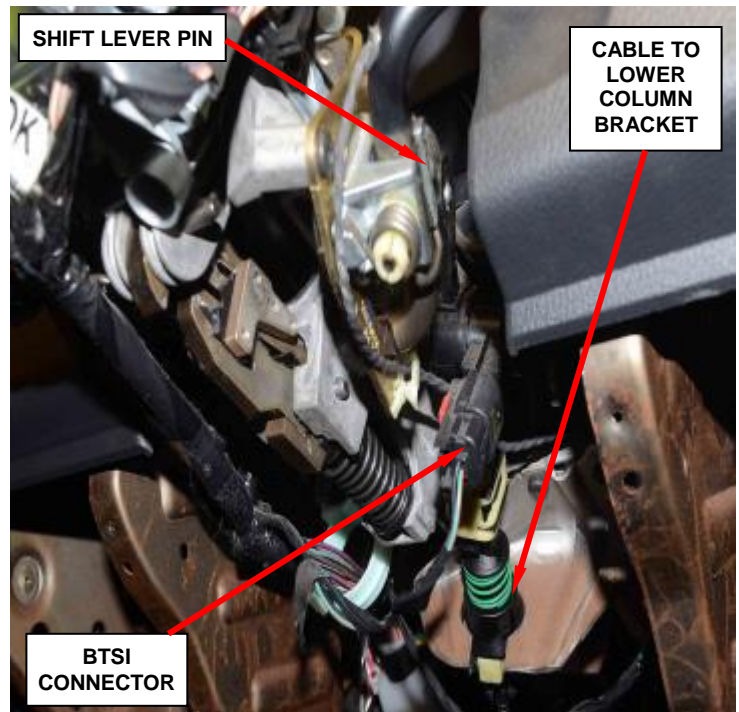
Figure 90 – Gear Shift Cable

13. Disconnect the gearshift cable from the column (Figure 90).
 - a. Disconnect the BTSI wiring connector.
 - b. Disconnect cable at lower column bracket and shift lever pin.

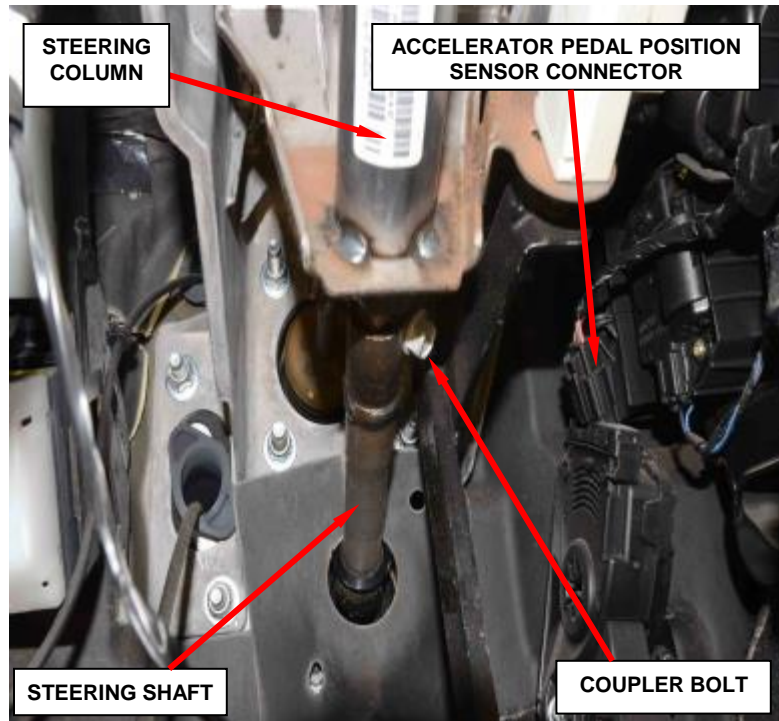
Figure 91 – Steering Shaft Coupler

14. Remove and **discard** the upper steering shaft coupler bolt from the column (Figure 91).

15. Separate the shaft from the coupler.

WARNING: Secure the steering wheel appropriately to avoid rotation and damage to the clockspring.

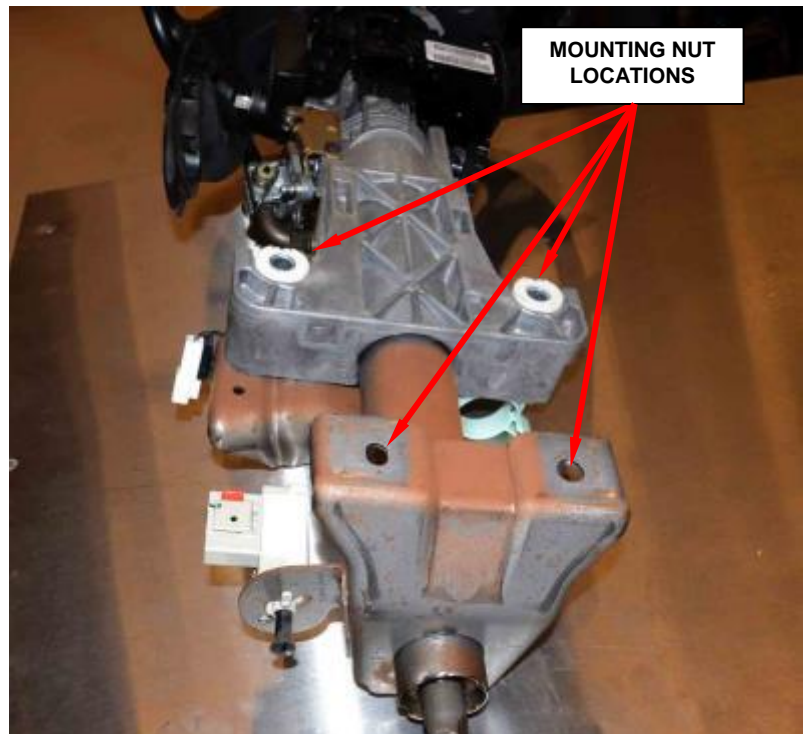
Figure 92 - Steering Column Mounting (Column Removed for Photographic Purposes)

16. Remove the four steering column mounting nuts (Figures 92 and 93).

66. Position the steering column on the dash panel support and loosely install the mounting nuts.
67. Firmly slide the steering column upward against the studs in dash panel and hand tighten the nuts.
68. Center steering column in dash opening and tighten mounting nuts to 28 N·m (21 ft. lbs.).

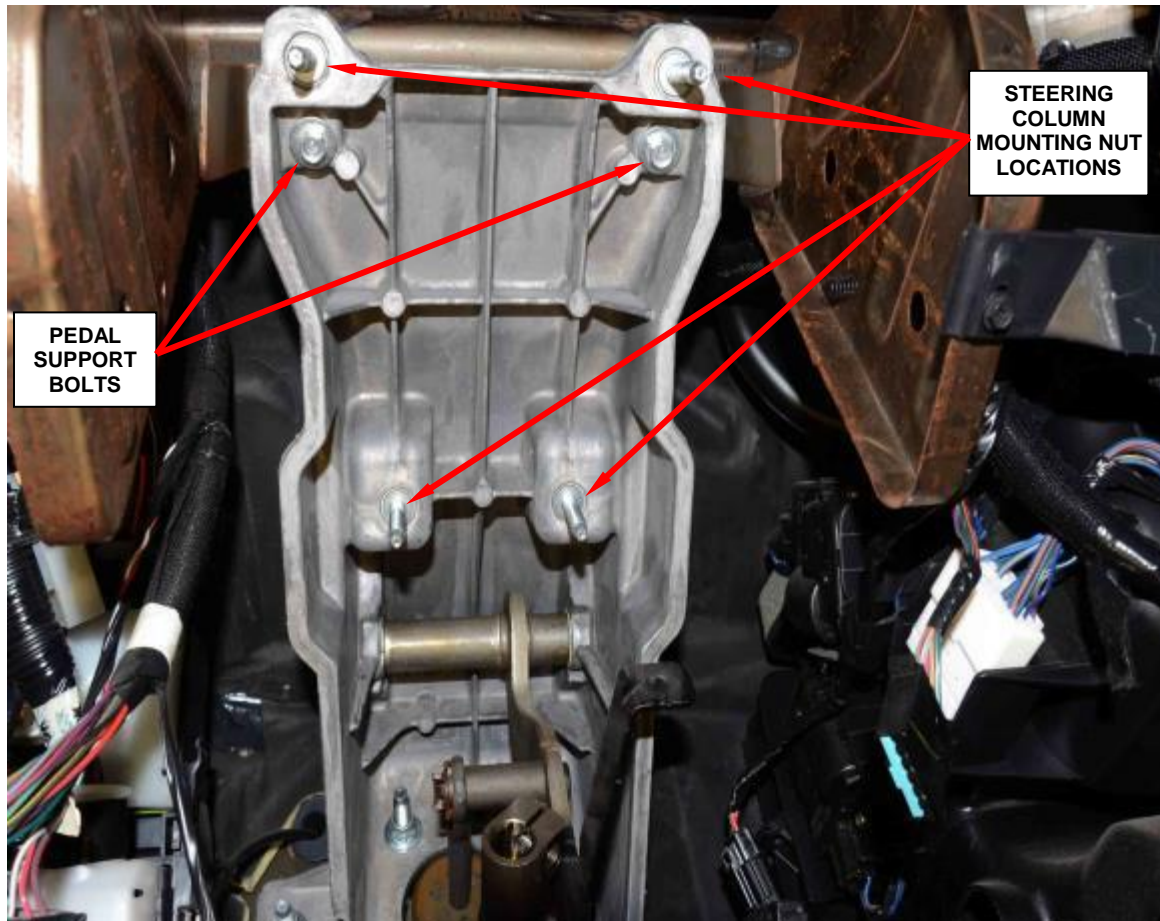
Figure 93 – Pedal Support Bolts

18. Remove the bolts from the pedal support (Figure 93).

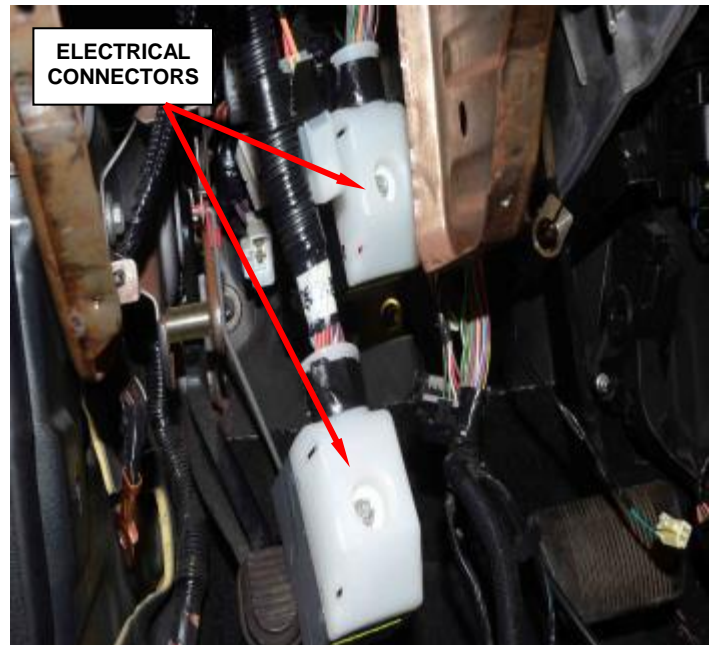
Figure 94 – Electrical Connectors

19. Loosen the screws and disconnect the electrical connectors (Figure 94).
