Revised (2) May 2019

Dealer Service Instructions for:

Safety Recall U03 / NHTSA 18V-021 Passenger Airbag Inflator

The front passenger airbag inflator (PAB) on about 328,000 of the above vehicles may contain propellant that degraded after prolonged exposure to high absolute humidity, high temperatures and high temperature cycling. Activation of an inflator with degraded propellant, in a vehicle crash where the PAB is designed to deploy, may result in an inflator explosion. An inflator explosion may cause metal fragments to pass through the air bag and into the vehicle interior at high speed, which may result in injury or death to vehicle occupants.

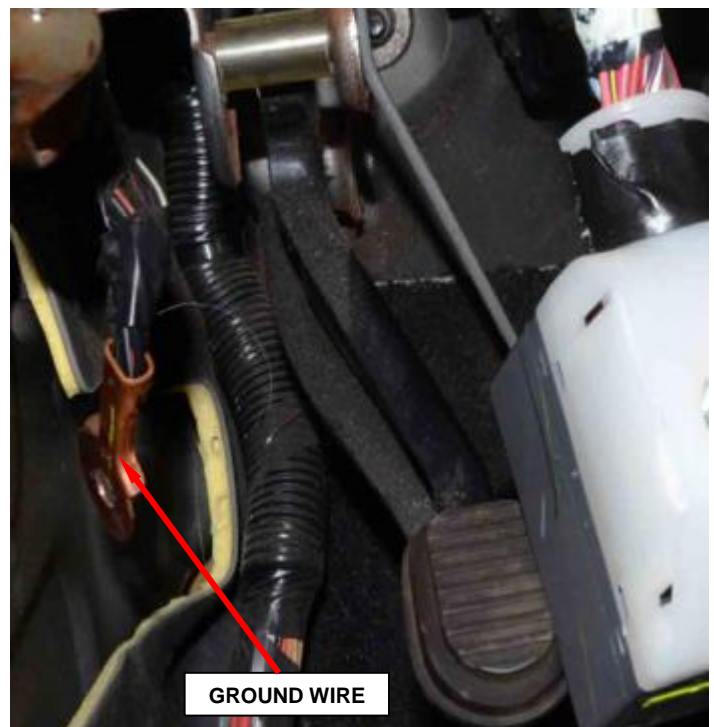
Figure 95 – Bolt and Ground Location

20. Remove the bolt and the ground from the left A-pillar (Figure 95).

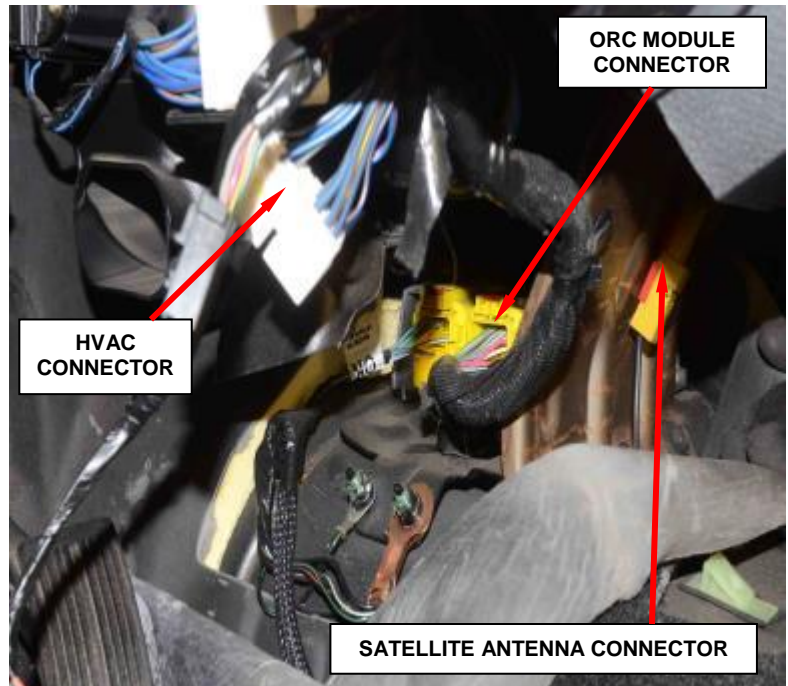
Figure 96 – ORC Module

21. Disconnect one ORC module electrical connector (Figure 96).
22. Disconnect the HVAC electrical connector (Figure 96).
23. Disconnect the satellite antenna connector (Figure 96).
24. Remove the two center support bolts (Figure 97).
25. Remove the two left support bolts (Figure 97).

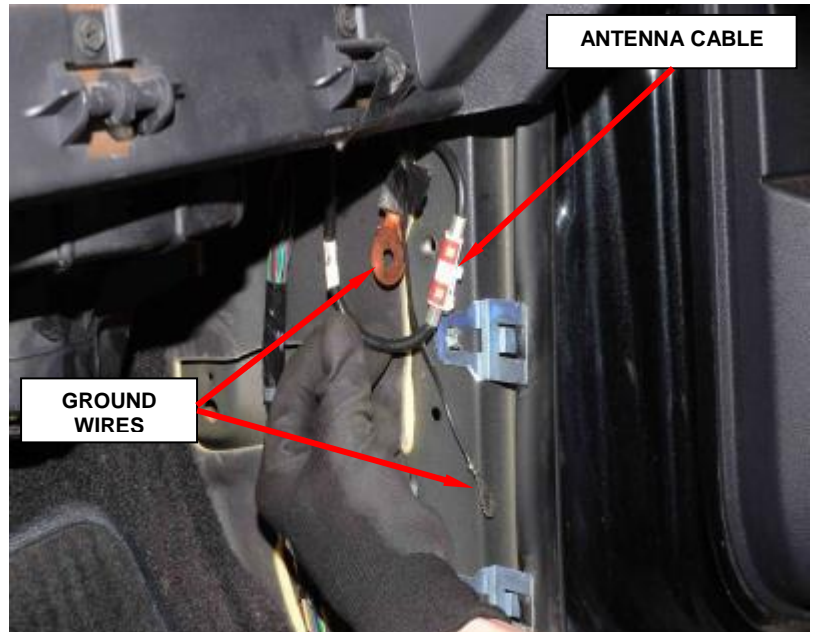
Figure 98 – Ground Bolt and Nut

26. Remove the bolt and nut and disconnect the grounds on the right A-pillar (Figure 98).

27. Disconnect the antenna cable (98).

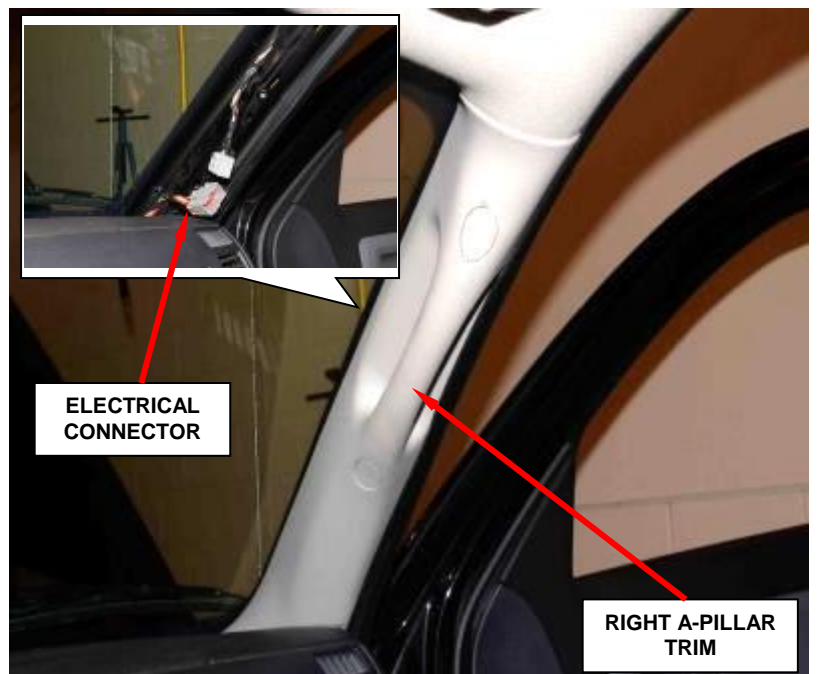
Figure 99 – A-Pillar Trim (Right Side Shown)

28. Remove the right and left side A-pillar trim (Figure 99).

29. Disconnect the right side A-pillar electrical connector (Figure 99).

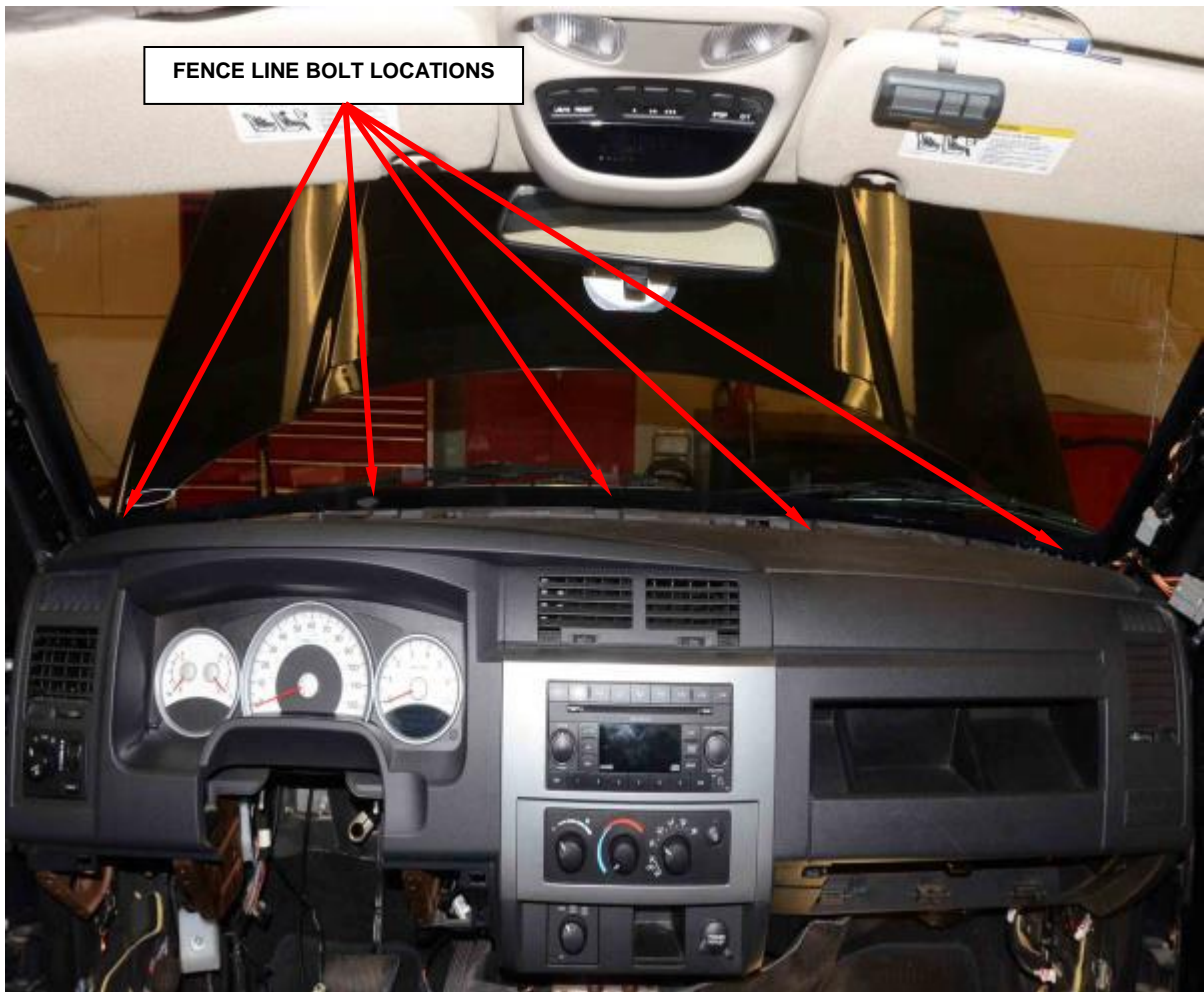
Figure 100 - Fence Line Bolts

31. Remove the five upper fence line bolts (Figure 100).

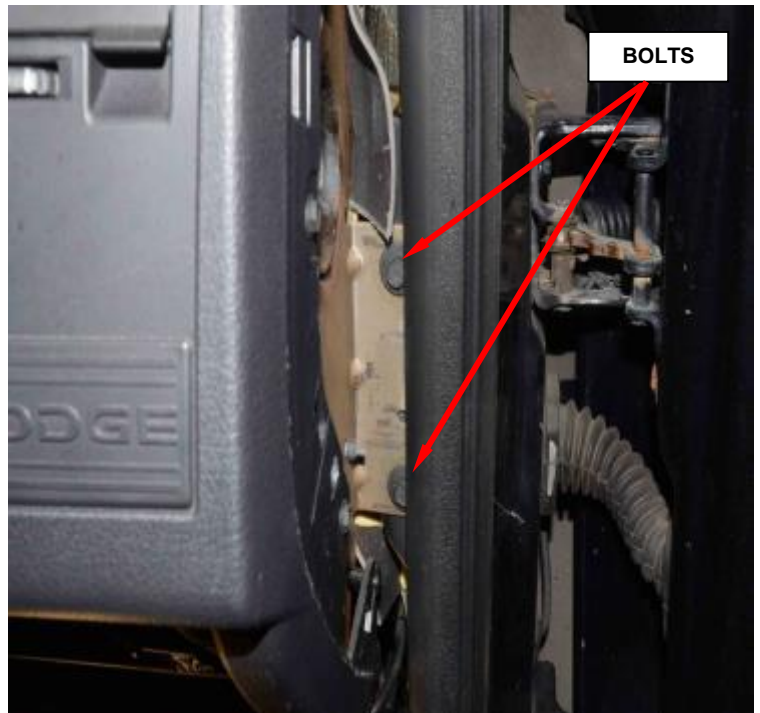
Figure 101 - Right Side Support Bolts

32. Remove the right side support bolts and with the help of another person, remove the instrument panel assembly from the vehicle and place on a soft clean surface (Figure 101).

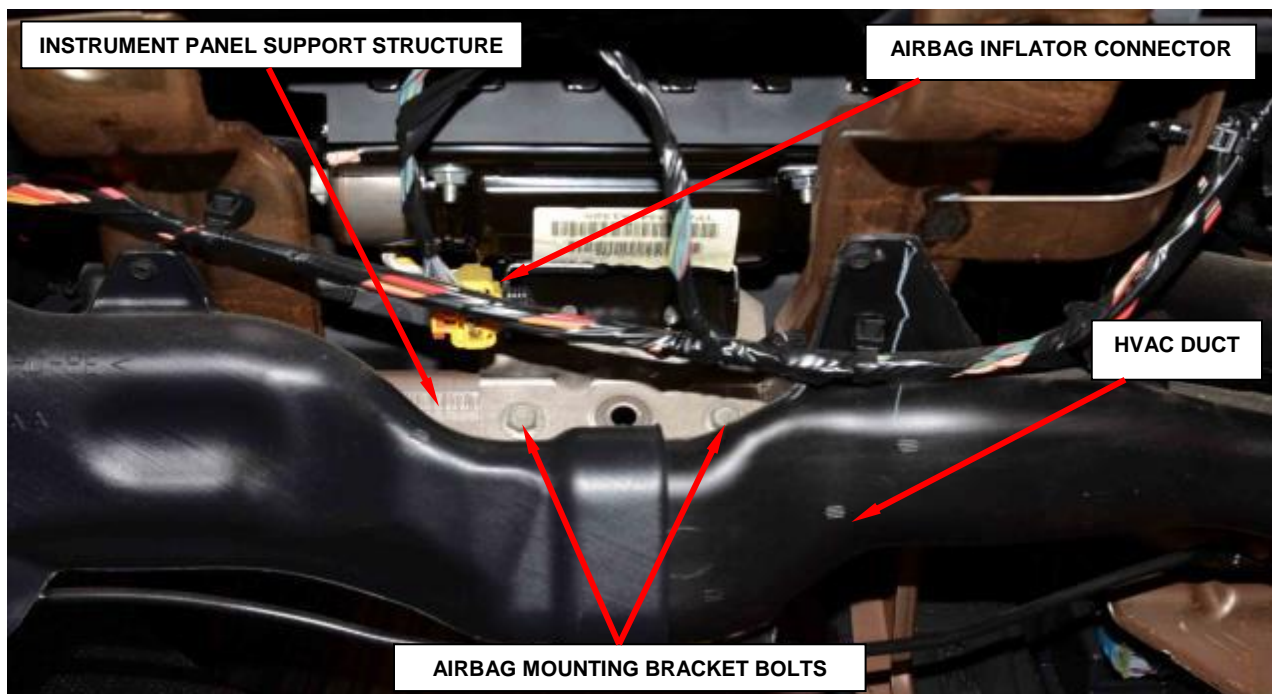
Figure 102 – Instrument Panel Mounting Bracket

33. Remove and save the two bolts that secure the passenger airbag bracket to the instrument panel support structure (Figure 102).

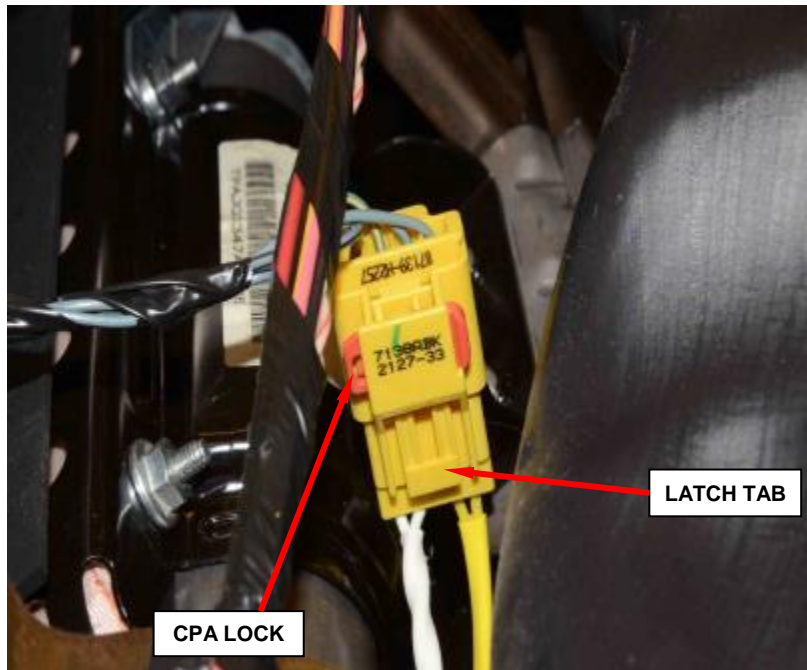
Figure 103 - Airbag Inflator Pigtail Connector

34. Disconnect the instrument panel wire harness connector from the airbag inflator pigtail connector on the right side of the airbag mounting bracket (Figures 102 and 103).

a. Slide the red Connector Position Assurance (CPA) lock on the connector toward the side of the connector (Figure 103).

b. Depress the connector latch tab and pull the two halves of the connector straight away from each other.

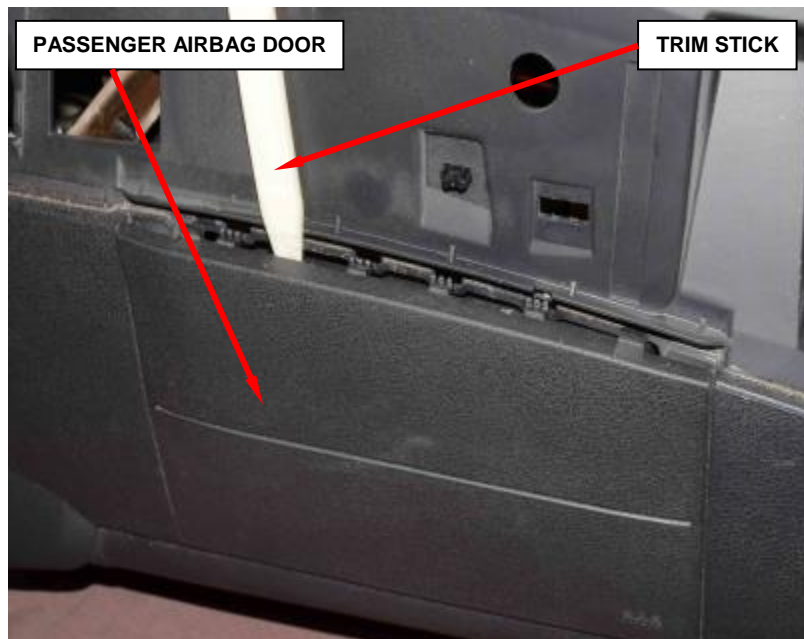
Figure 104 – Passenger Airbag Door

35. Using a trim stick or another suitable wide flat bladed tool, gently pry the forward and side edges of the passenger airbag door away from the top of the instrument panel far enough to disengage the snap features on the door from the receptacles in the instrument panel top pad (Figure 104).

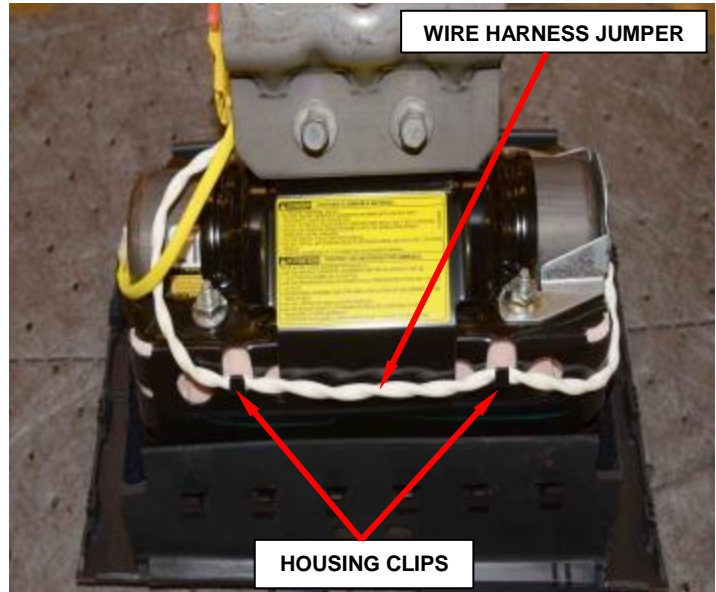
Figure 105 – Passenger Airbag Assembly

- a. Place the passenger airbag assembly on a soft surface to prevent damage using the foam block provided with the inflator kit.
- b. Disengage the wire harness jumper from the housing clips in two places (Figure 105).

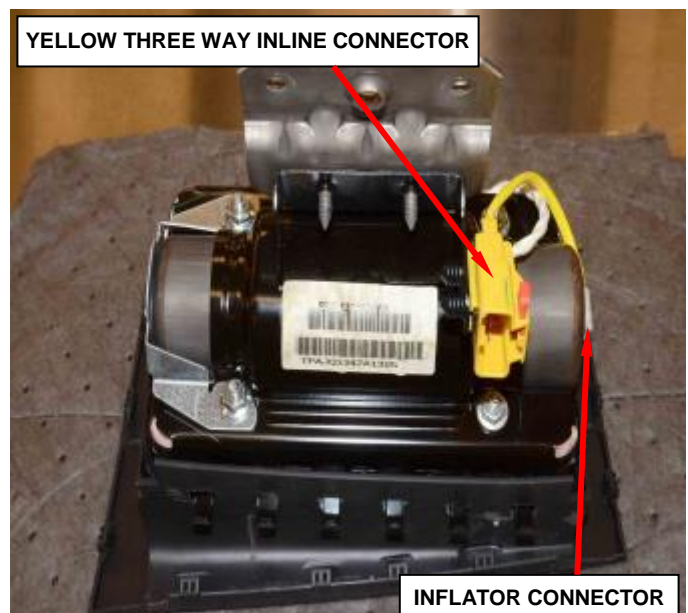
Figure 106 – Inflator Connectors

- c. Disconnect the single yellow wire inflator connector from the end of the inflator using pliers (Figure 106).
- d. Remove the yellow three way inline connector from the housing bracket (Figure 106).

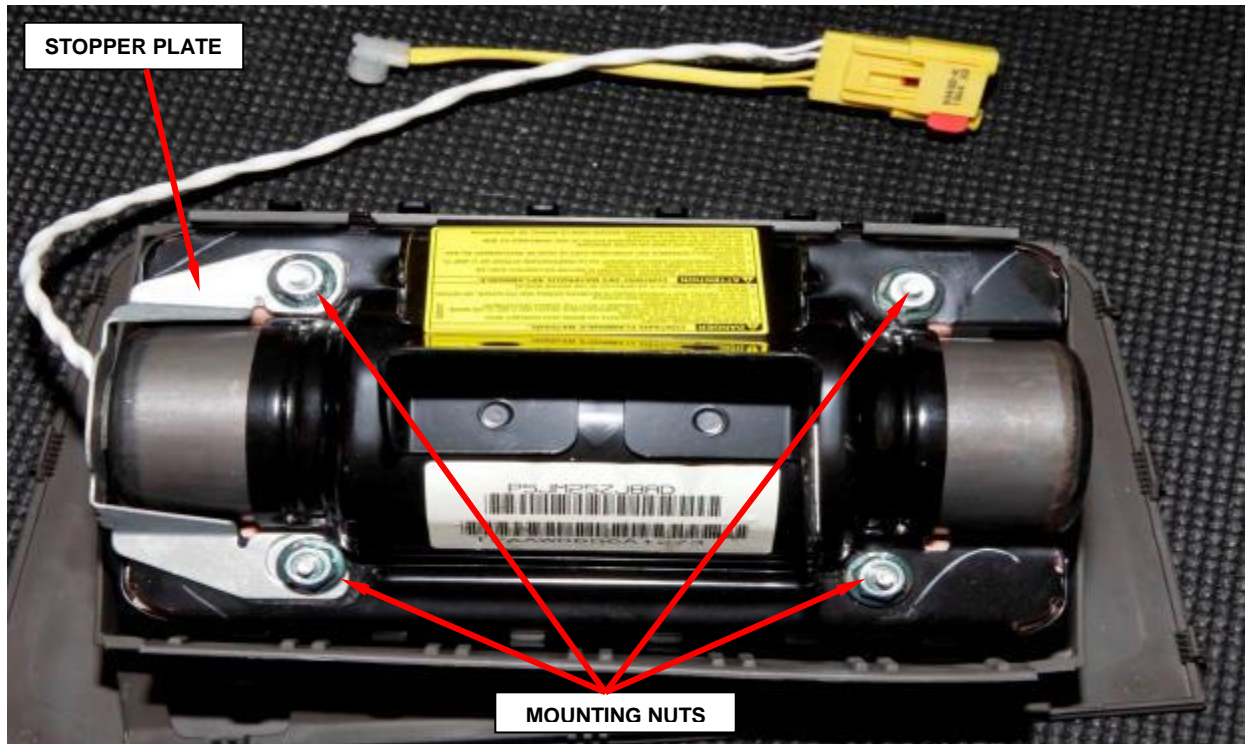
Figure 107 – Mounting Nuts and Stopper Plate

e. Remove and discard the four mounting nuts and stopper plate from the passenger airbag module (Figure 107).

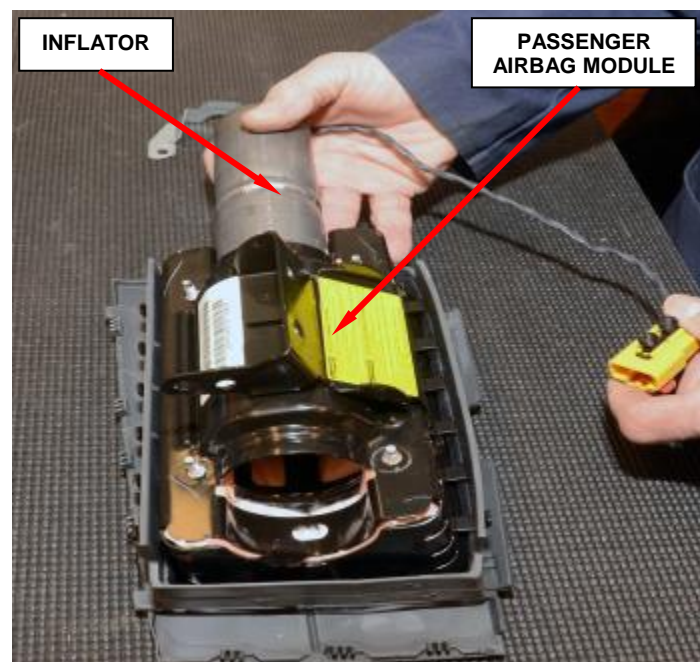
Figure 108 - Inflator Removal

f. Slide the inflator out of the passenger airbag module (Figure 108).

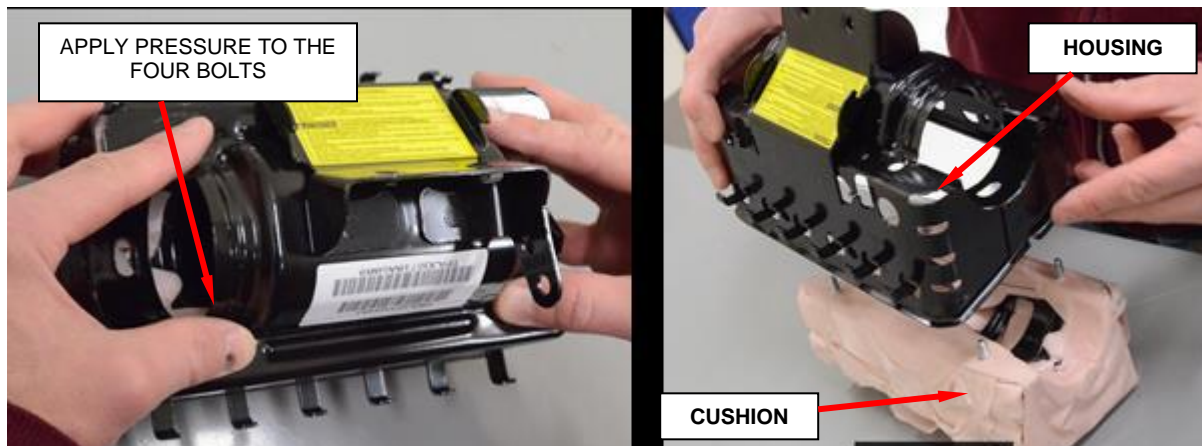
Figure 109 – Remove Airbag Cushion from Housing

h. Remove airbag cushion from housing by applying pressure to the bolts, set cushion aside (Figure 109).

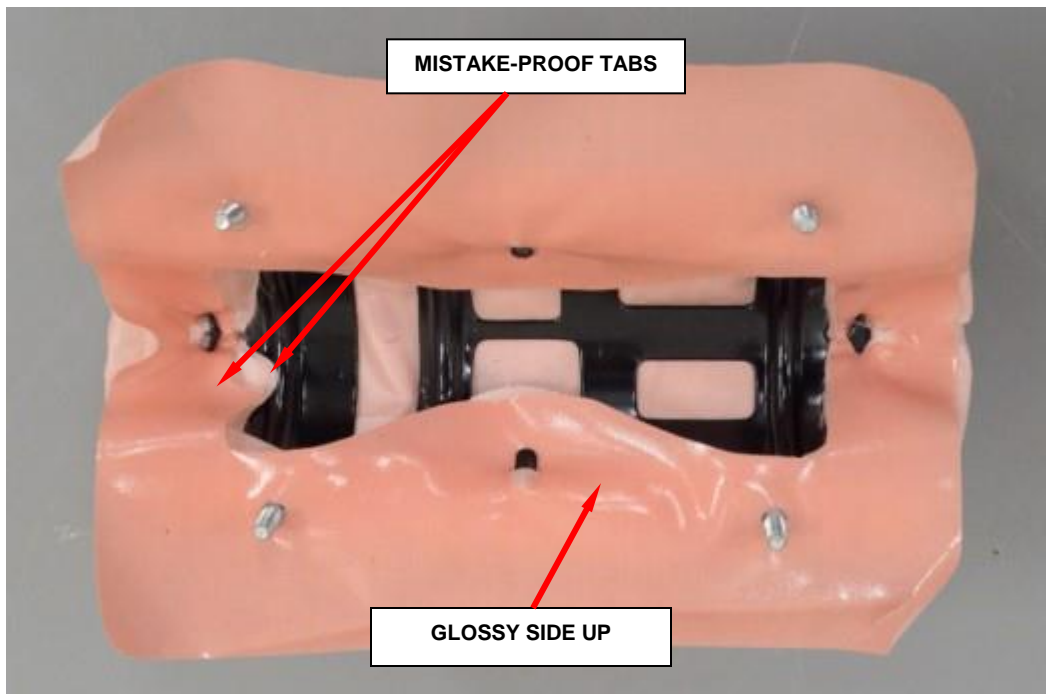
Figure 110 – Fabric Gasket to Cushion (Glossy Side Up)

- i. Place the fabric gasket, glossy side up, onto cushion. Mistake-proof tab should be aligned to the tab on the cushion (Figure 110).

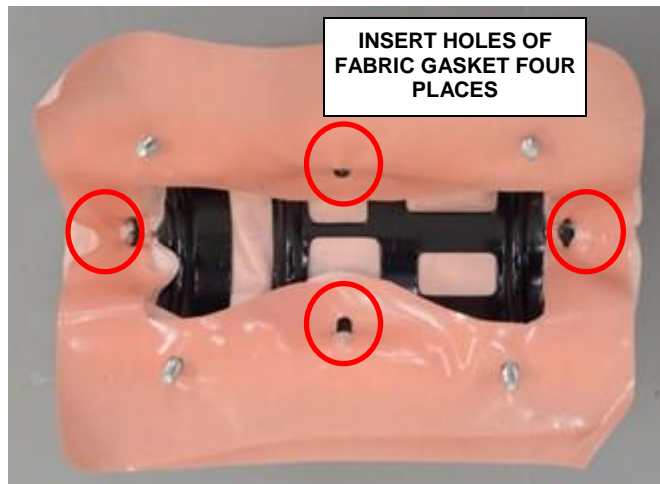
Figure 111 – Fabric Gasket

- j. With the help of a trim tool insert the holes of fabric gasket, four places (Figure 111).

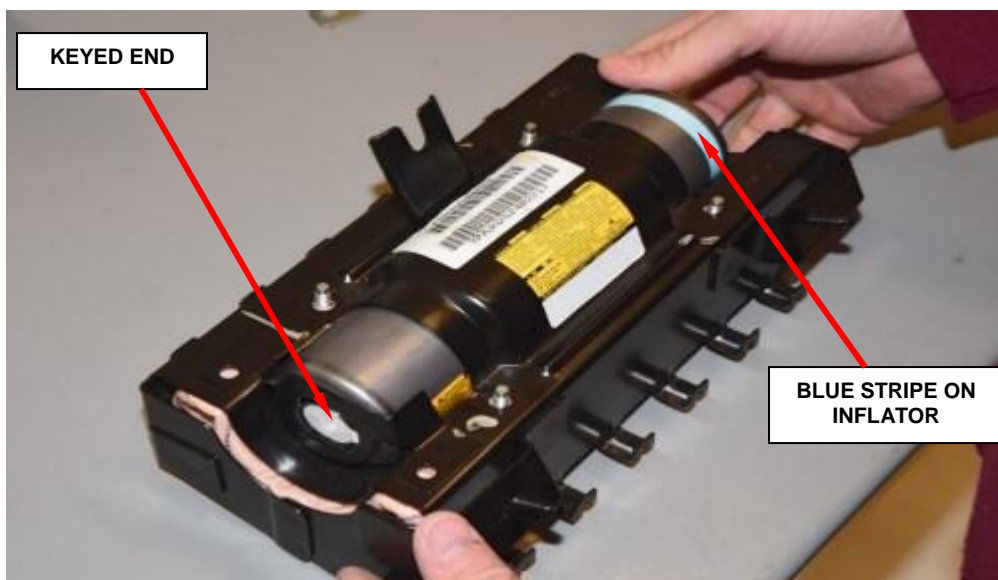
Figure 112 – Insert Inflator

- k. Slide **new** inflator into housing. The keyed end is inserted first, therefore the blue stripe on the inflator will be located at the open end, as shown (Figure 112).

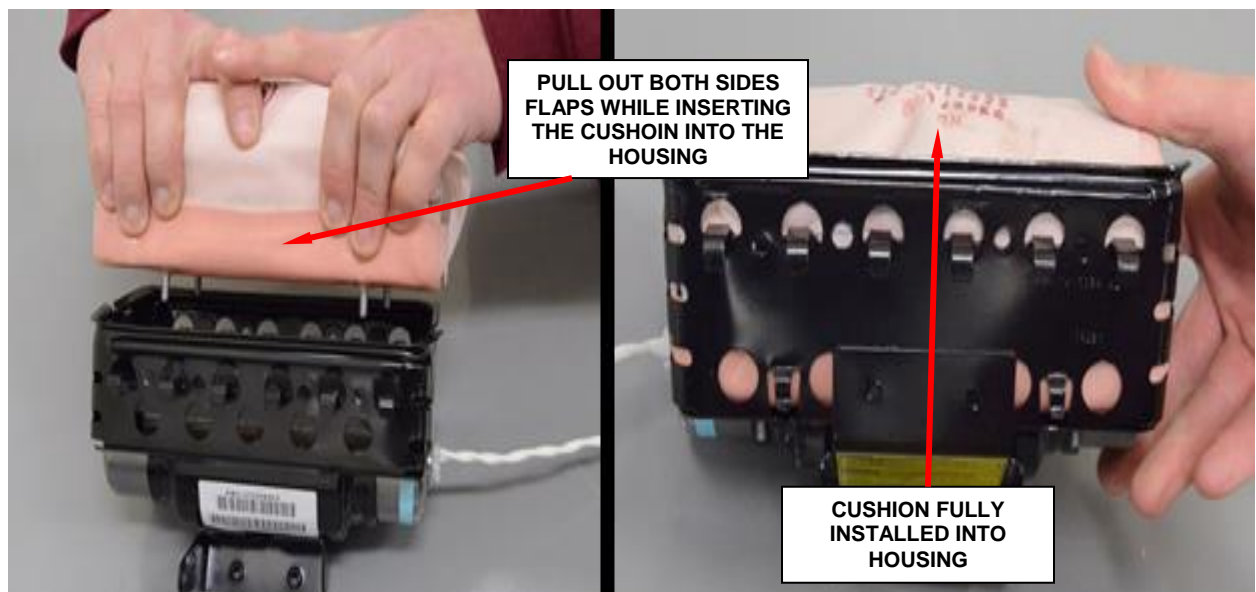
Figure 113 - Side Flaps Must Be Held Out

1. Insert the cushion, pulling out both side flaps (Figure 113).

NOTE: The spacing between the bolts is different on both sides, thus mistake-proof.

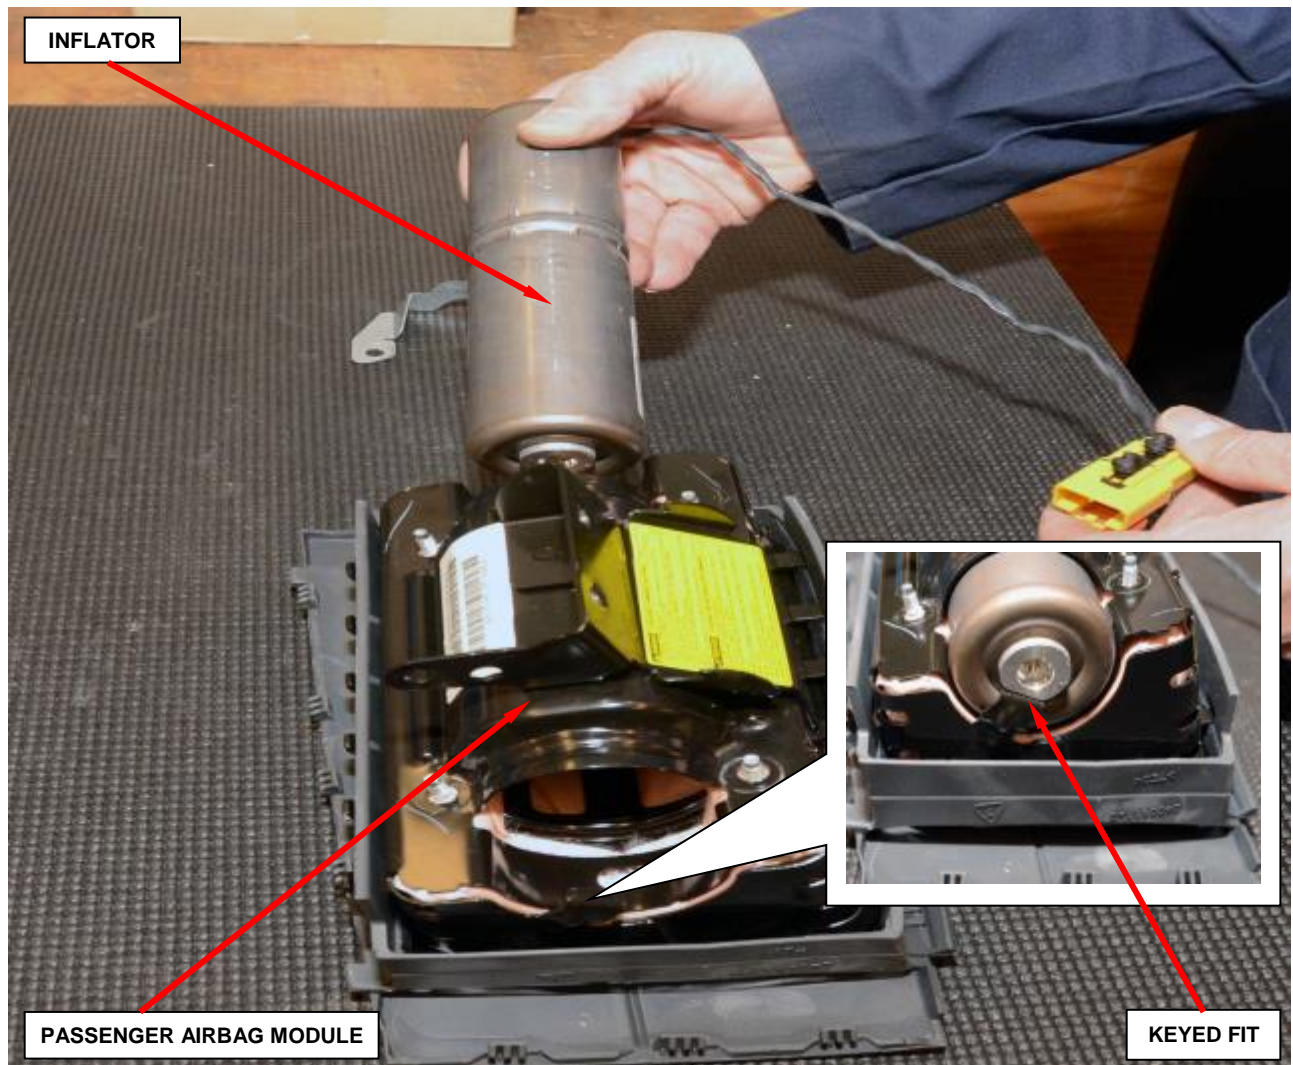
Figure 114 – Passenger Inflator Installation

NOTE: The inflator is keyed to fit into the housing (Figure 114).

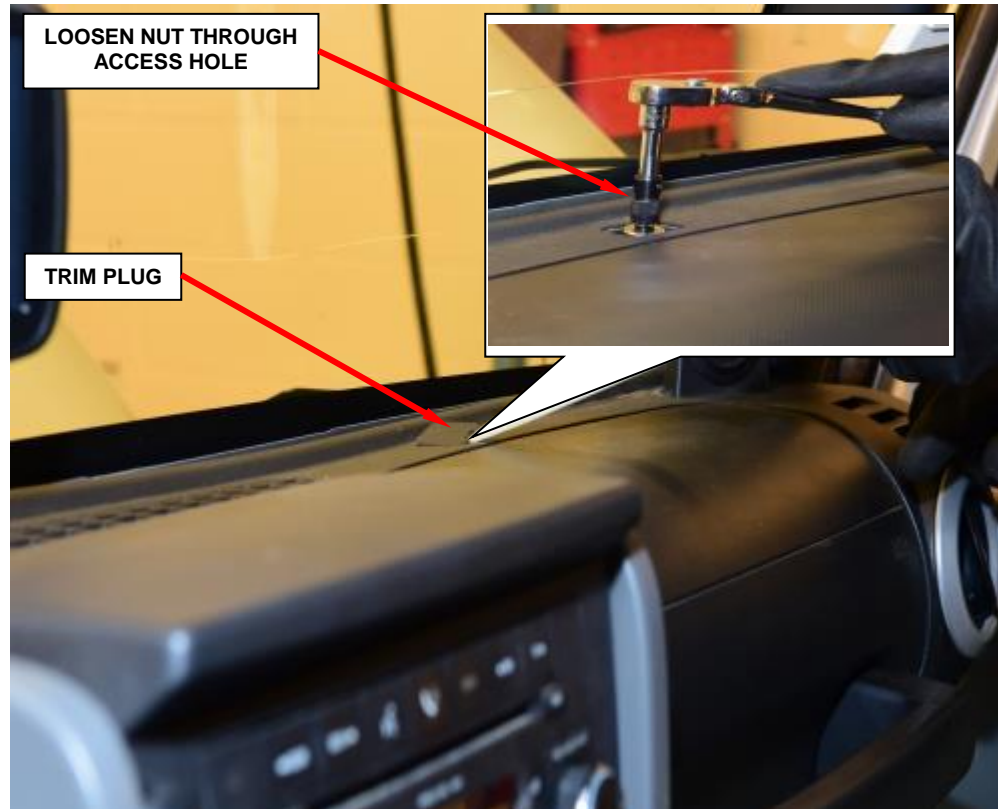
Figure 115 – Trim Plug Access Hole

2. Remove the trim plug from the access hole in the top of the instrument panel between the windshield and the forward edge of the passenger airbag door (Figure 115).

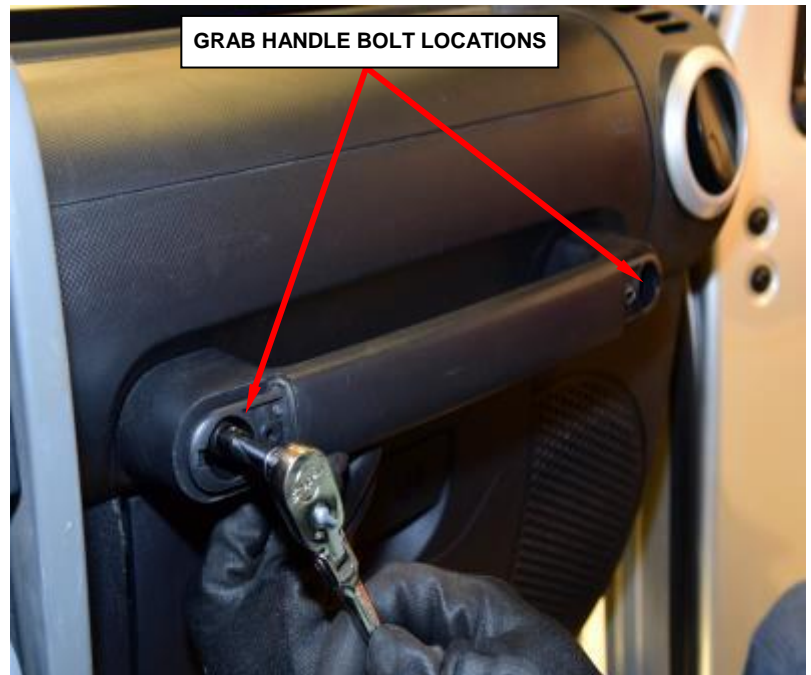
Figure 116 – Grab Handle Bolts

4. Remove the grab handle above the glove box door from the instrument panel.
 - a. Using a trim stick C-4755 or equivalent, slide the grab handle trim caps off the trim handle.
 - b. Remove and save the two bolts and remove the grab handle (Figure 116).

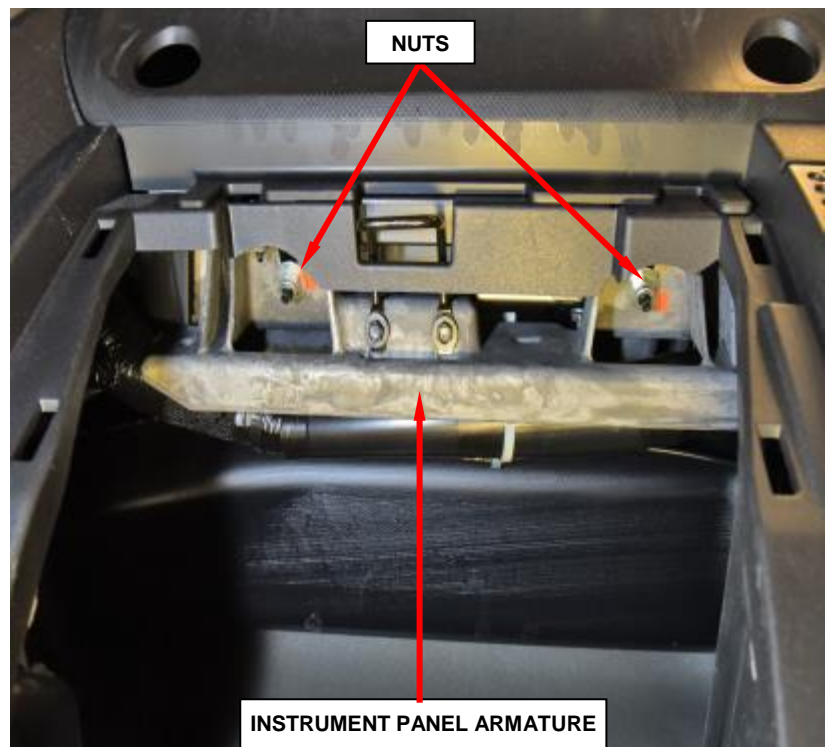
Figure 117 – Lower Passenger Airbag Nuts

5. Remove the glove box from the instrument panel.
 - a. Open the glove box and squeeze the stop tabs inward.
 - b. Lower the glove box and release the hinges and remove the glove box.
6. Reach up into the instrument panel glove box opening to access and remove and **save** the two nuts that secure the passenger airbag lower studs to the instrument panel armature on each side of the glove box latch striker (Figure 117).

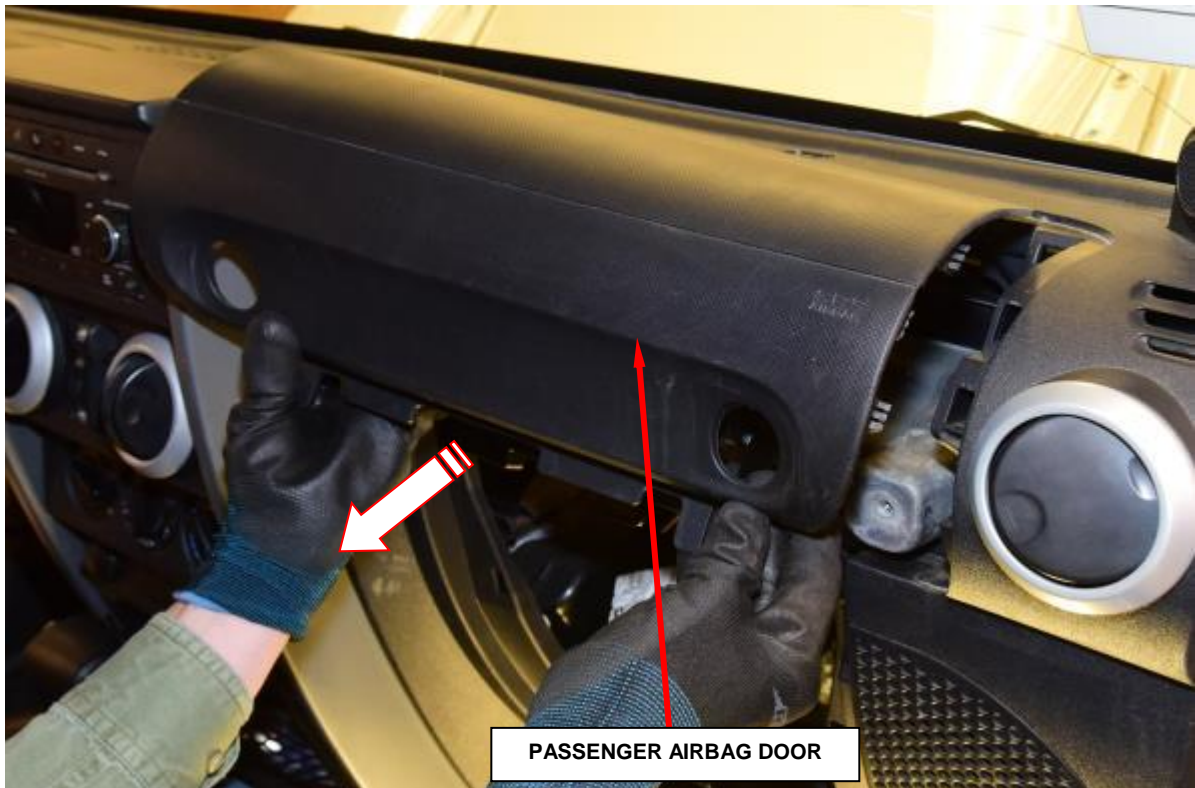
Figure 118 – Passenger Airbag Door

7. Using a trim stick or another suitable wide flat-bladed tool, gently pry the edges of the passenger airbag door rearward far enough to disengage the snap features in the instrument (Figure 118).
8. Grasp the lower edge of the passenger airbag door and pull the door and airbag rearward far enough to access the two instrument panel wire harness connections.

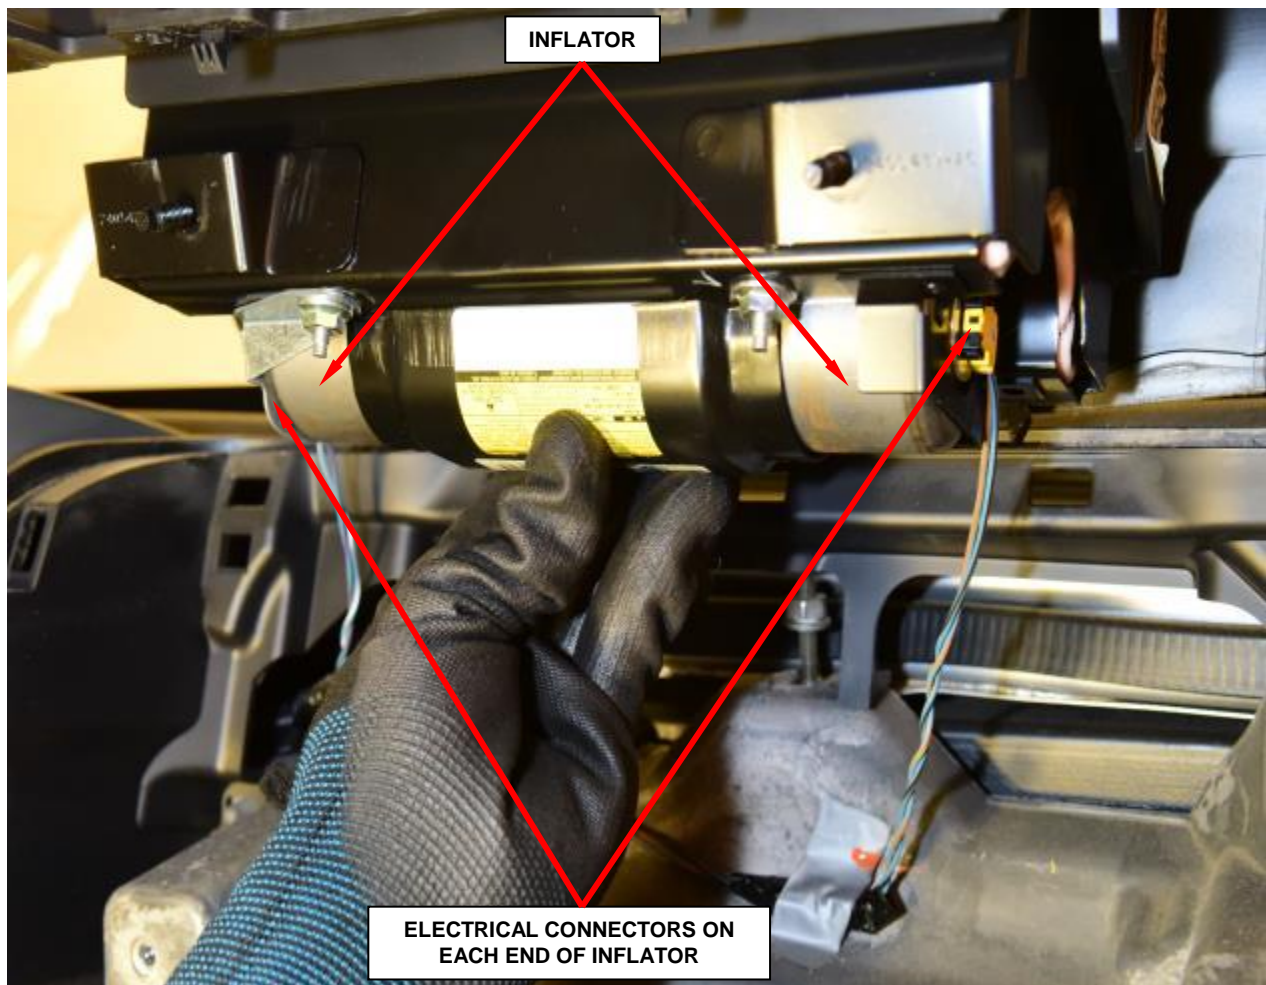
**Figure 119 – Airbag Inflator Electrical Connectors**

9. Disconnect the instrument panel wire harness connectors from the airbag inflator. Firmly grasp and pull the lock straight out from the connector insulator, then pull the insulators straight out from the airbag inflator to disconnect them from the connector receptacles (Figure 119).
10. Remove the passenger airbag and airbag door from the instrument panel as a unit and continue with Step 31.

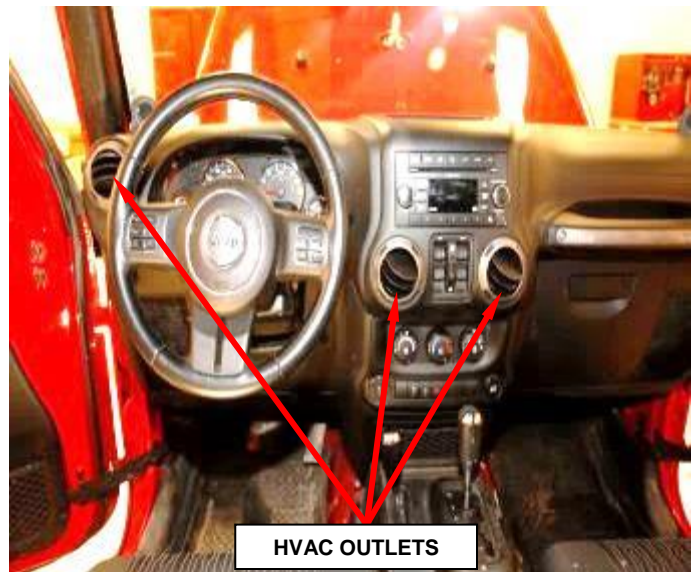
Figure 120 – HVAC Outlets

11. Remove the three HVAC outlets (Figure 120).

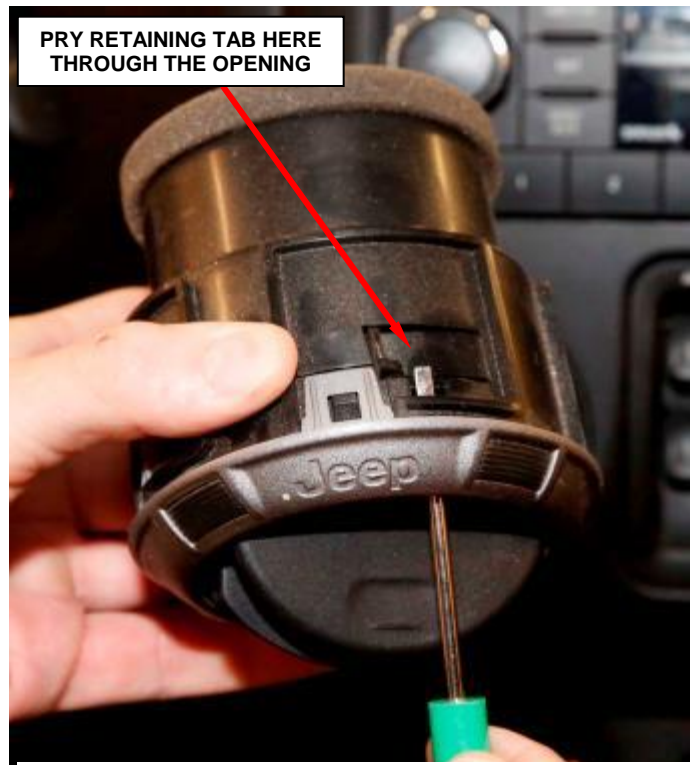
Figure 121 - HVAC Outlet Tab

- a. Each air outlet is secured by a retaining tab located on the outlet, and a stop tab located on the back of the trim panel. Access the retaining tab from the inside of the air outlet, through the square openings provided (Figure 121).
- b. Rotate the louvers of the air outlet in the instrument panel to the eleven-o'clock position.
- c. Adjust the louvers partly downward for best access.
- d. Working from inside of the air outlet, place a small screwdriver or equivalent through the square opening, located at the twelve-thirty position.

- e. Carefully pry the retaining tab toward the center of the air outlet and rotate the outlet counterclockwise (Figure 121)

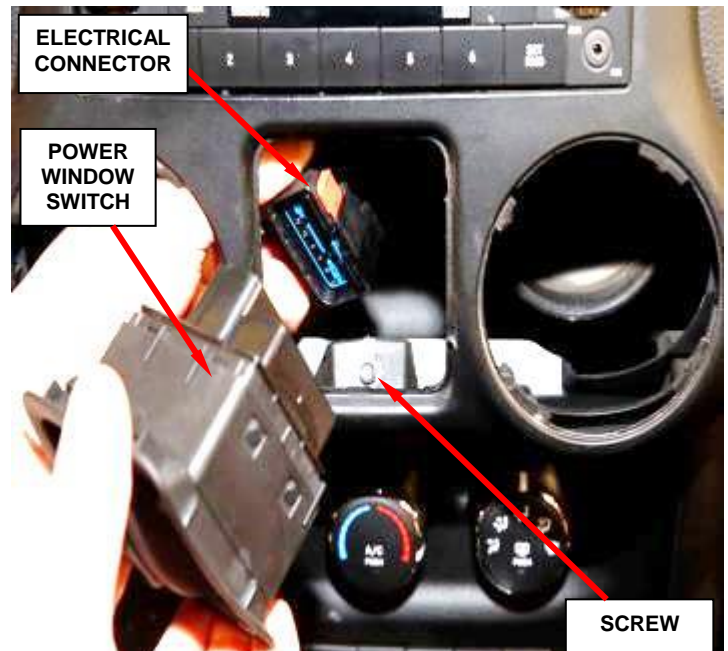
Figure 122 – Power Window Switch

12. Position the steering wheel into the full down position.
13. Remove the steering column opening cover.
14. If equipped with power windows, using a Trim Stick C-4755 or a suitable flat bladed tool, gently pry the switch assembly away from the instrument cluster bezel (Figure 122).

15. For vehicles without power windows, using a Trim Stick C-4755 or a suitable flat bladed tool, gently pry the storage bin assembly away from the bezel and remove.
16. Disconnect the switch assembly electrical connector and remove the switch (Figure 122).
17. Remove the screw from the power window switch opening (Figure 122).
18. Remove the storage bin mat and remove the top screw (Figure 123).

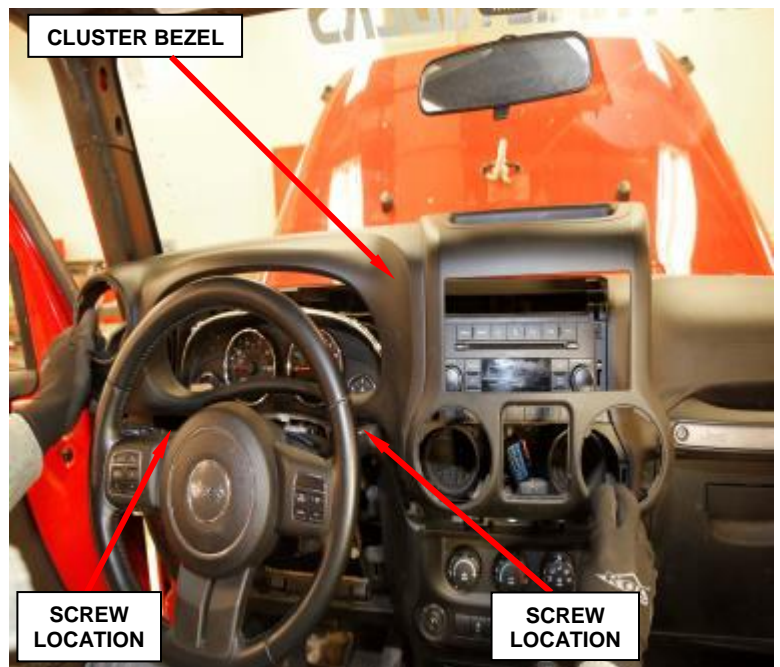
Figure 124 – Cluster Bezel Screws

19. Remove the two screws below the cluster on both sides of the steering column (Figure 124).

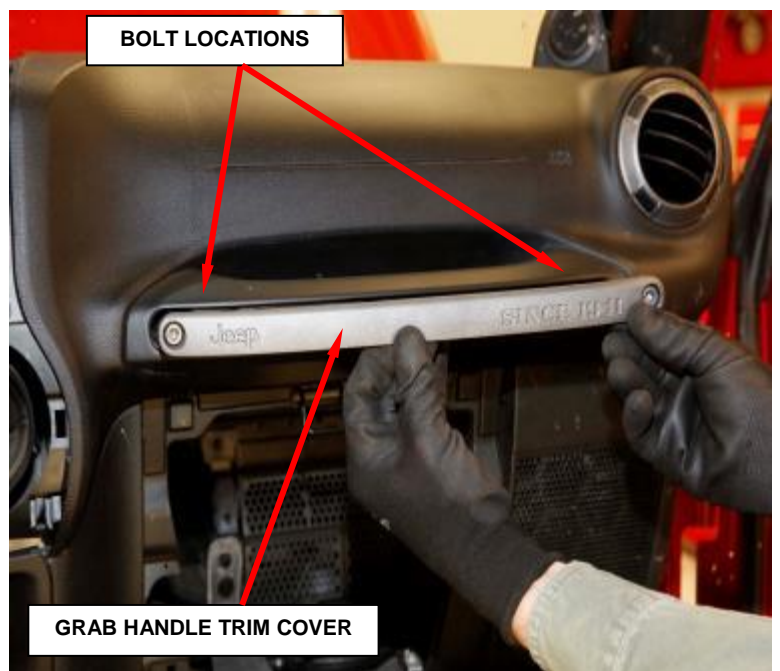
Figure 125 – Grab Handle

21. Release the remaining retaining clips and remove the bezel.
22. Remove the glove box from the instrument panel.
23. Using a trim stick C-4755 or equivalent, separate and remove the grab handle trim cover (Figure 125).

24. Remove the two bolts and remove the grab handle (Figure 125).

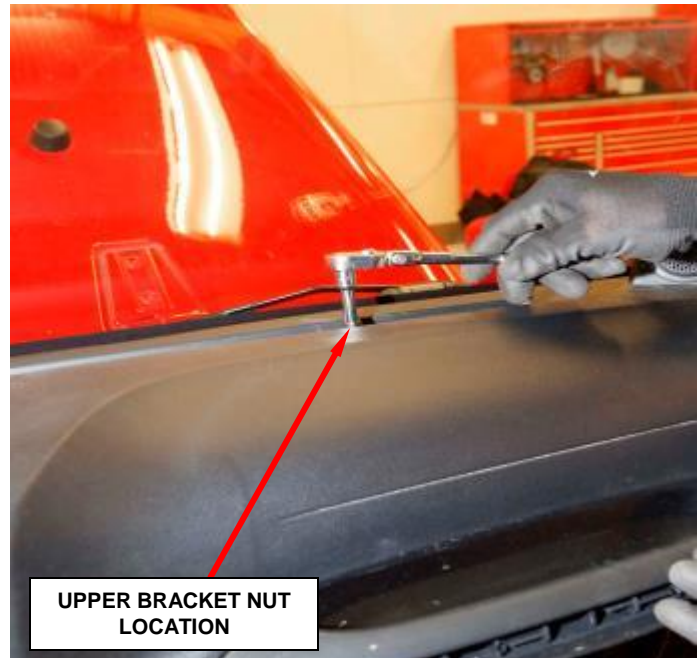
Figure 126 – PAB Upper Bracket Nut

26. Working through the access hole, **loosen** the nut that secures the PAB upper bracket and the instrument panel armature to the stud near the windshield fence line (Figure 126).

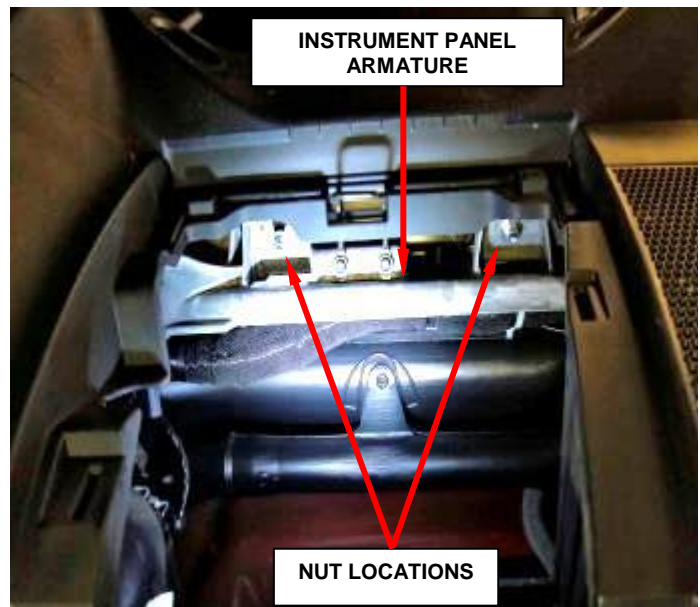
Figure 127 – PAB Lower Nuts

27. Reach up into the instrument panel glove box opening to access and remove and save the two nuts that secure the PAB lower studs to the instrument panel armature on each side of the glove box latch striker (Figure 127).
