Revised (2) May 2019

Dealer Service Instructions for:

Safety Recall U03 / NHTSA 18V-021 Passenger Airbag Inflator

The front passenger airbag inflator (PAB) on about 328,000 of the above vehicles may contain propellant that degraded after prolonged exposure to high absolute humidity, high temperatures and high temperature cycling. Activation of an inflator with degraded propellant, in a vehicle crash where the PAB is designed to deploy, may result in an inflator explosion. An inflator explosion may cause metal fragments to pass through the air bag and into the vehicle interior at high speed, which may result in injury or death to vehicle occupants.

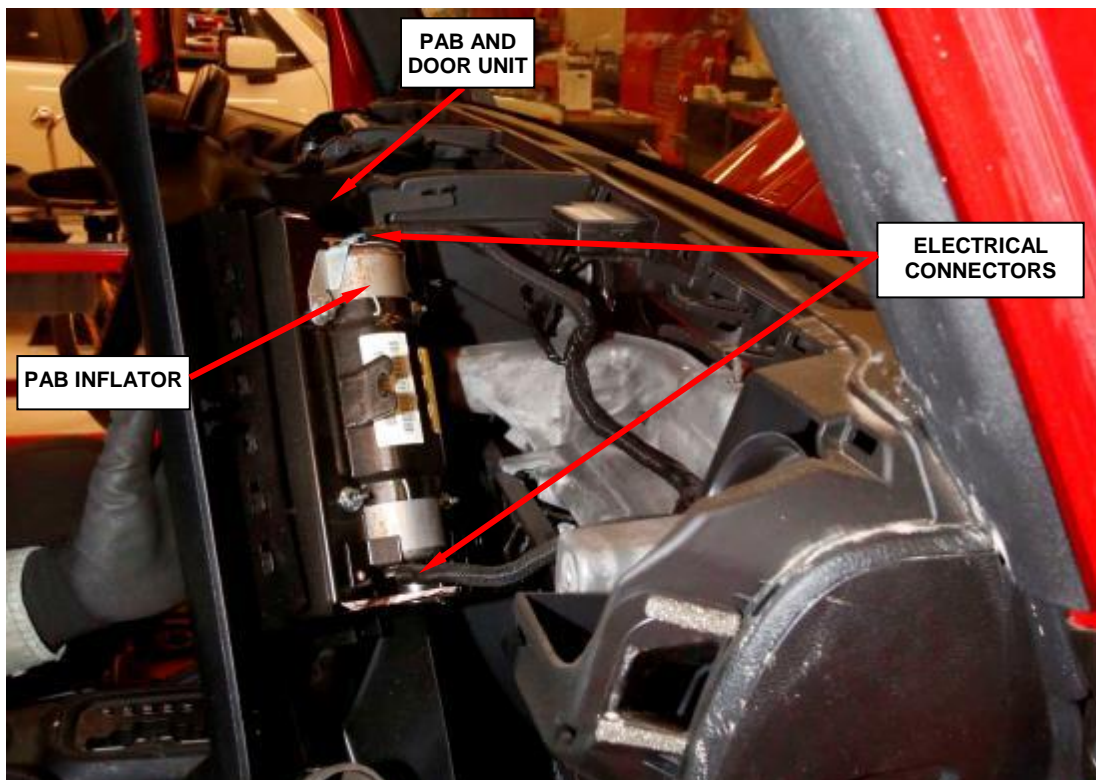
Figure 128 – Electrical Connectors

28. Grasp the lower edge of the PAB door and pull the door and PAB unit rearward far enough to access the two instrument panel wire harness connections to the PAB inflators at each side of the PAB housing (Figure 128).

29. Disconnect the two panel wire electrical connectors from the PAB inflators. Firmly grasp and pull the lock straight out from the connector insulator, then pull the insulators straight out from the inflator to disconnect them from the connector receptacles (Figure 128).
30. Remove the PAB and door from the instrument panel as a unit.

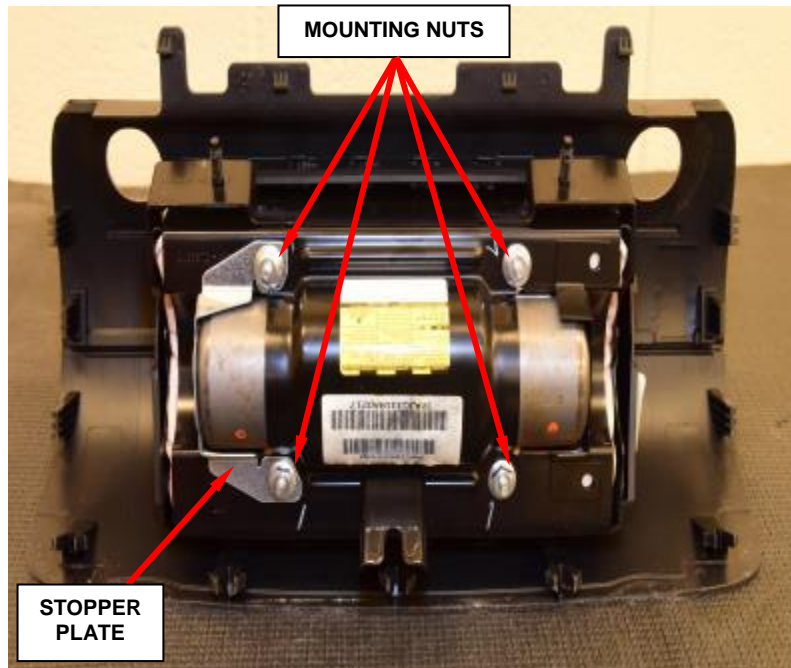
Figure 129 – Mounting Nuts

b. Remove and **discard** the four mounting nuts from the passenger airbag module (Figure 129).

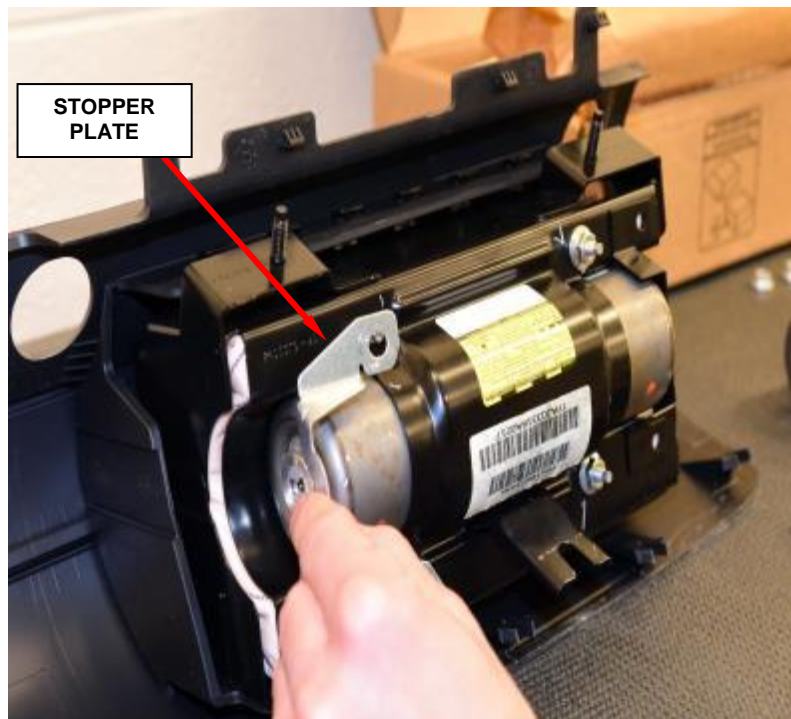
Figure 130 – Stopper Plate

c. Remove and save the stopper plate from the passenger airbag module (Figure 130).

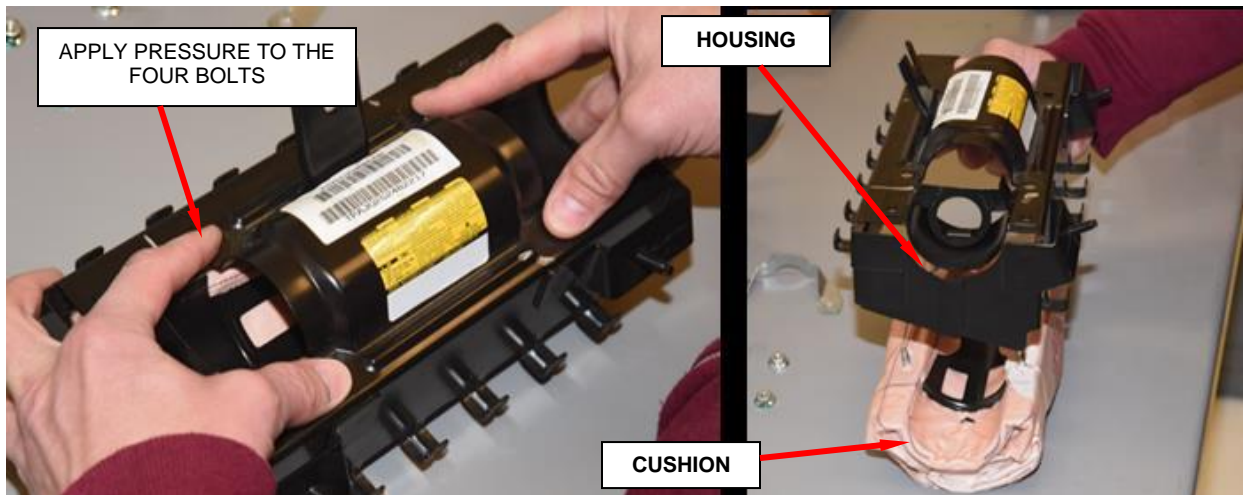
Figure 131 – Remove Airbag Cushion from Housing

- d. Slide inflator out of the housing.
- e. Remove the airbag module from the door.
- f. Remove airbag cushion from housing by applying pressure to the bolts, set cushion aside (Figure 131).

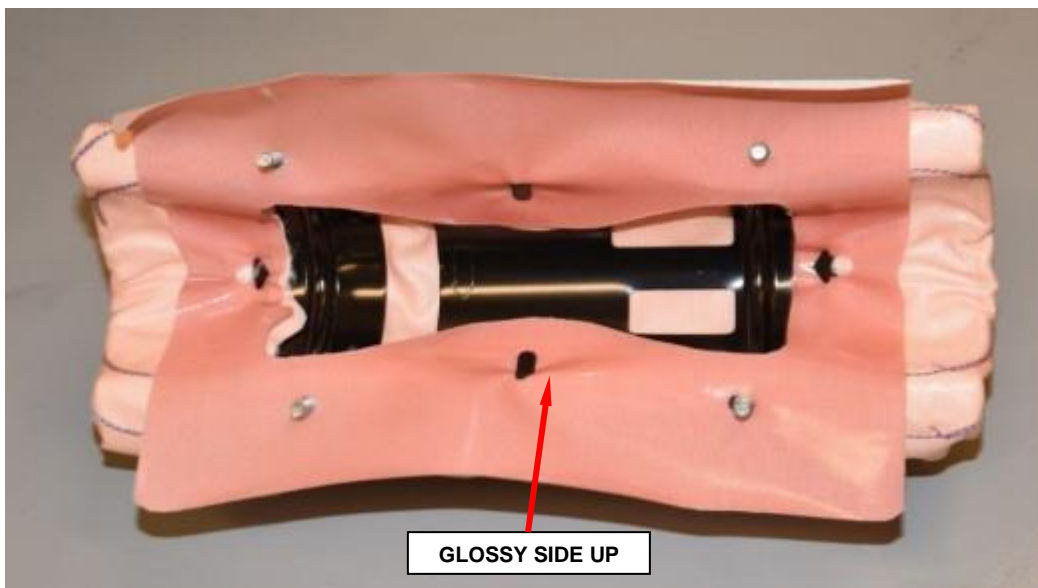
- g. Place the fabric gasket, glossy side up, onto cushion. Mistake-proof tab should be aligned to the tab on the cushion (Figure 132).

Figure 132 – Fabric Gasket to Cushion (Glossy Side Up)

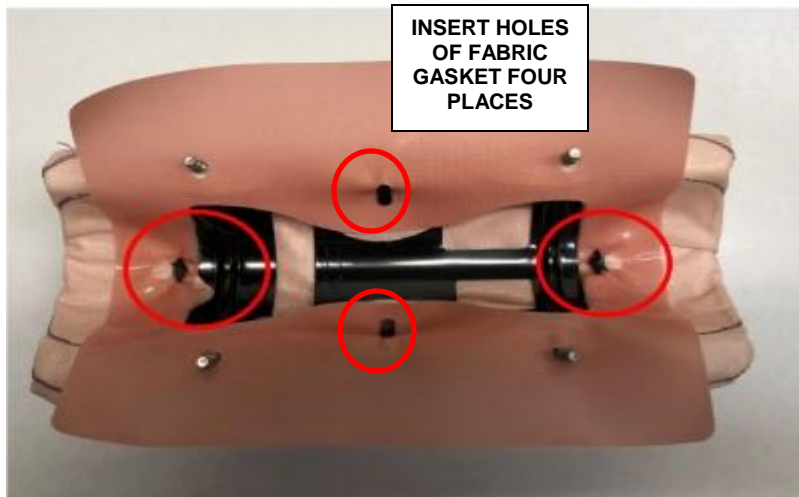
Figure 133 - Fabric Gasket

- h. With the help of a trim tool insert the holes of fabric gasket, four places (Figure 133).

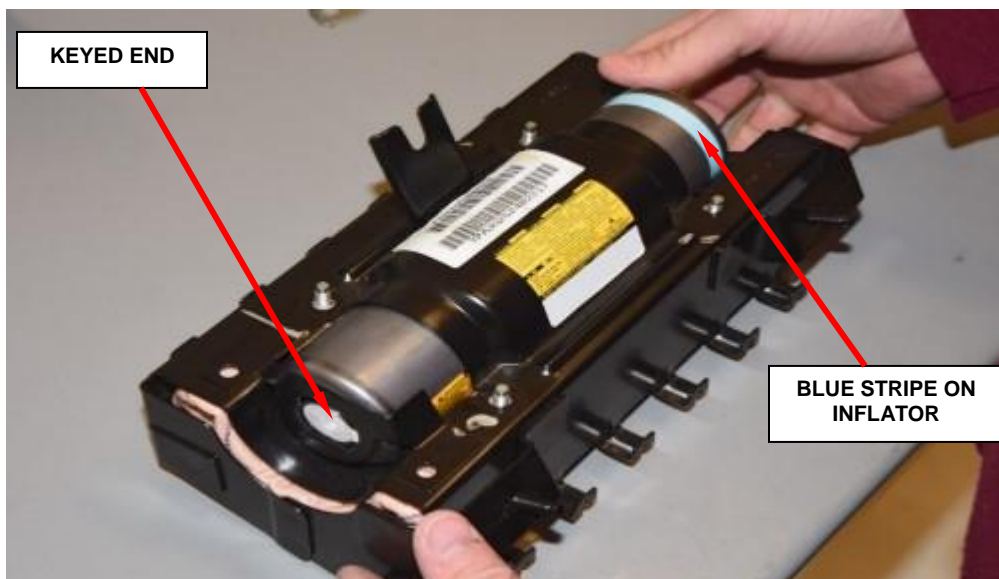
- i. Slide **new** inflator into housing. The keyed end is inserted first, therefore the blue stripe on the inflator will be located at the open end, as shown (Figure 134).

Figure 134 – Insert Inflator (Shown with Cushion Installed)

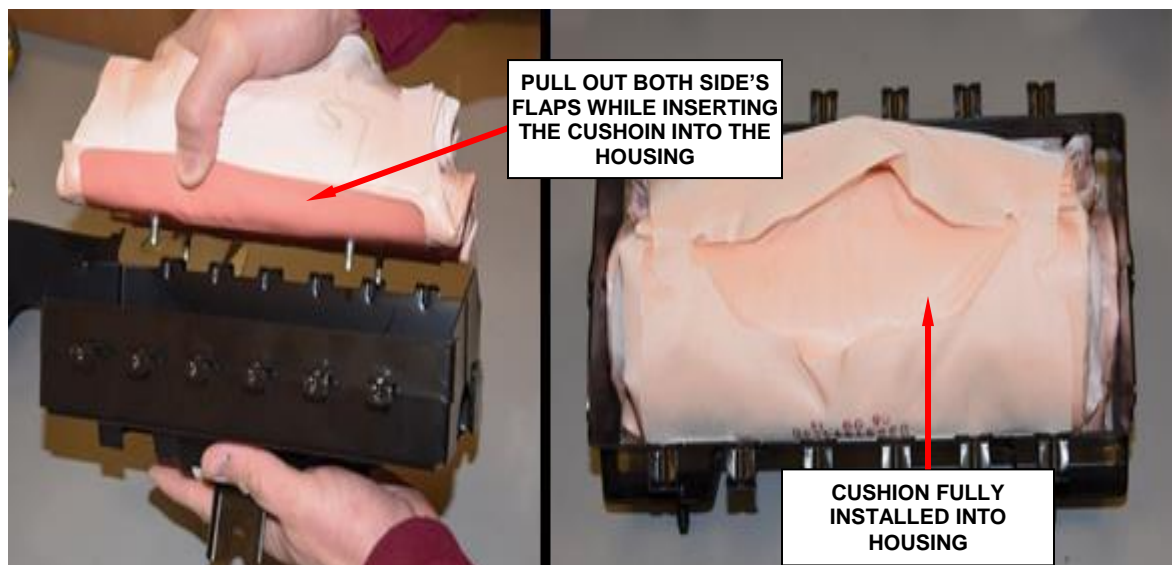
- j. Insert the cushion, pulling out both side flaps (Figure 135).

NOTE: The spacing between the bolts is different on both sides, thus mistake-proof.

Figure 135 - Side Flaps Must Be Held Out

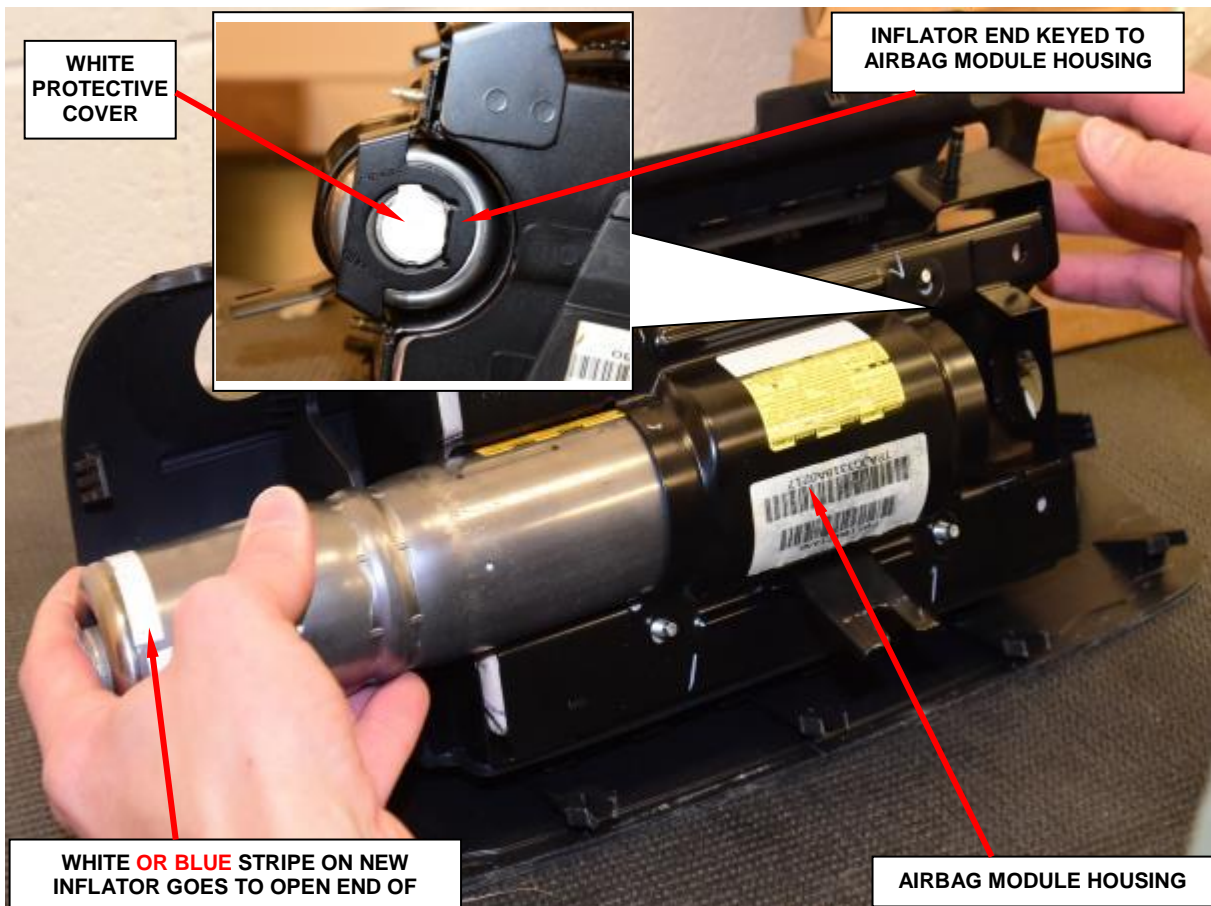
Figure 136 – Inflator Installation

NOTE: The inflator's key **MUST** line up with the housing's key (Figure 136).

NOTE: The inflator is keyed to fit into the housing. Ensure that when the new inflator is inserted, the keyed end goes in first (Figure 136).

n. Slide the **NEW** inflator into the passenger airbag module housing. The keyed end is inserted first; therefore, the white stripe on the **NEW** inflator will be located at the open end (Figure 136).

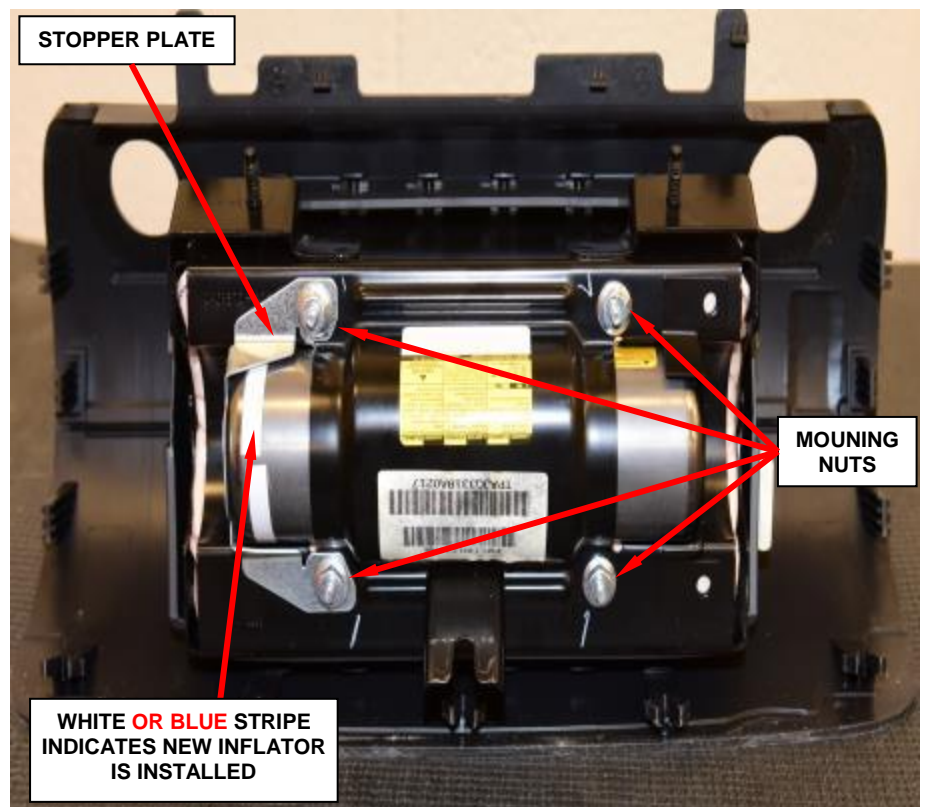
Figure 137 – Retrofit Complete

- o. Install the stopper plate to the airbag module (Figure 137).
- p. Install the four new mounting nuts to the airbag module and tighten to 62 in. lbs. (7 N·m) (Figure 137).
- q. Passenger airbag retrofit is complete (Figure 137).
