# TECHNICAL INSTRUCTIONS FOR SAFETY RECALL G0P FRONT PASSENGER AIRBAG INFLATOR CERTAIN 2008 – 2013 MY SCION xB

**Updated 1-9-18**

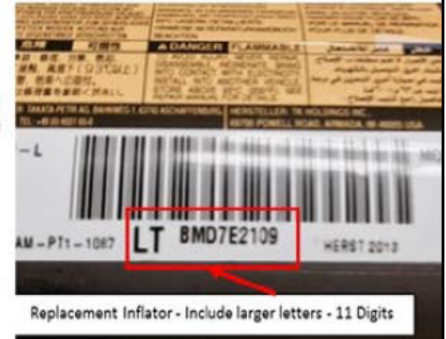
How to Identify the Inflator serial code on the Original and Replacement Inflator can?

The Inflator serial code is an **11 digit code** on the Inflator can. It can be found with a bar code on removing the Inflator can from the Airbag Assembly unit.

The first two characters of the **Original Inflator Serial code** will be from [AA, AB, AJ, FD or JD].

The first two characters of the **Replacement Inflator Serial code** will be either 'LT' or 'LR'.

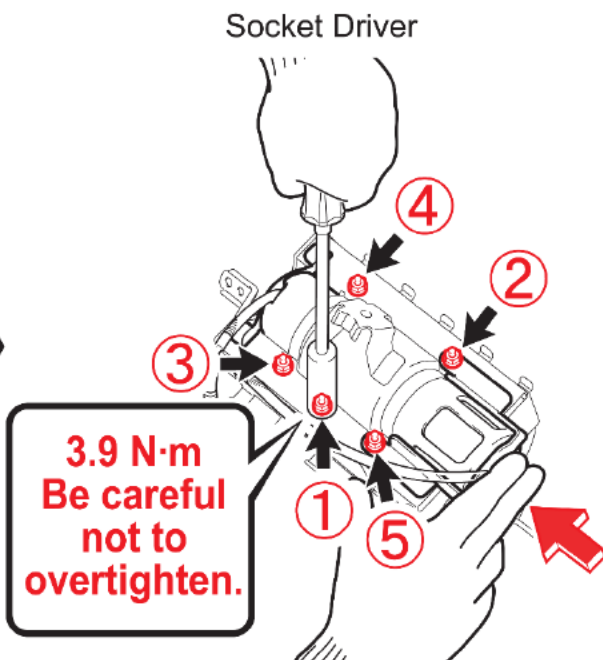
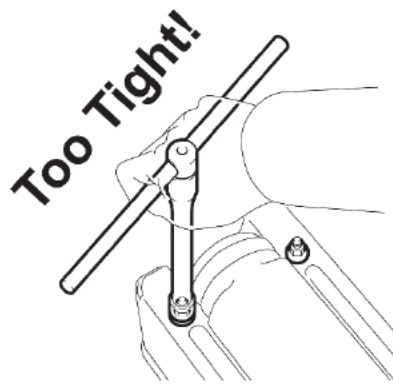
R1707250013

**The tightening torque is low (3.9 N·m). Use of an air ratchet wrench or tightening strongly with a T-handle wrench or a ratchet handle may cause deformation of the stud bolt.**

**Too Tight!**

**These tools cause overtightening !**
