**TECHNICAL INSTRUCTIONS**  
**FOR**  
**SAFETY RECALL GLH**  
**FRONT PASSENGER AIRBAG INFLATOR REPLACEMENT**  
**CERTAIN 2010 MY IS 250/350 CONVERTIBLE**

The subject vehicles are equipped with front passenger airbag inflators produced by Takata. The propellant in these inflators may degrade after prolonged exposure to high absolute humidity and fluctuating high temperatures. Degraded propellant can cause inflator rupture during airbag deployment. In the event of an inflator rupture, metal fragments could pass through the airbag cushion material, striking the vehicle occupants, and result in serious injury or death.

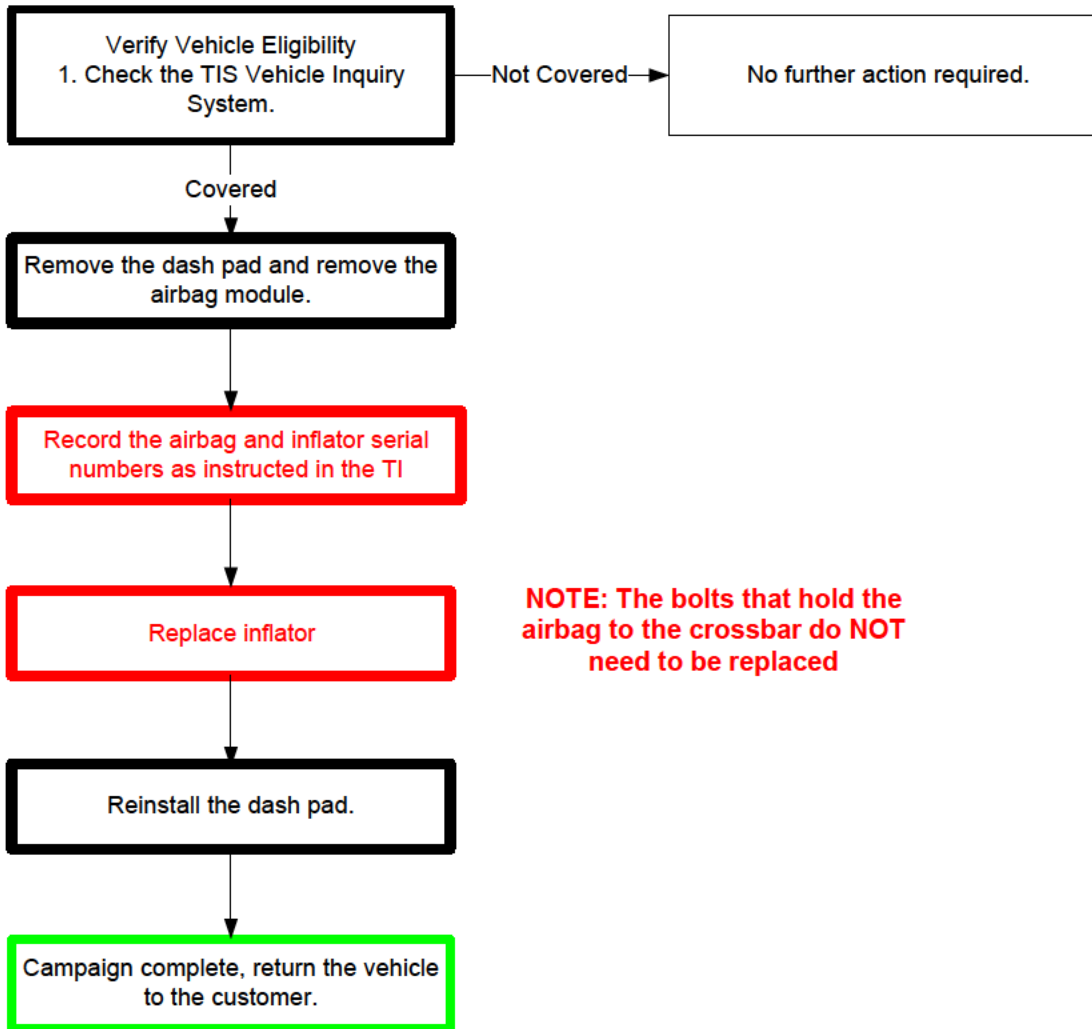
## I. OPERATION FLOW CHART

The flow chart is for reference only. **DO NOT** use it in place of the full technical instructions. Follow **ALL** steps as outlined in the full technical instructions to confirm the campaign is completed correctly.

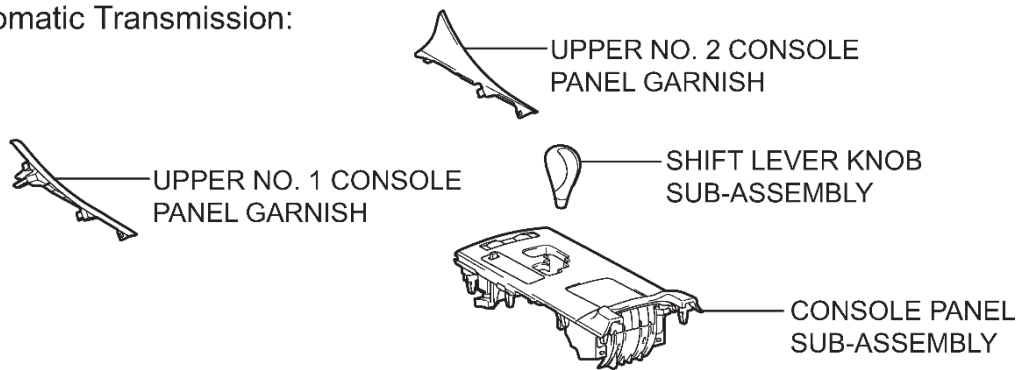
for Automatic Transmission:

**VII. FRONT PASSENGER AIRBAG REMOVAL**  
**COMPONENTS**

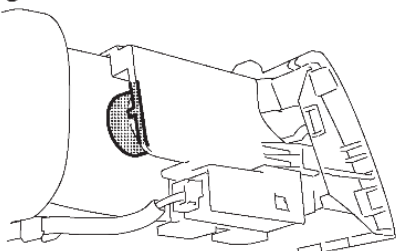
Back side of part manufactured  
before August 2008:

Using your finger on the left side push out at the point shown to disengage the 4 claws.

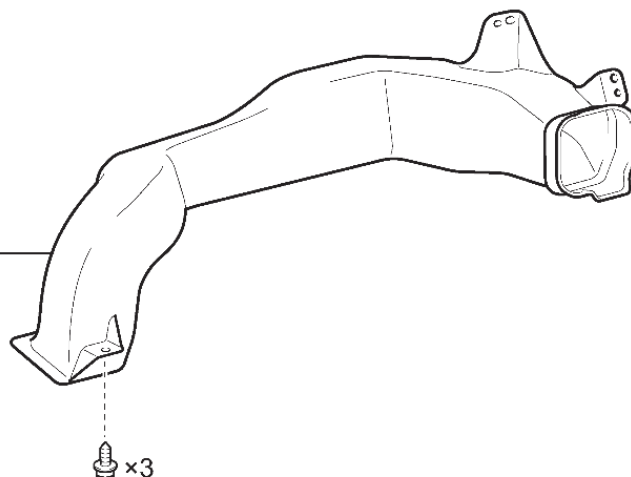
- a) Remove the 3 screws and the side defroster nozzle.  
b) Remove the 2 screws and the heater to register duct.

● INSTRUMENT PANEL PASSENGER  
AIRBAG ASSEMBLY W/O DOOR

No.3 HEATER TO REGISTER DUCT

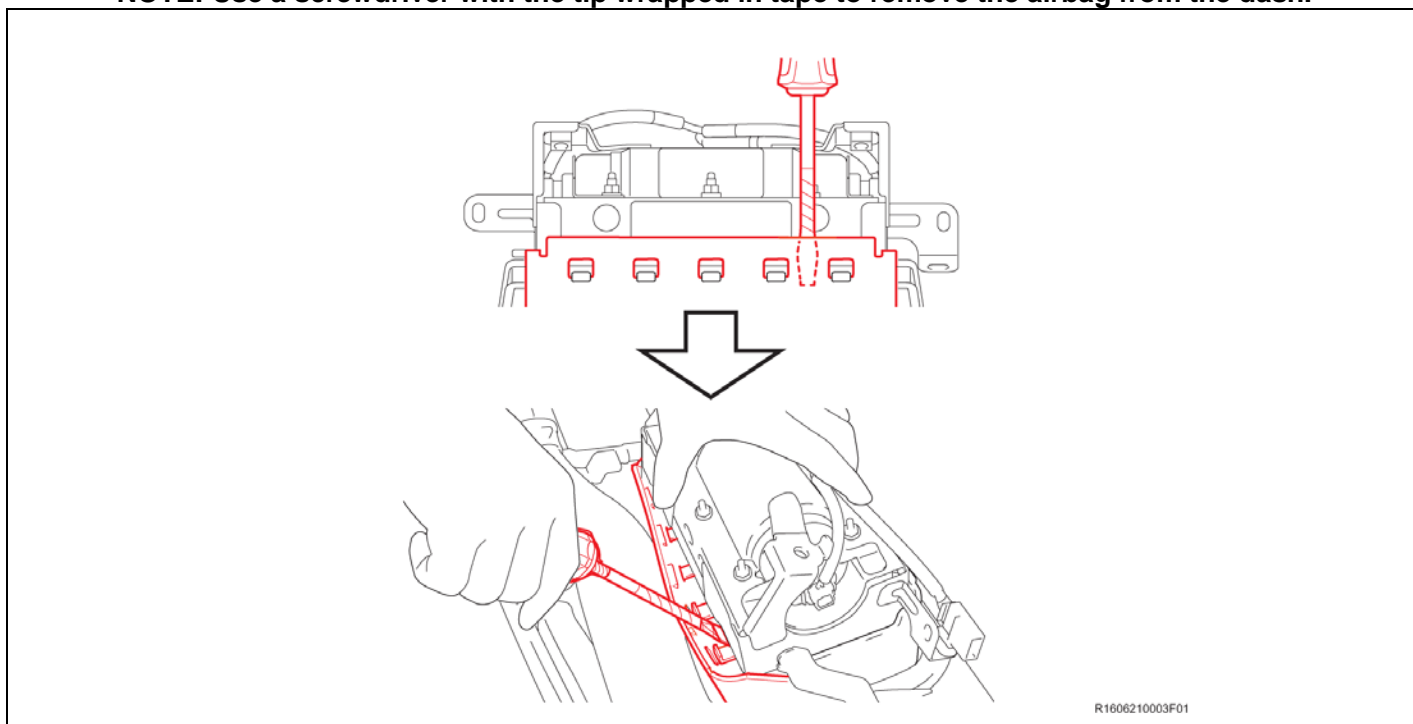
- c) Remove the 4 bolts, disengage the straps, and then remove the airbag assembly.

**NOTE: Use a screwdriver with the tip wrapped in tape to remove the airbag from the dash.**

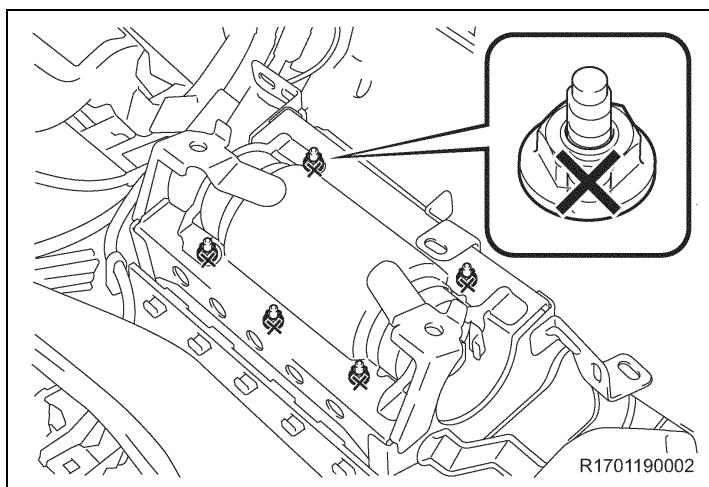
- d) Using a screwdriver to release the lock button of the connector.

- e) Disconnect the 2 connectors.

- f) Disengage the 2 clamps.

**NOTE: The removed instrument panel wire will not be reused.**

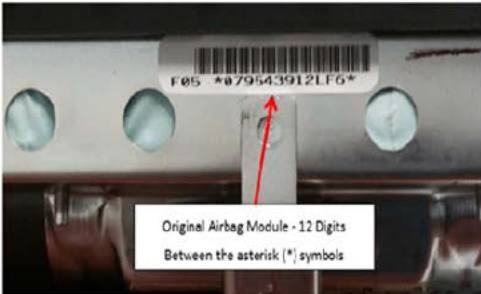
#### Airbag Serial Number Label Example

- The airbag serial number is **ALWAYS** the 12 **DIGITS** located between the asterisks.
- The 3 digits before the asterisk **ARE NOT** part of the serial number, and **SHOULD NOT** be entered or an inaccurate response may be returned.

Original Airbag Module - 12 Digits Between the asterisk (\*) symbols

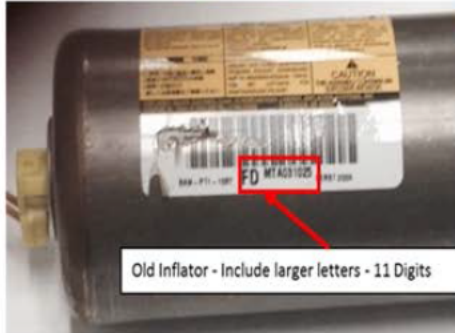
### Original Inflator

The Inflator serial code is an 11 digit code on the Inflator can. It can be found with a bar code on removing the Inflator can from the Airbag Assembly unit.

The first two characters of the Original Inflator Serial code will be from [AA, AB, AJ, FD or JD].

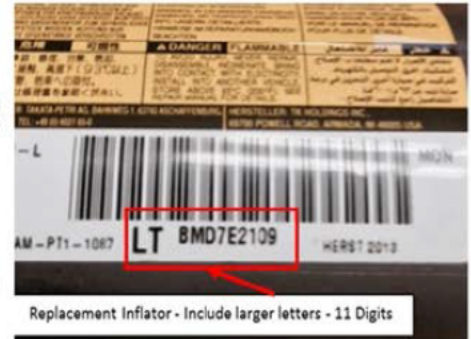
### Replacement Inflator

The first two characters of the Replacement Inflator Serial code will be either 'LT' or 'LR'.

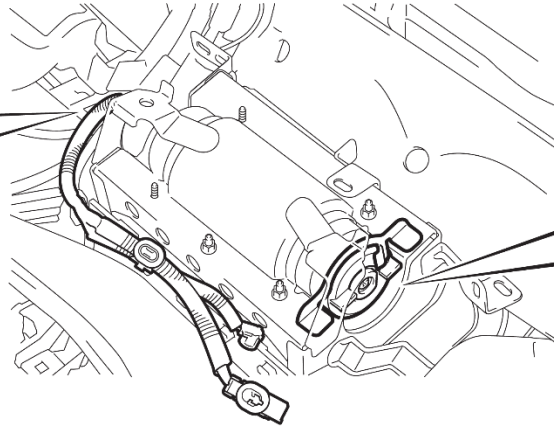
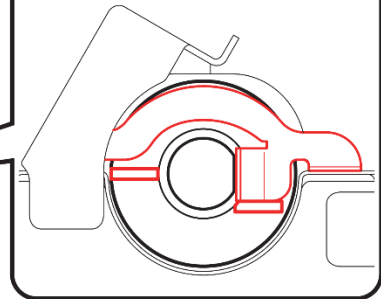
#### Check orientation

a) Install the new inflator as shown.

- Make sure the inflator is correctly positioned.
- The inflator cannot be fully inserted if it is upside down.

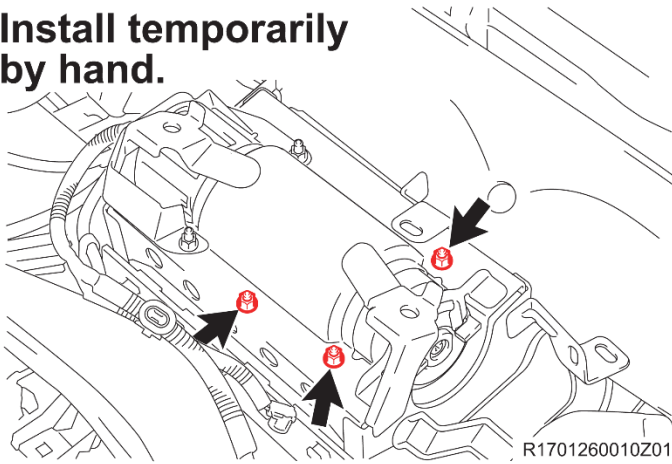
**Install temporarily  
by hand.**

f) Install the **NEW** positioner plate.

g) Temporarily install 2 **NEW** nuts.

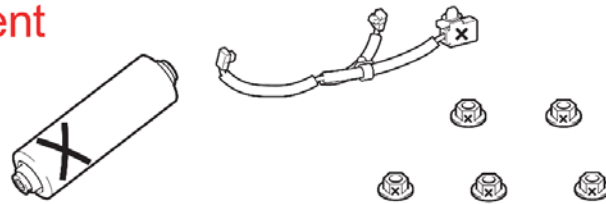
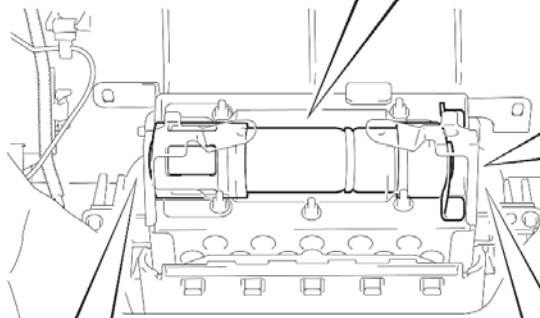
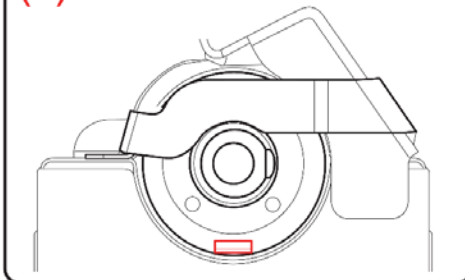
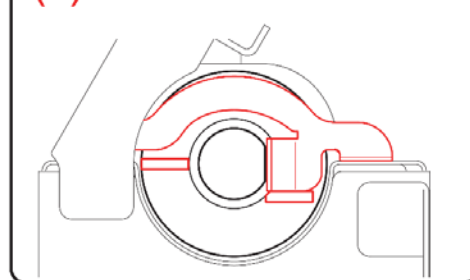
- j) Push the inflator towards the position determining plate and eliminate any gaps.

- If any gaps exist, the flats may move apart and could result in abnormal operation during airbag deployment.

**(a) Replacement  
of parts.**

**(b) No gap.**

**(b) Check orientation.**

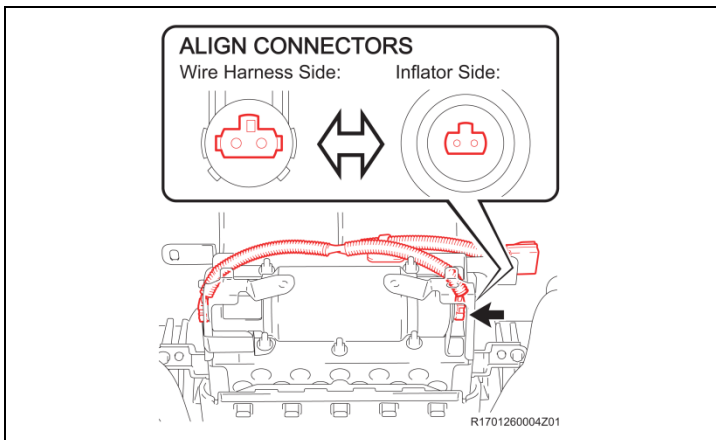
- l) Engage the 2 clamps for the new wire harness.

- m) Connect the connector and the secondary lock.

**NOTE: Ensure that the connector is securely connected.**

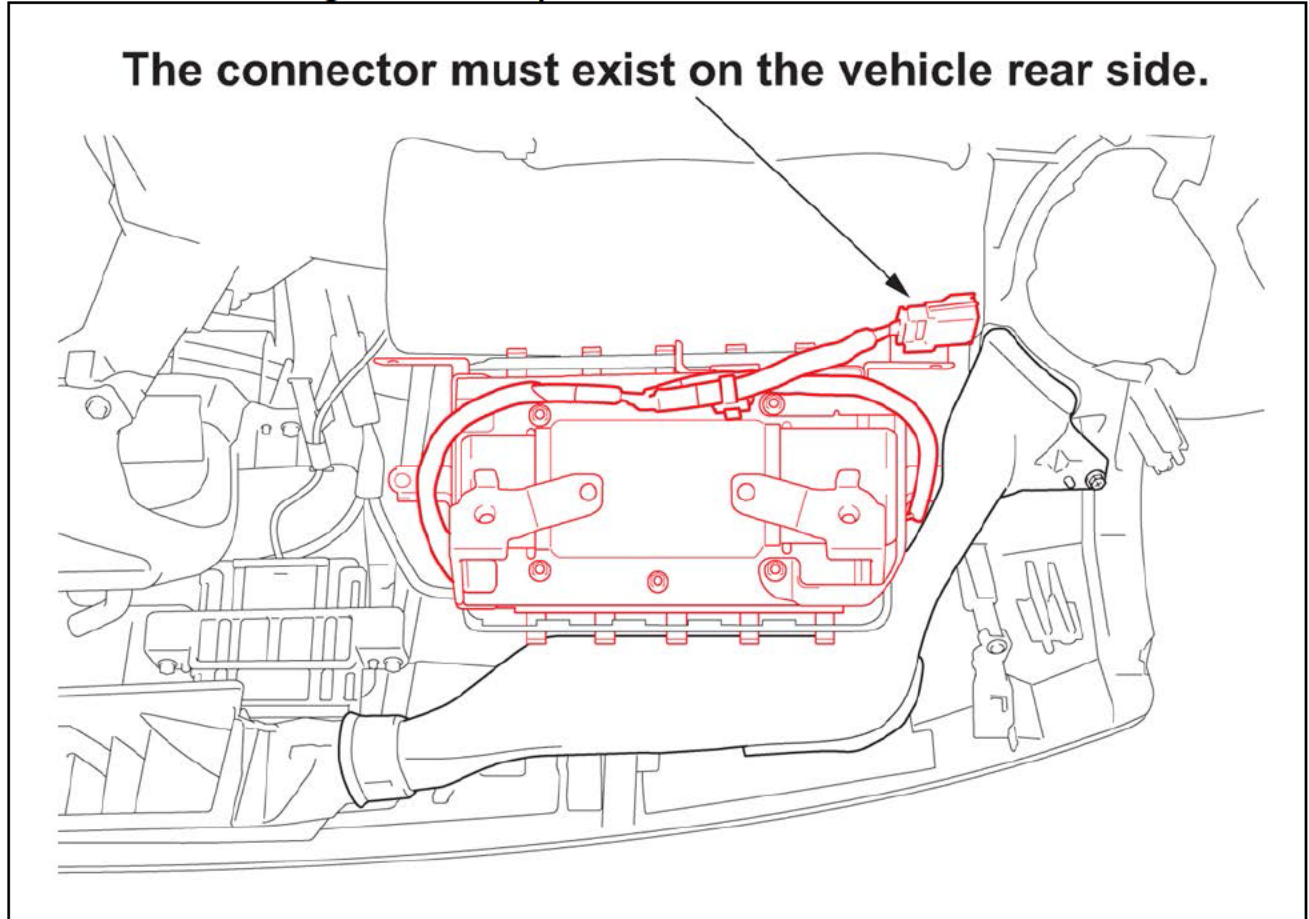
**NOTE:** Ensure the airbag connectors is positioned as shown
