# IMPORTANT UPDATE

## TECHNICAL INSTRUCTIONS FOR SAFETY RECALL GLG FRONT PASSENGER AIRBAG MODULE CERTAIN 2010-2013 MY GX 460 **UPDATED 1-9-2018**

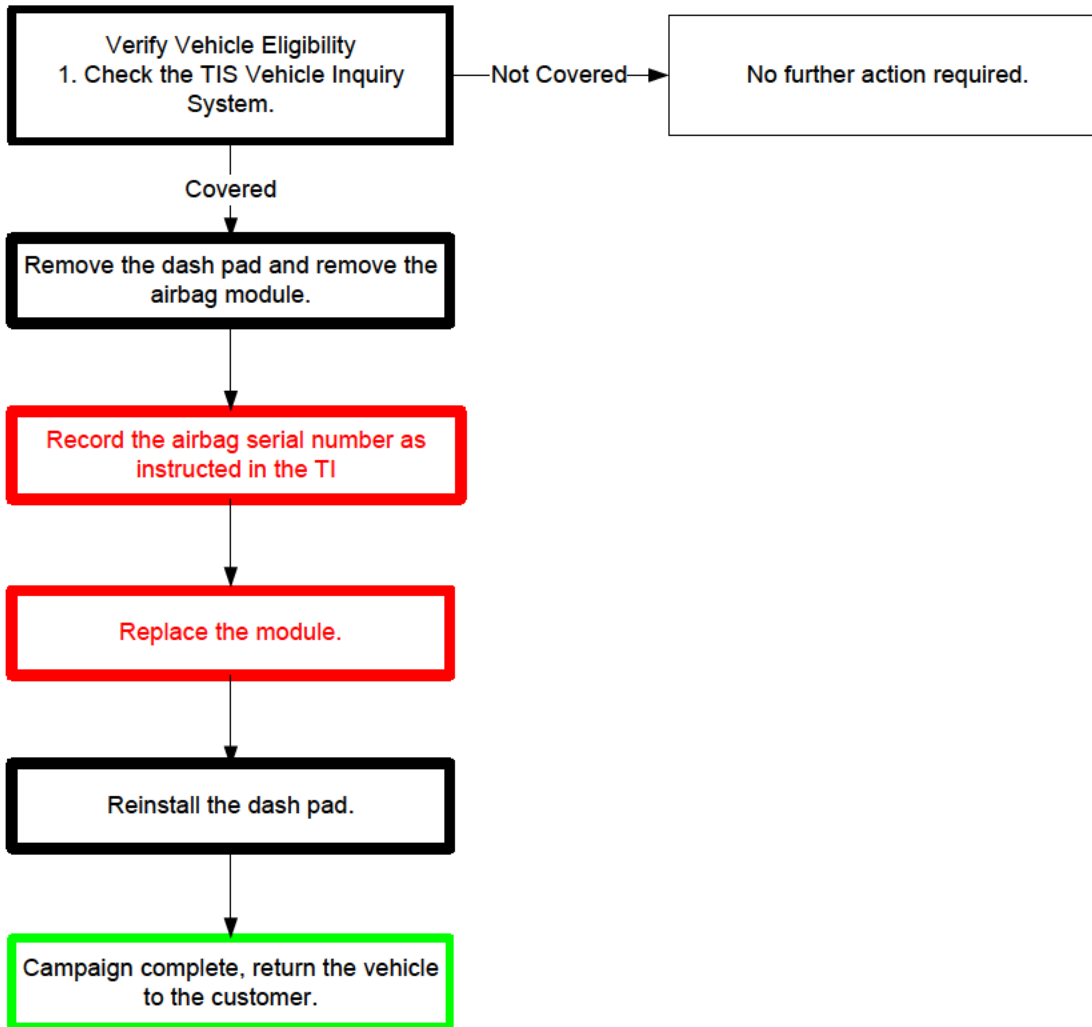
## I. OPERATION FLOW CHART

The flow chart is for reference only. **DO NOT** use it in place of the full technical instructions. Follow **ALL** steps as outlined in the full technical instructions to confirm the campaign is completed correctly.

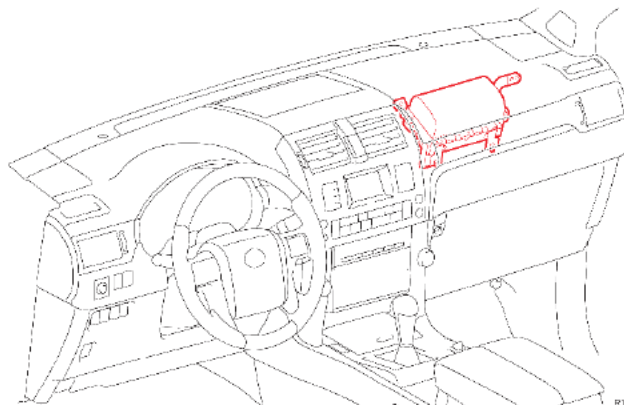
The subject vehicles are equipped with front passenger airbag inflators produced by Takata. The propellant in these inflators may degrade after prolonged exposure to high absolute humidity and fluctuating high temperatures. Degraded propellant can cause inflator rupture during airbag deployment. In the event of an inflator rupture, metal fragments could pass through the airbag cushion material, striking the vehicle occupants, and result in serious injury or death.

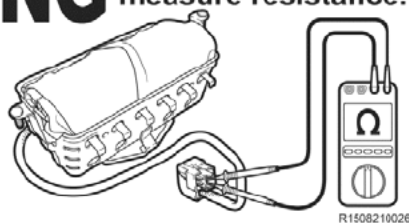
R1508210026

#### 2. DO NOT MEASURE RESISTANCE

- a) **NEVER** measure the resistance of an airbag, this may cause accidental activation.

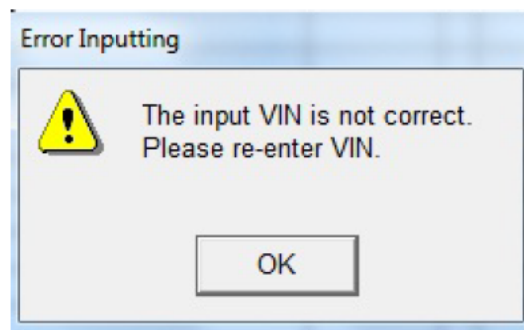
### 2. RUN A DIAGNOSTIC REPORT

- After the health check has completed, run a diagnostic report by clicking on the link on the health check screen.

**NOTE: If the VIN was not entered in ALL CAPS when Techstream was launched, an error will be displayed and there will be a prompt to reenter the VIN**

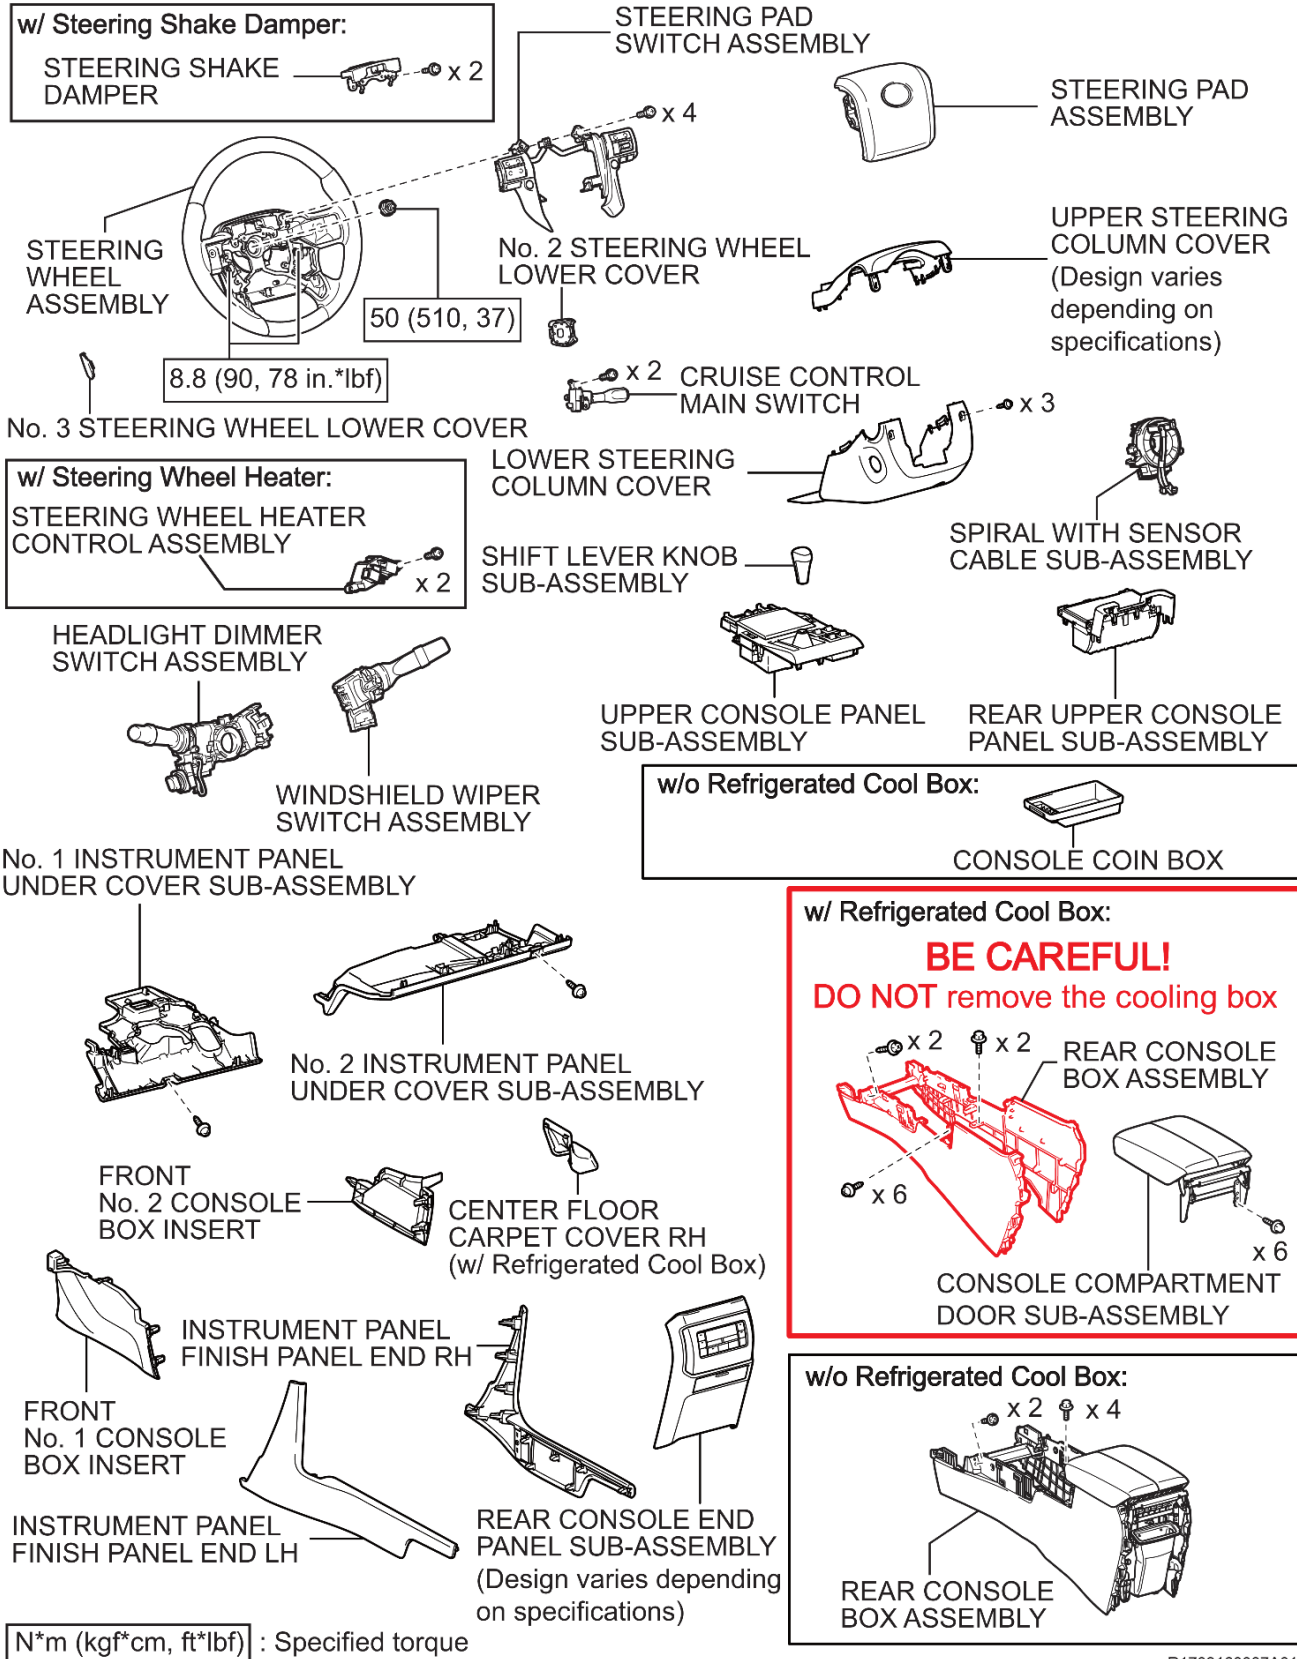
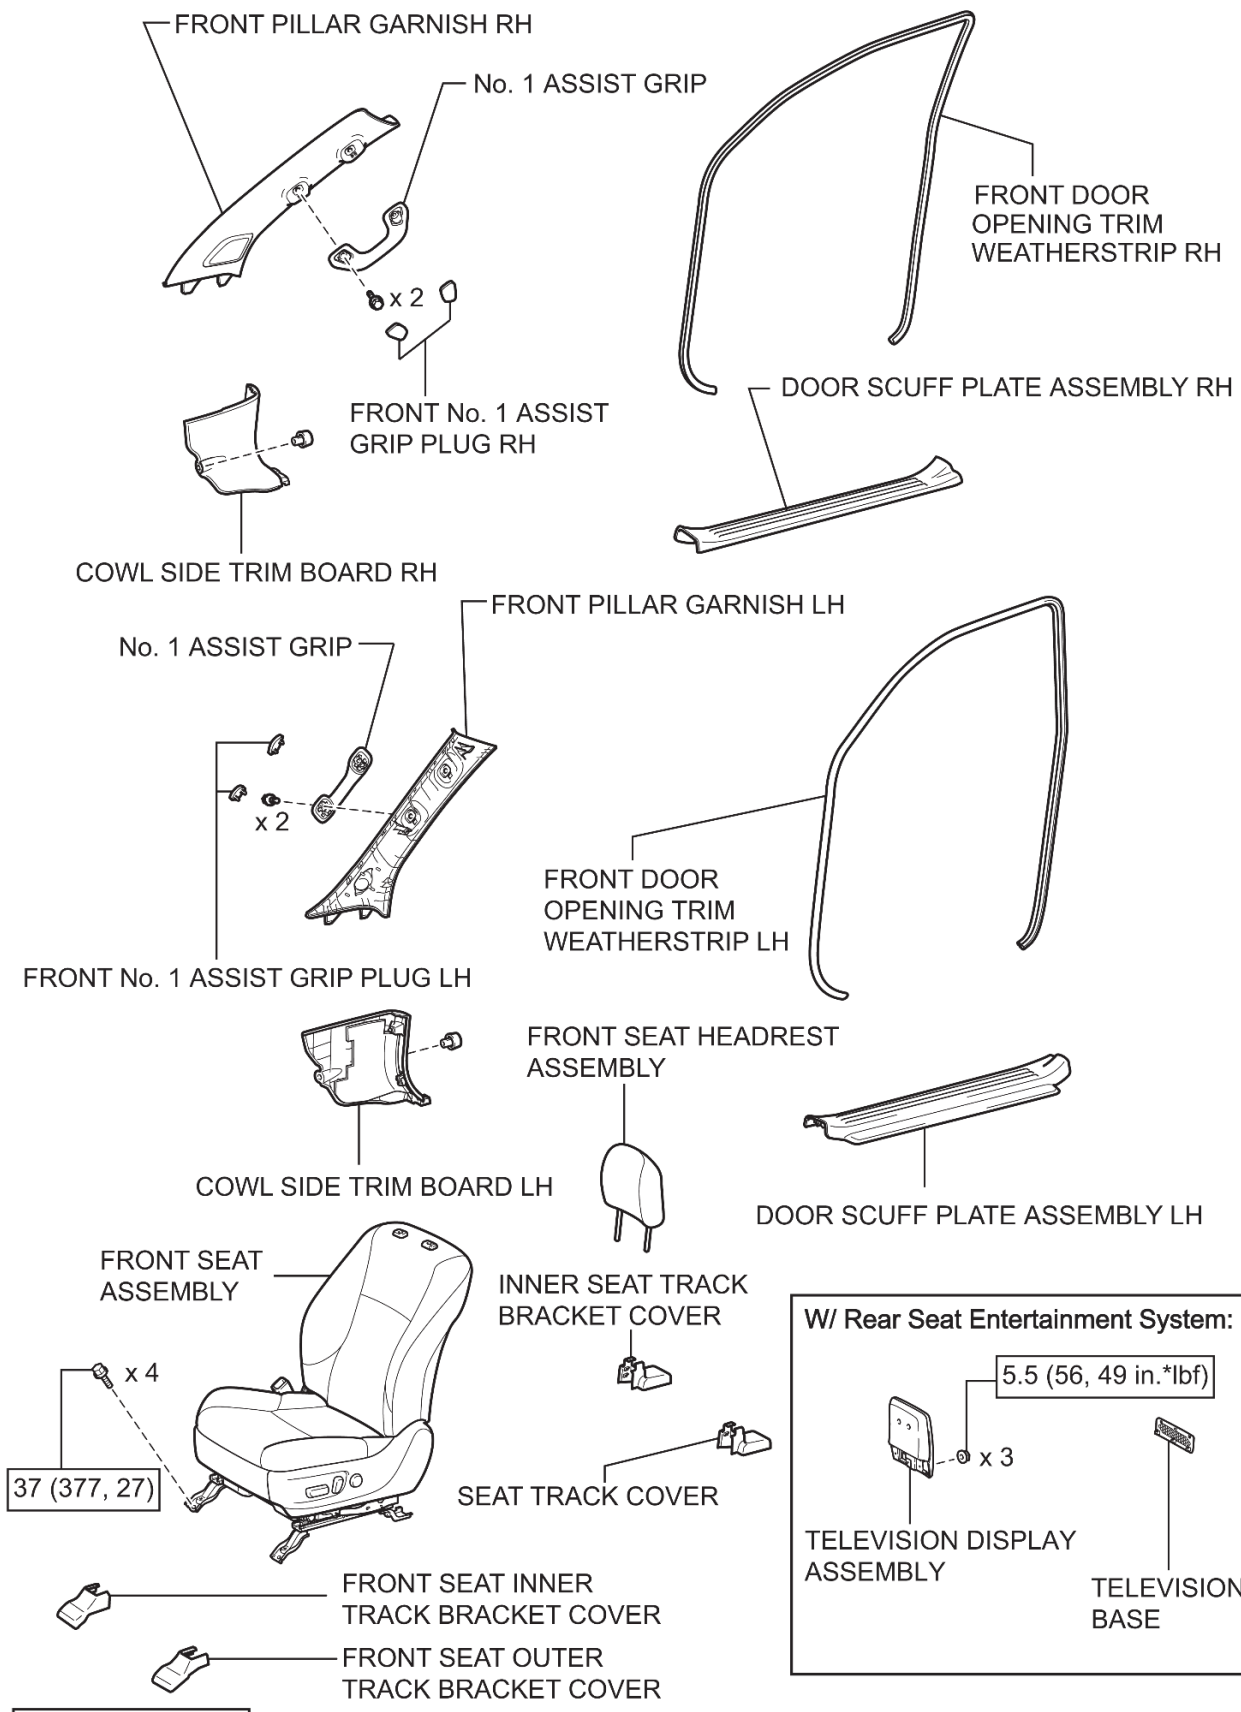
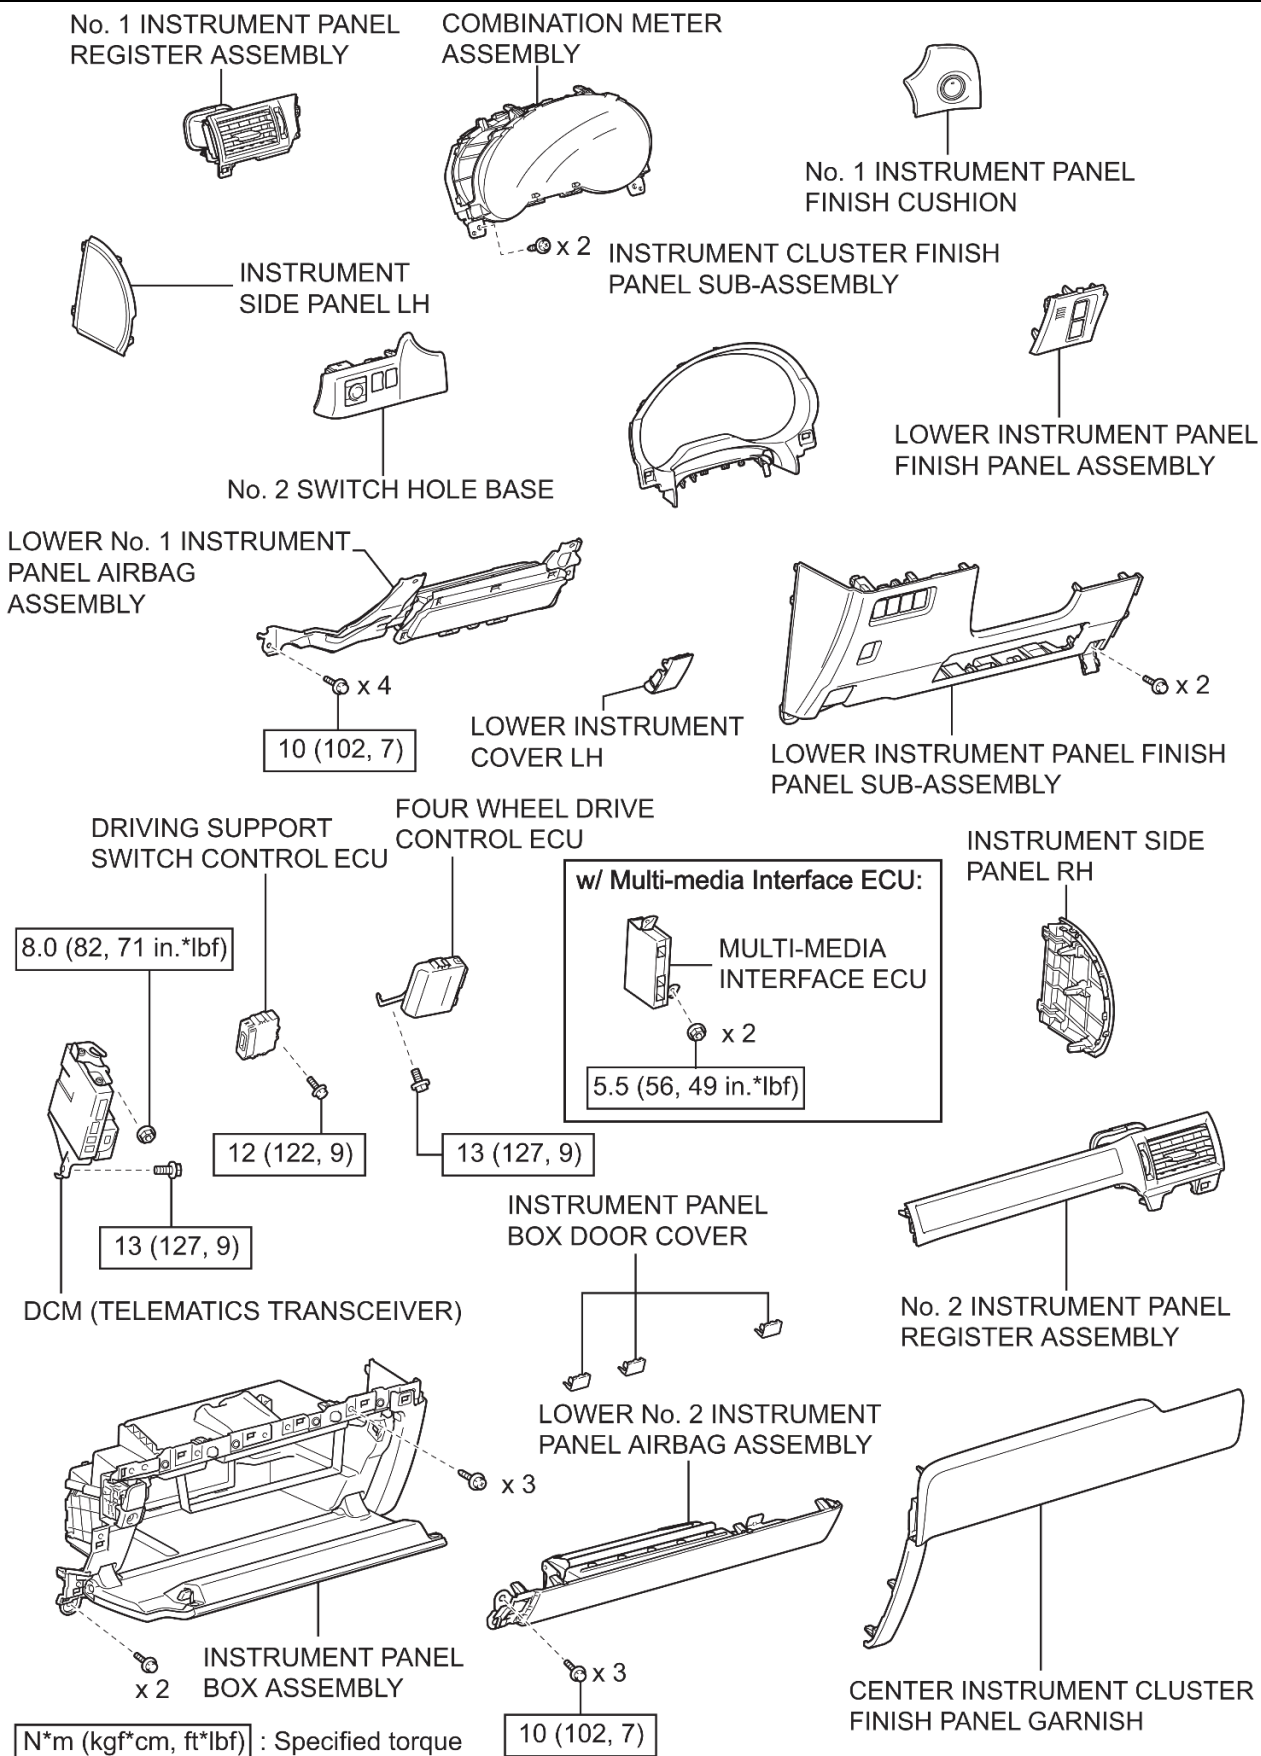
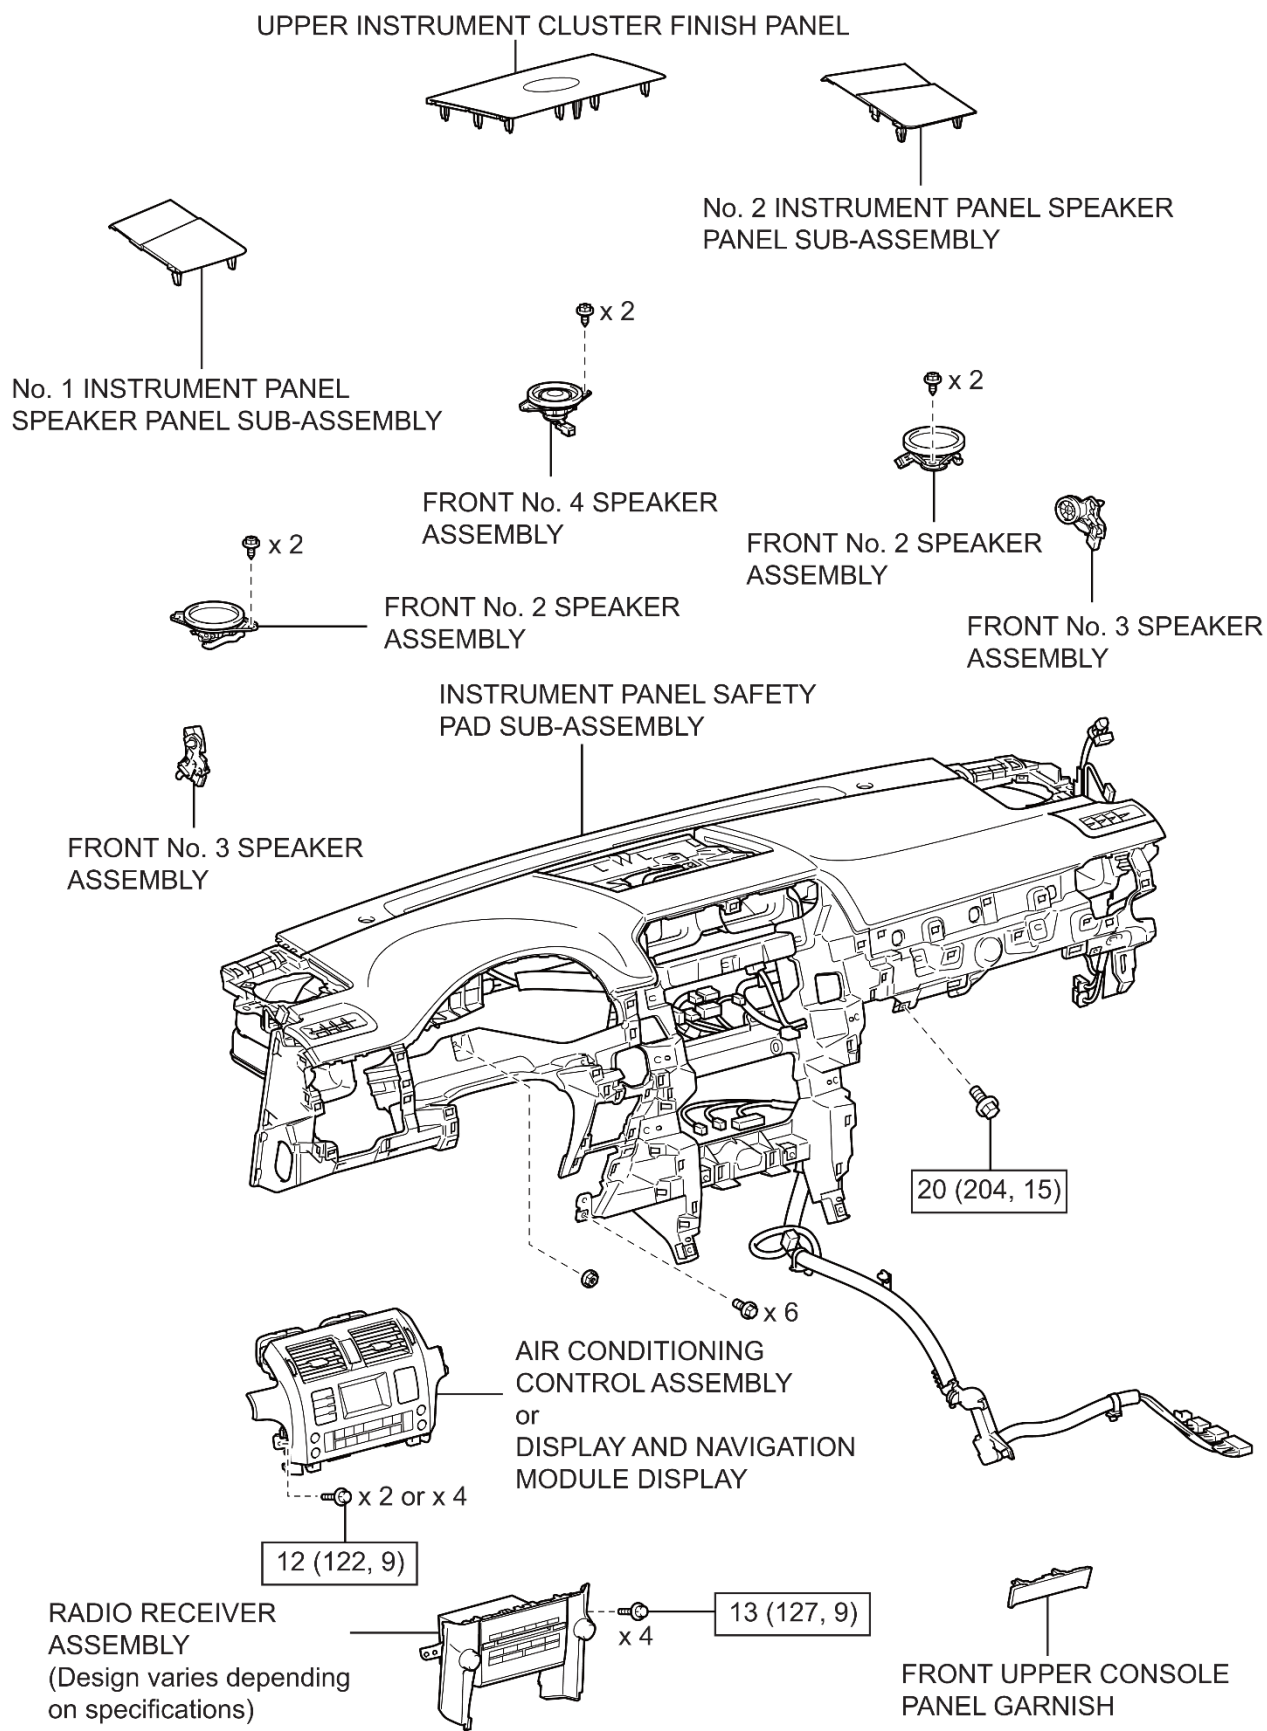
## VII. FRONT PASSENGER AIRBAG REMOVAL COMPONENTS

N\*m (kgf\*cm, ft\*lbf) : Specified torque

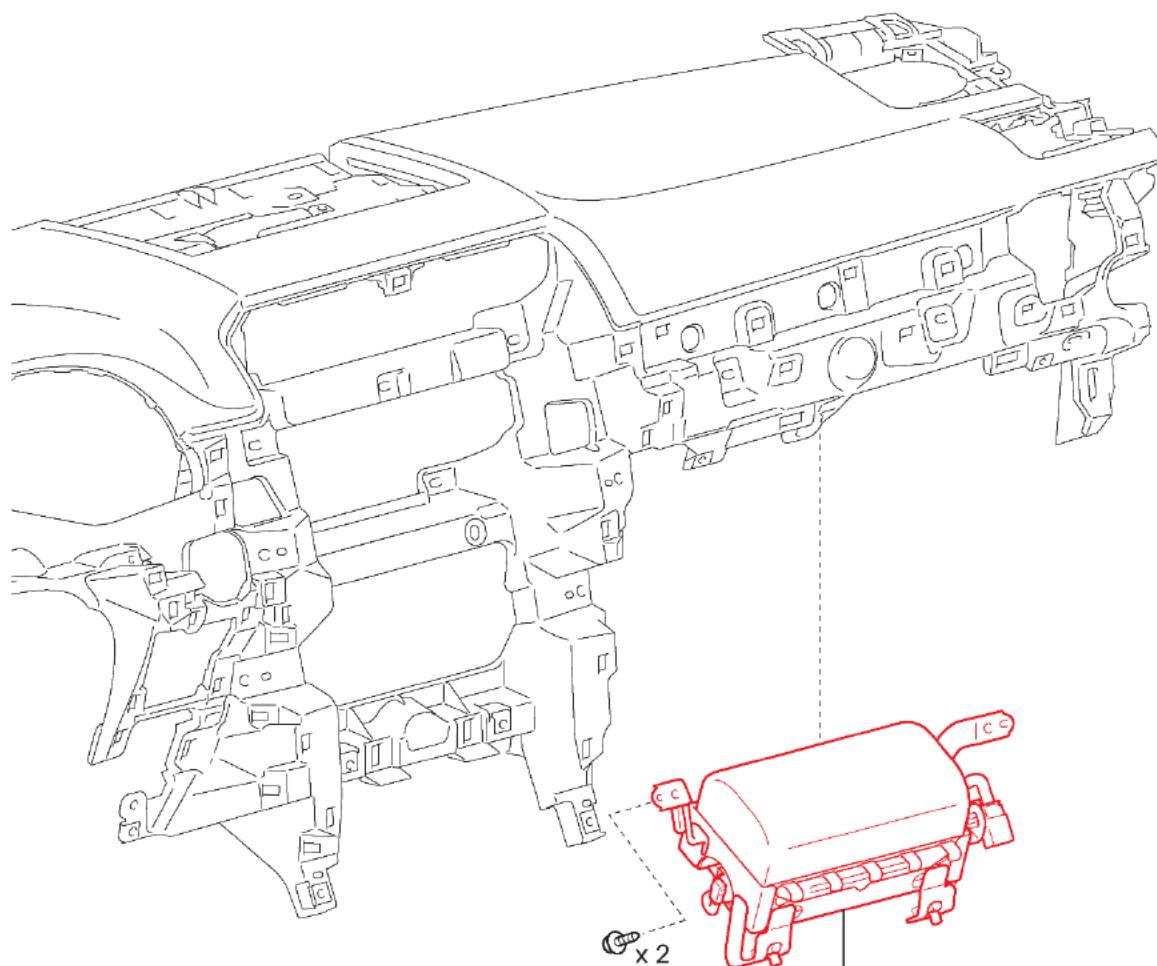
R1702160008

● Replacement part

● INSTRUMENT PANEL PASSENGER  
AIRBAG ASSEMBLY W/O DOOR

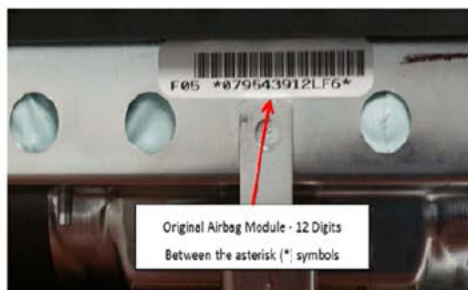
Record Airbag Serial Number

#### How to Identify an Airbag module Assembly number?

The Airbag module Assembly serial number is a 12 digit code. It can be found along with a bar code on opening the Airbag assembly unit. To manually enter these details into the application, the technician has to identify the 12 digit code between two Asterisks (\*) inside the Airbag assembly unit. The first seven characters of this 12 digit code are numbers and the 10<sup>th</sup> digit is either 'K' or 'L' always.

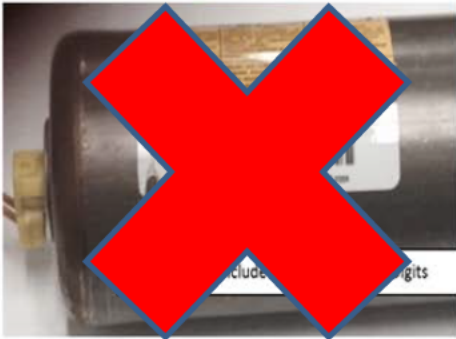
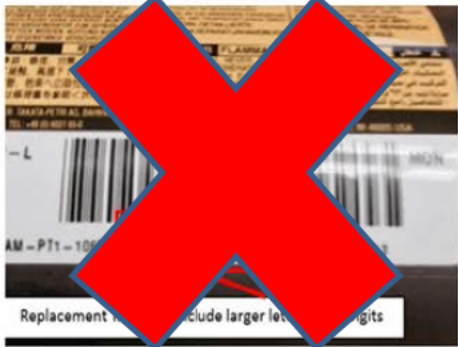
How to Identify the Inflator serial code on the Original and Replacement Inflator can?

The Inflator serial code is an **11 digit code** on the Inflator can. It can be found with a bar code on removing the Inflator can from the Airbag Assembly unit.

The first two characters of the **Original Inflator Serial code** will be from [AA, AB, AJ, FD or JD].

The first two characters of the **Replacement Inflator Serial code** will be either 'LT' or 'LR'.

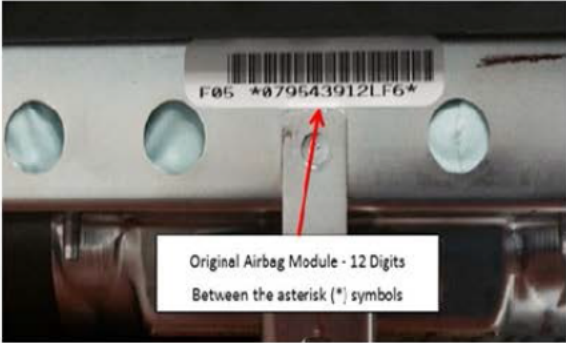
Original Airbag Module - 12 Digits  
Between the asterisk (\*) symbols

#### How to Identify an Airbag module Assembly number?

The Airbag module Assembly serial number is a **12 digit code**. It can be found along with a bar code on opening the Airbag assembly unit. To manually enter these details into the application, the technician has to identify the 12 digit code between two Asterisks (\*) inside the Airbag assembly unit. The first seven characters of this 12 digit code are numbers and the 10<sup>th</sup> digit is either 'K' or 'L' always.

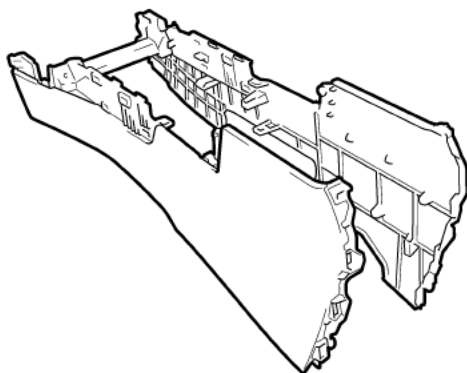
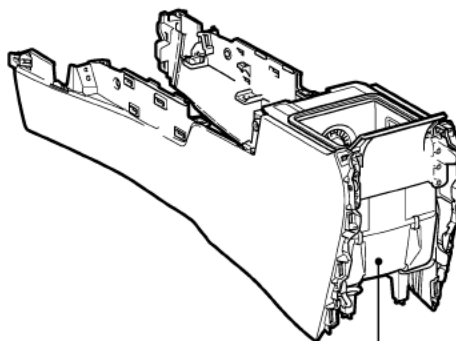
R1703300004

NOTE: The trim around the cool box can be removed and installed without disconnecting the refrigerant lines.

Leave the cooling box on the vehicle.

COOLING BOX

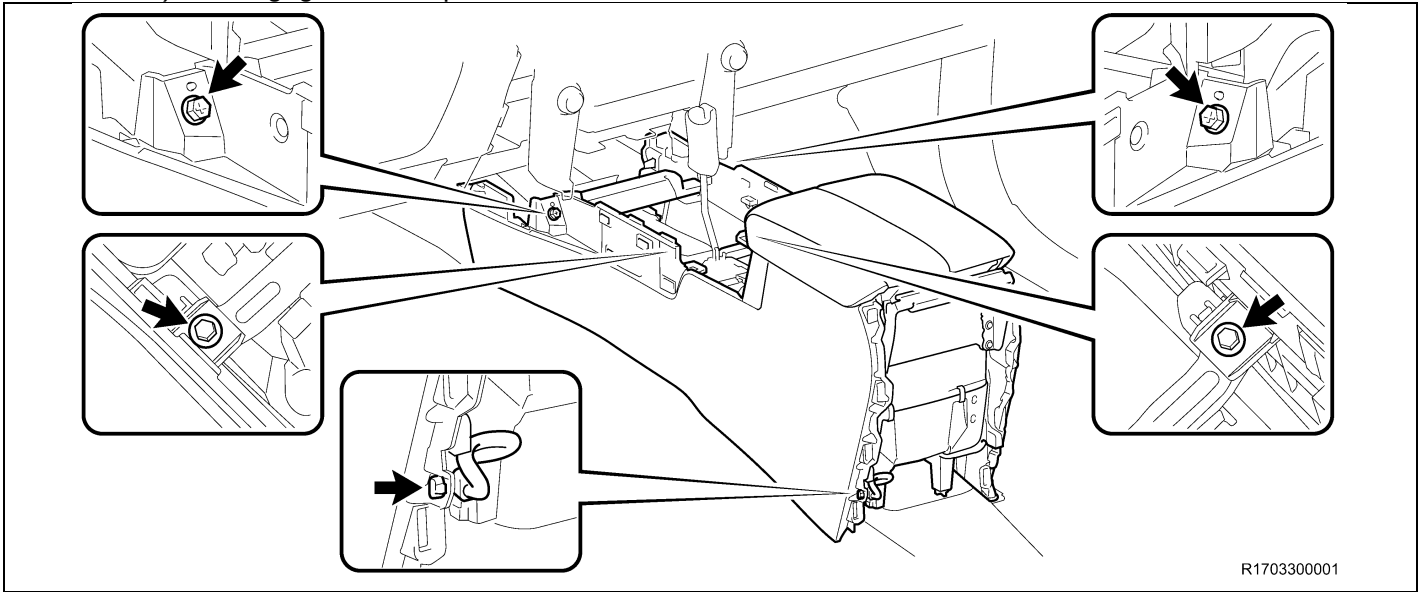
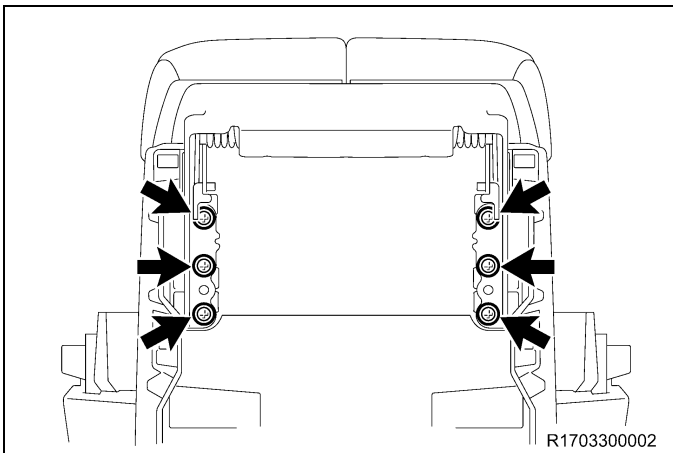
## 1. REMOVE THE CONSOLE BOX

- a) Remove the 2 bolts and 2 screws.
- b) Disengage the clamp.

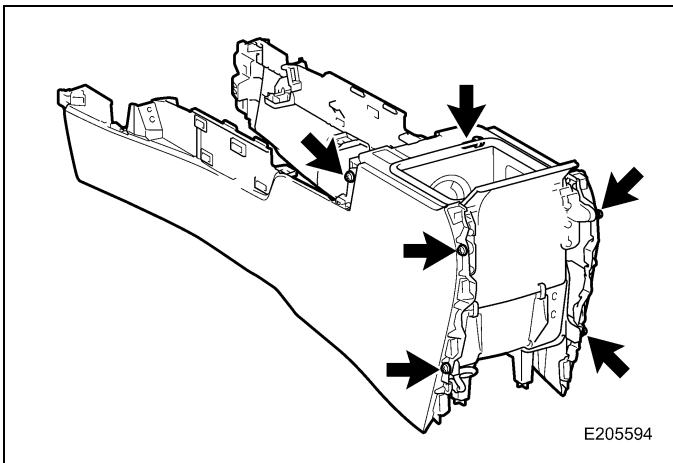
- c) Remove the 6 screws.
- d) Remove the console door.

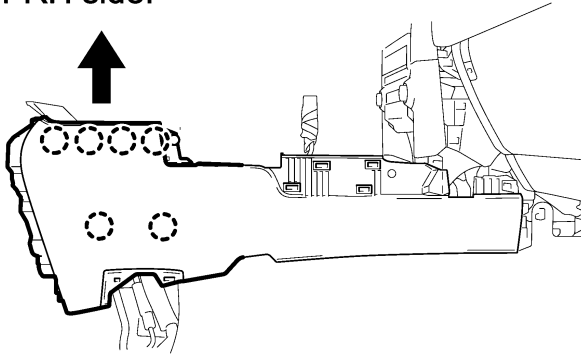
R1703290002

- e) Remove the 6 screws.

for RH side:

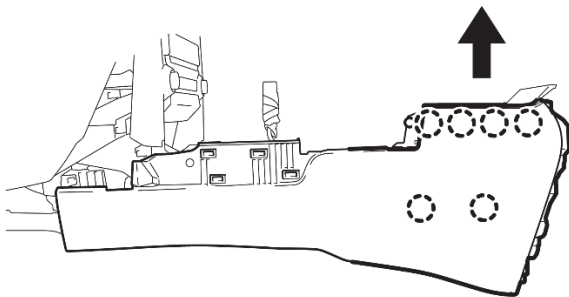
R1703290003

for LH side:

○ : Claw

- f) Disengage the 6 claws on each side of the console as shown.

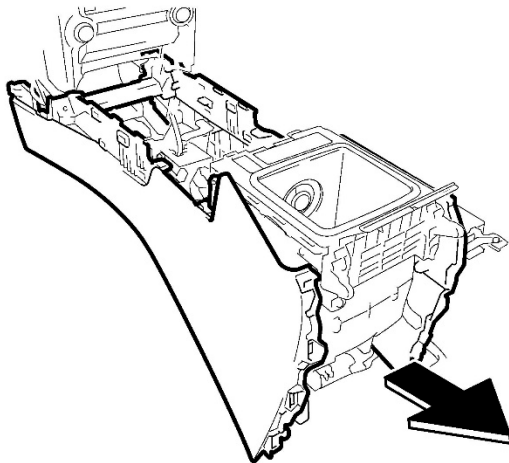
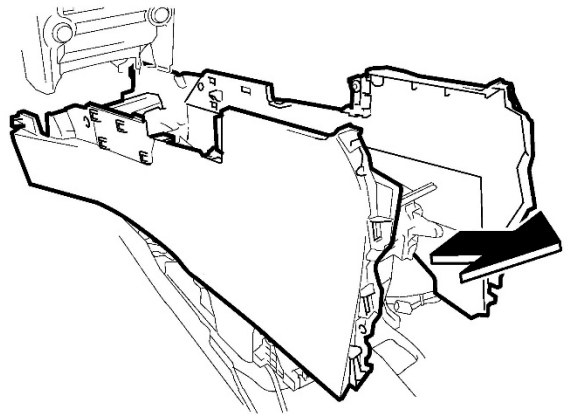
- g) Pull the console box towards the rear of the vehicle, then lift the rear of the box as shown, and remove from vehicle.

**Do not damage  
surrounding components**

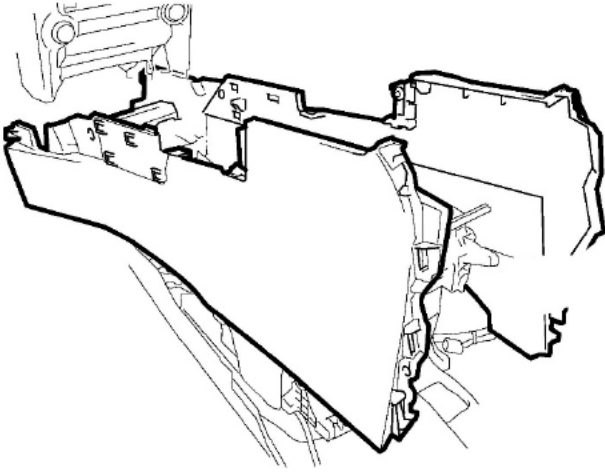
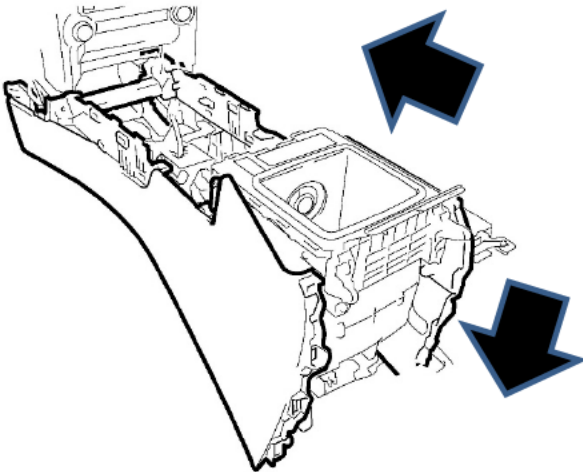
**Do not damage  
surrounding components**

- a) Install the front of the console box with rear section lifted as shown.

- b) Lower the rear of the box and then slide it forward.

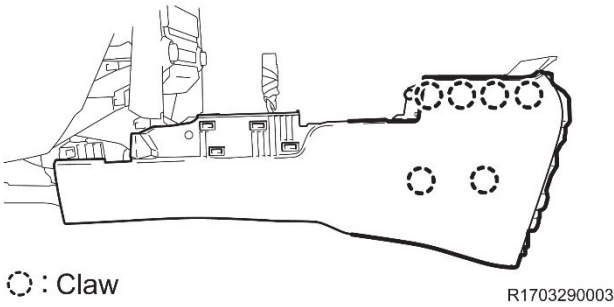
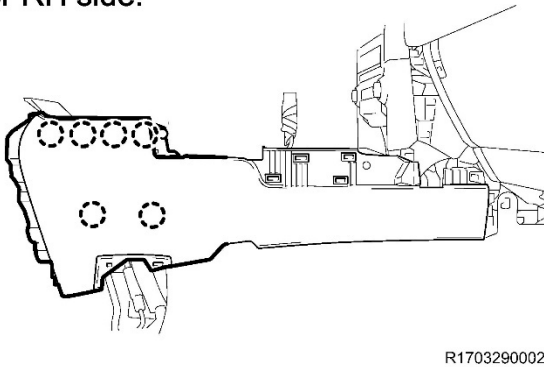
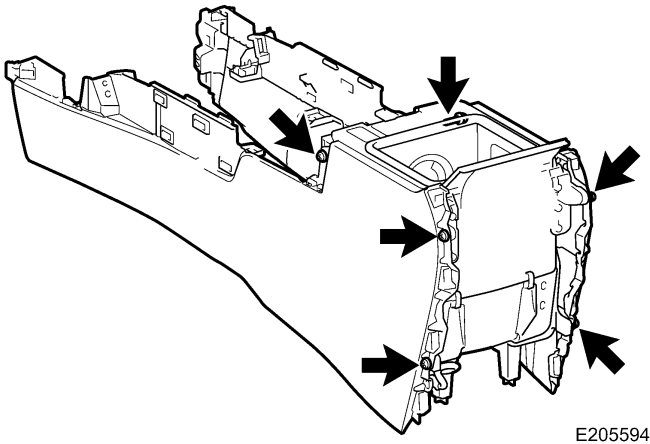
for LH side:

for RH side:

- c) Reengage the 6 claws on each side of the console as shown.

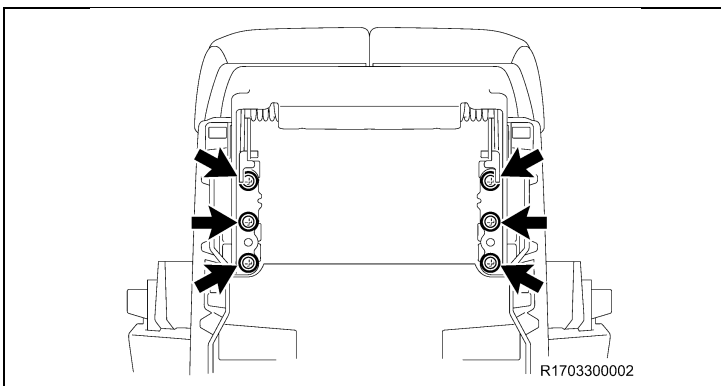
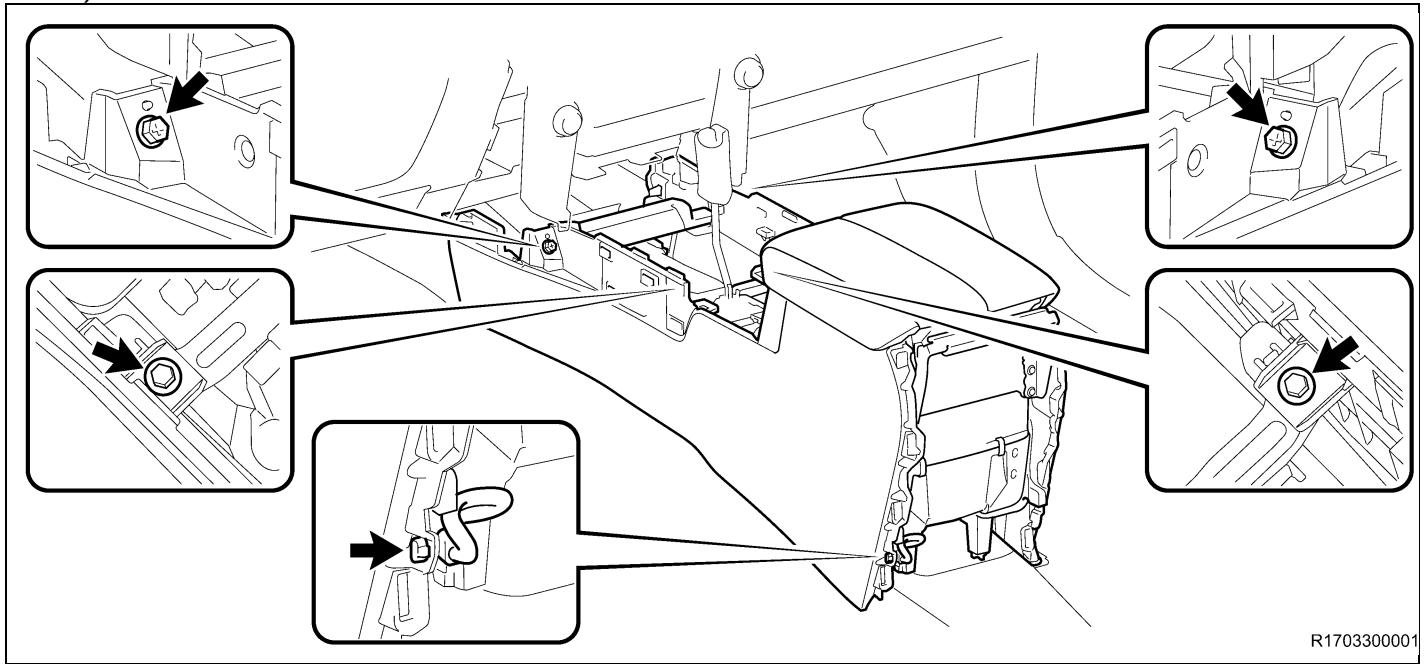
- d) Reinstall the 6 screws.

- e) Reinstall the console door.  
f) Reinstall the 6 screws

- g) Reengage the clamp.
- h) Reinstall the 2 bolts and 2 screws.

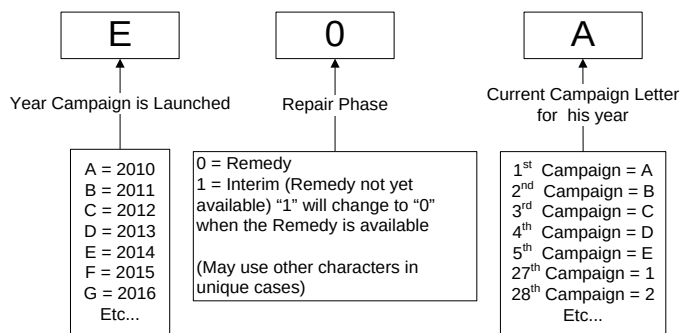
## B. CAMPAIGN DESIGNATION DECODER

Examples:

A0D = Launched in 2010, Remedy Phase, 4<sup>th</sup> Campaign Launched in 2010
