# TECHNICAL INSTRUCTIONS FOR SAFETY RECALL G0R FRONT PASSENGER AIRBAG INFLATOR MODULE CERTAIN 2008 - 2010 MY SCION xB

**UPDATED 1-9-2018**

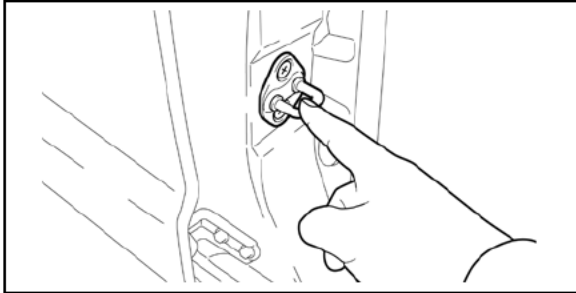
#### 1. ELIMINATE STATIC ELECTRICITY

- Before starting work and periodically while working on the vehicle, touch a metallic part of the vehicle to discharge static electricity in the body.

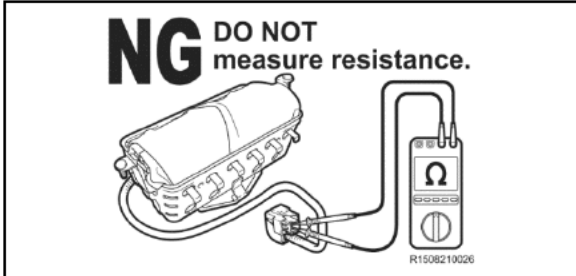
#### 2. DO NOT MEASURE RESISTANCE

- DO NOT** measure resistance of airbag components, this may cause accidental activation.

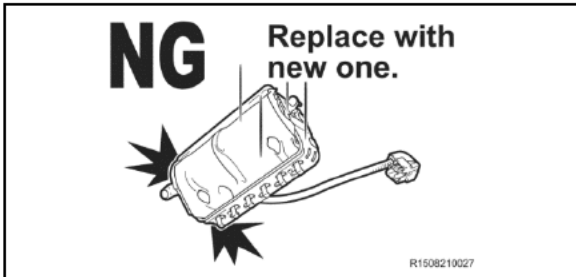
#### 3. HANDLE THE AIRBAG CAREFULLY

- If an airbag is dropped, replace it with a **NEW** one.

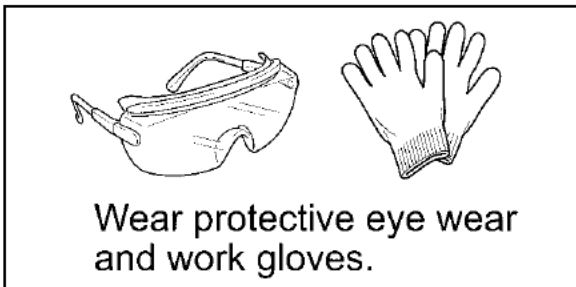
#### 4. WEAR PROTECTIVE EQUIPMENT

- Always wear appropriate protective equipment when working on the SRS.

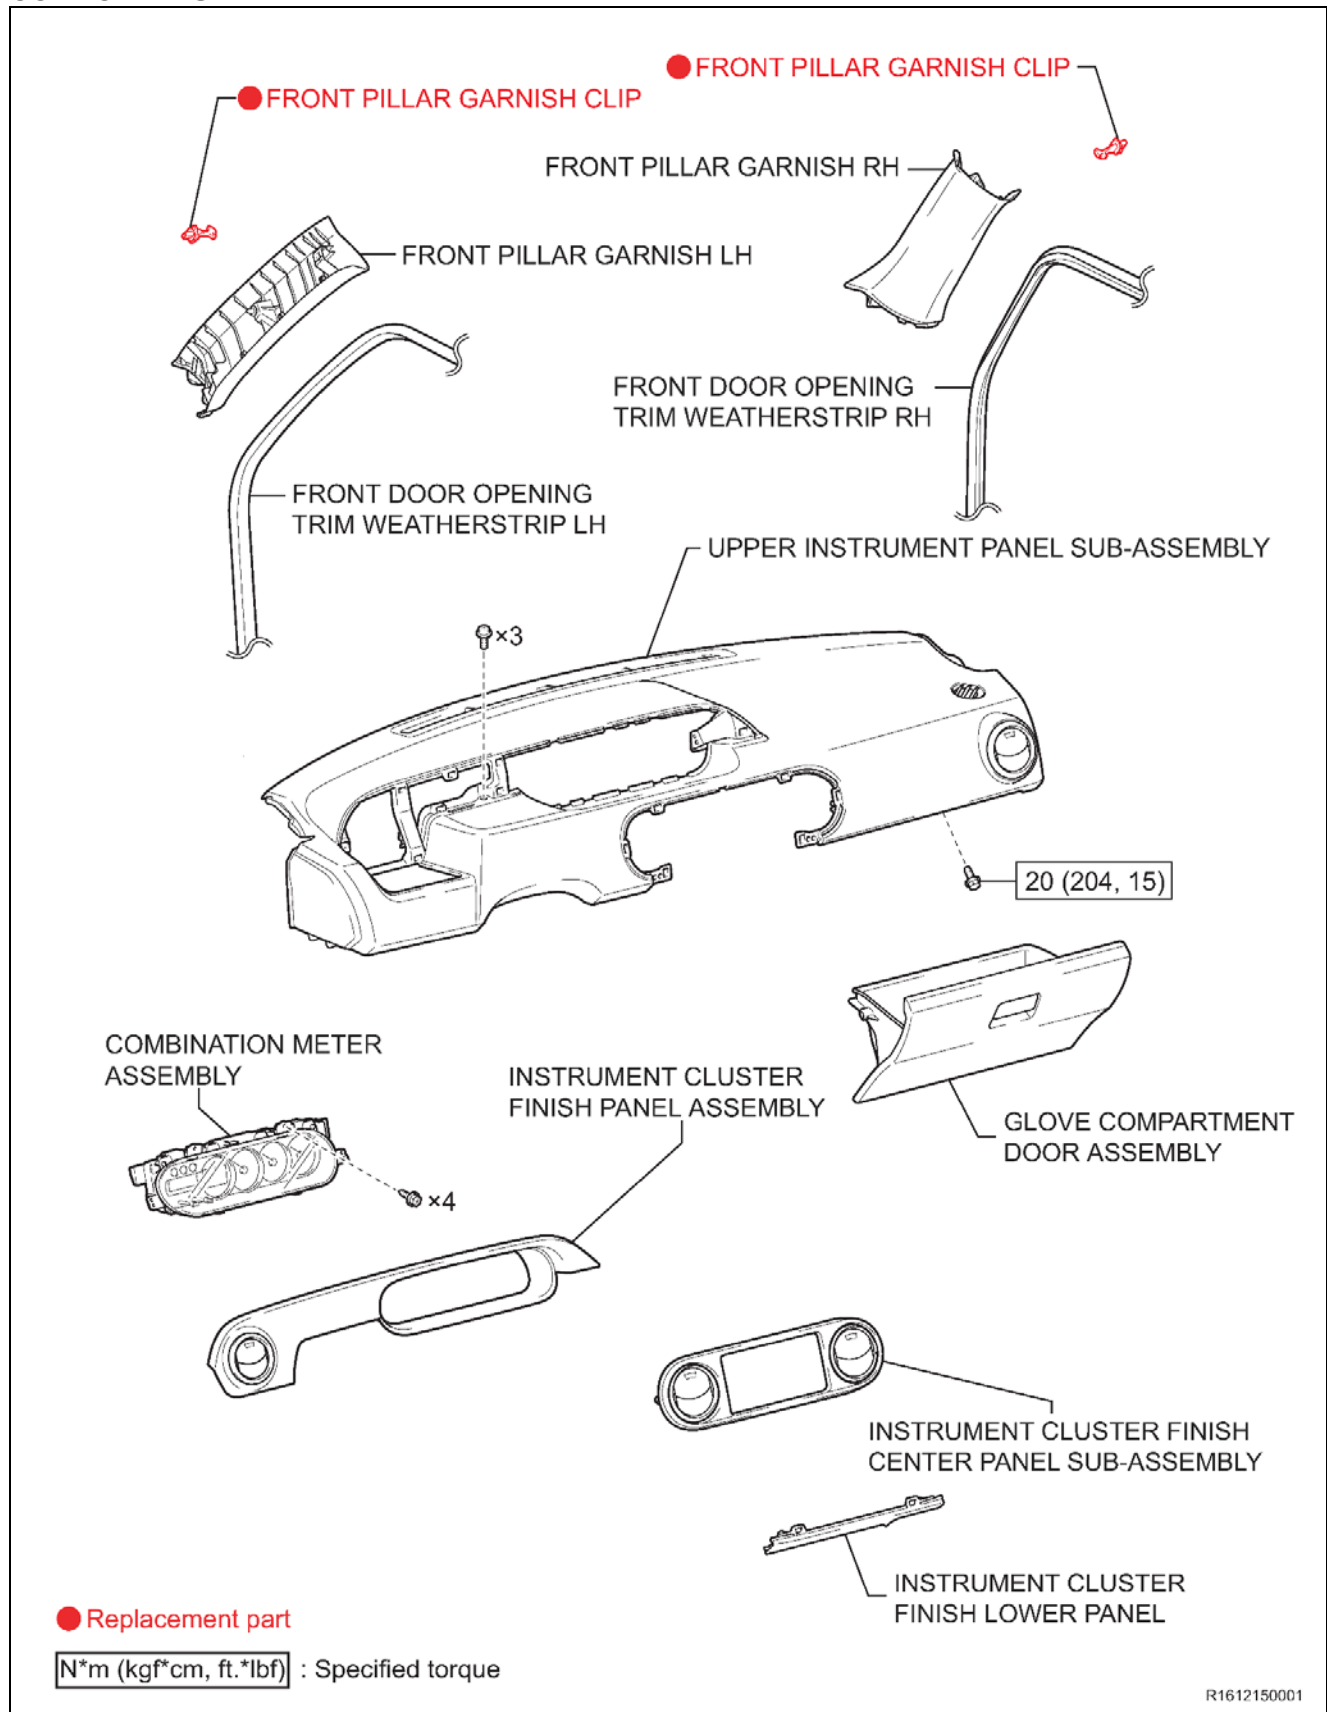
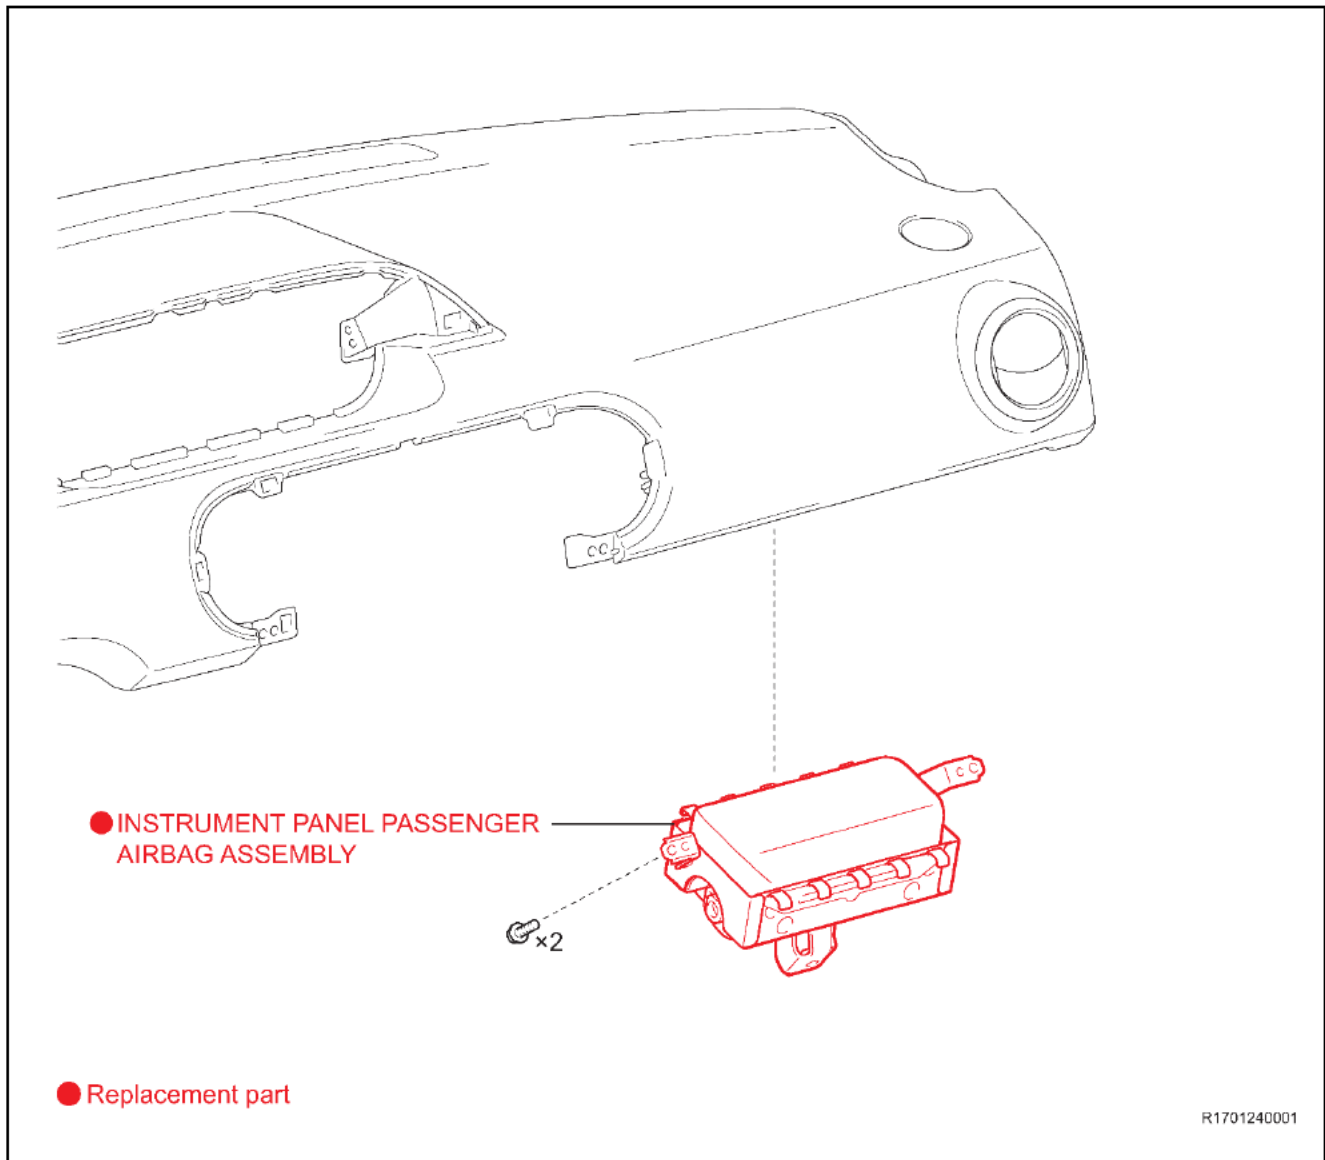
### COMPONENTS

## 1. REMOVE THE AIRBAG MODULE

a) Refer to TIS for instructions on airbag removal:
