# IMPORTANT UPDATE

## TECHNICAL INSTRUCTIONS FOR SAFETY RECALL G0P FRONT PASSENGER AIRBAG INFLATOR MODULE CERTAIN 2009 –2013 MODEL YEAR MATRIX

**Updated 1-9-18**

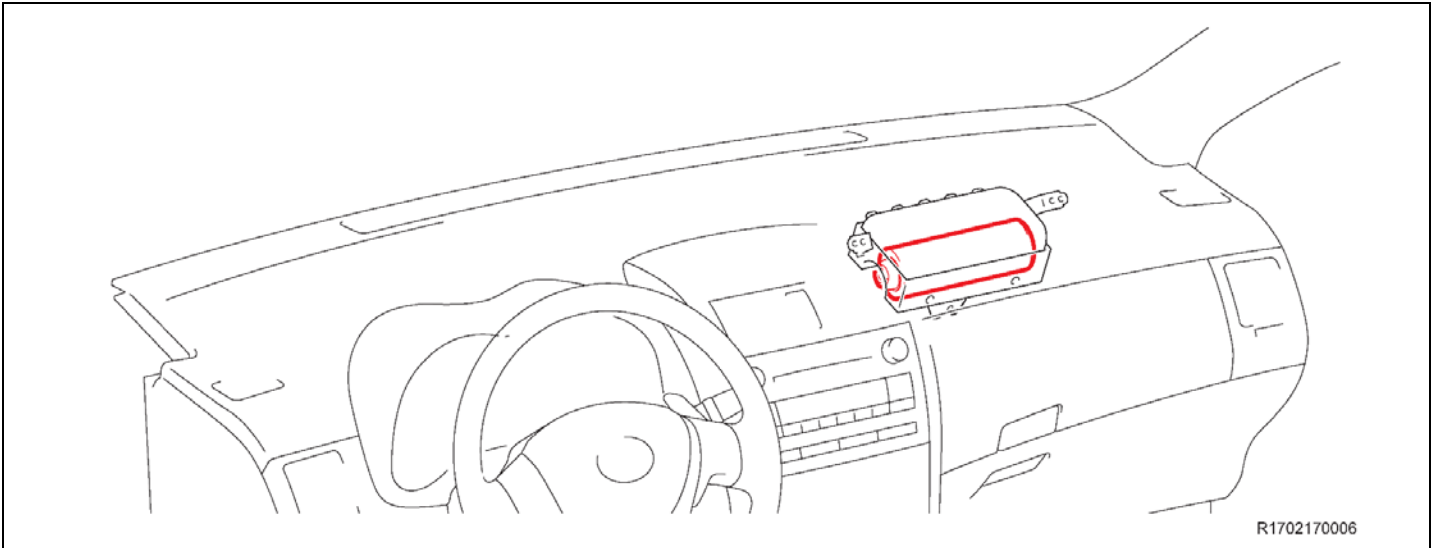
The subject vehicles are equipped with front passenger airbag inflators produced by Takata. The propellant in these inflators may degrade after prolonged exposure to high absolute humidity and fluctuating high temperatures. Degraded propellant can cause inflator rupture during airbag deployment. In the event of an inflator rupture, metal fragments could pass through the airbag cushion material, striking the vehicle occupants, and result in serious injury or death.

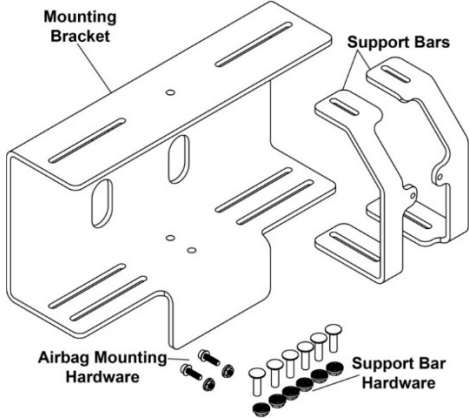
| Image | Name | Quantity |
|---|---|---|
| | Airbag Mounting Bracket & hardware | 1 |

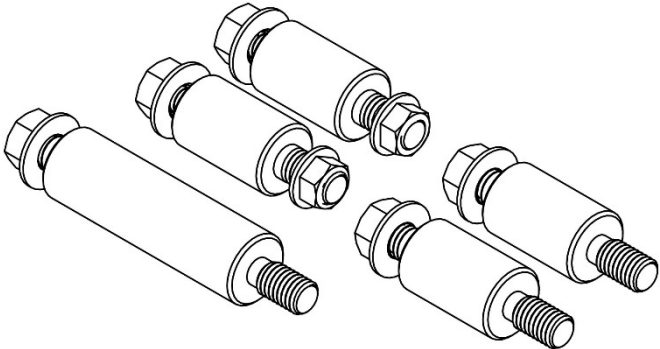
| Image | Name | Quantity |
|---|---|---|
| | Adaptor set* | 1 |

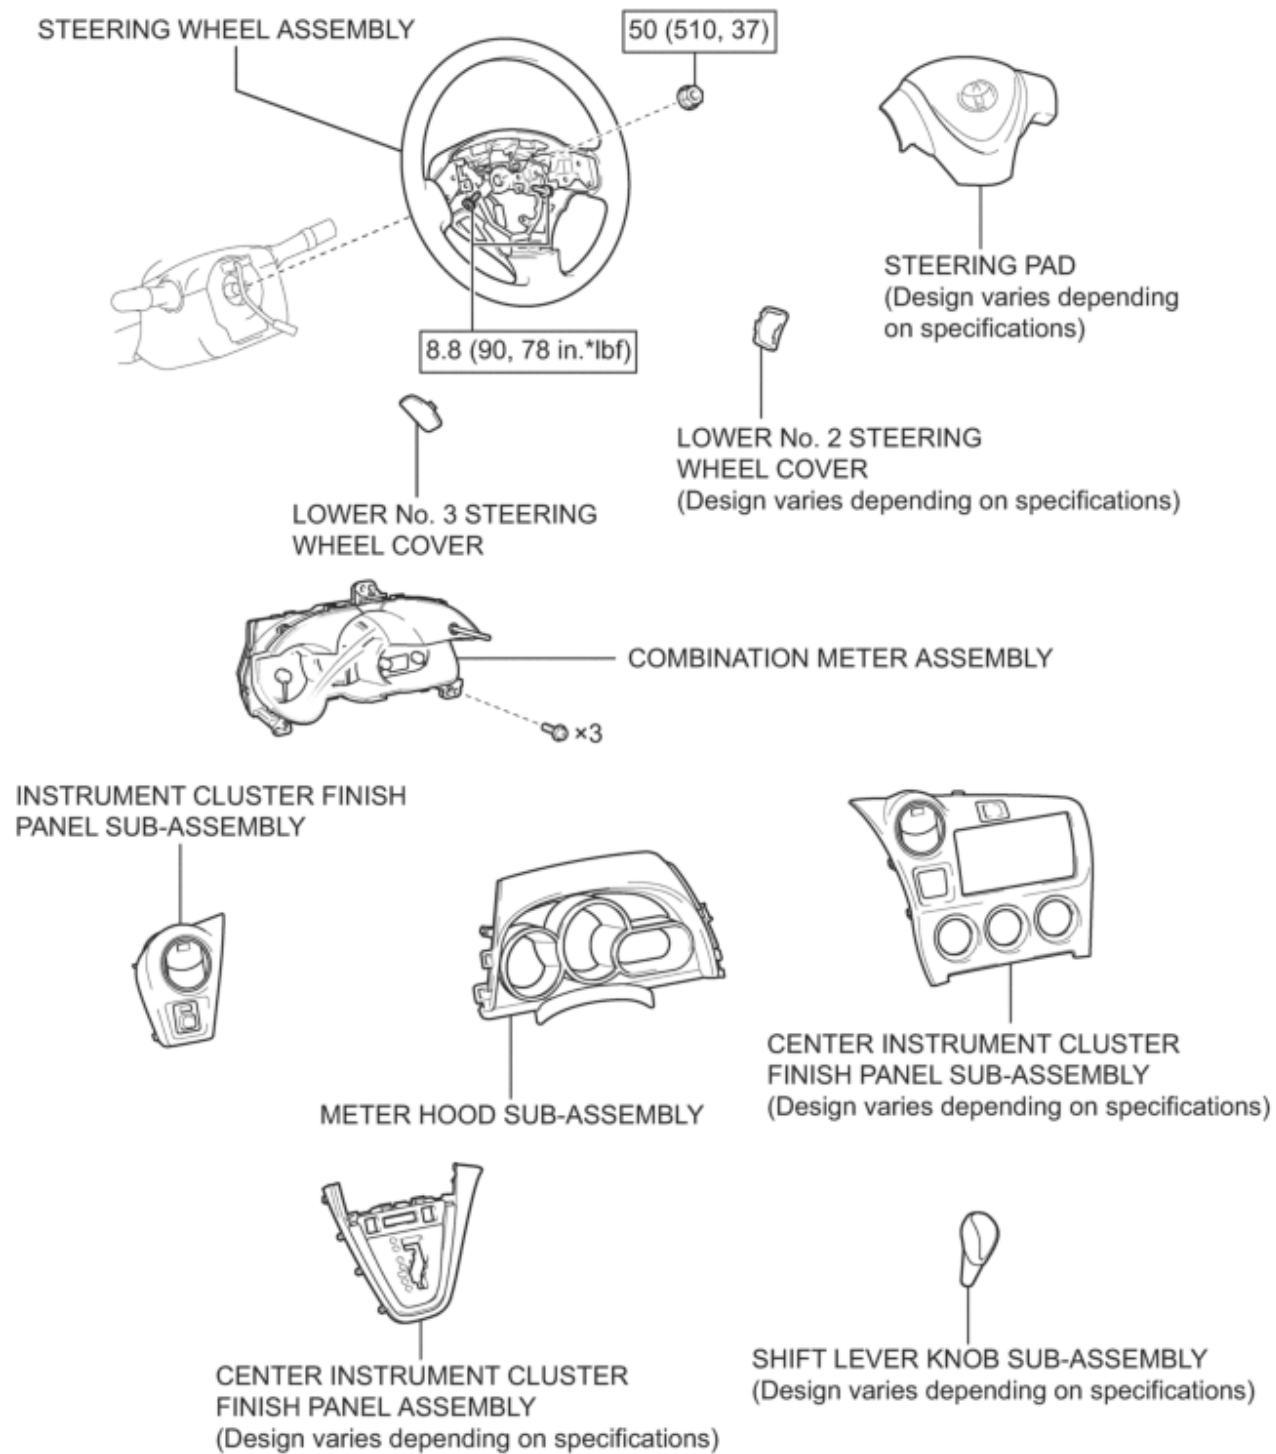
R1703010002

**N\*m (kgf\*cm, ft\*lbf)** : Specified torque

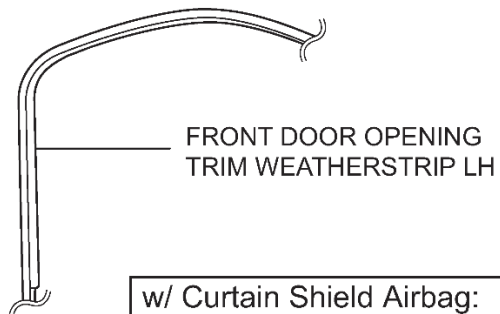
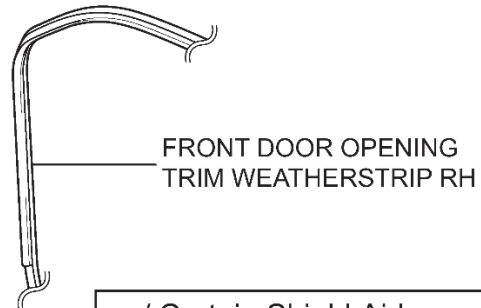
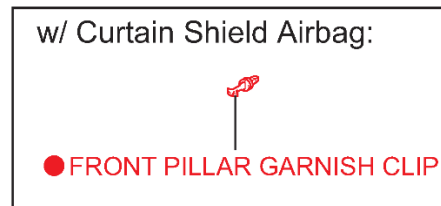
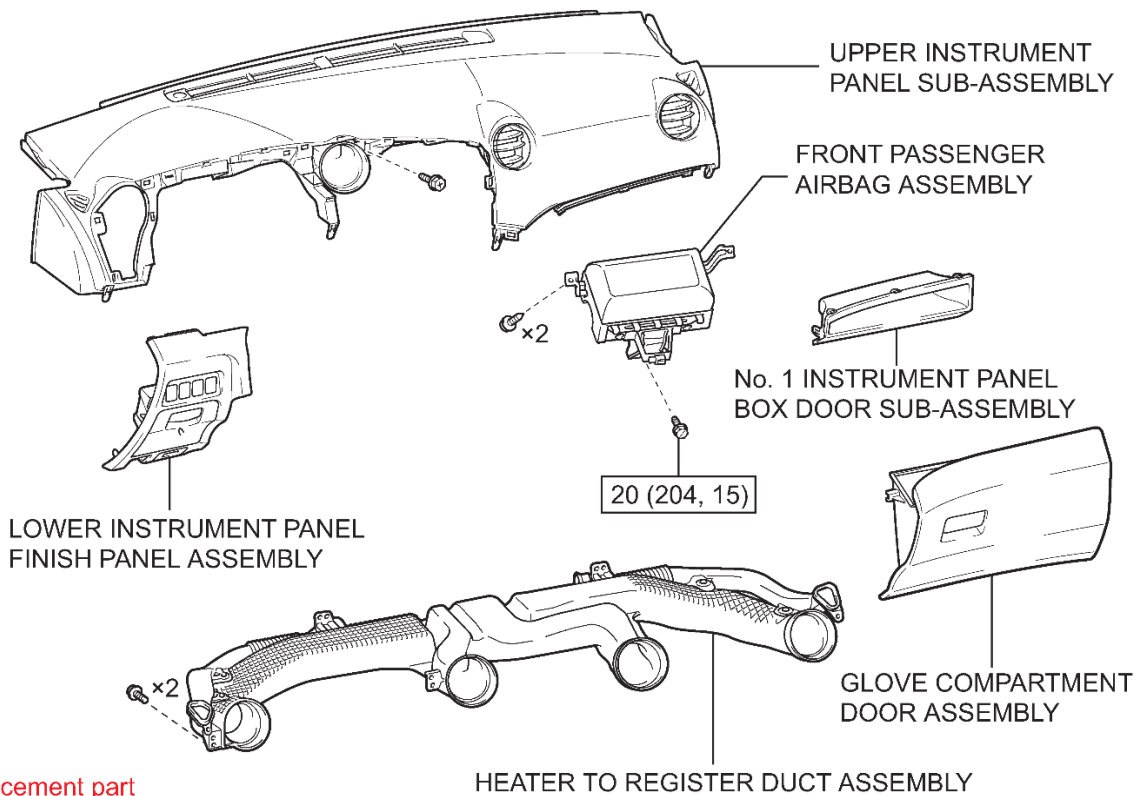
R1703010003

● : Replacement part

N\*m (kgf\*cm, ft.\*lbf) : Specified torque

**3.9 N·m (40, 35 in.\*lbf)**  
**Be careful not to**  
**overtighten.**

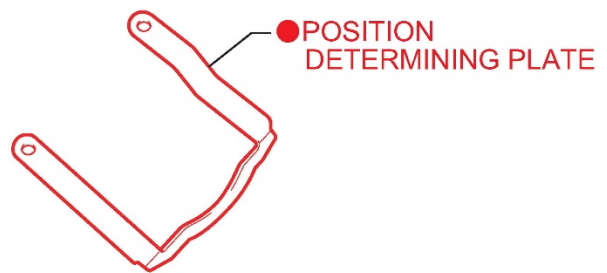
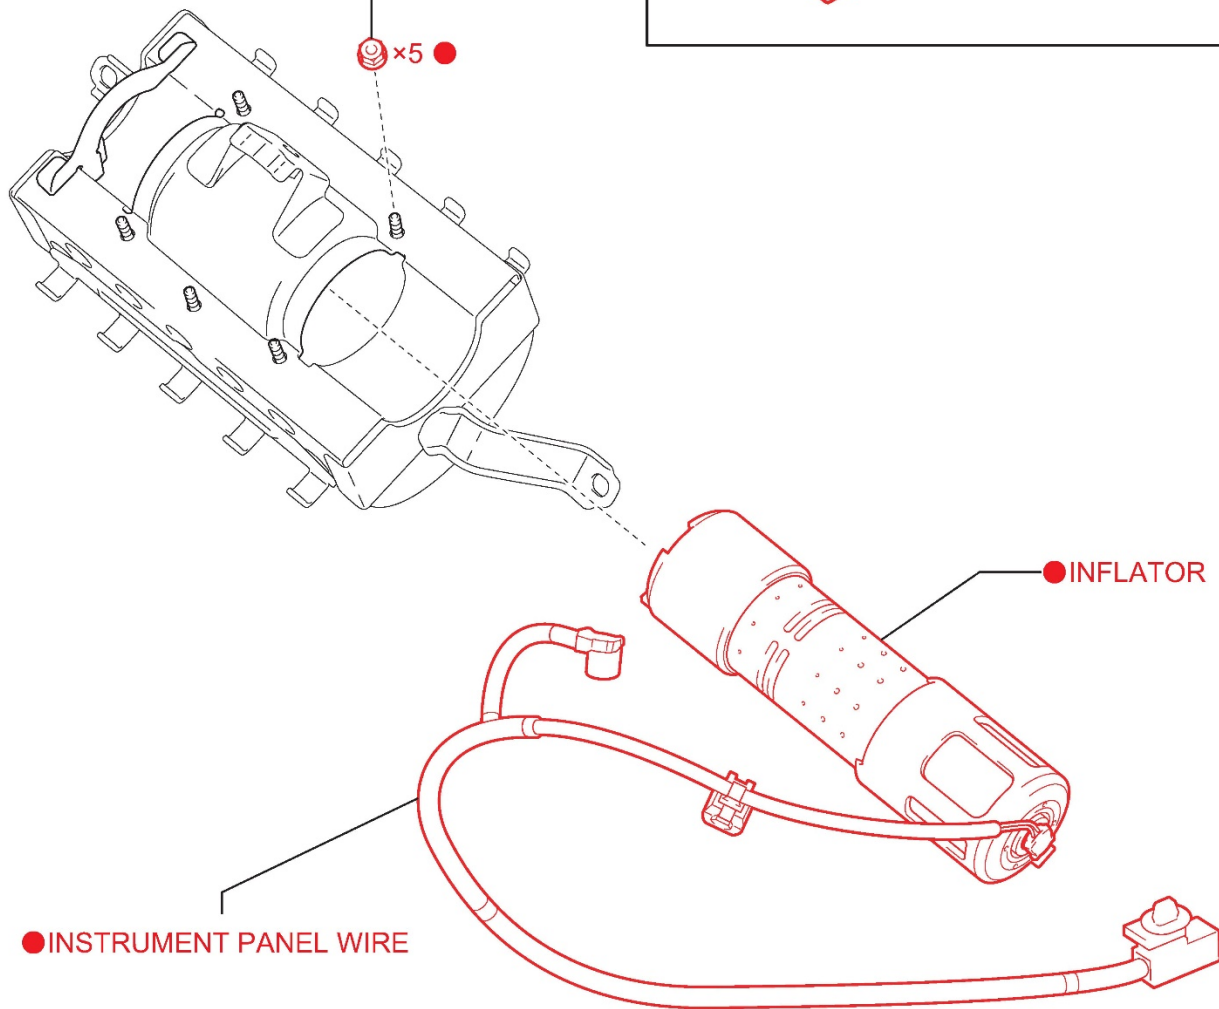
R1702270035

for MATRIX:

● : Replacement part

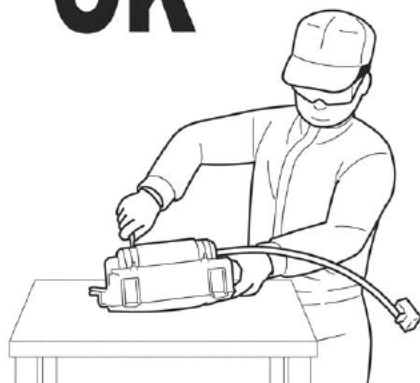
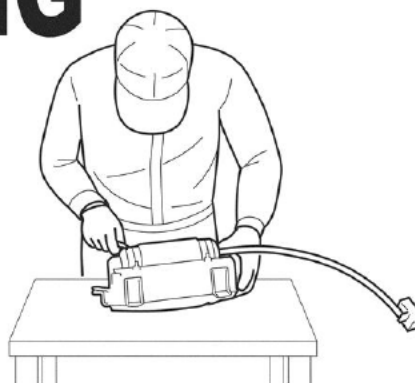
R1301230008E

- Carefully place the airbag on the bench inflator side up.

- Avoid standing directly over the inflator.

# OK

# NG

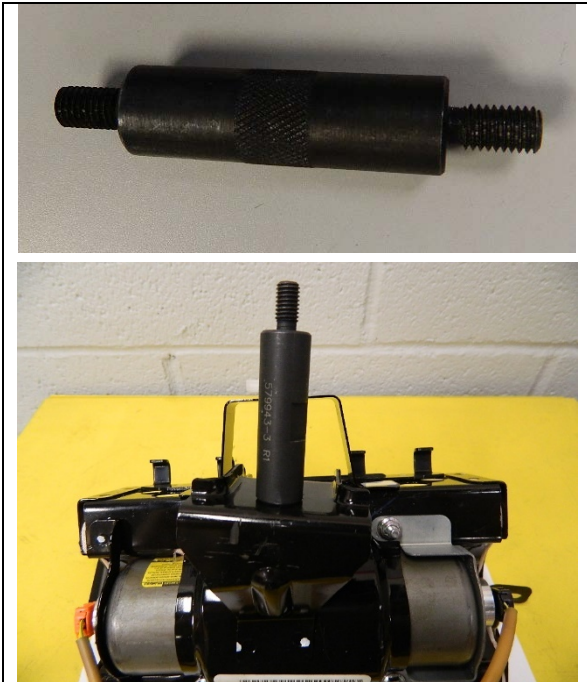
d) Mark all 5 nuts so they will not be reused.

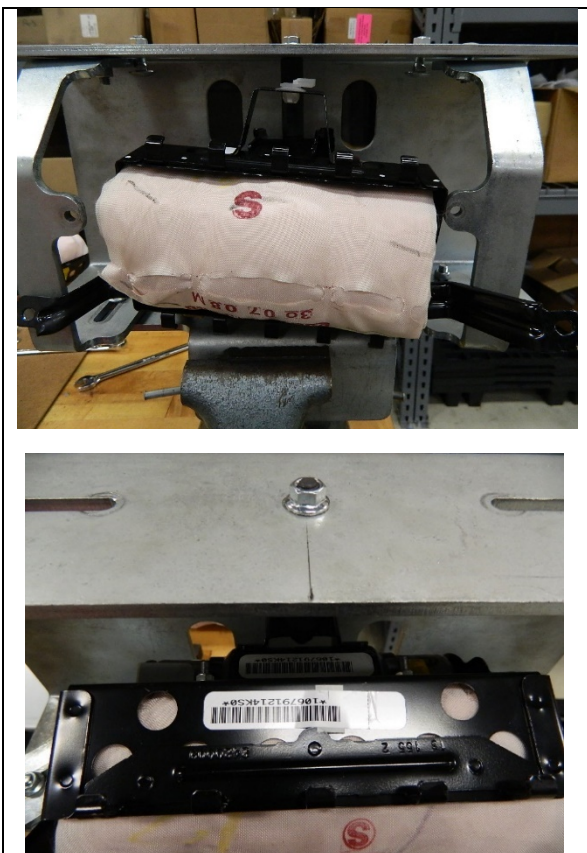
e) Use the long adaptor shown.

f) Thread the adaptor into the airbag as shown.  
**Note: Use the same mounting nut on the airbag that attaches the airbag to the vehicles cross tube.**

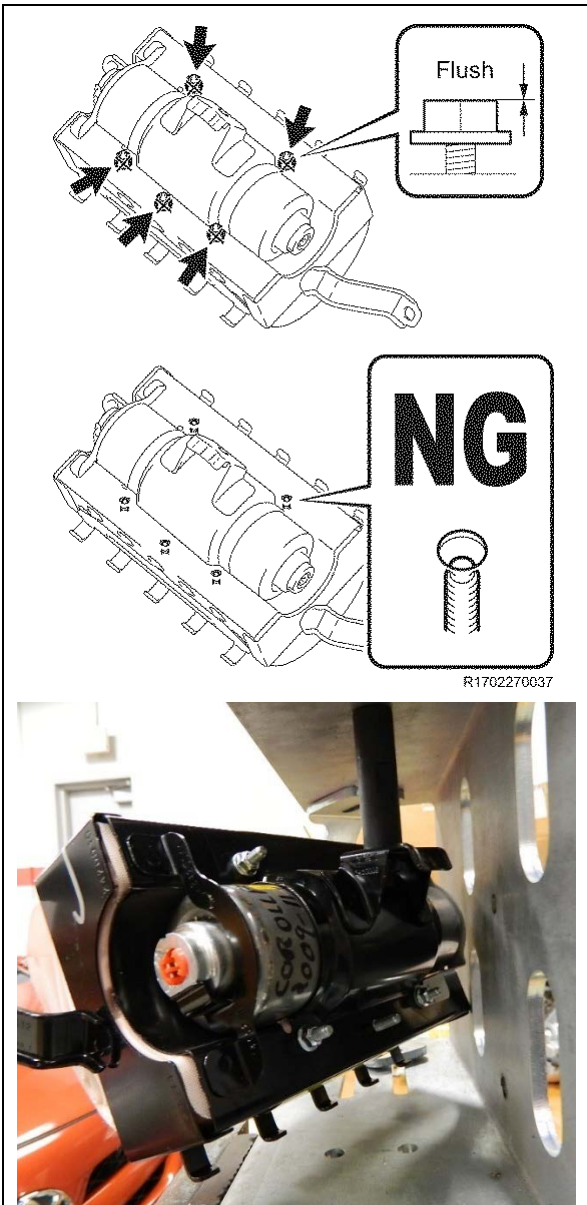
g) Mount the airbag into the mounting bracket as shown. Pass the stud on the adaptor through the hole in the middle of the bracket with the nut.

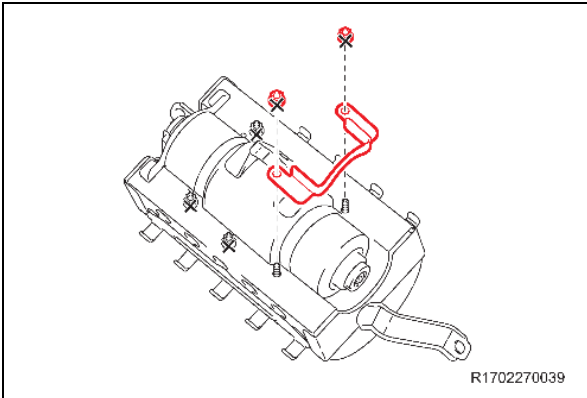
- a) Loosen the 5 nuts until the nuts are at the top of the studs as shown, through the openings in the mounting bracket.

**Note:** The airbag may need to be turned to the left or right to access the center nut.

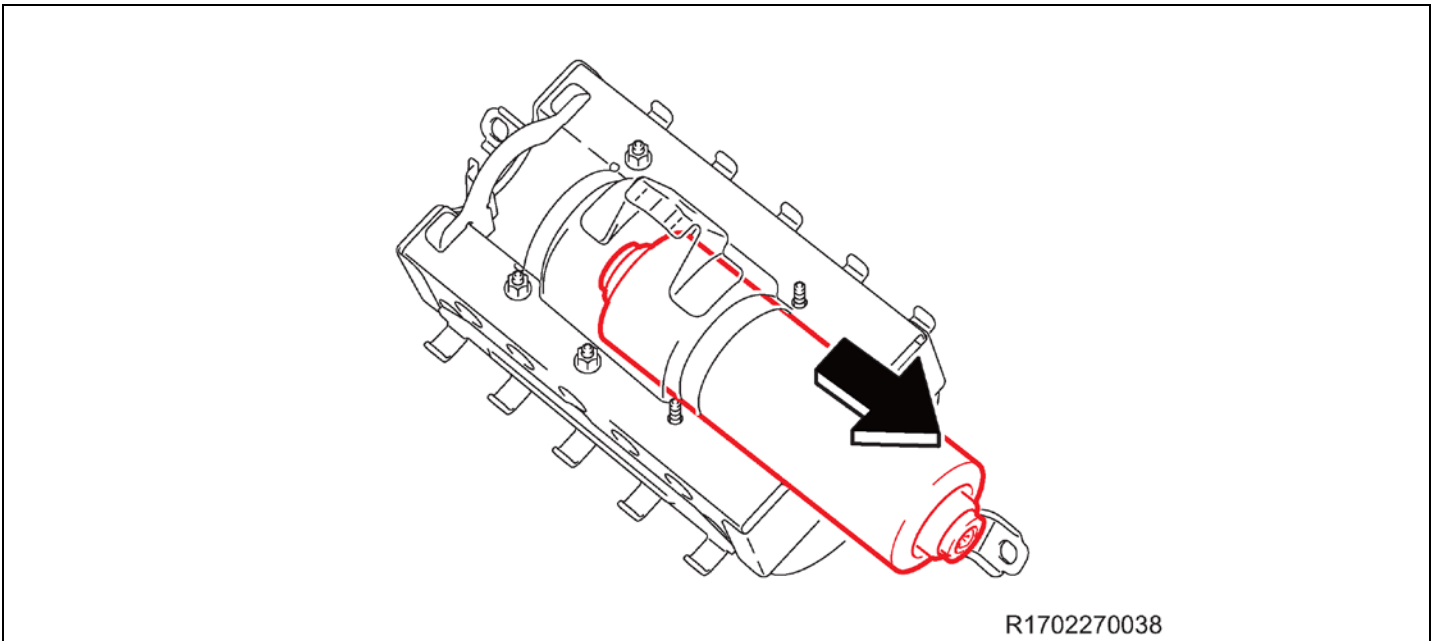
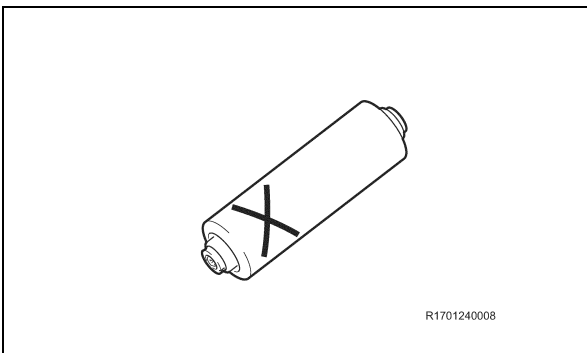
- a) Gently push in the studs until the nuts make contact with the housing to loosen the inflator for removal.

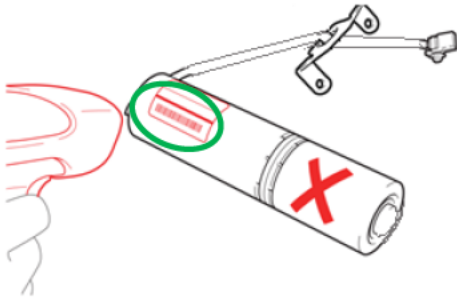
Step a) Old Inflator (bar code)

- Scan the **OLD** inflator bar code.
- Scan the **NEW** inflator QR code.

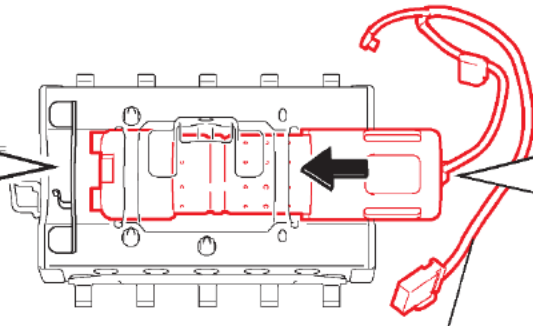
R1702270040

- a) Carefully slide the new inflator into the airbag assembly and align as shown.

**DO NOT** insert fully.

Check orientation

Upper side

Bottom

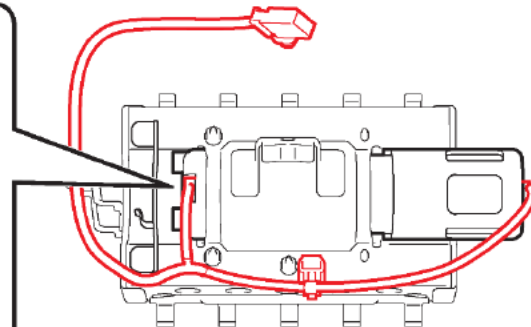
R1702270041

- b) Connect the connector to the inflator and ensure that the connector lock is fully engaged as shown.  
c) Route and secure the wire harness as shown.

**ALIGN CONNECTORS**

Wire Harness Side:

Inflator Side:

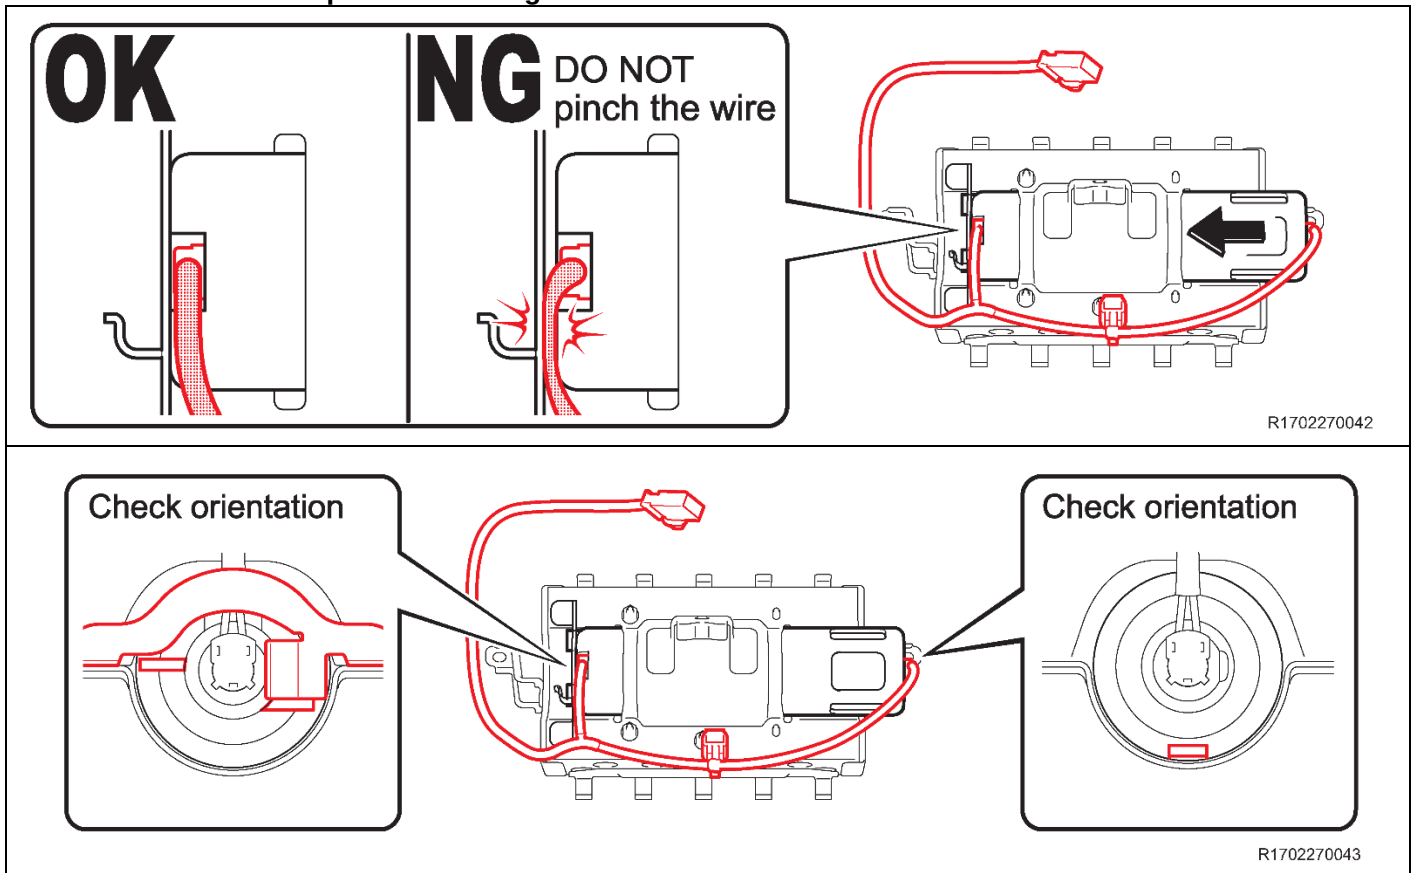
R1703080015

d) Fully insert the inflator and ensure that the inflator is correctly oriented as shown.

**NOTE: DO NOT pinch the wiring between the bracket and the inflator.**

**OK**

Install the plate so that  
there is no float

**NG**

DO NOT mistake the  
orientation of the plate

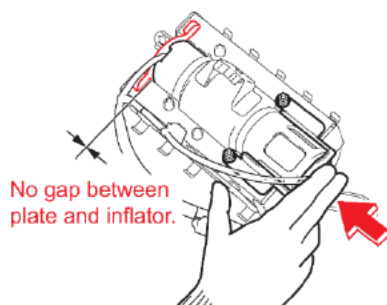
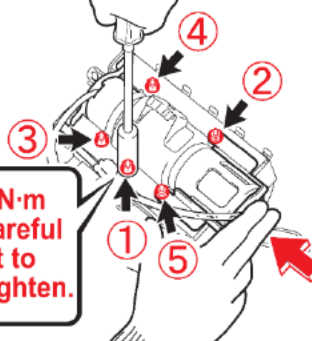
R1702270046

- a) Tighten the 5 nuts evenly in several increments in the sequence shown. Use a socket driver or torque wrench to tighten the nuts.

Torque: 35in. lbf (3.9N·m)

- There will be some resistance when tightening the nuts because they are self-locking, confirm the nuts are tightened correctly.
- **DO NOT** use a power tool, T-handle, or ratchet when tightening the nuts to avoid over torqueing and deforming the studs.
- You may need to turn the airbag to the left or right with in the mounting bracket to access the center nut.

**OK**

Socket Driver

**Too Tight!**

**These tools cause overtightening !**

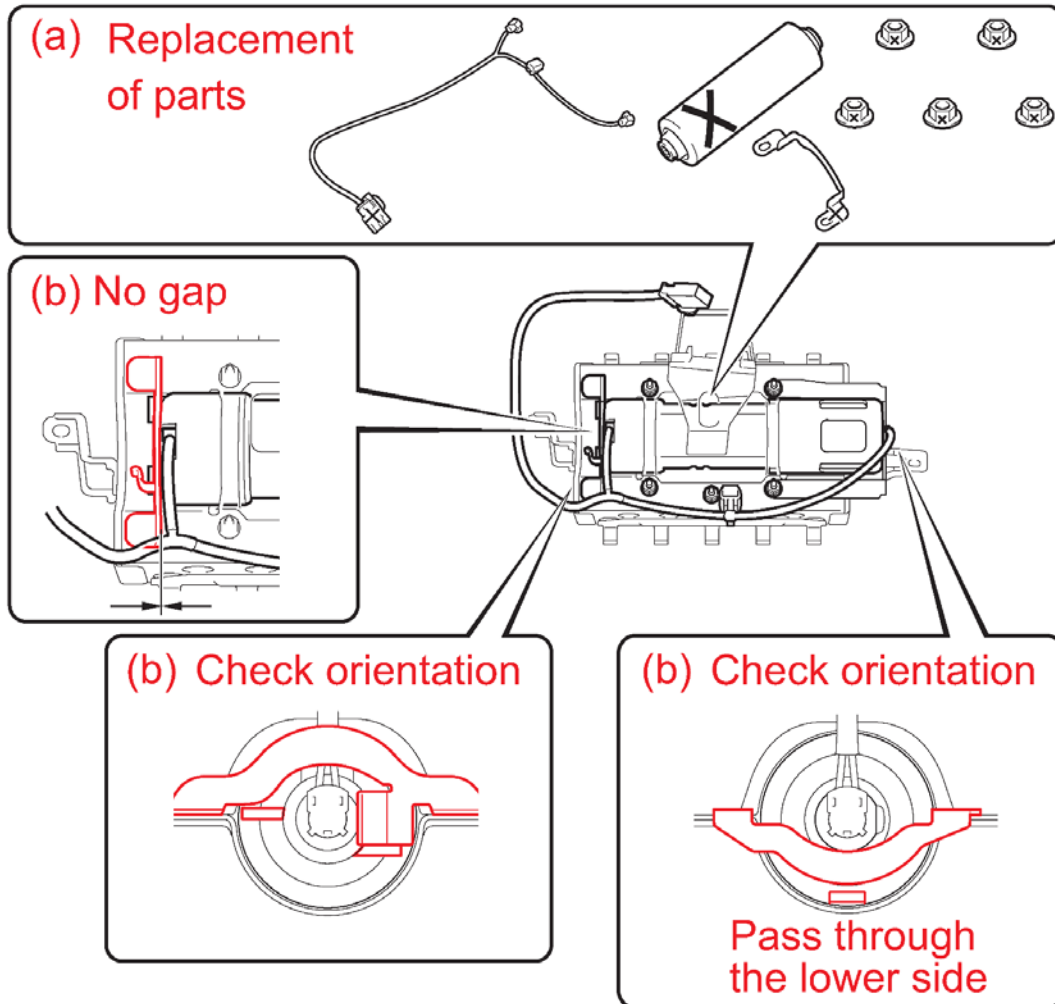
R1703080022

- a) Confirm the **NEW** inflator and 5 **NEW** nuts have been installed.
- b) Confirm the position of the inflator and position determining plates are correct.
- c) Confirm the routing of the inflator wire harness.
