## TECHNICAL INSTRUCTIONS FOR SAFETY RECALL GLG/GLH/HLA

### FRONT PASSENGER AIRBAG INFLATOR REPLACEMENT CERTAIN 2006 – 2013 MY IS 250/350 and 2008 – 2014 MY IS F

**Updated 01-14-2021**

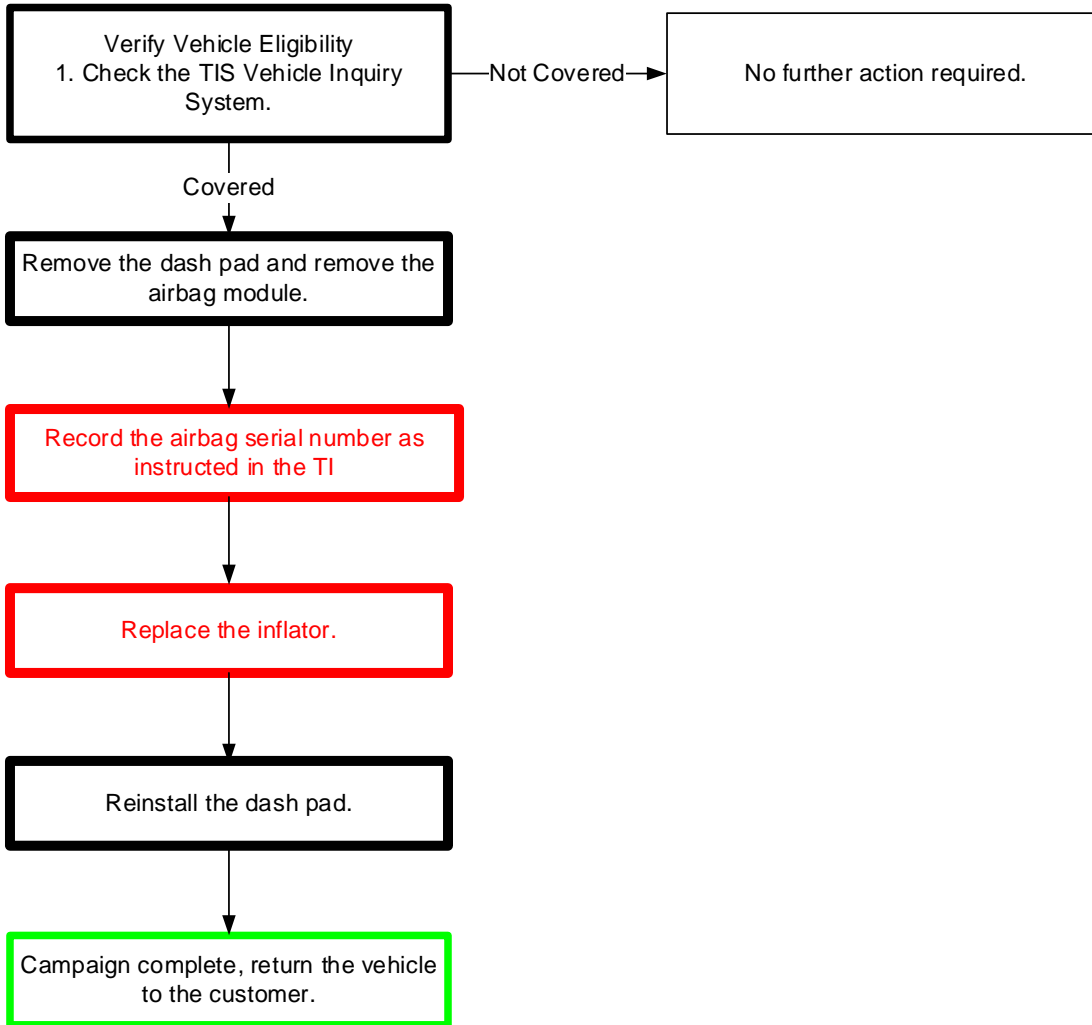
## I. OPERATION FLOW CHART

The flow chart is for reference only. **DO NOT** use it in place of the full technical instructions. Follow **ALL** steps as outlined in the full technical instructions to confirm the campaign is completed correctly.

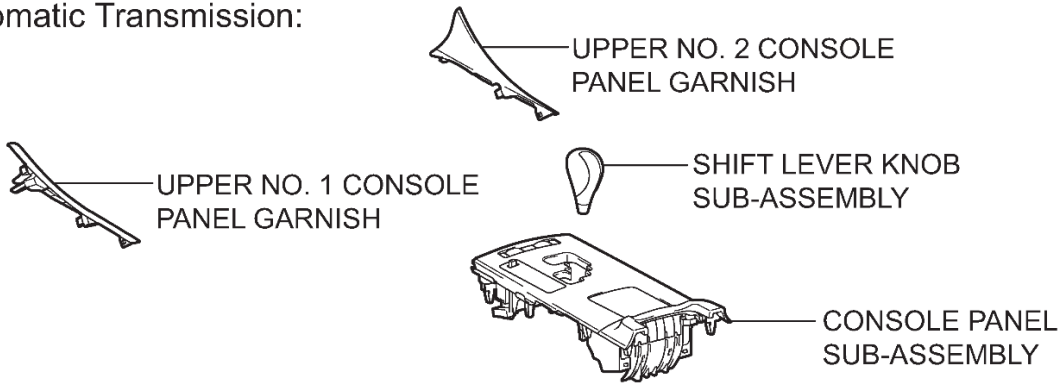
# VII. FRONT PASSENGER AIRBAG REMOVAL COMPONENTS

for Automatic Transmission:

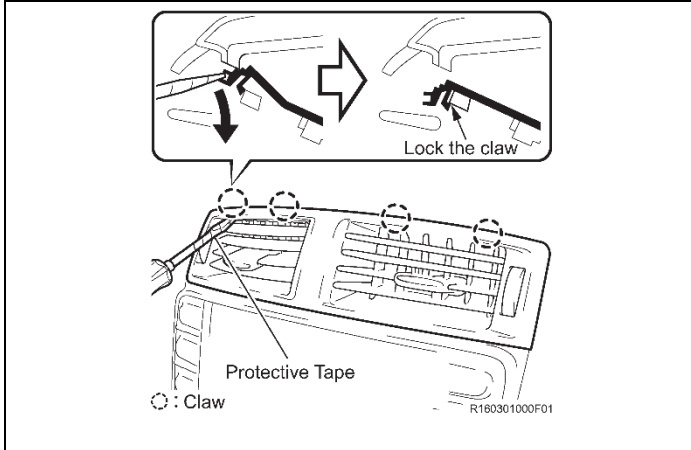
Removing the No. 3 air register

Remove any peripheral parts on left and right side of the register to allow access to the back of the register.

Wrap the tip of a screwdriver with tape.

Lock the 4 claws inside the register as shown.

**NOTE:** Do not use a molding removal tool to remove the register it could be damaged.

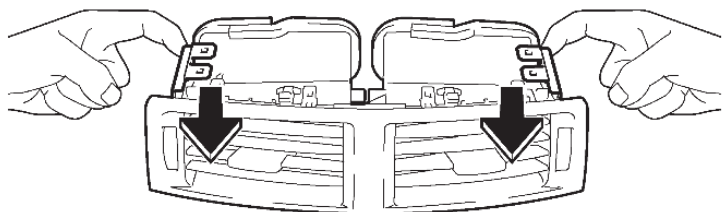
**【Example for removal of center register】**

**OK** Push from the back side

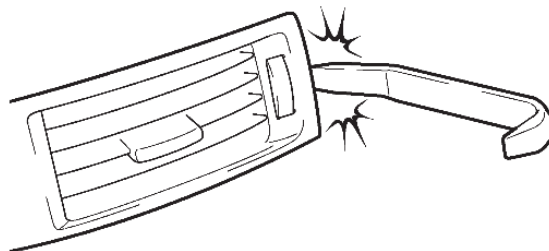
**NG** Pry from the front side

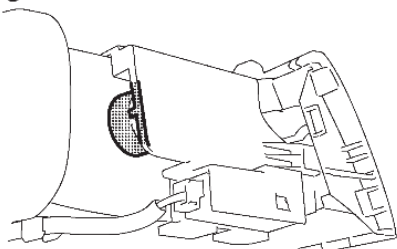
Using your finger on the left side push out at the point shown to disengage the 4 claws.

Back side of part manufactured  
before August 2008:

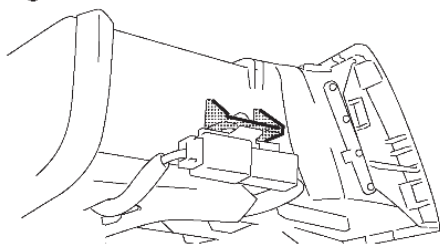
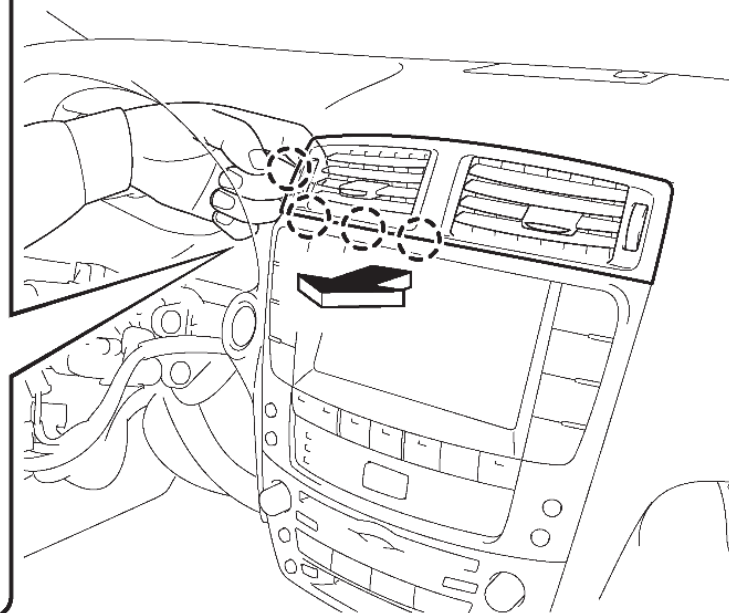
Back side of the part manufactured  
after August 2008:

○ : Claw

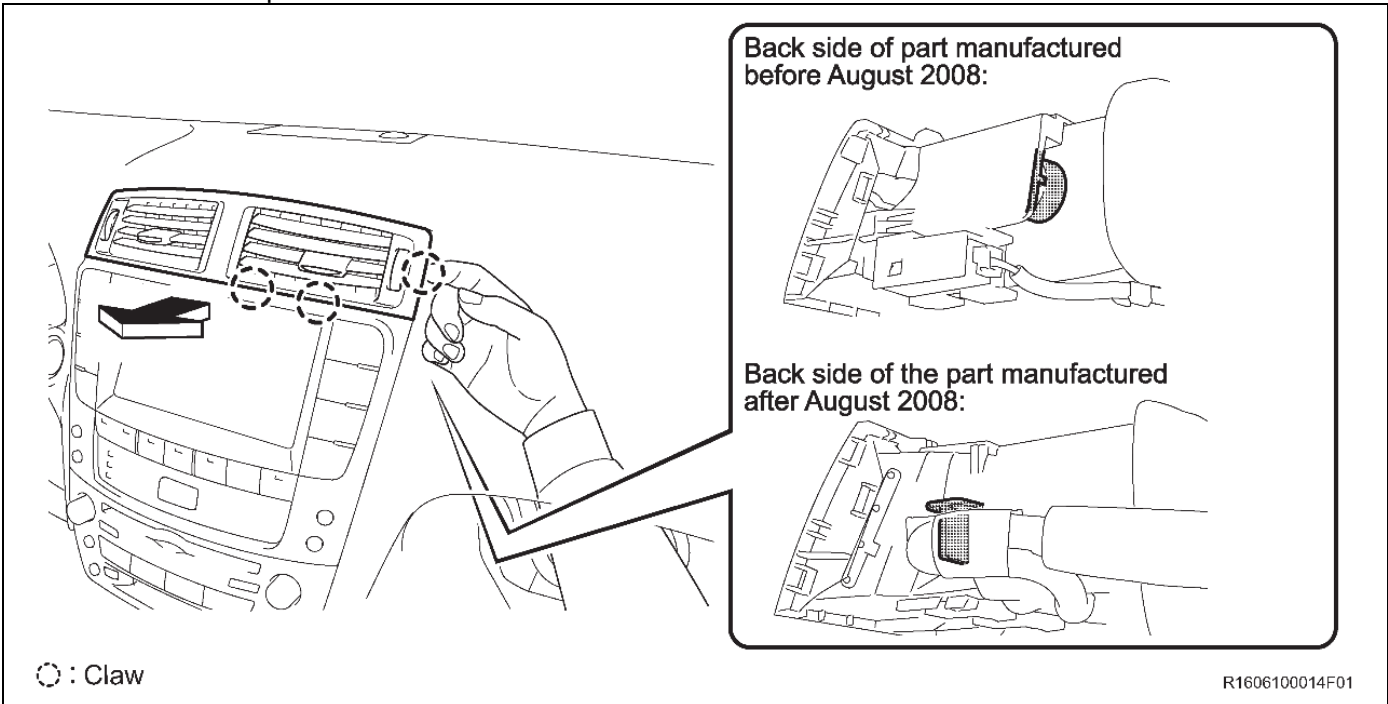
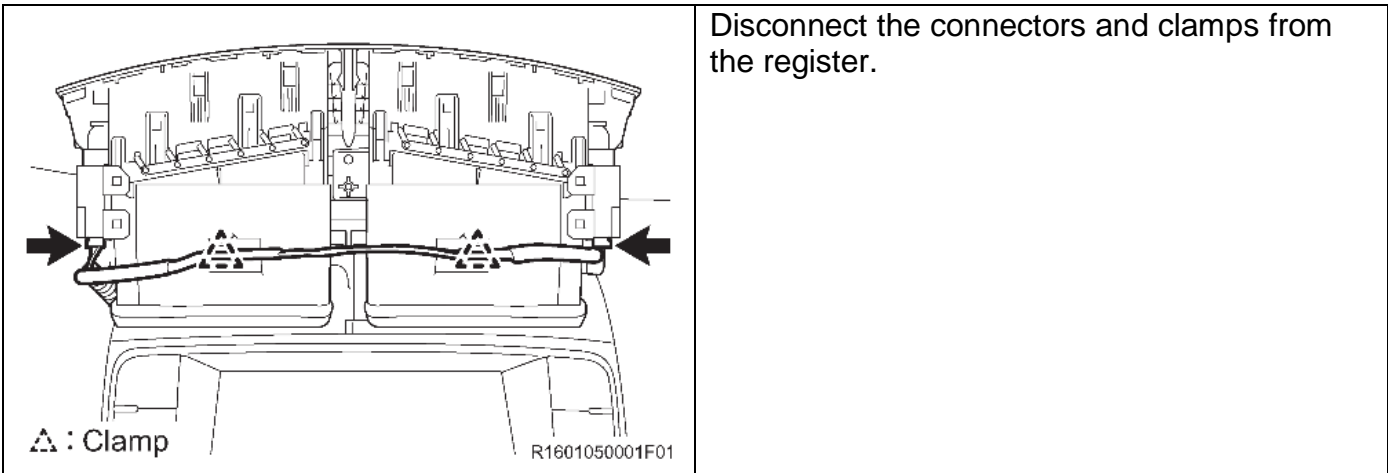
Using your finger on the right side push out at the point shown to disengage the 3 claws and remove the register from the instrument panel.

**NOTE: DO NOT contact the positioning tabs while removing the instrument panel as the panel could be damaged.**

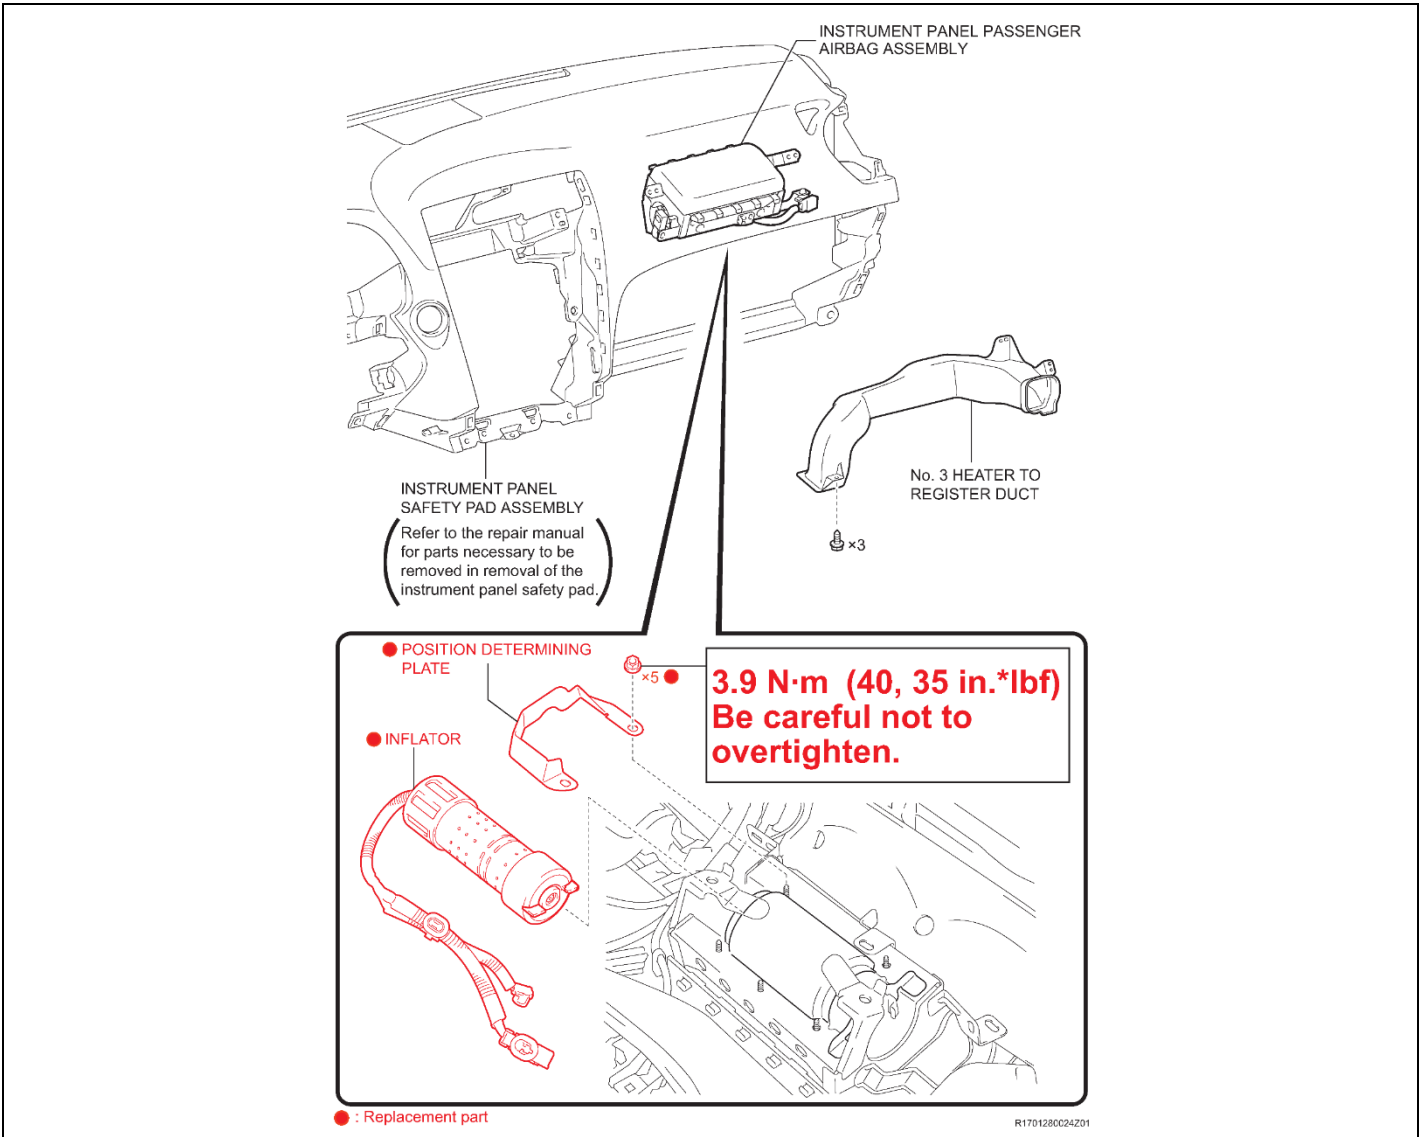
- a) Remove the 3 screws and the side defroster nozzle.
- b) Remove the 2 screws and the heater to register duct.

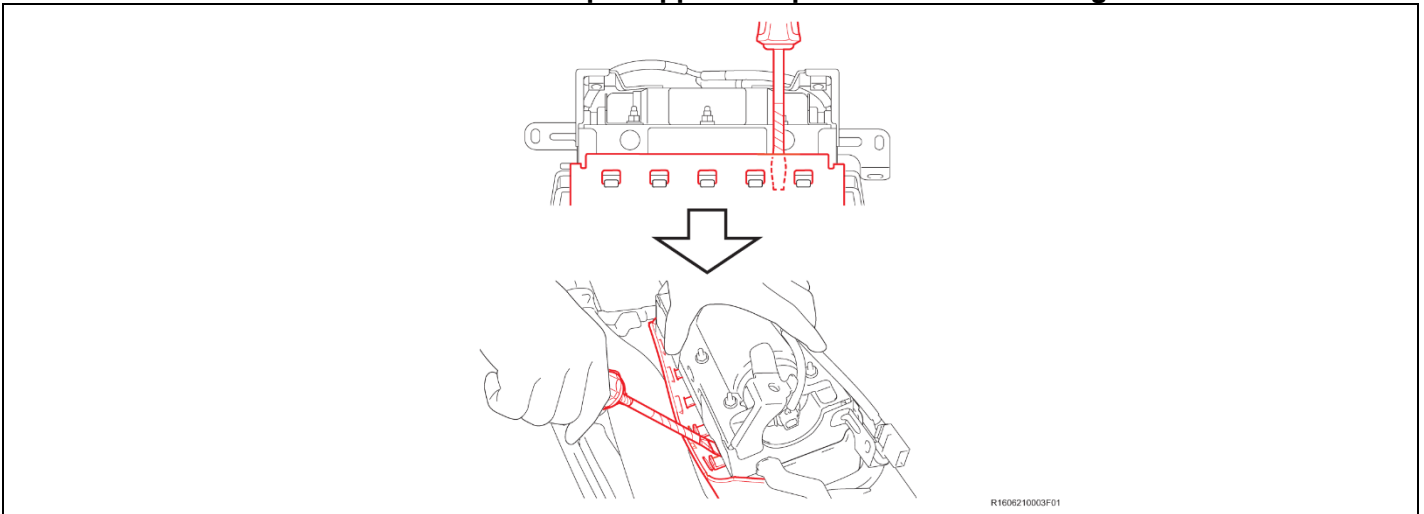
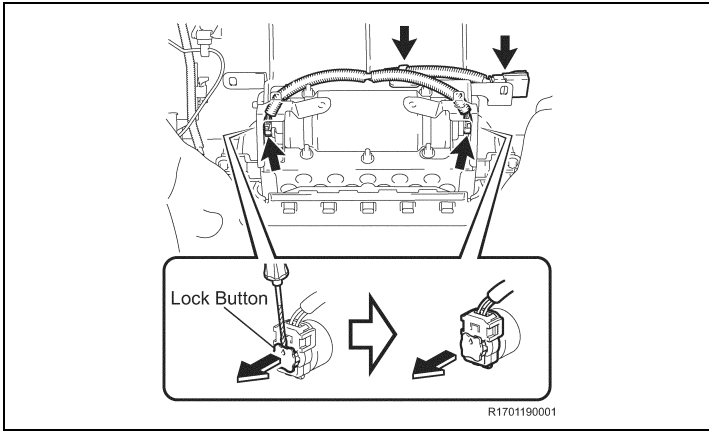
- c) Remove the 4 bolts, disengage the straps, and then remove the airbag assembly.

**NOTE: Use a screwdriver with the tip wrapped in tape to remove the airbag from the dash.**

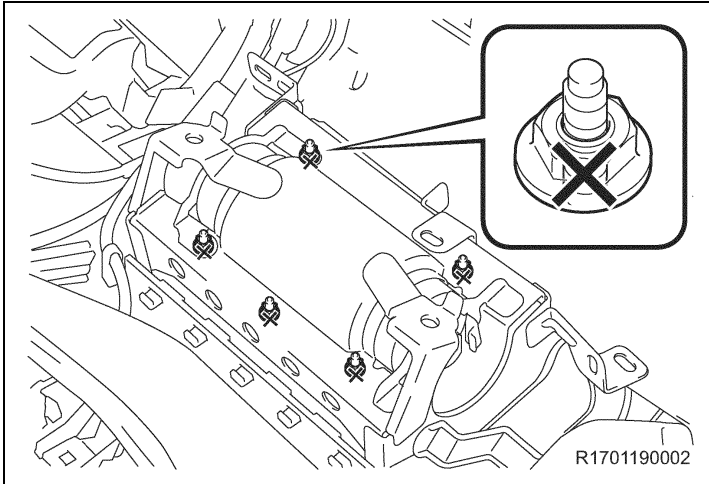
- d) Using a screwdriver to release the lock button of the connector.
  - e) Disconnect the 2 connectors.
  - f) Disengage the 2 clamps.
- NOTE: The removed instrument panel wire will not be reused.**

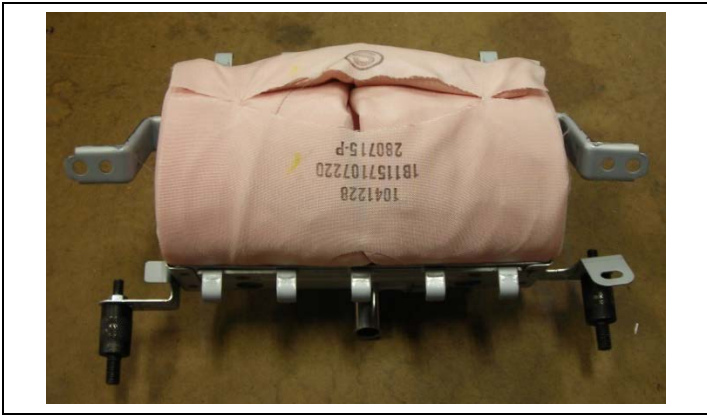
- a) Mark the 5 self locking nuts to prevent reuse.

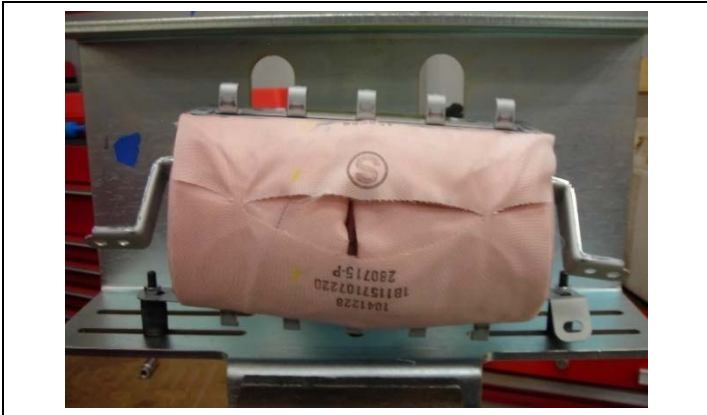
b) Mount the adaptors (579943-3R3) to the airbag as shown.

**NOTE: The 6mm stud mounts to the airbag.**

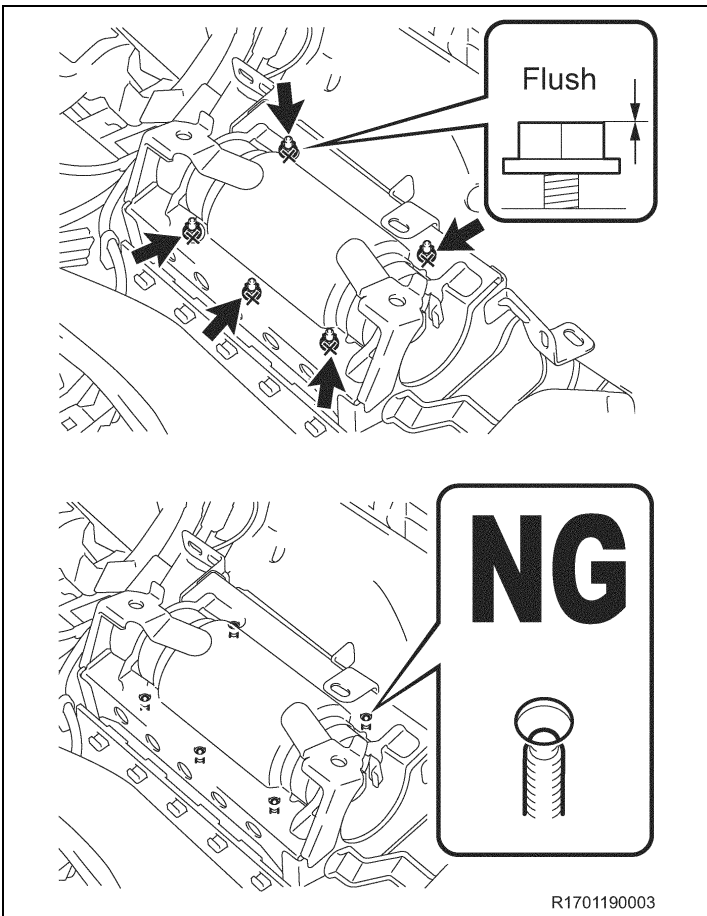
c) Mount the airbag to the mounting bracket as shown.

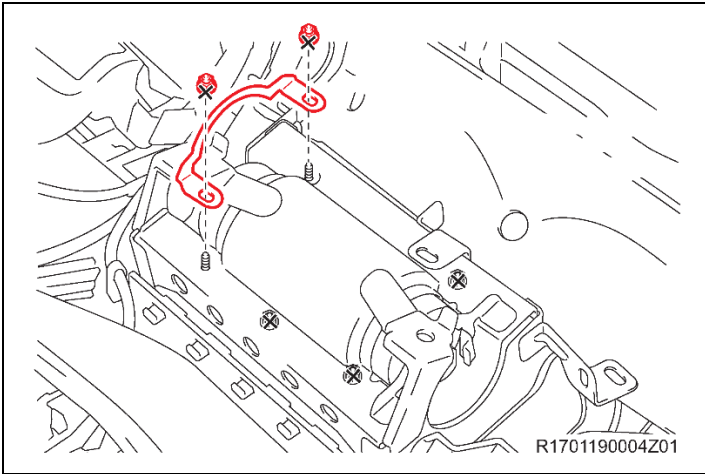
d) Loosen the 5 nuts until each nut is flush with the top of the stud as shown.

**NOTE: You may need to slide the airbag to the left or right to access the middle nut. DO NOT use power tools to remove the nuts.**

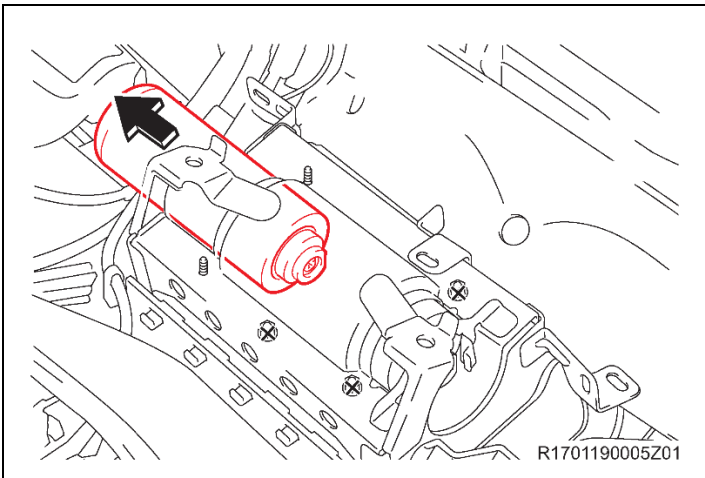
- e) Loosen and discard the 2 nuts on the end where the positioning plate is removeable.
- f) Remove and discard the plate.

**NOTE:**  
**DO NOT use power tools.**

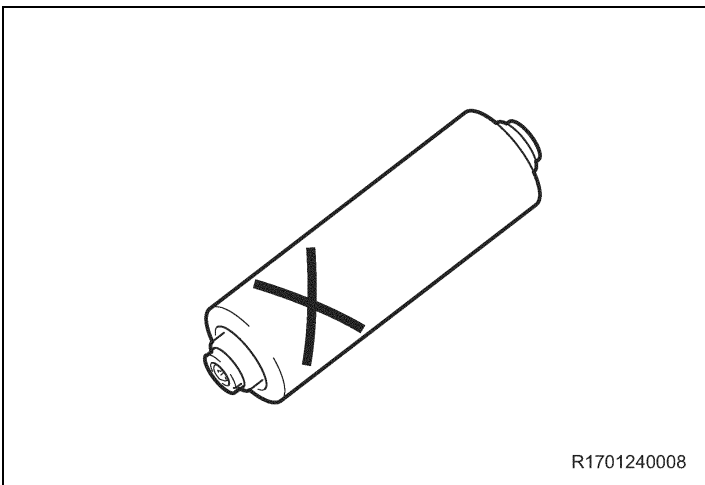
- g) Remove the inflator.

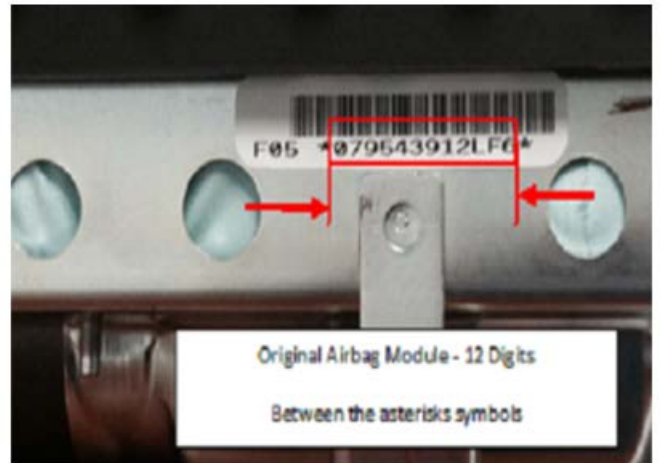
- The airbag serial number is **ALWAYS** the **12 DIGITS** located between the asterisks.
- The 3 digits before the asterisk **ARE NOT** part of the serial number, and **SHOULD NOT** be entered or an inaccurate response may be returned.

Original Airbag Module - 12 Digits  
Between the asterisks symbols

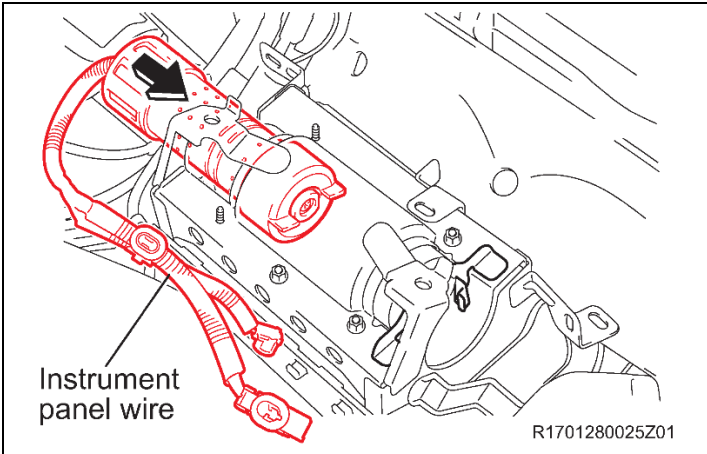
a) Install the new inflator as shown.

b) Ensure that the inflator is oriented in the correct position as shown.

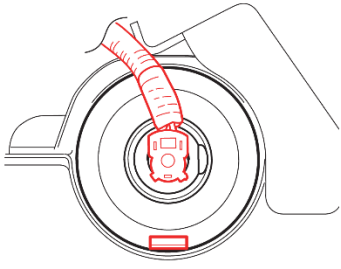
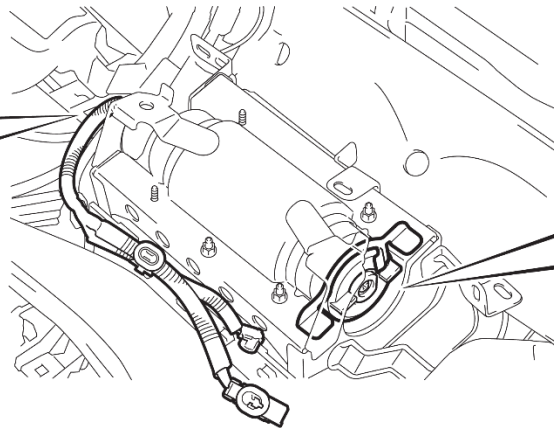
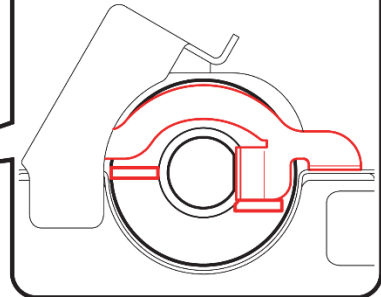
- Make sure the inflator is correctly positioned.
- The inflator cannot be fully inserted if it is upside down.

Check orientation

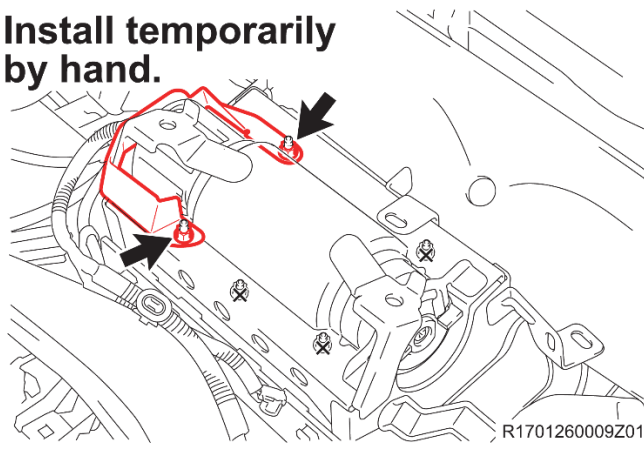
Install temporarily  
by hand.

a) Install the **NEW** positioner plate.

b) Temporarily install 2 **NEW** nuts.

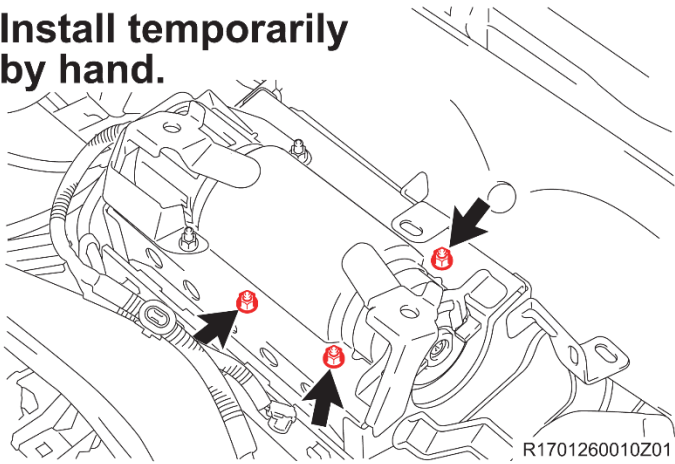
- c) Remove and discard the 3 remaining nuts.
- d) Temporarily install 3 **NEW** nuts.

e) Push the inflator towards the position determining plate and eliminate any gaps.

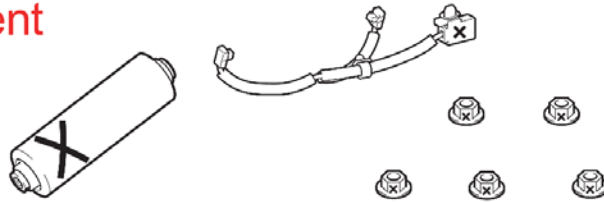
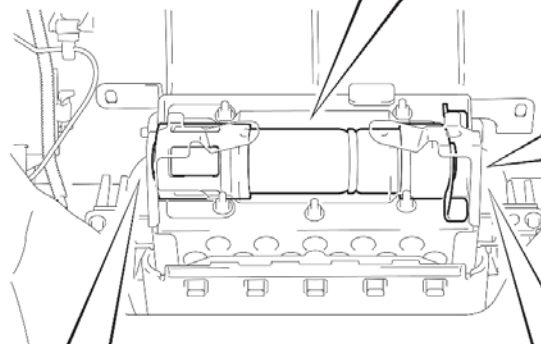
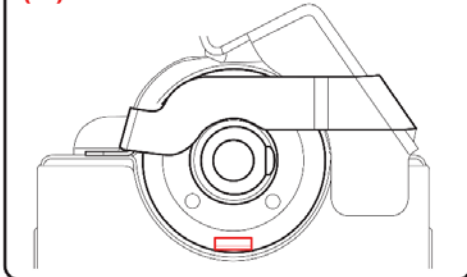
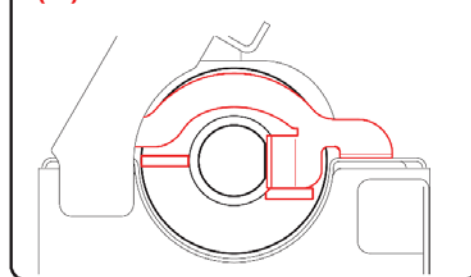
- If any gaps exist, the flats may move apart and could result in abnormal operation during airbag deployment.

(a) Replacement  
of parts.

(b) No gap.

(b) Check orientation.

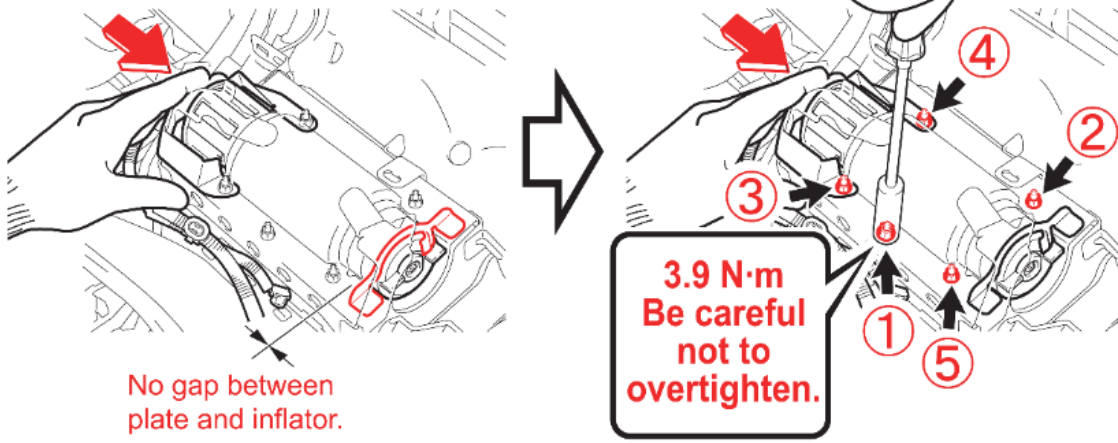
f) Tighten the 5 nuts evenly in several increments in the sequence shown. Use a socket driver or torque wrench to tighten the nuts.

Torque: 35 in. lbf (3.9N·m)

# OK

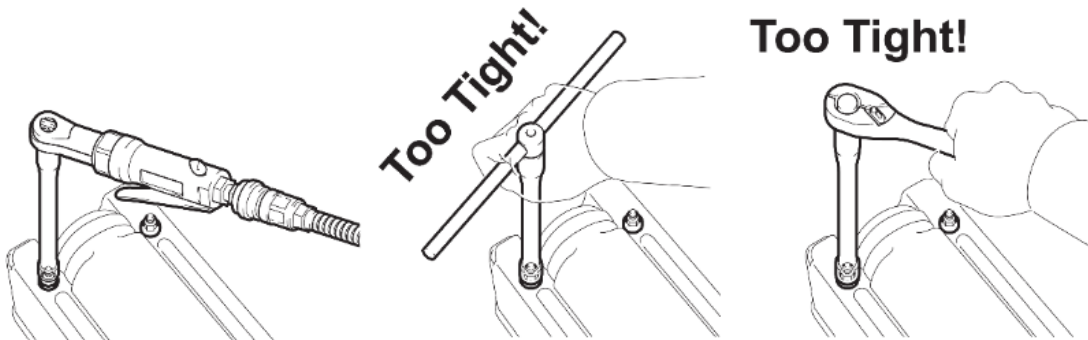
# NG

## These tools cause overtightening !

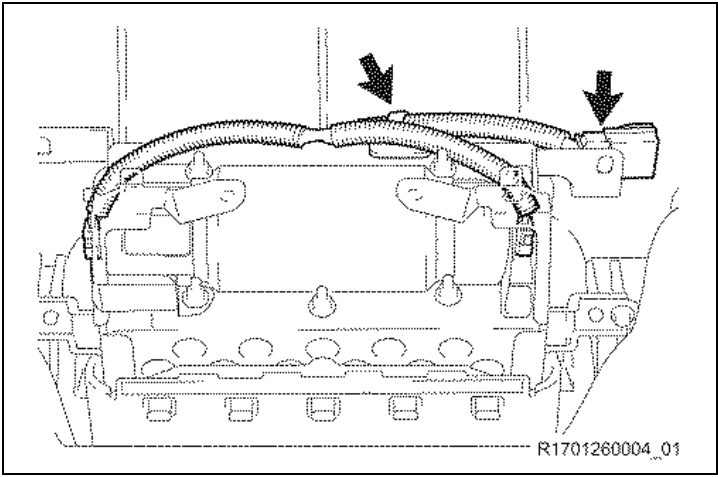
g) Engage the 2 clamps for the new wire harness.

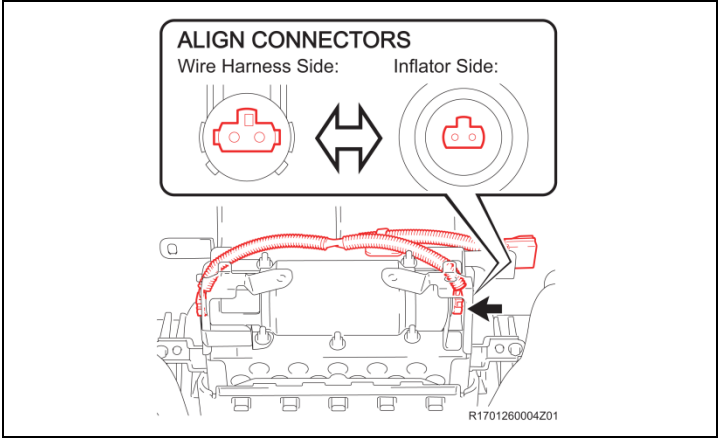
h) Connect the connector and the secondary lock.

**NOTE: Ensure that the connector is securely connected.**

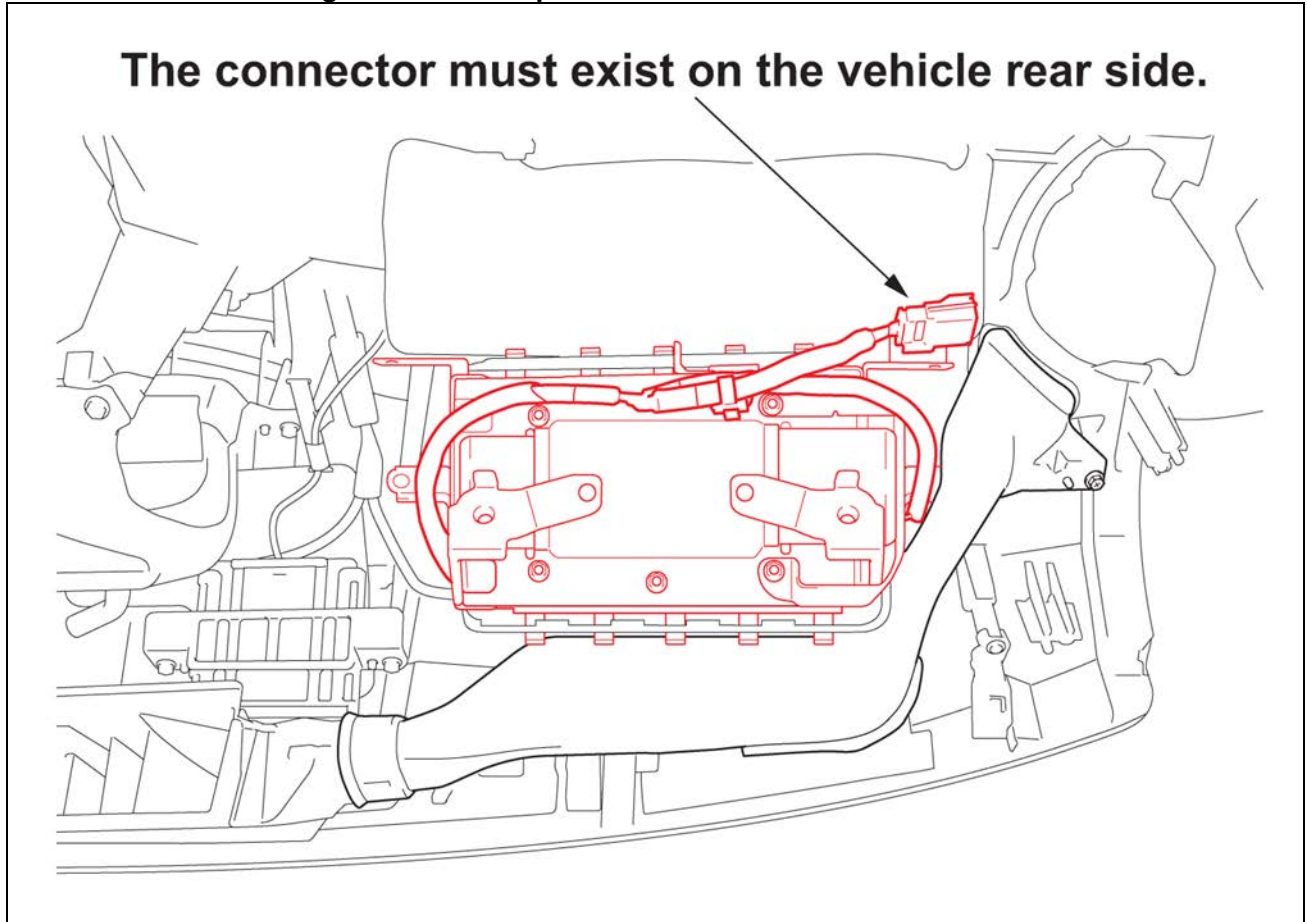
- a) Position the airbag assembly in the instrument panel, engage the straps, and then install the 4 bolts.

- The bolts do NOT need to be replaced. Reinstall the original bolts

**NOTE:** Ensure the airbag connectors is positioned as shown
