# IMPORTANT UPDATE

## TECHNICAL INSTRUCTIONS FOR SAFETY RECALL H0A FRONT PASSENGER AIRBAG INFLATOR MODULE CERTAIN 2008 - 2009 MY SCION xB

**UPDATED 1-9-2018**

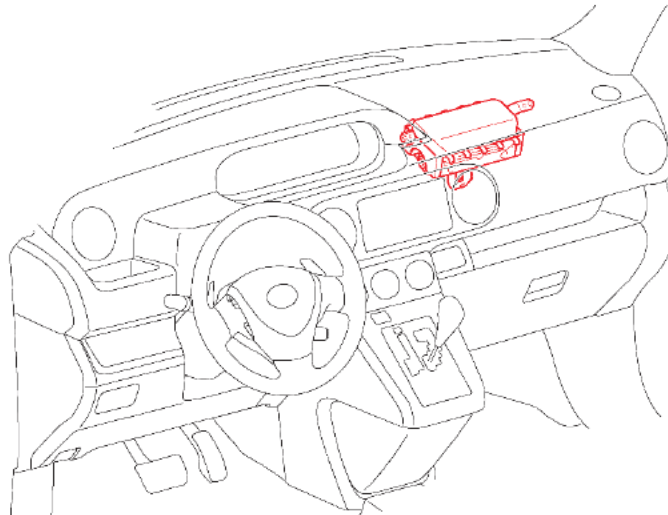
C162294

The subject vehicles are equipped with front passenger airbag inflators produced by Takata. According to Takata, the propellant in these inflators may degrade after prolonged exposure to high absolute humidity and fluctuating high temperatures. Degraded propellant can cause inflator rupture during airbag deployment. In the event of an inflator rupture, metal fragments could pass through the airbag cushion material, striking the vehicle occupants, and result in serious injury or death.

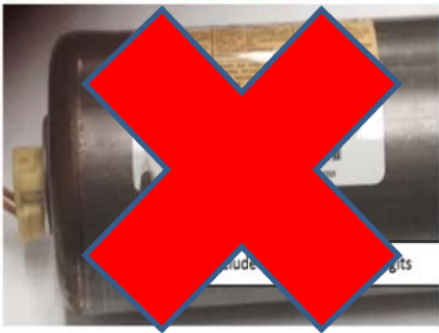
**Original Inflator**

How to Identify the Inflator serial code on the Original and Replacement Inflator can?

The Inflator serial code is an 11 digit code on the Inflator can. It can be found with a bar code on removing the Inflator can from the Airbag Assembly unit.

The first two characters of the Original Inflator Serial code will be from [AA, AB, AJ, FD or JD].

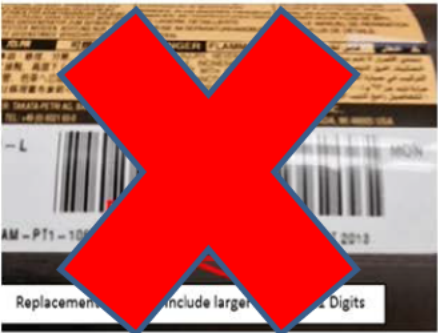
**Replacement Inflator**

The first two characters of the Replacement Inflator Serial code will be either 'LT' or 'LR'.

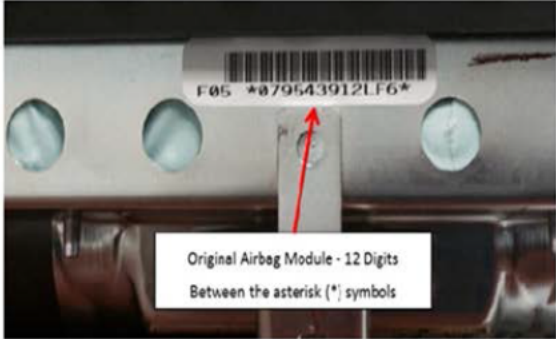
Original Airbag Module - 12 Digits  
Between the asterisk (\*) symbols

The Airbag module Assembly serial number is a 12 digit code. It can be found along with a bar code on opening the Airbag assembly unit. To manually enter these details into the application, the technician has to identify the 12 digit code between two Asterisks (\*) inside the Airbag assembly unit. The first seven characters of this 12 digit code are numbers and the 10<sup>th</sup> digit is either 'K' or 'L' always.
