TECHNICAL INSTRUCTIONS
FOR
SAFETY RECALL J0A/J0B/J0C
FRONT PASSENGER AIRBAG INFLATOR MODULE
CERTAIN 2003 – 2008 MODEL YEAR COROLLA

UPDATE 05/28/2020

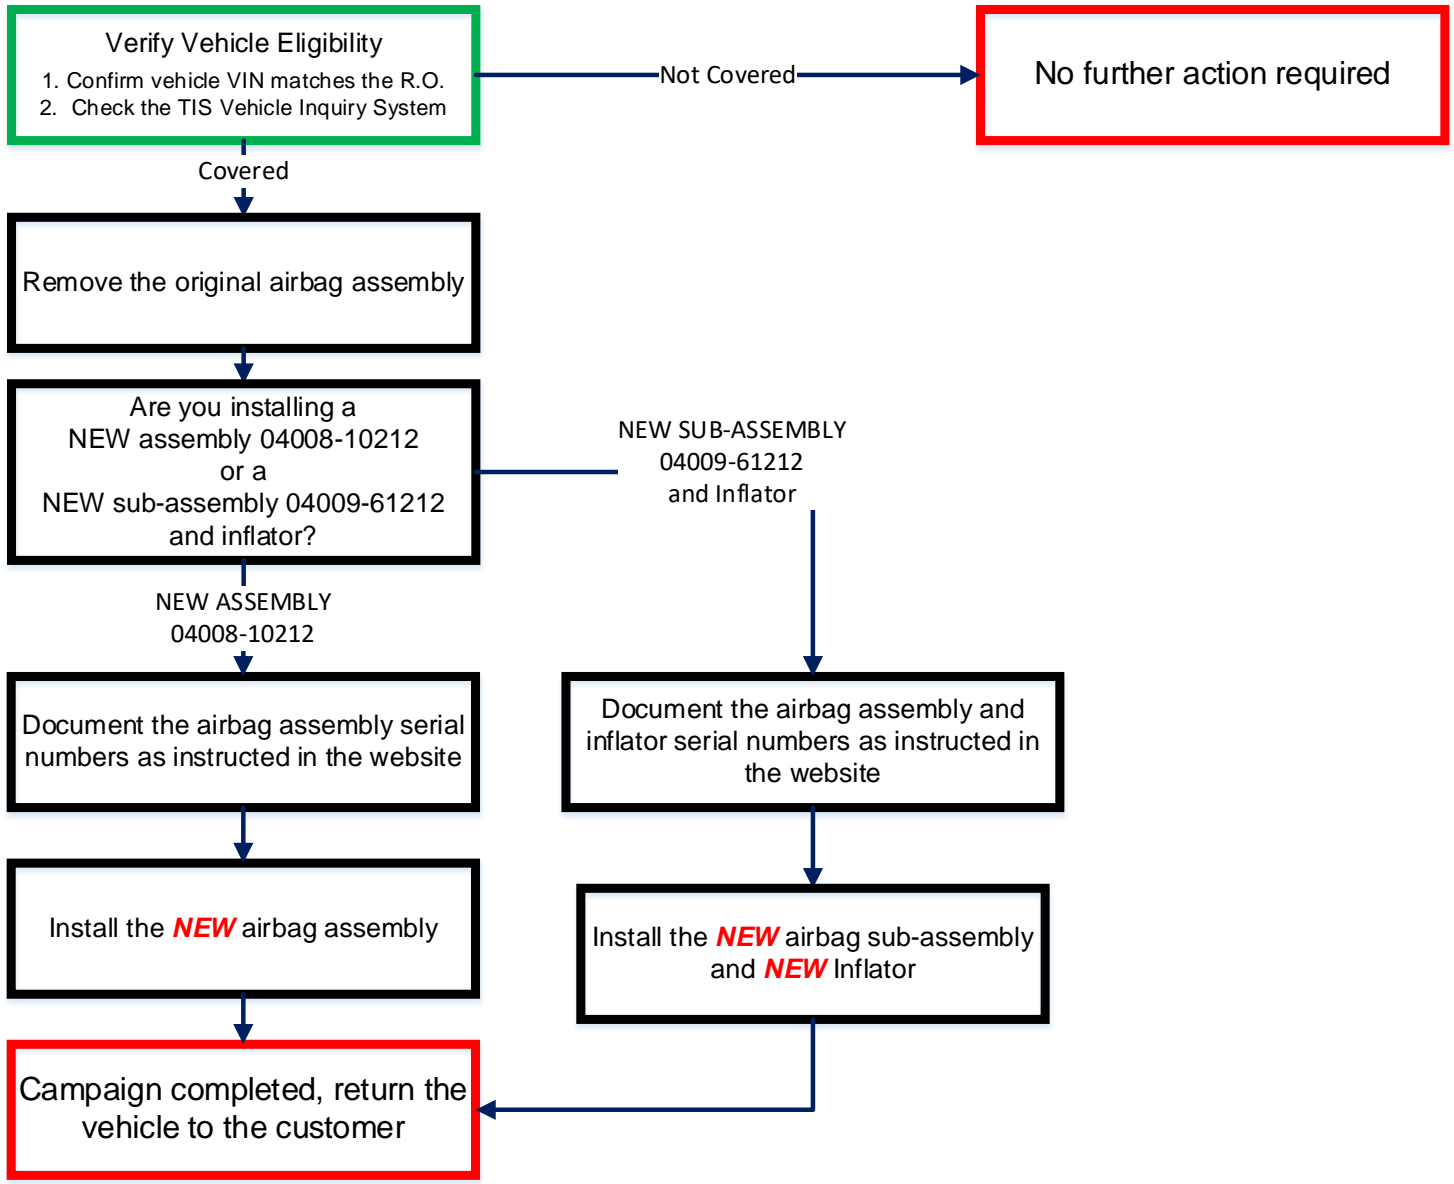
I. OPERATION FLOW CHART

The flow chart is for reference only. **DO NOT** use it in place of the full technical instructions. Follow **ALL** steps as outlined in the full technical instructions to confirm the campaign is completed correctly.

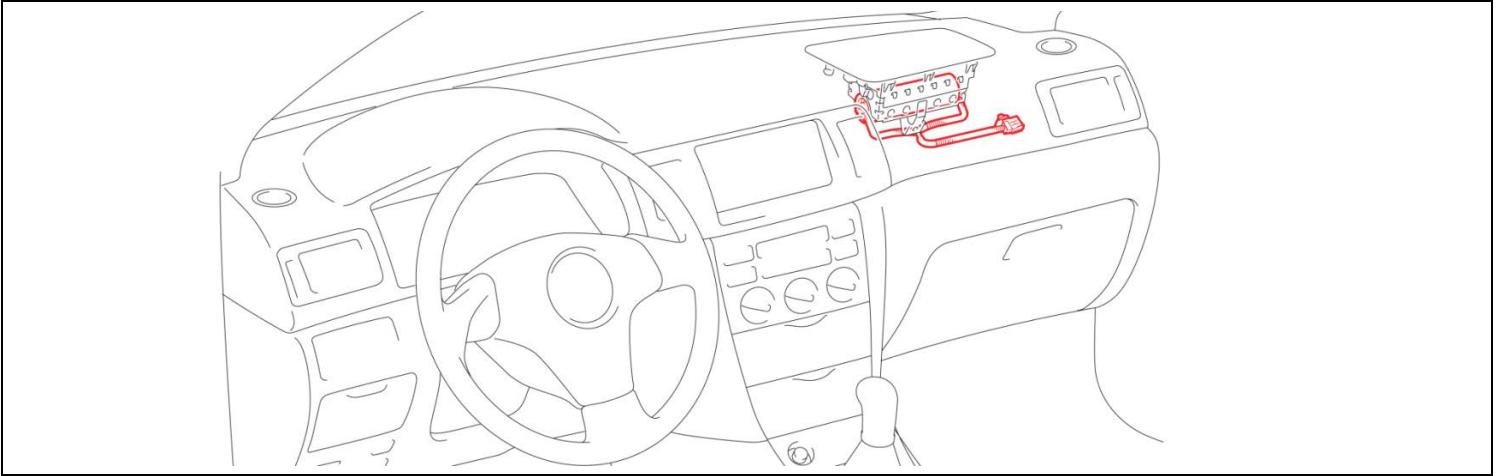
The subject vehicles are equipped with front passenger airbag inflators produced by Takata. The propellant in these inflators may degrade after prolonged exposure to high absolute humidity and fluctuating high temperatures. Degraded propellant can cause the inflator to explode during airbag deployment. In the event of an inflator explosion, metal fragments could pass through the airbag cushion material, striking the vehicle occupants, and result in serious injury or death.

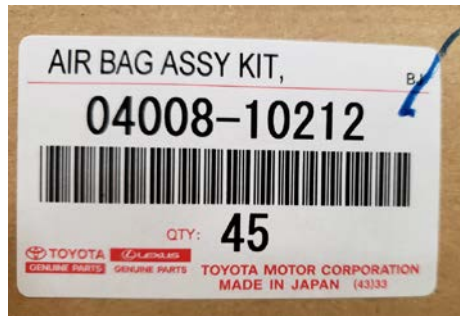
Make sure the parts box has a check mark as seen in the image above

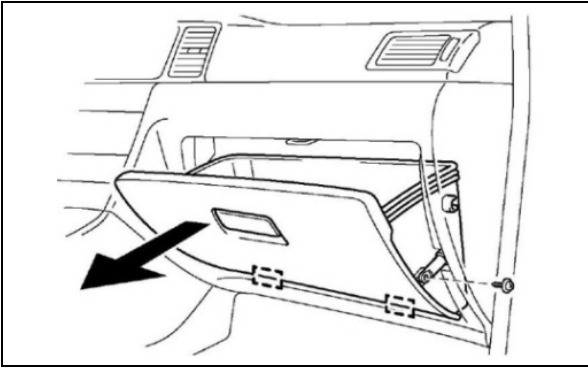
1. REMOVE THE GLOVE BOX

- Remove the screw and disconnect the stopper sub-assembly.
- Completely remove the glove box from the dashboard.

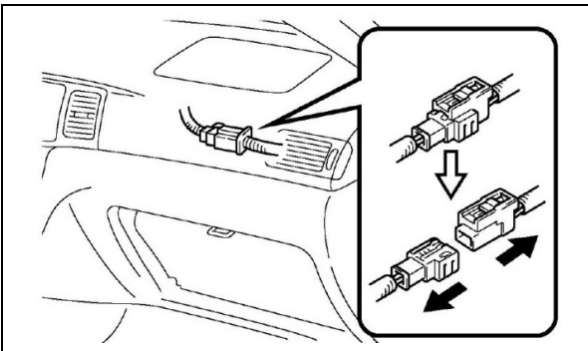
2. REMOVE THE AIRBAG ASSEMBLY

- Disconnect the negative battery cable.

- Wait at least 90 seconds after disconnecting the cable from the negative battery terminal to prevent airbag and seat belt pre-tensioner deployment.
- Follow all precautions as outlined on TIS before servicing the SRS system.

- Disconnect the airbag connector.

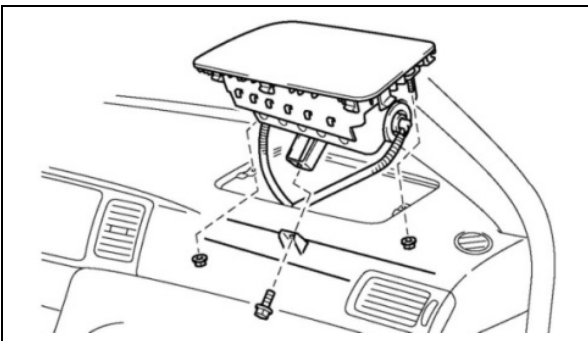
- Remove the bolt and 2 nuts and remove the airbag assembly.
NOTE: Use caution to avoid scratching or damaging the dashboard assembly, place protective tape on the dashboard if needed.

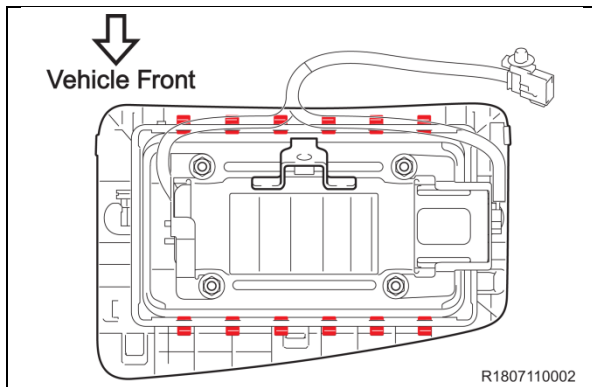
5. INSTALL THE INSTRUMENT PANEL PASSENGER AIRBAG ASSEMBLY COVER

- a) Install a **NEW** instrument panel passenger airbag taking care not to mistake the mounting direction.
- b) Check that the 12 claws of the instrument panel passenger airbag have engaged securely.

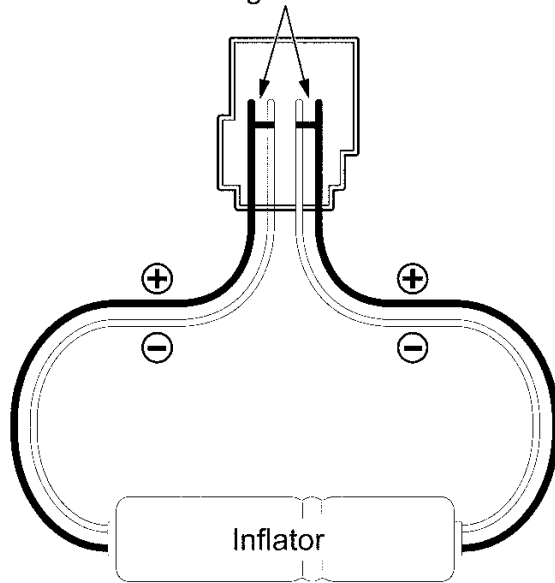
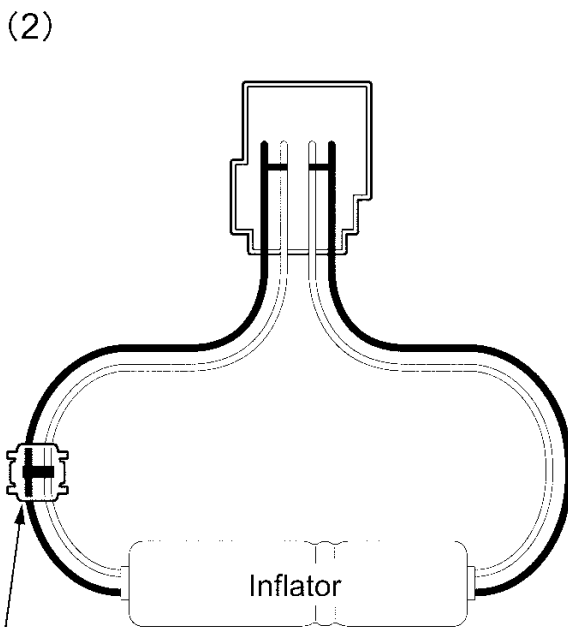
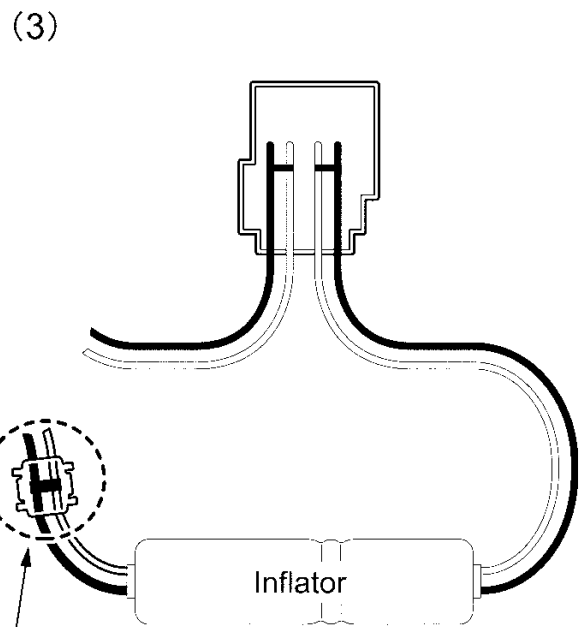
The connector of the inflator module contains a short circuiting mechanism to eliminate voltage variances when the connector(1) is disconnected. To allow for the replacement of the inflator module, a new short circuit(2) **MUST** be created before cutting the wires(3) and removing the inflator. The following steps **MUST** be followed exactly as described to ensure the work is completed correctly and safely.

(1)
Short circuiting on both sides.

Create new short circuit using electro tap.

Short circuiting is maintained even after cutting harness.

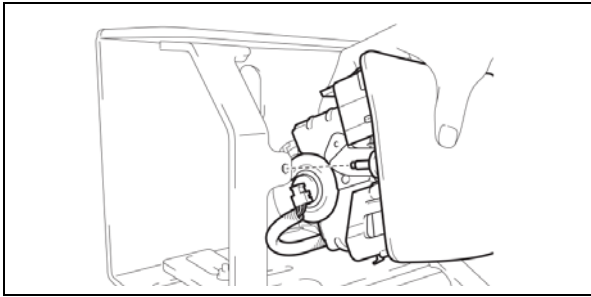
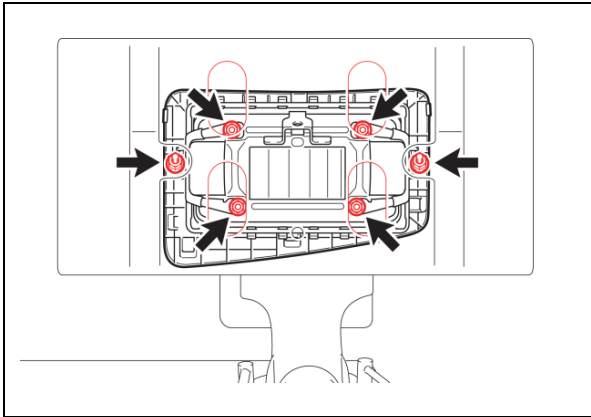
1. MOUNT THE AIRBAG IN THE MOUNTING BRACKET

- a) Position the two mounting studs on the airbag assembly into the holes on the bracket support bars.
- b) Install the airbag to the support bars with the nuts supplied in the bracket kit.
- c) Position the airbag so that all four stopper plate nuts can be removed through the access holes.
- d) Tighten the nuts holding the support bars to the mounting bracket.
- e) Confirm the following:
 - Mounting bracket is secure in the vise.
 - Airbag is secure in the support bars.
 - The center mounting bracket on the airbag assembly is facing upward.
 - Support bars are secure on the mounting bracket using 1 bolt/nut at the top of each support bar and 2 nuts/bolts at the bottom of each support bar.

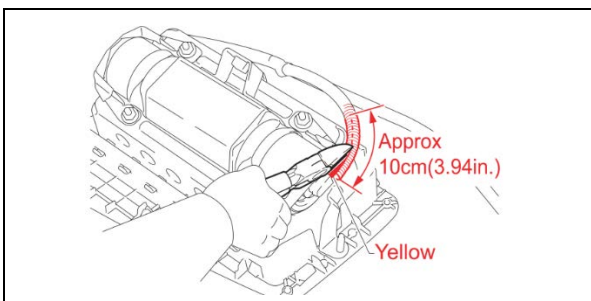
2. PREPARE TO INSTALL THE SHORT CIRCUIT

- a) Cut the yellow corrugated tube on the harness approximately 4 inches (10 cm) using nippers.

- **DO NOT** damage the wires in the tube.
- **DO NOT** use a knife or razor blade to cut the tube to avoid damaging the wires.
- This may be performed on either end of the inflator.

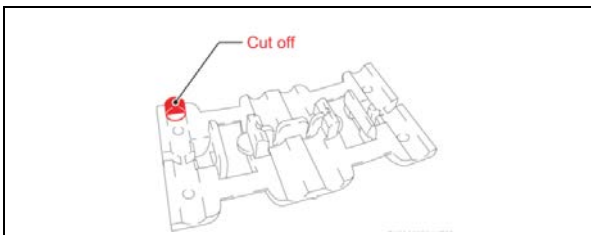
- b) Cut off the tab of the electro tap shown in the illustration.

This tab **MUST** be removed to ensure a good short.

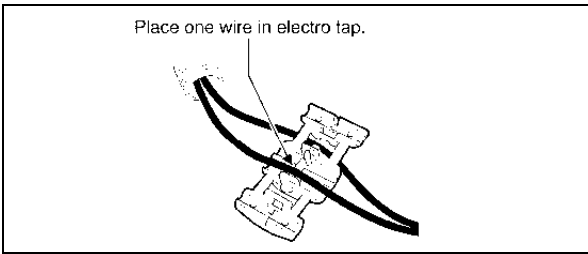
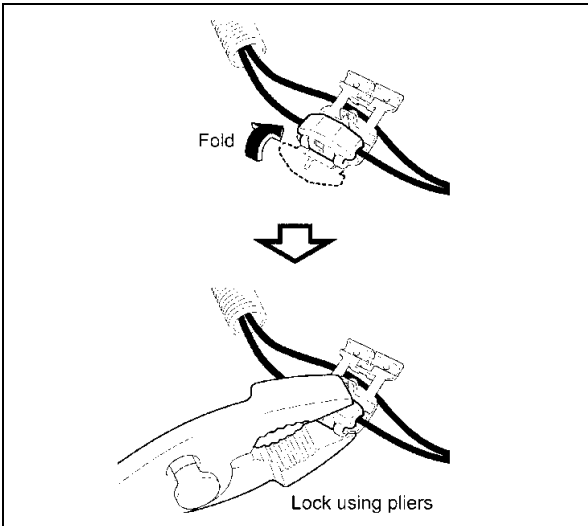
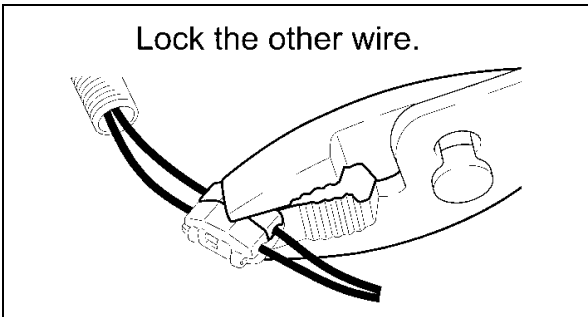
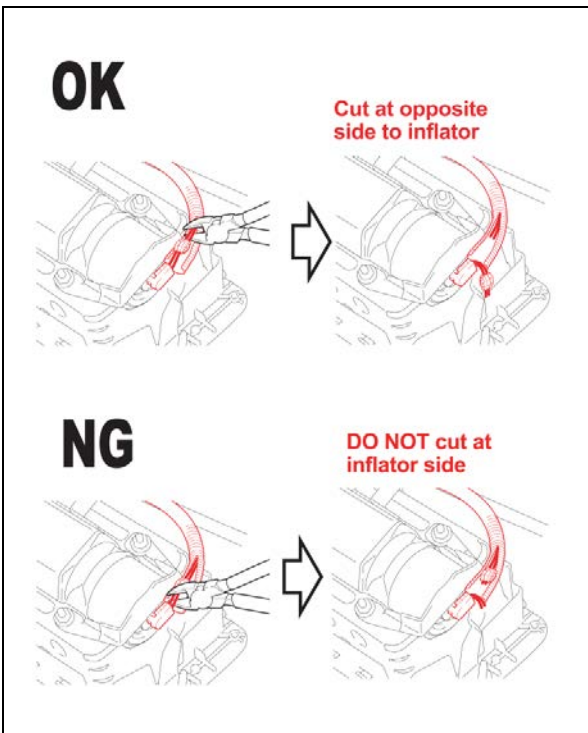
3. CREATE A NEW SHORT CIRCUIT IN THE INFLATOR HARNESS

- a) Place one wire in the electro tap as shown in the illustration.
- b) Fold and pinch the half of the electro tap with the wire and use pliers to lock the electro tap.

- **DO NOT** work on both wires at the same time to avoid errors.
- Pliers **MUST** be used to confirm the electro tap is firmly locked in place.

- c) Set the other wire in the electro tap and lock it in place using pliers.

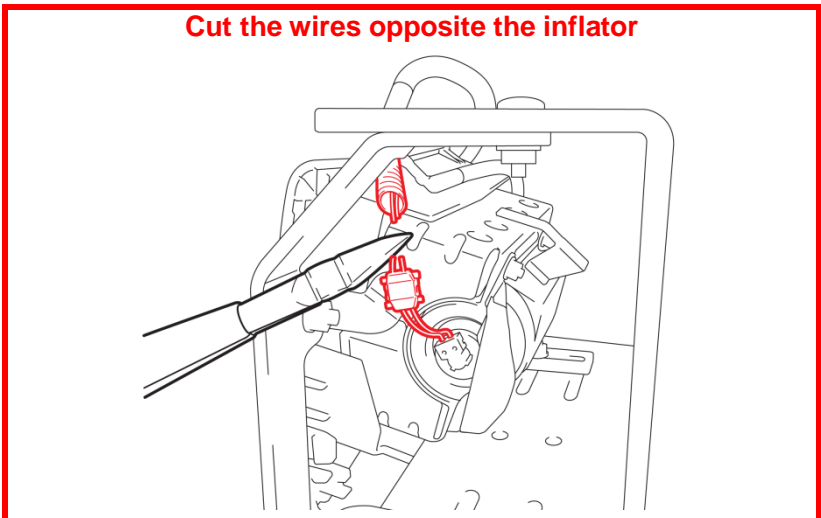
4. CUT THE INFLATOR WIRES

- a) Cut the 2 wires at the side of the electro tap that is farthest away from the inflator.

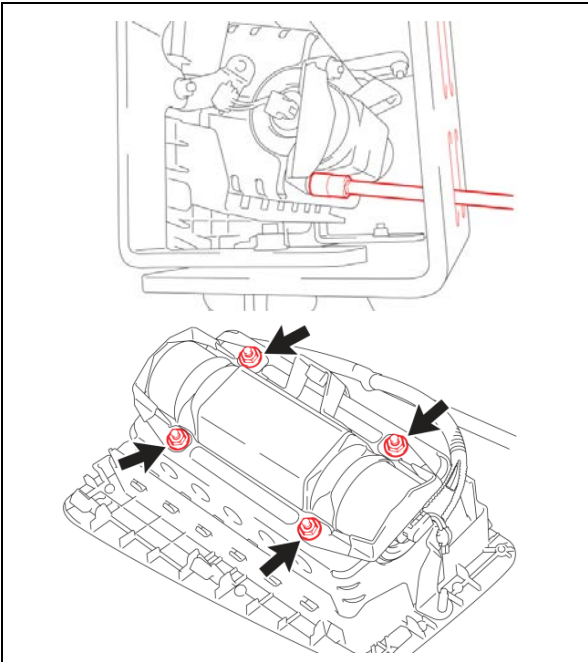
5. REMOVE THE SELF LOCKING NUTS

- a) Use the access holes in the bracket to remove the 4 nuts.

- **DO NOT** use power tools.
- The bracket support bars may need to be repositioned to remove the nuts through the access holes.

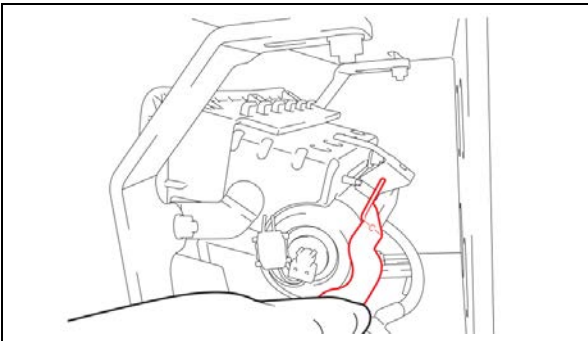
- b) Remove the stopper plates.

- c) Discard the 4 nuts and 2 stopper plates as they are not to be reused.

NOTE: DO NOT reuse the old nuts, new nuts **MUST** be used.

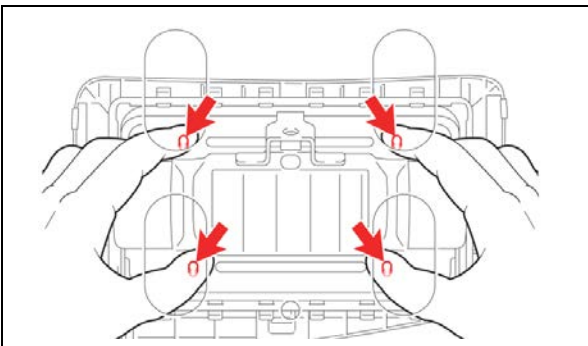
6. REMOVE THE INFLATOR

- a) Gently push in the 4 studs to loosen the inflator for removal.

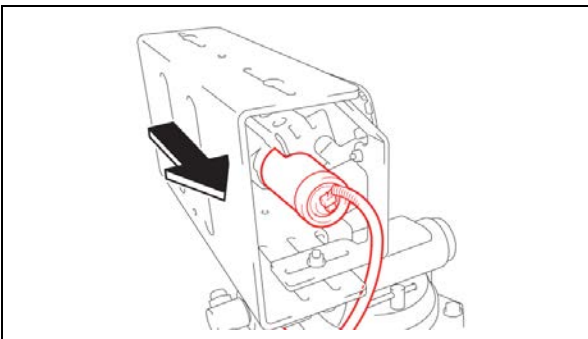
- b) Remove the inflator from the airbag assembly and place it on a safe work surface.

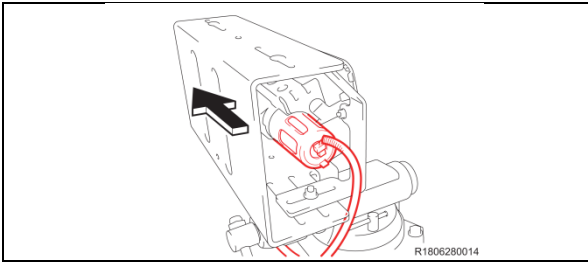
7. INSTALL THE NEW INFLATOR

- a) Carefully slide the new inflator into the airbag assembly.

- **DO NOT** connect the inflator harness at this time. It is **CRITICAL** to install the plates first to confirm the inflator is installed in the correct position before connecting the harness.

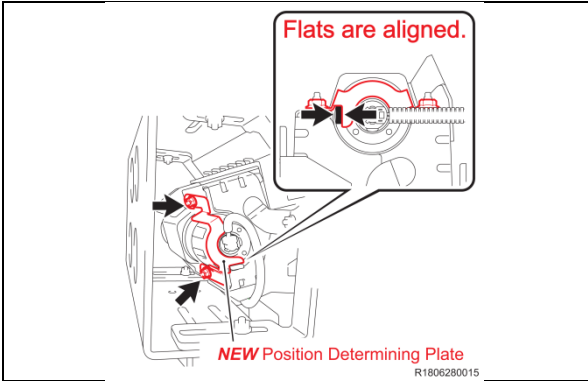
8. INSTALL THE NEW POSITION DETERMINING PLATE

- a) Place the **NEW** position determining plate on the side where the harness is already connected.

- Confirm the flats on the position determining plate and inflator are aligned.
- **DO NOT** pinch the harness between the inflator and the plate.

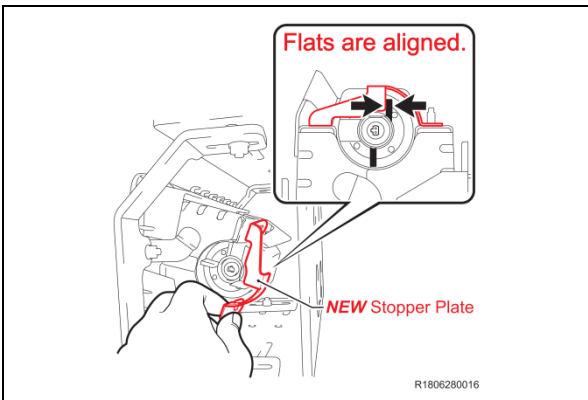
9. INSTALL THE NEW POSITION DETERMINING PLATE

- a) Place the **NEW** position determining plate on the airbag assembly on the unconnected side.

- Confirm the flats on the position determining plate and inflator are aligned.

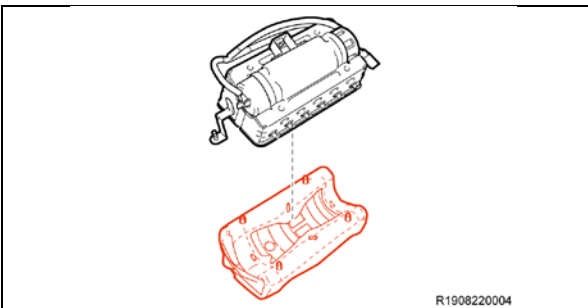
8. REPLACE THE INSTRUMENT PANEL PASSENGER AIRBAG SUB-ASSEMBLY

- a) Remove the instrument panel passenger airbag sub-assembly from airbag case.
 b) Store the removed instrument panel passenger airbag sub-assembly in a replacement part box or other safe location.
 c) Install the **NEW** instrument panel passenger airbag sub-assembly.

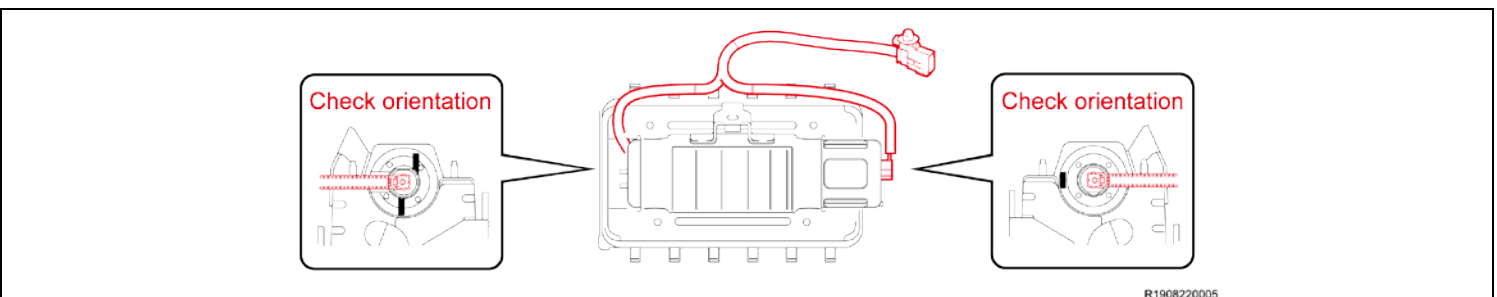
- e) Place the inflator following the top-and-bottom orientation shown in the illustration.

- Make sure that the inflator is oriented correctly as shown in the illustration, not upside down.
- If the passenger airbag inflator is upside down, it will not be able to be fully inserted.

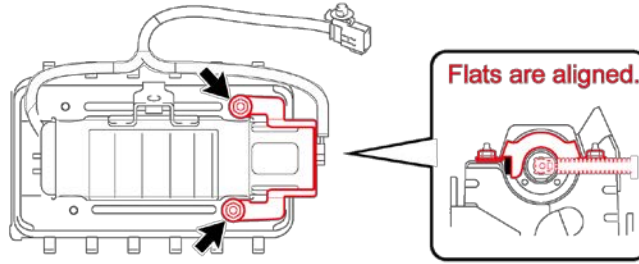
R1908220006

f) Loosely install the plate and airbag inflator with the 2 **NEW** self-locking nuts.

• **DO NOT** mistake the orientation of the plate.

Install loosely
by hand

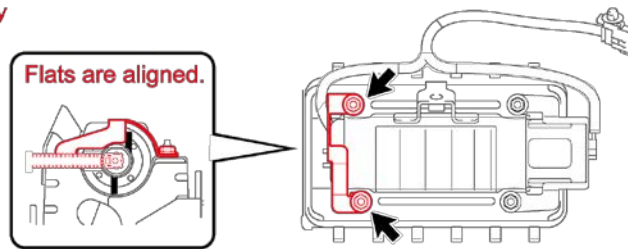
R1908220007

g) Loosely install the plate and airbag inflator with the 2 **NEW** self-locking nuts.

Install loosely
by hand

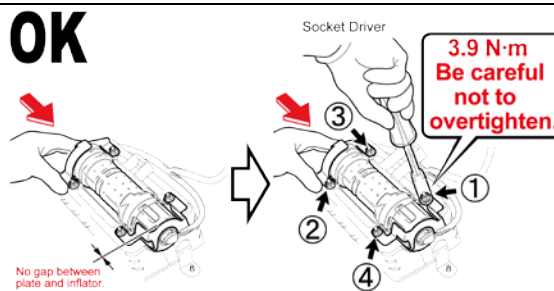
R1908220009

i) Tighten 5 nuts evenly in several increments in the order shown in the illustration using a socket driver while pushing the inflator and plate. (You will encounter some resistance during tightening because these nuts are self-locking nuts.)

Torque: 3.9 N*m (40 kgf*cm, 35 in.*lbf)

The tightening torque is low (3.9 N-m). Use of an air ratchet wrench, a T-handle wrench, or a ratchet handle may cause the stud bolt to stretch or break.

OK **NG** **NG** **NG**

These tools cause overtightening !

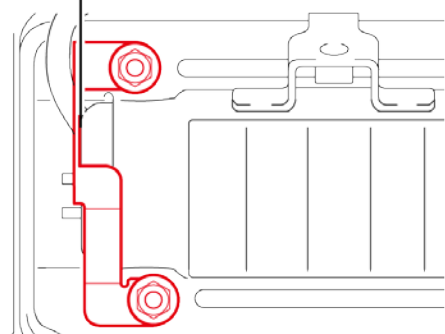
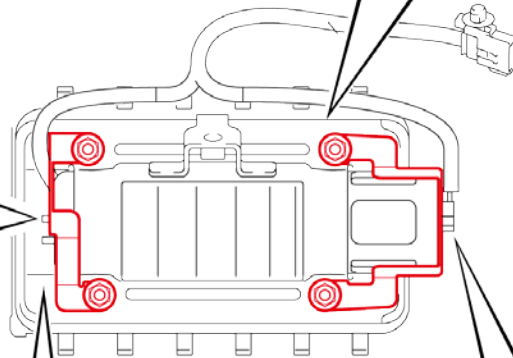
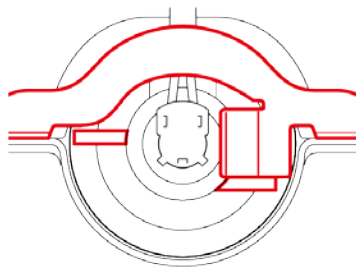
R1908220003

- a) Check that the instrument panel passenger airbag sub-assembly and 4 self-locking nuts are replaced.
- b) Check that positions of the inflator and the position determining plate are correct.
(The flats should be aligned and there should be no gap.)

(a) Replacement
of parts

(b) No gap.

(b) Check orientation

Pass through
the upper side

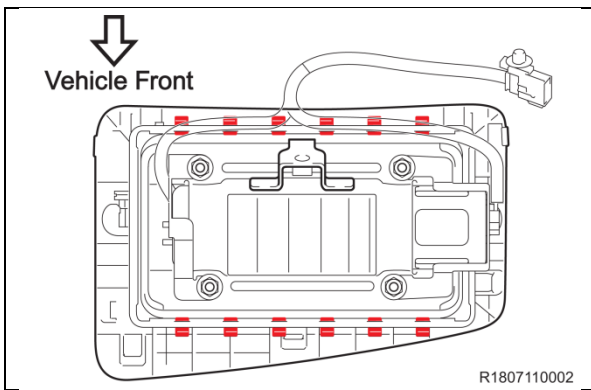
1. INSTALL THE INSTRUMENT PANEL PASSENGER AIRBAG ASSEMBLY W/O DOOR

- Install the instrument panel passenger airbag taking care not to mistake the mounting direction.
- Check that the 12 claws of the instrument panel passenger airbag have engaged securely.
