#### **TECHNICAL INSTRUCTIONS**

# SAFETY RECALL J0A/J0B/J0C FRONT PASSENGER AIRBAG INFLATOR MODULE CERTAIN 2002 –2007 MODEL YEAR SEQUOIA

**Update 10/17/2019**

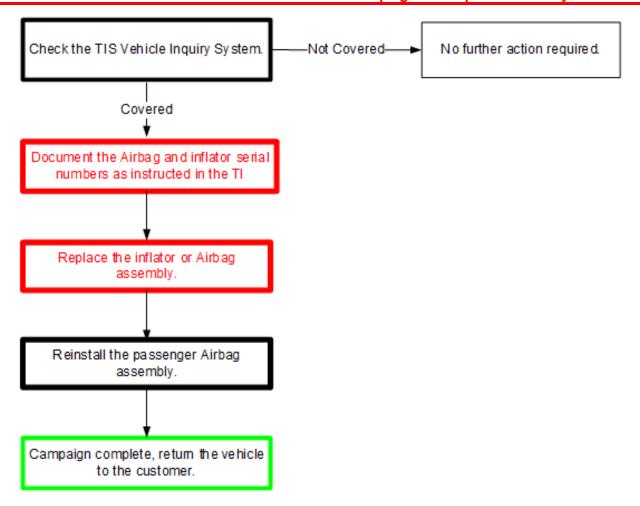
#### I. OPERATION FLOW CHART

The flow chart is for reference only. *DO NOT* use it in place of the full technical instructions. Follow *ALL* steps as outlined in the full technical instructions to confirm the campaign is completed correctly.

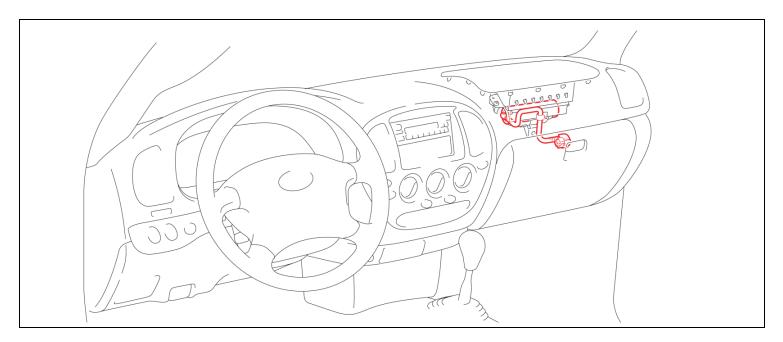
The subject vehicles are equipped with front passenger airbag inflators produced by Takata. The propellant in these inflators may degrade after prolonged exposure to high absolute humidity and fluctuating high temperatures. Degraded propellant can cause the inflator to explode during airbag deployment. In the event of an inflator explosion, metal fragments could pass through the airbag cushion material, striking the vehicle occupants, and result in serious injury or death.

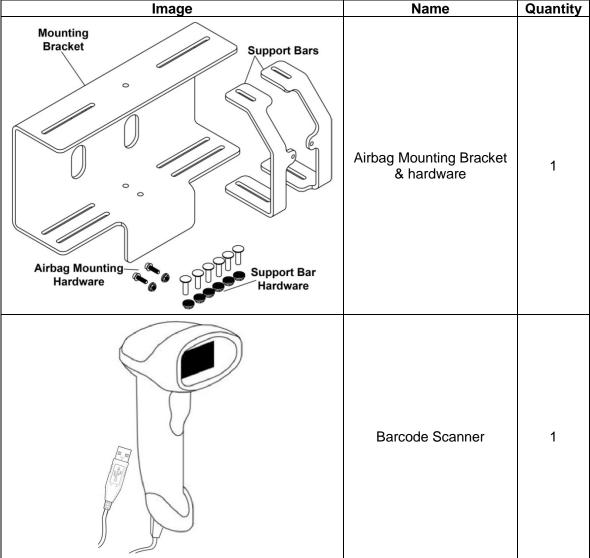
**E04 CAMPAIGN TOOLS** – These tools where previously provided to the dealership for campaign D0F and will

be used for campaign E04. These tools are required when performing this repair.

NOTE: These tools *CANNOT* be ordered through the parts or tools system. There is a very limited supply of tools, but if additional tools are needed, contact your regional representative.

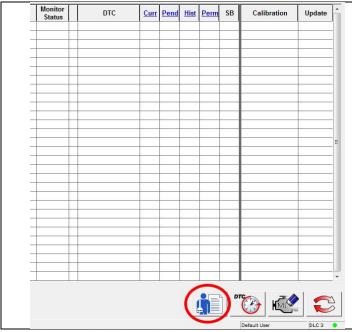
a) After the health check has completed, run a diagnostic report by clicking on the link on the health check screen.

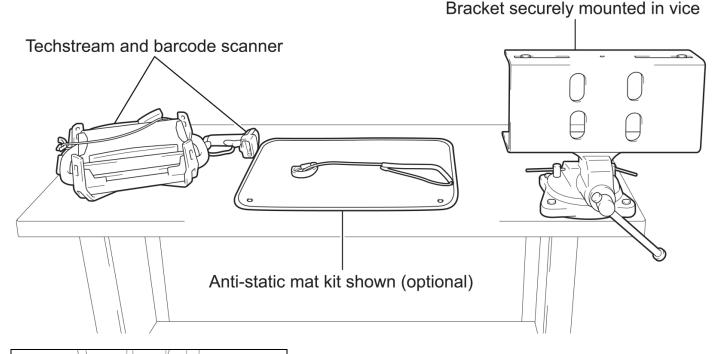
The bracket assembly that was provided at the launch of SSC D0F is a critical added-safety feature that *MUST* be used when replacing the inflator module. Confirm the bracket assembly is installed securely in the vise and confirm the work area being used is appropriate. The anti-static mat set that is an essential SST may be available at your dealership and is optional to use during inflator replacement. If the anti-static kit is not available, before starting work and periodically while working on the vehicle, touch a metallic part of the vehicle to discharge static electricity in the body.

Confirm there are no loose objects or people exposed to the back side of the bracket for safety in the unlikely event of airbag deployment due to improper work procedures (Remember that the inflator *IS NOT* being replaced due to an inadvertent deployment concern).

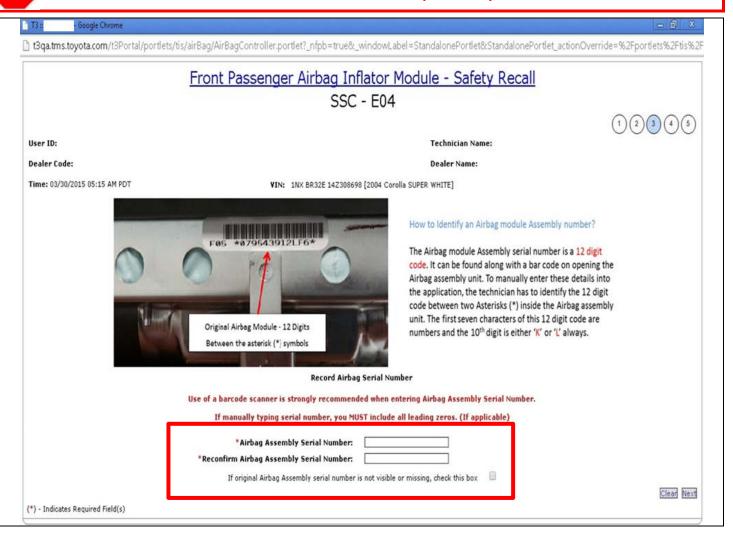
Airbag Serial Number Label Example

- The airbag serial number is *ALWAYS* the 12 *DIGITS* located between the asterisks.
- The 3 digits before the asterisk ARE NOT part of the serial number, and SHOULD NOT be entered or an inaccurate response may be returned.

The AIRBAG ASSEMBLY serial number and the INFLATOR serial number are DIFFERENT. The AIRBAG ASSEMBLY serial number MUST be recorded prior to replacement.

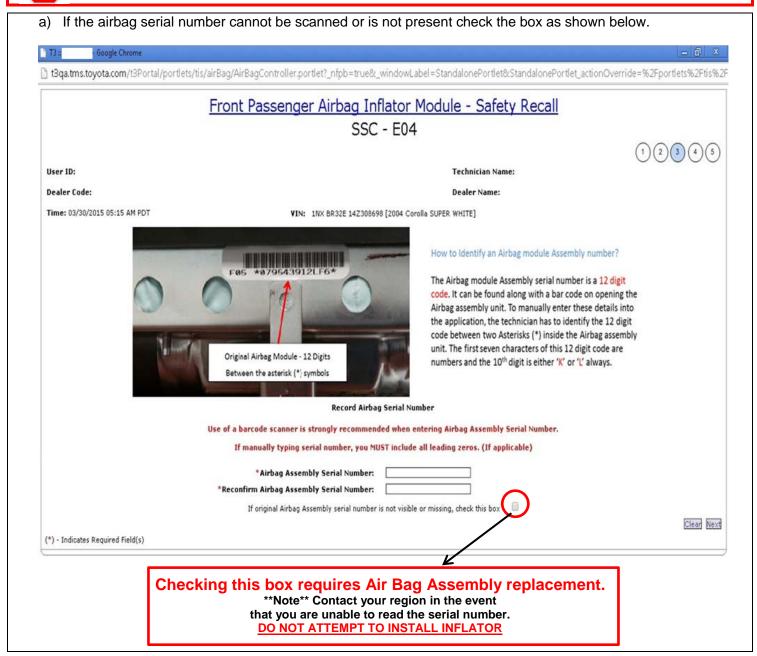
# AIRBAG ASSEMBLY SERIAL NUMBER <u>FOR 2005 MY SEQUOIA</u> (OR IS MISSING OR IS UNREADABLE)

If the airbag serial number and barcode are not legible or are not present, check the box in the application indicating the serial number is not legible and contact your regional representative.

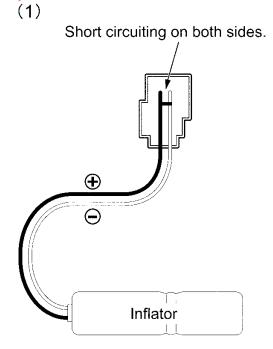
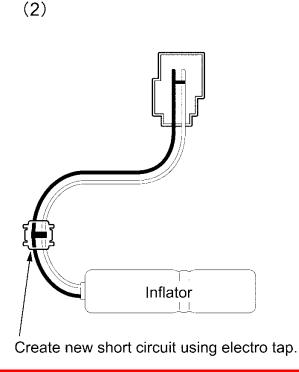
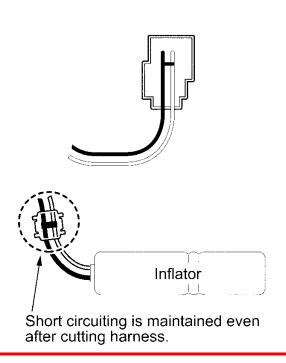
The connector of the inflator module contains a short circuiting mechanism to eliminate voltage variances when the connector(1) is disconnected. To allow for the replacement of the inflator module, a new short circuit(2) *MUST* be created before cutting the wires(3) and removing the inflator. The following steps *MUST* be followed exactly as described to ensure the work is completed correctly and safely.

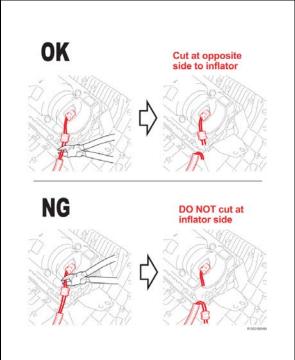
c) Set the other wire in the electro tap and lock it in place using pliers.

**DO NOT** measure resistance of the inflator wires, this may cause accidental activation.

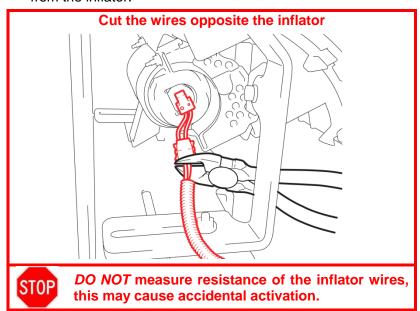
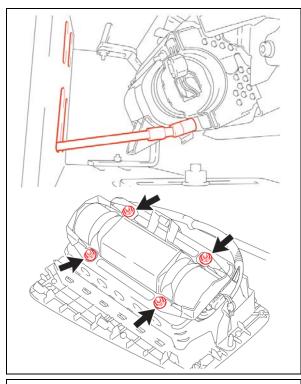
a) Cut the 2 wires at the side of the electro tap that is farthest away from the inflator.

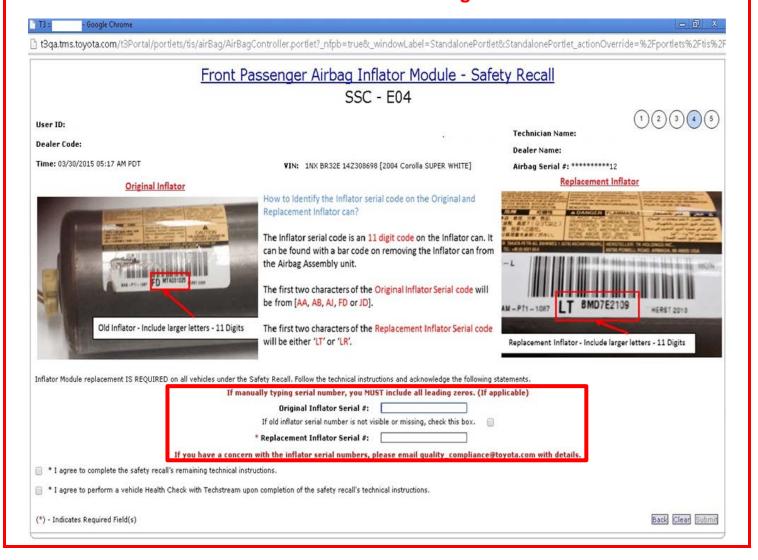
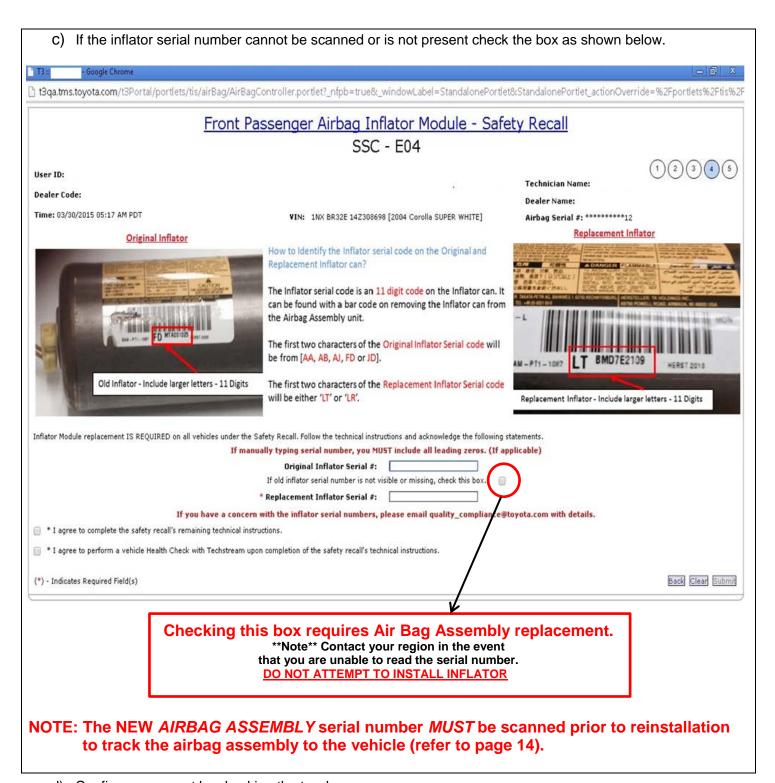
- 7. SCAN THE OLD AND NEW INFLATOR SERIAL NUMBER
  - a) Scan the OLD inflator serial number and mark the old inflator so that it will not be reused.
  - b) Scan the **NEW** inflator serial number.

Depending on the serial data scanned during a previous Takata repair, you may NOT be asked to enter an Original Inflator Serial Number

- d) Confirm agreement by checking the two boxes.
- e) Record the Warranty Authorization # to be included in the warranty claim.
- f) Place the old inflator in the parts box and take it immediately to the parts department.

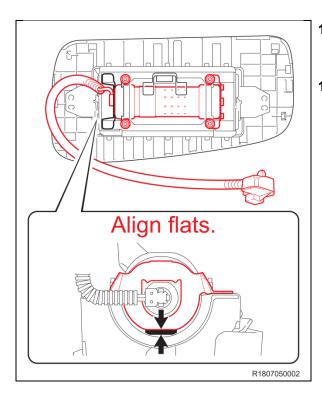
a) Tighten the nuts evenly in two increments following the sequence shown in the illustration. Use a socket driver or torque wrench to tighten the nuts.

Torque: 35in. lbf (3.9N·m)

- There will be some resistance when tightening the nuts because they are self-locking, confirm the nuts are tightened correctly.
- DO NOT use a power tool, T-handle, or ratchet when tightening the nuts to avoid over torqueing.
