TECHNICAL INSTRUCTIONS
FOR
SAFETY RECALL J0A/J0B/J0C
FRONT PASSENGER AIRBAG INFLATOR MODULE
CERTAIN 2003 – 2005 MODEL YEAR COROLLA

UPDATE 6/13/2019

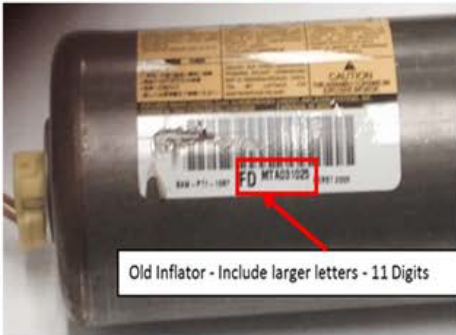
Original Inflator

Old Inflator - Include larger letters - 11 Digits

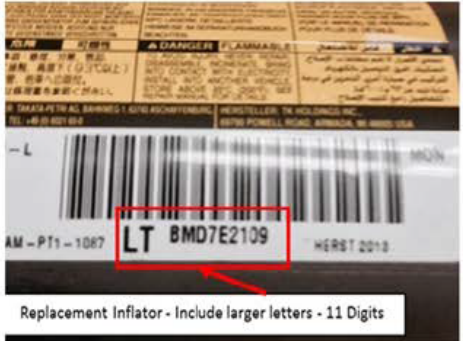
Replacement Inflator - Include larger letters - 11 Digits
