# IMPORTANT UPDATE

## TECHNICAL INSTRUCTIONS FOR SAFETY RECALL G0P/G0R/H0A FRONT PASSENGER AIRBAG INFLATOR MODULE CERTAIN 2009 –2013 MODEL YEAR MATRIX

**Updated 01-14-2021**

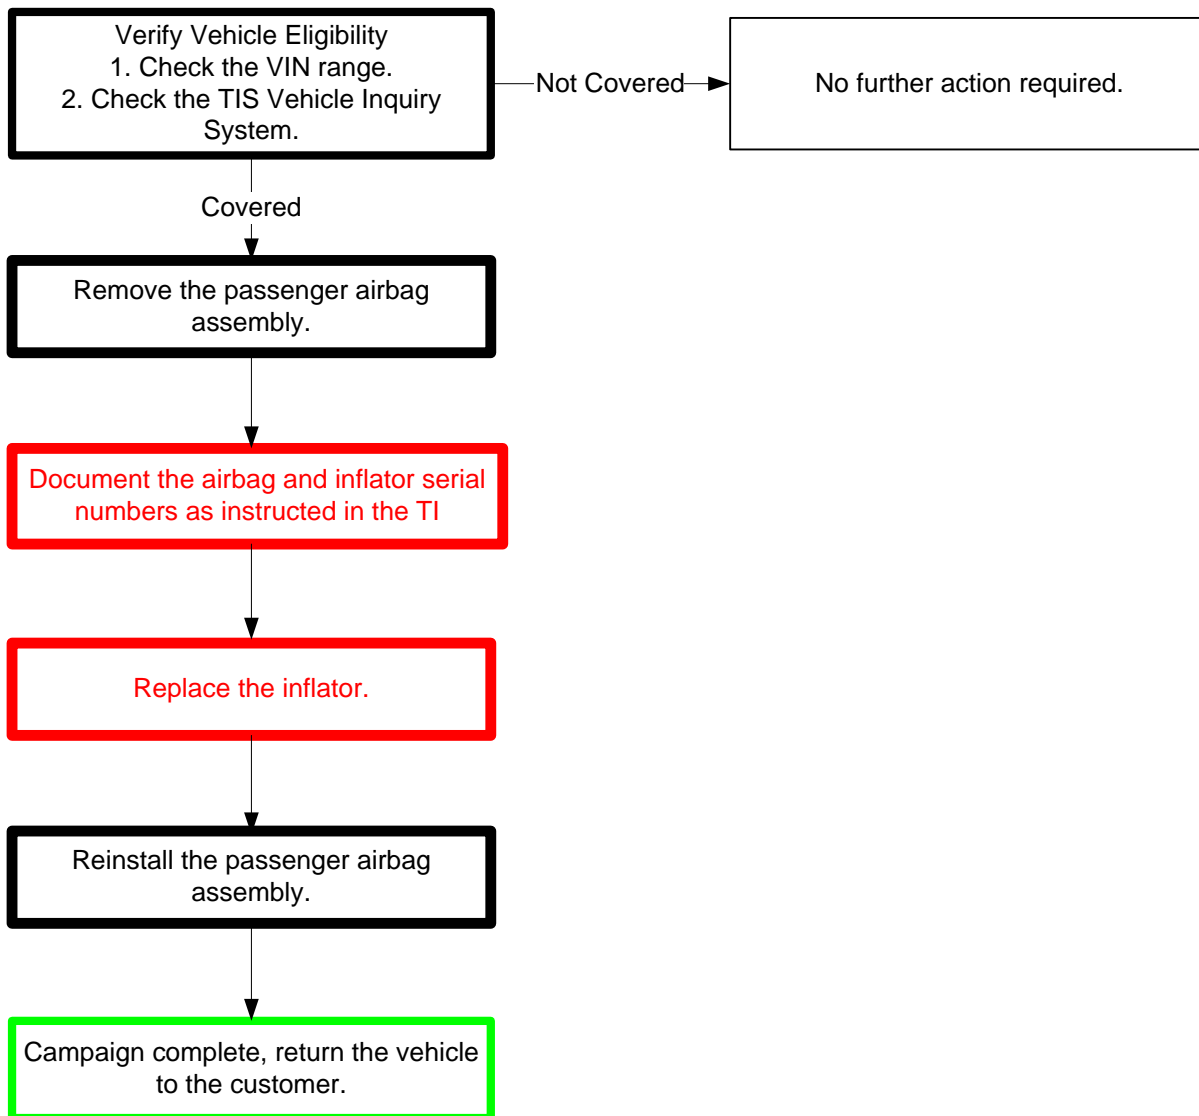
## I. OPERATION FLOW CHART

The flow chart is for reference only. **DO NOT** use it in place of the full technical instructions. Follow **ALL** steps as outlined in the full technical instructions to confirm the campaign is completed correctly.

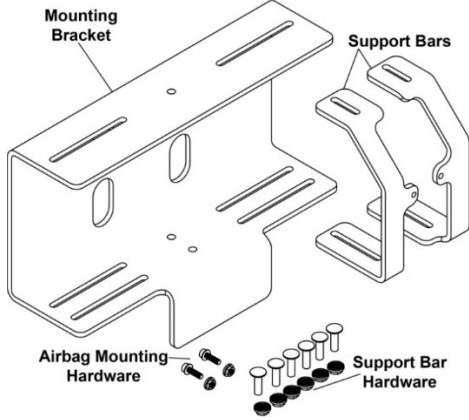
Airbag Mounting Bracket & hardware	1

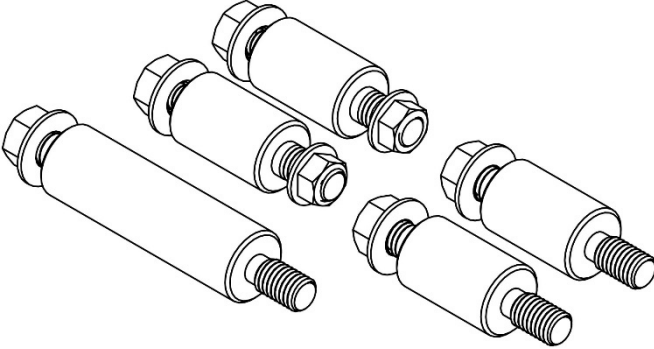
Adaptor set*	1

\*The adaptor set was sent to dealers at the start of this campaign.

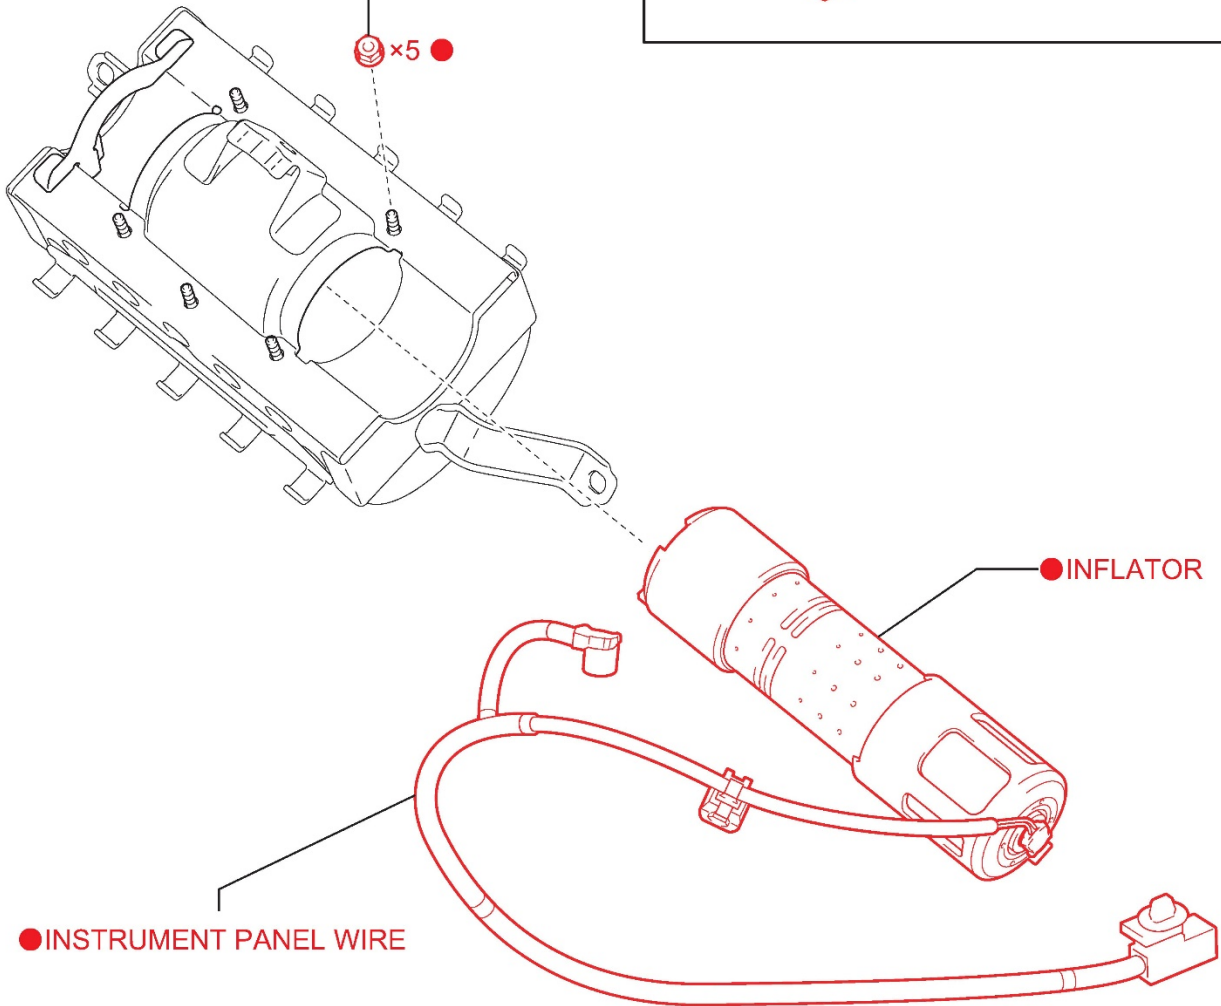
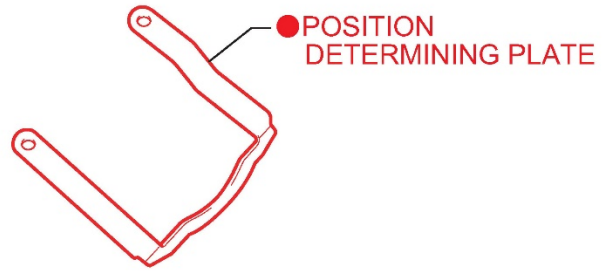
R1702270035

**3.9 N·m (40, 35 in.\*lbf)**  
**Be careful not to**  
**overtighten.**

for MATRIX:

● : Replacement part

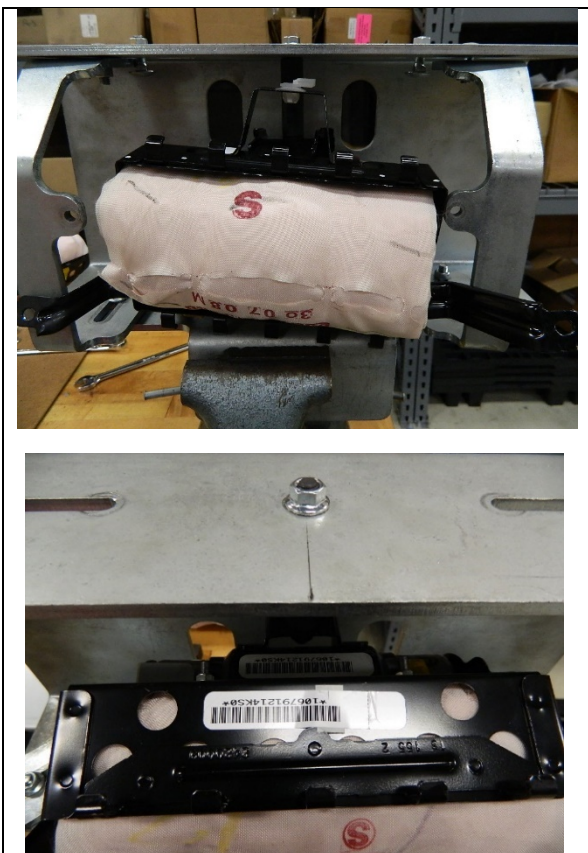
e) Use the long adaptor shown.

f) Thread the adaptor into the airbag as shown.  
**Note: Use the same mounting nut on the airbag that attaches the airbag to the vehicles cross tube.**

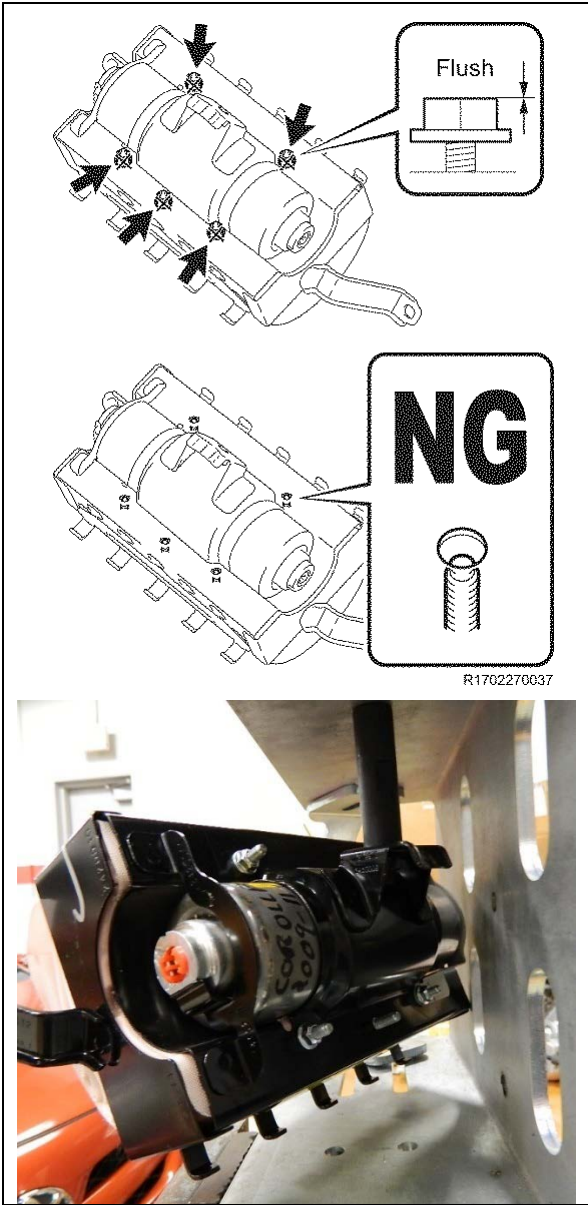
g) Mount the airbag into the mounting bracket as shown. Pass the stud on the adaptor through the hole in the middle of the bracket with the nut.

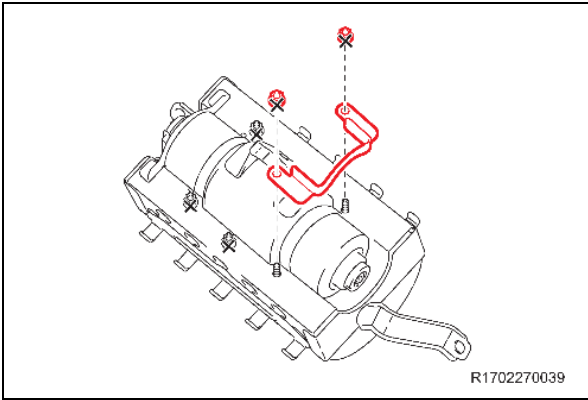
- a) Loosen the 5 nuts until the nuts are at the top of the studs as shown, through the openings in the mounting bracket.

**Note:** The airbag may need to be turned to the left or right to access the center nut.

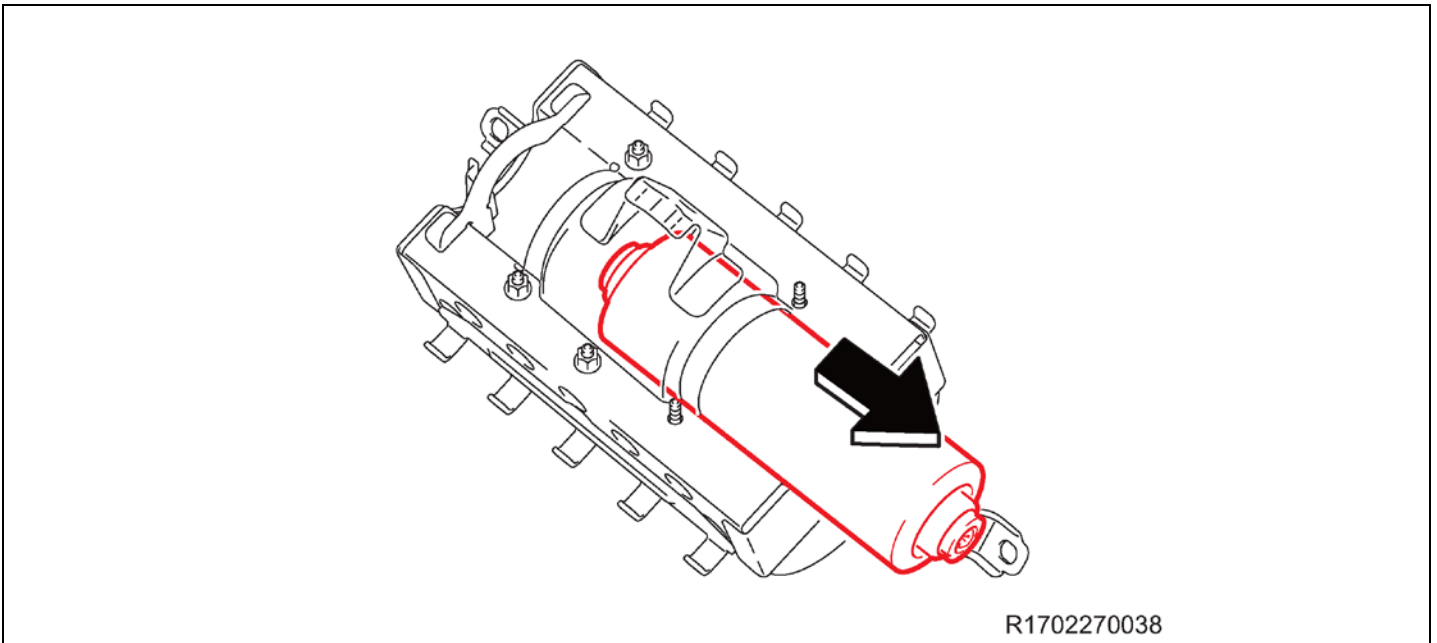
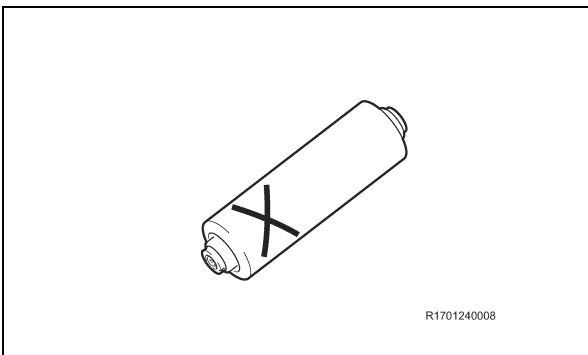
- a) Gently push in the studs until the nuts make contact with the housing to loosen the inflator for removal.

- b) Remove the inflator from the airbag assembly and place it on a safe work surface.
- c) Mark the old inflator so it is not reused.

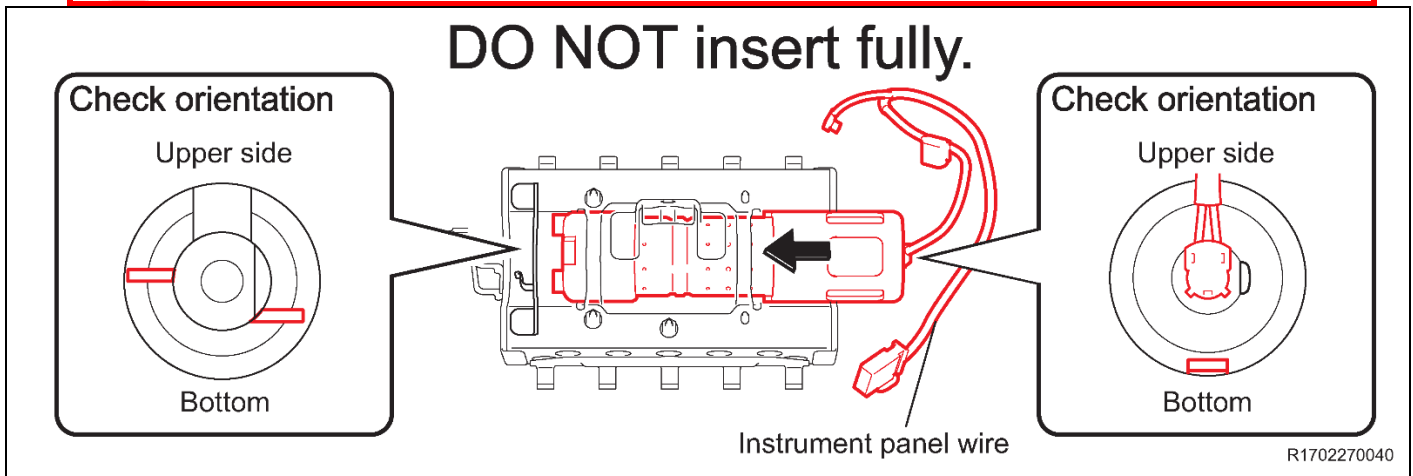
a) Carefully slide the new inflator into the airbag assembly and align as shown.

- **DO NOT** connect the inflator harness at this time. It is **CRITICAL** to first confirm that the inflator is installed in the correct position before connecting the harness.

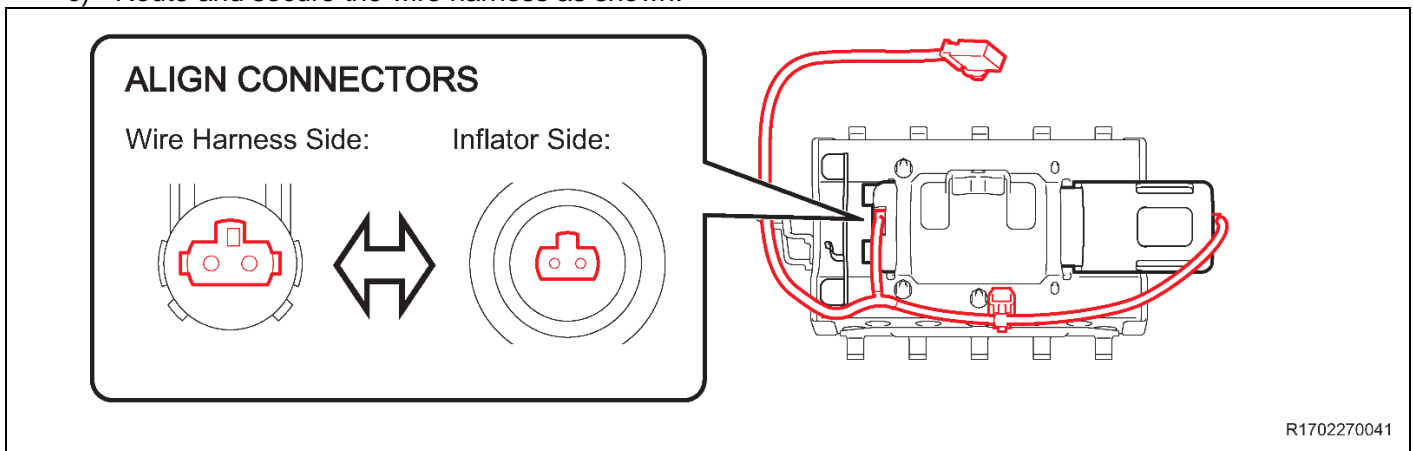
- b) Connect the connector to the inflator and ensure that the connector lock is fully engaged as shown.  
c) Route and secure the wire harness as shown.

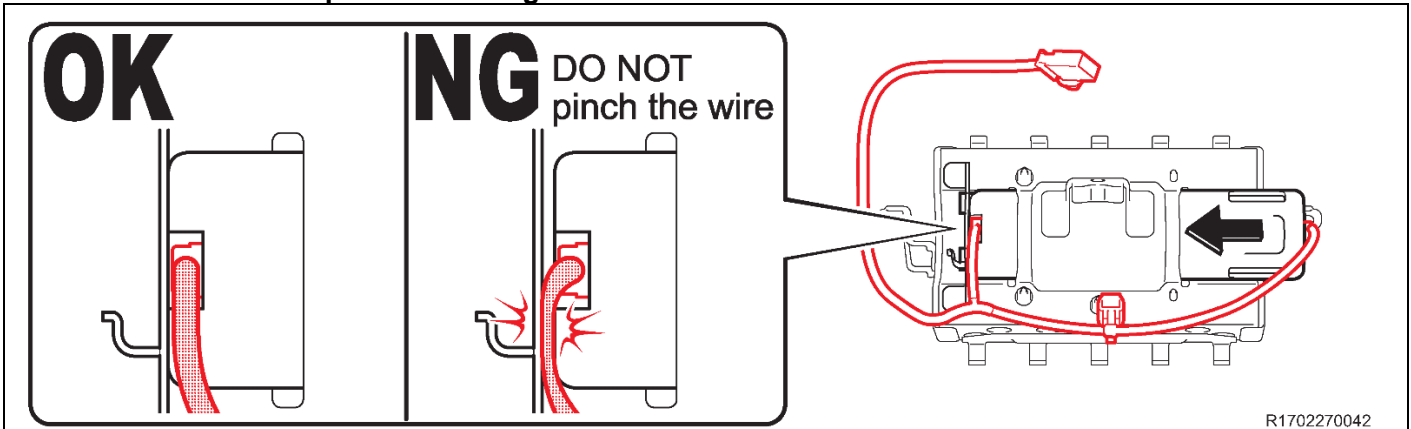
R1702270042

- d) Fully insert the inflator and ensure that the inflator is correctly oriented as shown.  
**NOTE: DO NOT pinch the wiring between the bracket and the inflator.**

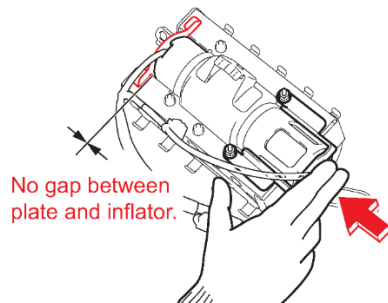
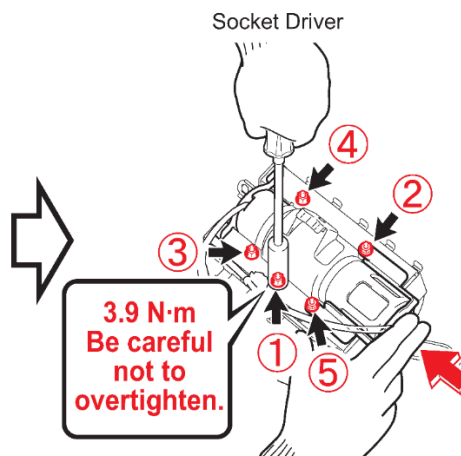
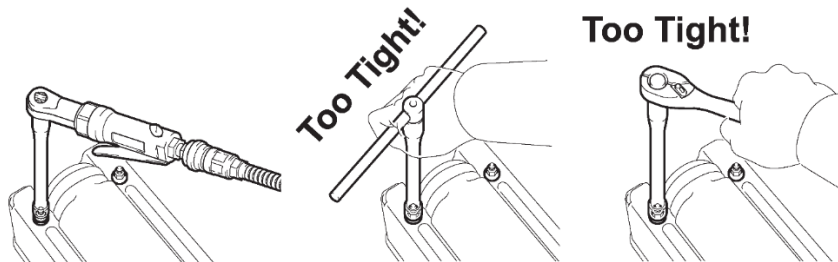
R1702270046

- a) Tighten the 5 nuts evenly in several increments in the sequence shown. Use a socket driver or torque wrench to tighten the nuts.

**Torque: 35in. lbf (3.9N·m)**

- There will be some resistance when tightening the nuts because they are self-locking, confirm the nuts are tightened correctly.
- **DO NOT** use a power tool, T-handle, or ratchet when tightening the nuts to avoid overtorqueing and deforming the studs.
- You may need to turn the airbag to the left or right with in the mounting bracket to access the center nut.

**These tools cause overtightening !**

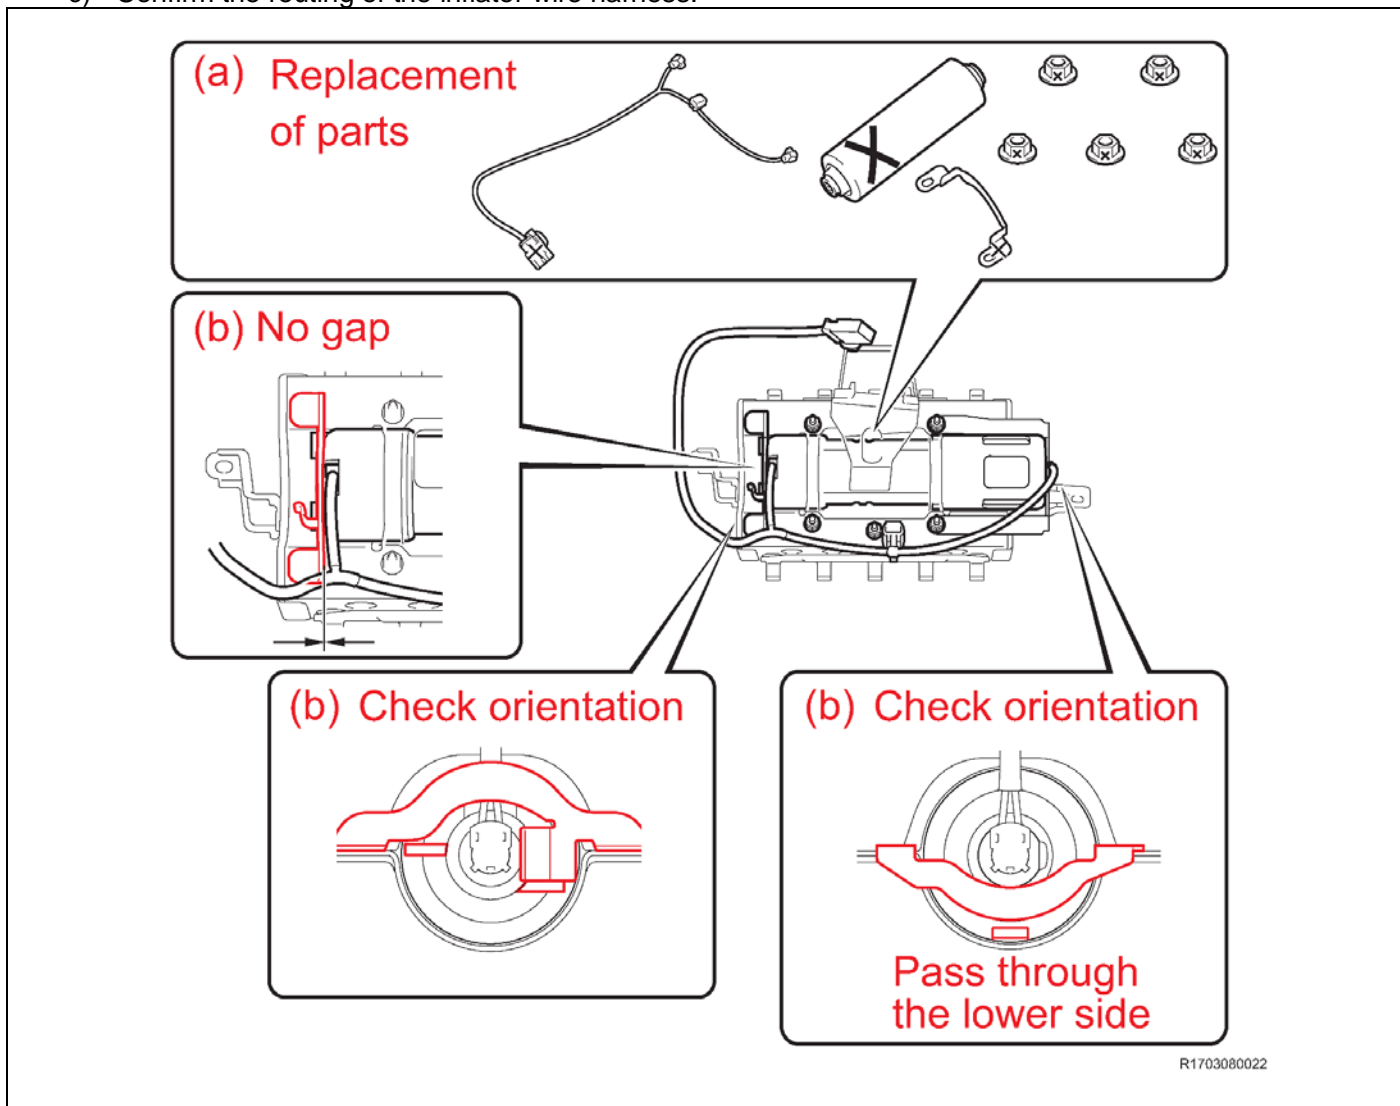
- a) Confirm the **NEW** inflator and 5 **NEW** nuts have been installed.
- b) Confirm the position of the inflator and position determining plates are correct.
- c) Confirm the routing of the inflator wire harness.
