**TECHNICAL INSTRUCTIONS**  
**FOR**  
**SAFETY RECALL J0A/J0B/J0C**  
**FRONT PASSENGER AIRBAG INFLATOR MODULE**  
**CERTAIN 2011-2013 MODEL YEAR SIENNA**

**Updated 01-14-2021**

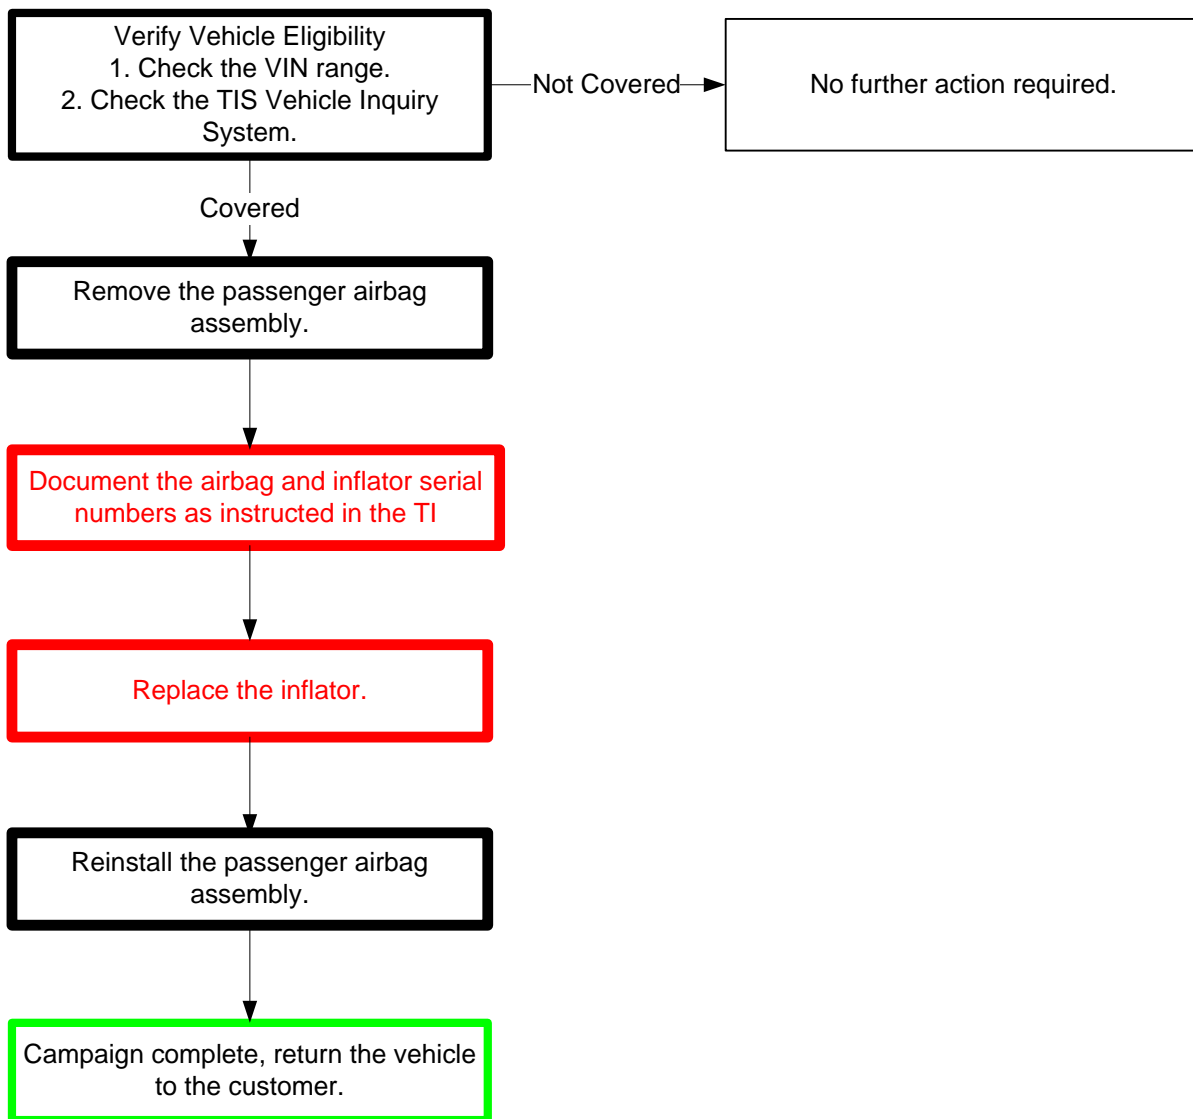
## I. OPERATION FLOW CHART

The flow chart is for reference only. **DO NOT** use it in place of the full technical instructions. Follow **ALL** steps as outlined in the full technical instructions to confirm the campaign is completed correctly.

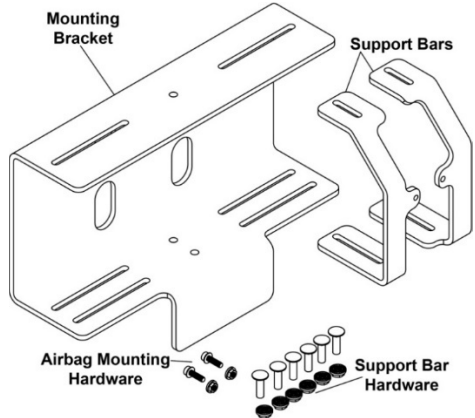
Airbag Mounting Bracket & hardware	1

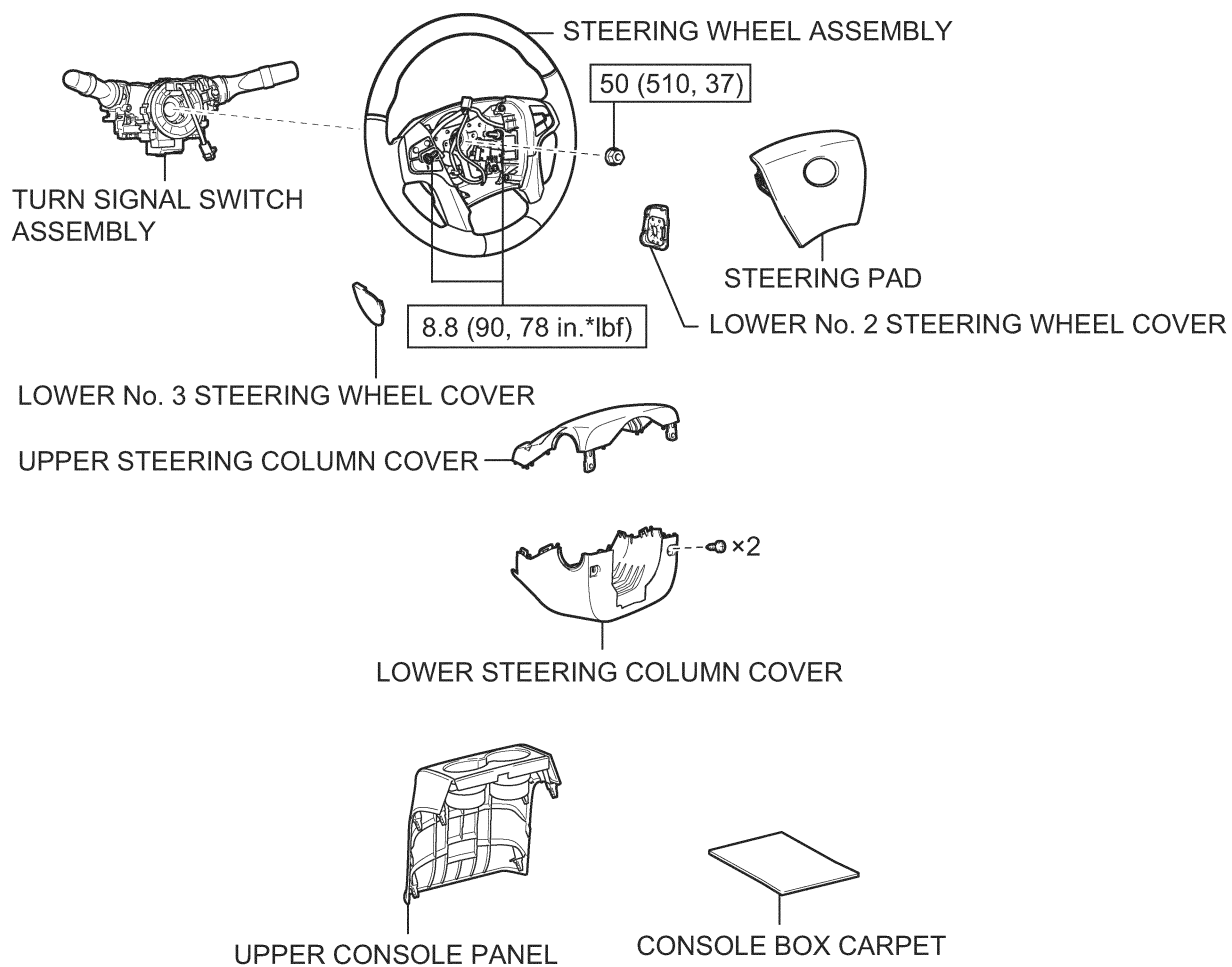
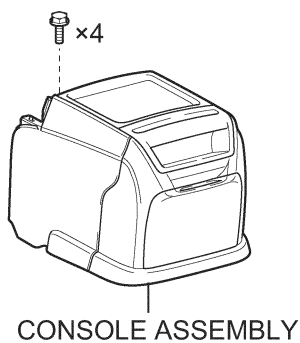
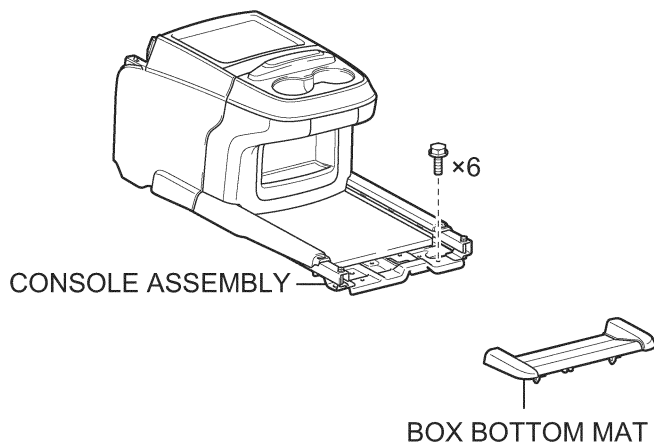
R1701060003

【for Fixed Type】

【for Slide Type】

**N\*m (kgf\*cm, ft.\*lbf)** : Specified torque

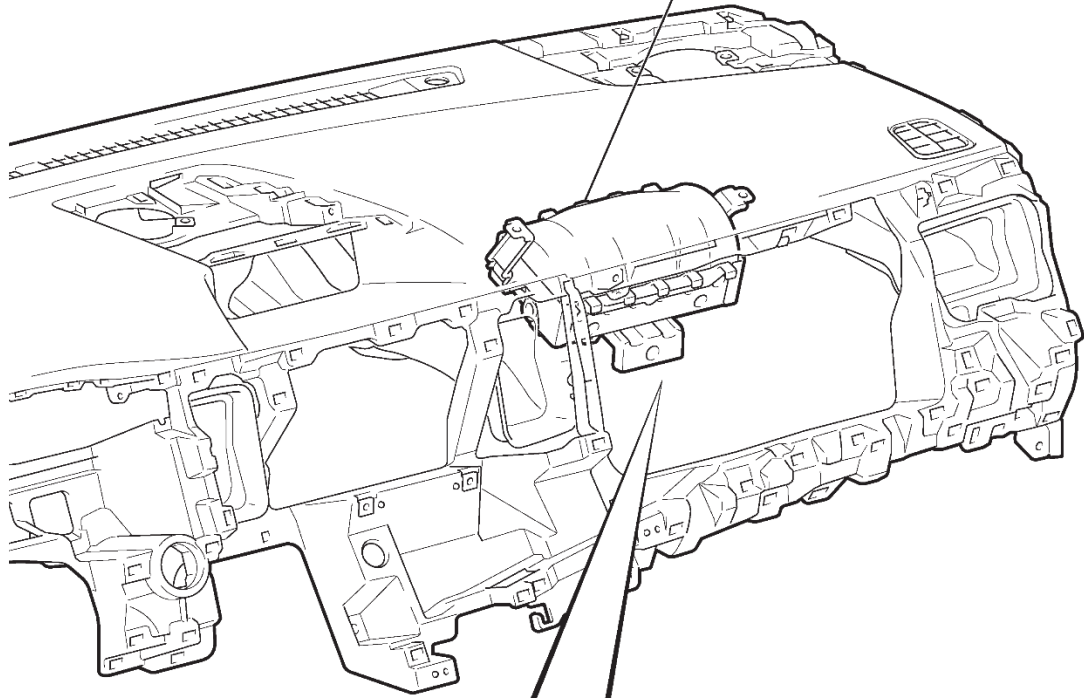
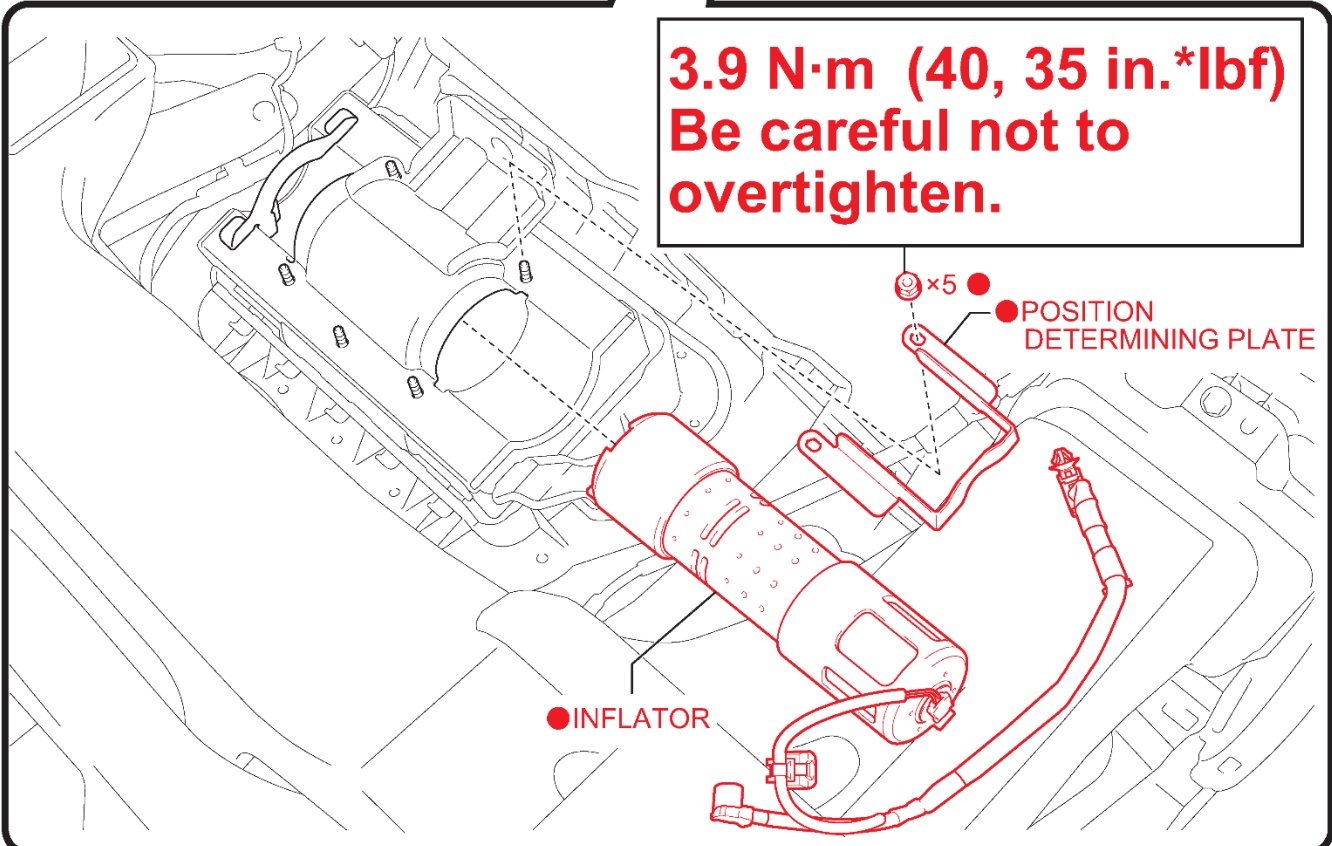
R1701280028H

INSTRUMENT PANEL PASSENGER AIRBAG ASSEMBLY

**3.9 N·m (40, 35 in.\*lbf)**  
**Be careful not to overtighten.**

● : Replacement part

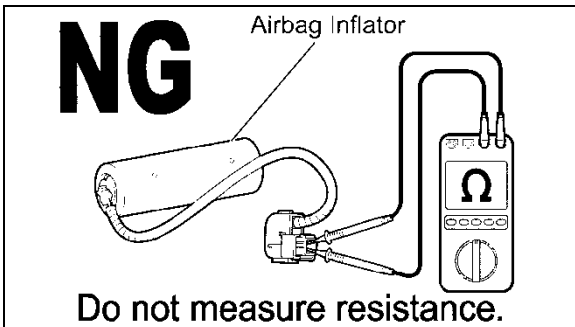
#### 1. ELIMINATE STATIC ELECTRICITY

- a) Before starting work and periodically while working on the vehicle, touch a metallic part of the vehicle to discharge static electricity in the body.

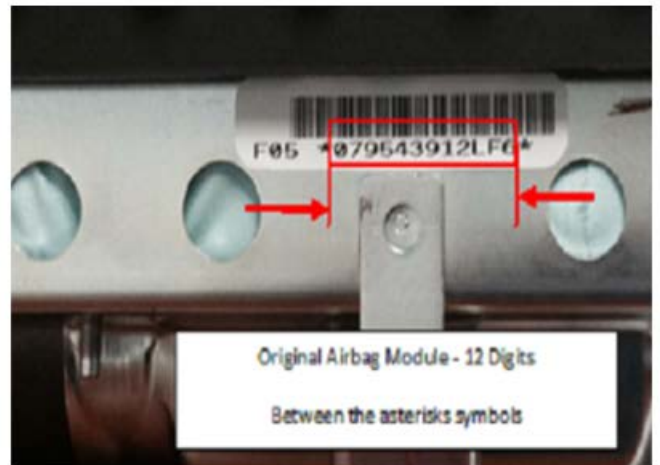
\* Re-confirm the Serial Number of *Original Airbag Assembly*:

Check if the airbag serial number is missing or not visible, or if installing a new airbag assembly

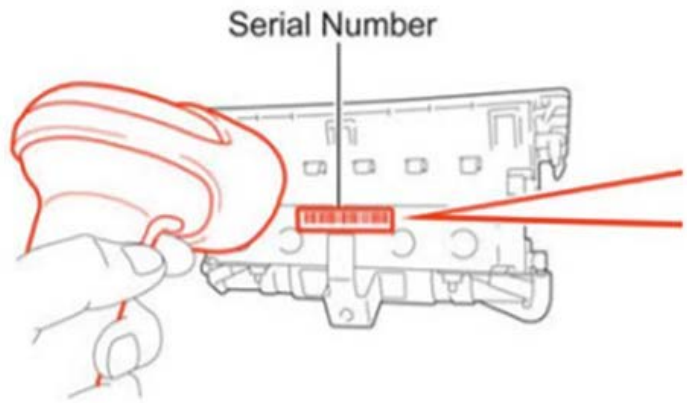
\* Serial Number of New Airbag Assembly:

\* Re-confirm the Serial Number of New Airbag Assembly:

The new **AIRBAG ASSEMBLY** serial number **MUST** be recorded prior to reinstallation to track the airbag assembly to the vehicle.

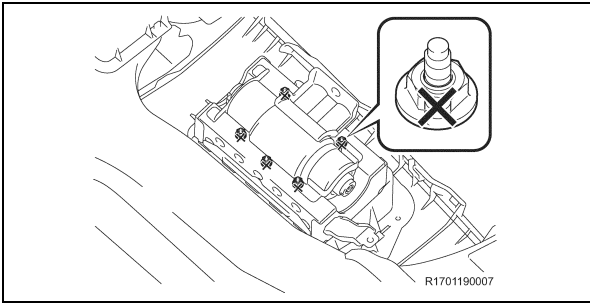
- Use a screwdriver to release the lock button on each end of the inflator.
- Disconnect both connectors.
- Disconnect the 2 wire harness clamps.
- Remove and discard the harness.

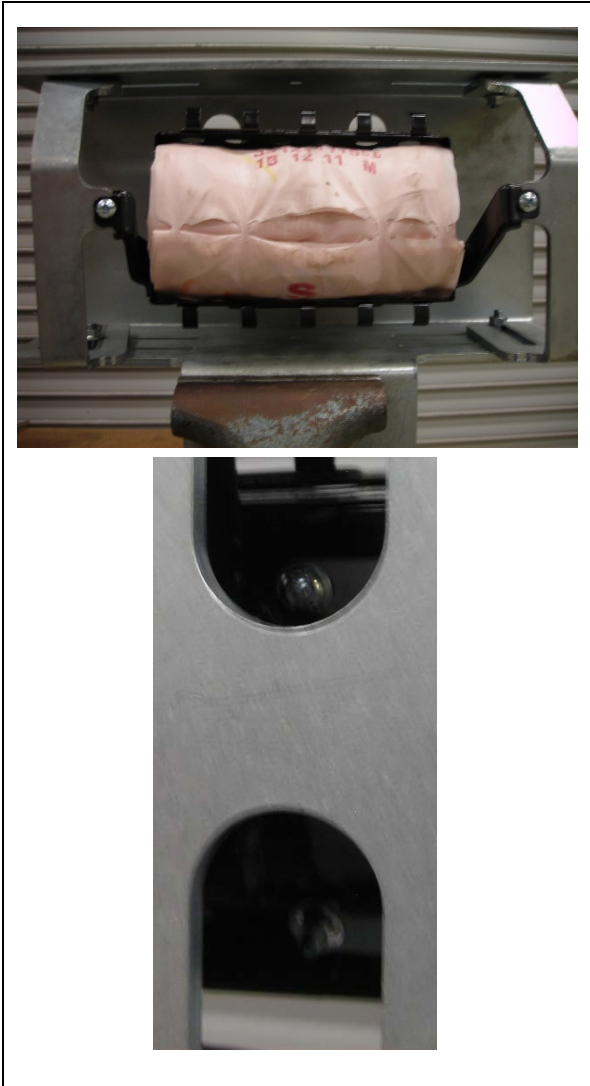
e) Mark all 5 nuts so they will not be reused.

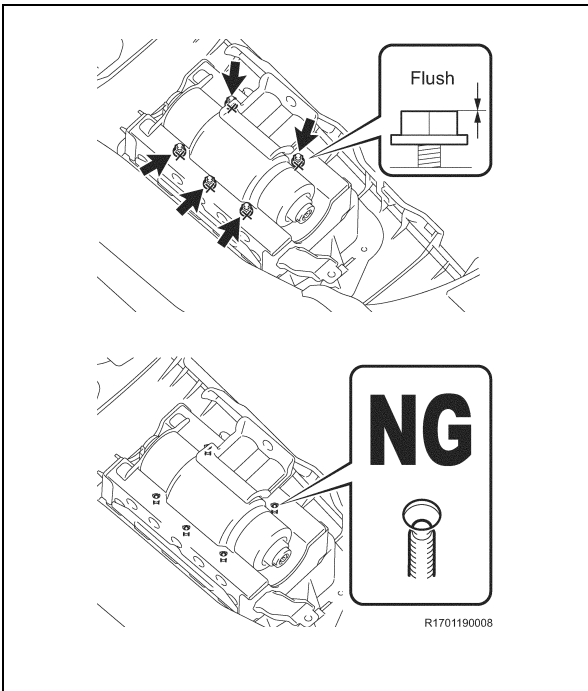
f) Mount the airbag into the mounting bracket as shown.

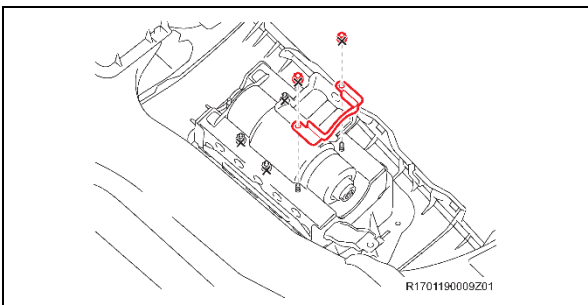
- a) Loosen the 5 nuts until the nuts are at the top of the studs as shown, through the openings in the mounting bracket.

**NOTE: Do not use power tools. It may be necessary to slide the airbag to the left or right to access the middle nut.**

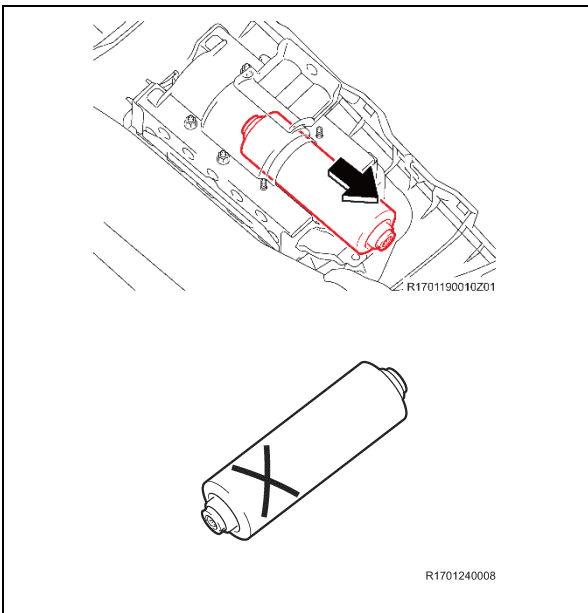
- a) Gently push the inflator in the direction shown.

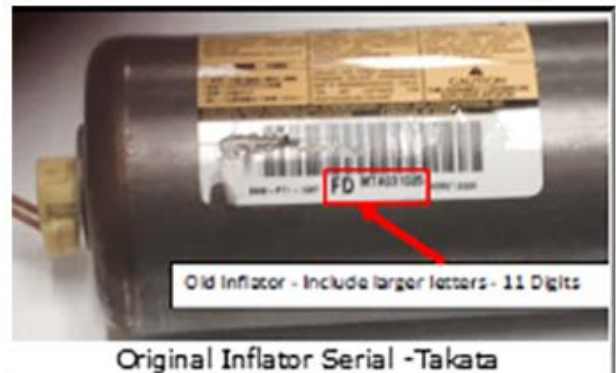
Check if the inflator serial number is missing or not visible, OR if installing a new airbag assembly

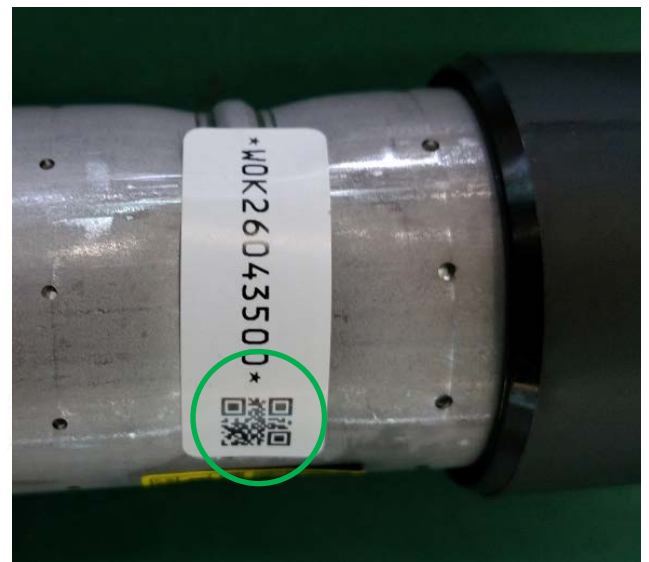
**REPLACEMENT Inflator Serial Number**

Scan or enter the **replacement** Inflator serial number into the website.

\* Serial Number of **Replacement** Inflator:

\* Re-confirm the Serial Number of **Replacement** Inflator:

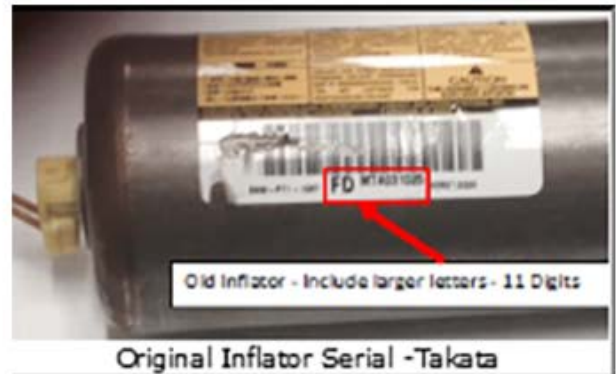
## ORIGINAL Inflator Serial Number

c) If the inflator serial number cannot be scanned or is not present check the box as shown below.

Check if the inflator serial number is missing or not visible. OR if installing a new airbag assembly

**Checking this box requires Air Bag Assembly replacement.**

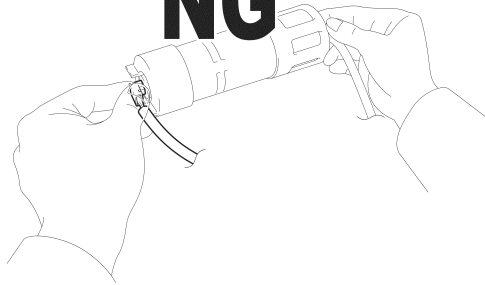
R170128003

- **DO NOT** connect the inflator harness at this time. It is **CRITICAL** to first confirm that the inflator is installed in the correct position before connecting the harness.

DO NOT CONNECT PREMATURELY  
CANNOT DISCONNECTED

**NG**

**NOTE:** Once connected the inflator harness cannot be disconnected without damaging the connector, and would require that the inflator and harness be replaced.

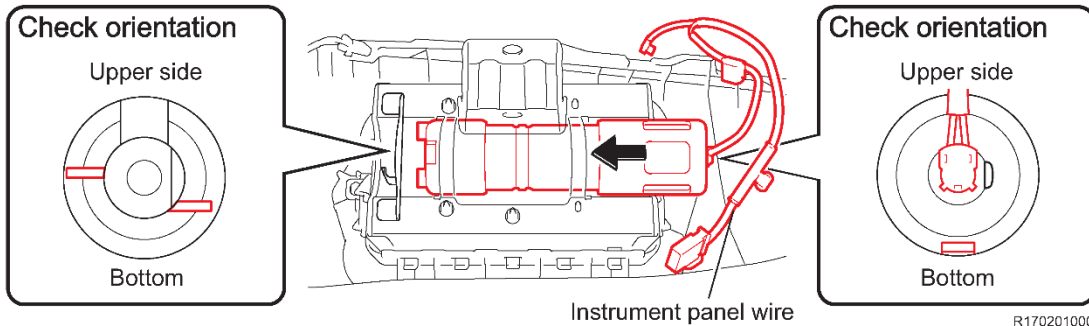
- a) Carefully slide the new inflator half way into the airbag assembly and align as shown.

**DO NOT** insert fully.

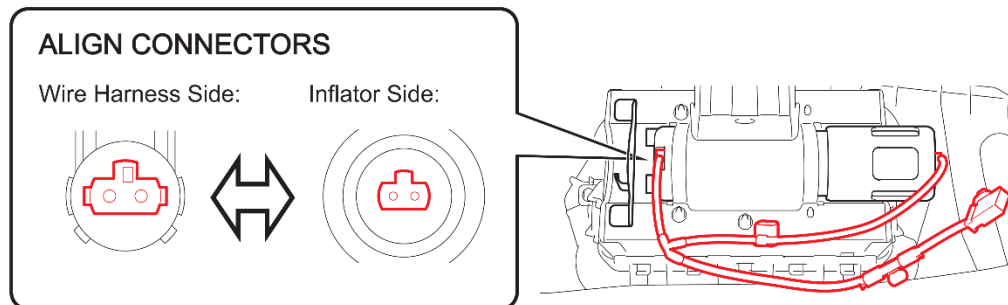
- b) Connect the connector to the inflator and ensure that the connector lock is fully engaged as shown.

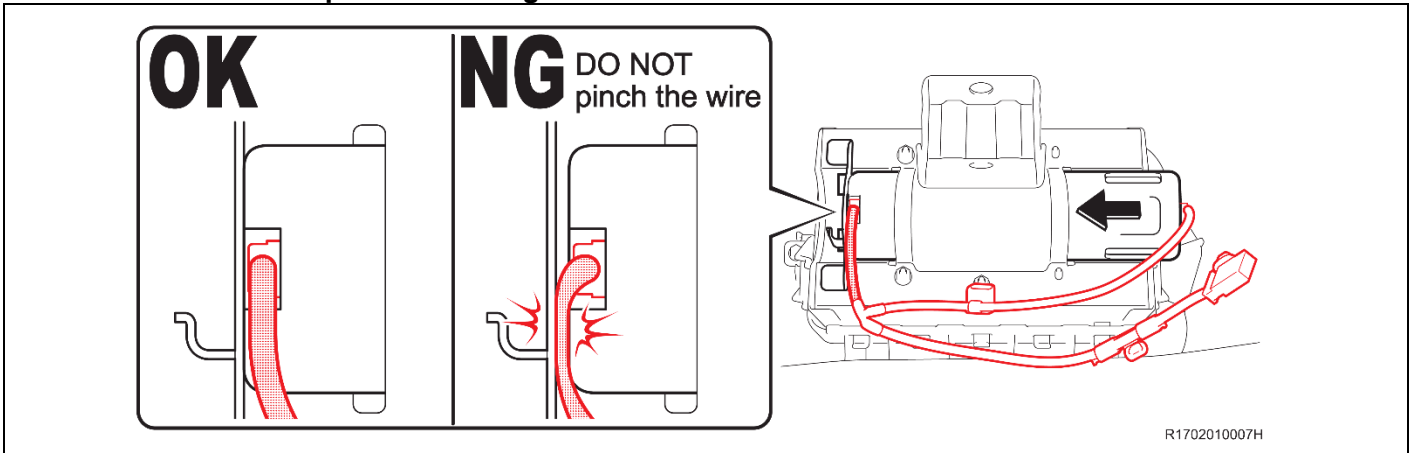
a) Fully insert the inflator and ensure that the inflator is correctly oriented as shown.

**NOTE: DO NOT pinch the wiring between the bracket and the inflator.**

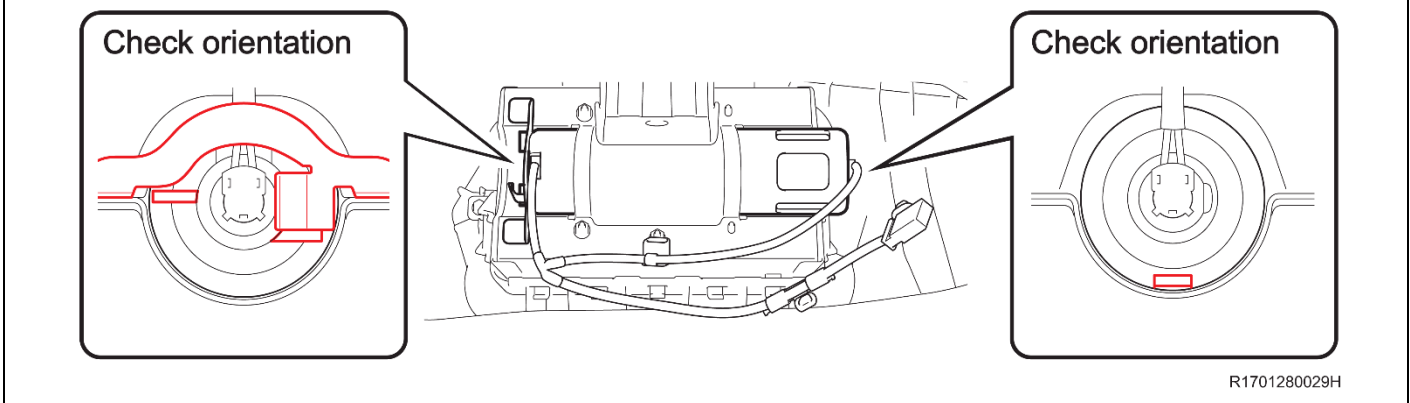
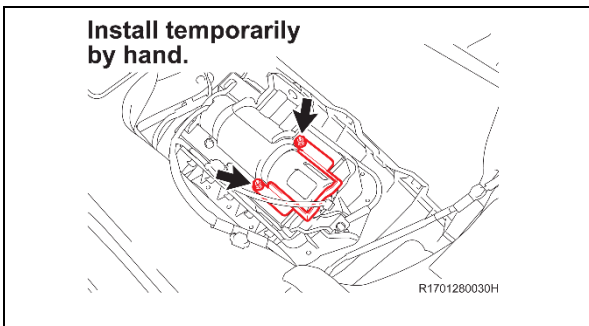
**NOTE: Ensure the inflator is correctly oriented.**

b) Install the **NEW** stopper plate.

c) Install 2 **NEW** nuts by hand.

**NOTE: Ensure that the stopper plate is the one from the kit and installed in the correct orientation.**

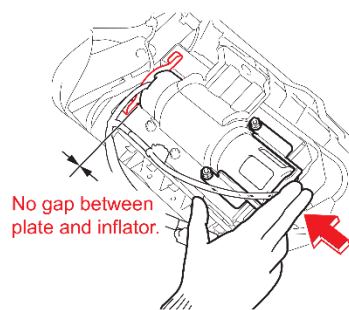
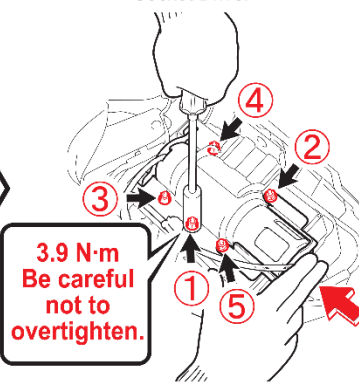
R1702010002H

- a) Tighten the 5 nuts evenly in several increments in the sequence shown. Use a socket driver or torque wrench to tighten the nuts.

Torque: 35in. lbf (40 kgf.cm, 3.9N·m)

- There will be some resistance when tightening the nuts because they are self-locking, confirm the nuts are tightened correctly.
- **DO NOT** use a power tool, T-handle, or ratchet when tightening the nuts to avoid overtorquing and deforming the studs.
- You may need to turn the airbag to the left or right with in the mounting bracket to access the center nut.

**OK**

Socket Driver

**These tools cause overtightening !**

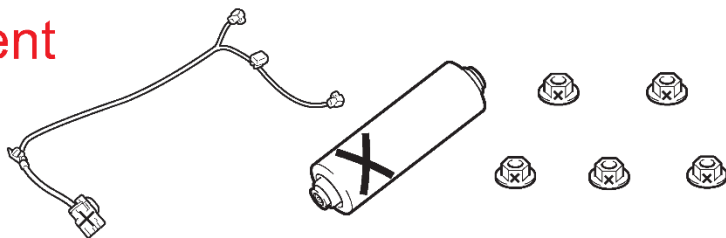
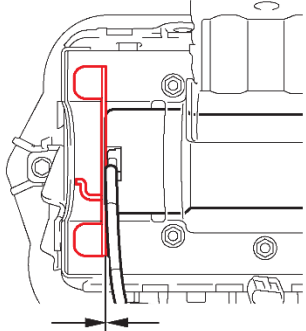
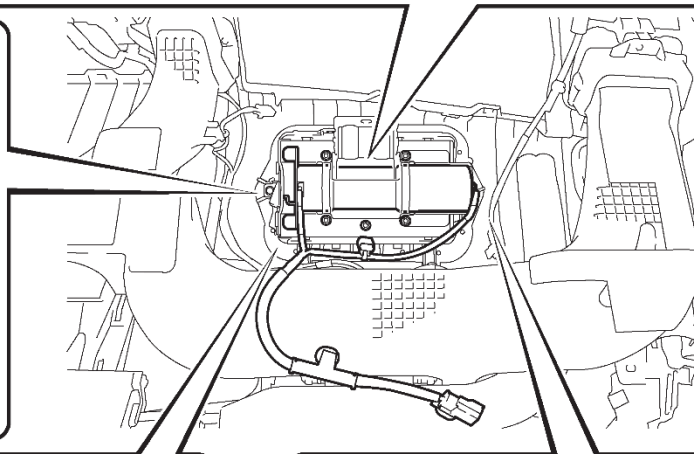
R1701280031H

- a) Confirm the **NEW** inflator and 5 **NEW** nuts have been installed.
- b) Confirm the position of the inflator and position determining plates are correct.
- c) Confirm the routing of the inflator wire harness.

(a) Replacement of parts.

(b) No gap.

(b) Check orientation
