**TECHNICAL INSTRUCTIONS**  
**FOR**  
**SAFETY RECALL J0A/J0B/J0C**  
**FRONT PASSENGER AIRBAG INFLATOR MODULE**  
**CERTAIN 2003 – 2005 MODEL YEAR COROLLA**

**UPDATE 8/28/2019**

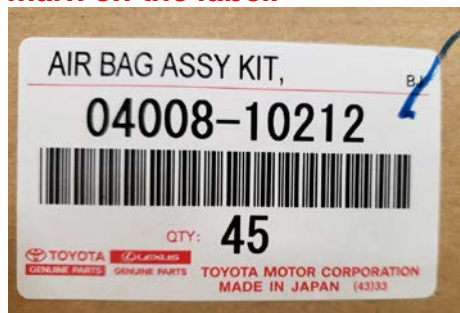
Make sure the parts box has a check mark as seen in the image above

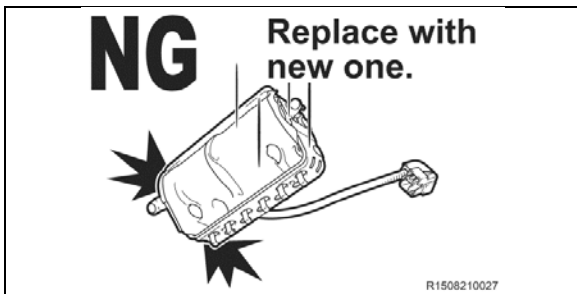
#### 3. HANDLE THE AIRBAG CAREFULLY

- a) If an inflator is dropped, replace it with a **NEW** module.
