TECHNICAL INSTRUCTIONS
FOR
SAFETY RECALL J0A/J0B/J0C
FRONT PASSENGER AIRBAG INFLATOR
CERTAIN 2008 – 2012 MY SCION xB

I. OPERATION FLOW CHART

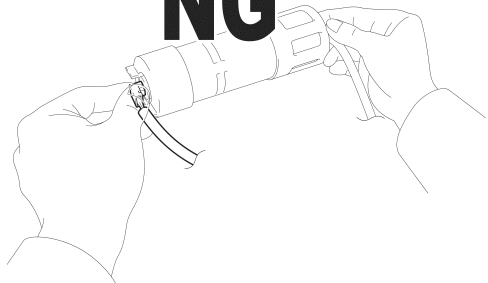
R170120000

1. IMPORTANT NOTICE WHEN CONNECTING INSTRUMENT PANEL WIRE CONNECTOR TO AIRBAG INFLATOR

- Once connected, the instrument panel wire connector cannot be disconnected from the airbag inflator. If the instrument panel wire connector is incorrectly connected to the inflator, replace the instrument panel wire and inflator with new ones.

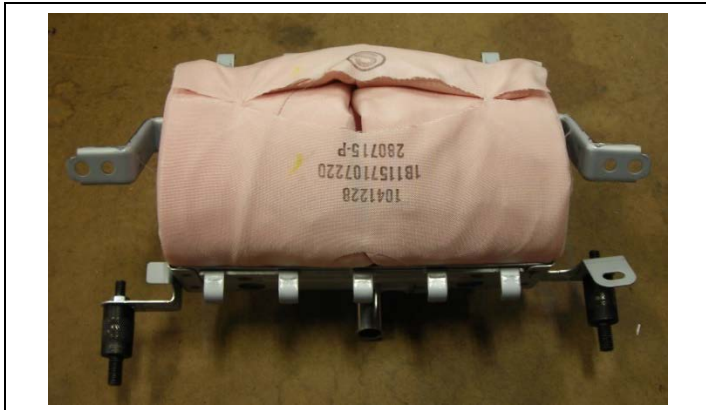
- a) Mount the adaptors (579943-3R3) to the airbag as shown.

NOTE: The 6mm stud mounts to the airbag.

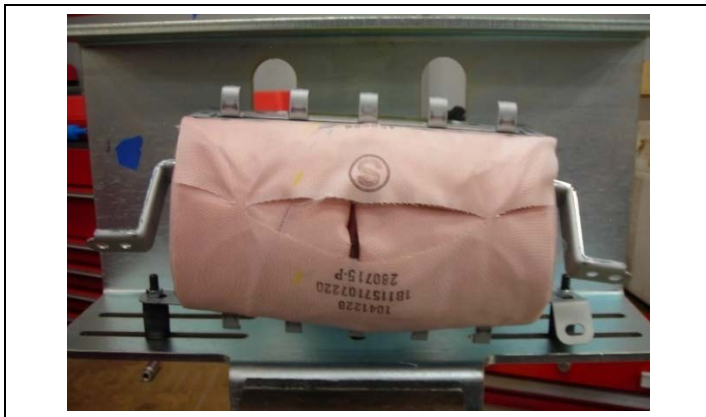
- b) Mount the airbag to the mounting bracket as shown.

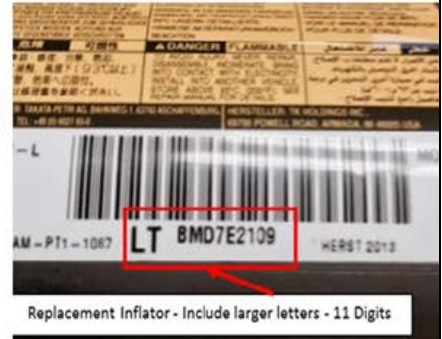
The first two characters of the Replacement Inflator Serial code will be either 'LT' or 'LR'.
