September 4, 2019

Version 5

Safety Recall: Front Passenger's Airbag Inflator Can Be Over-Pressurized (Phase 3)

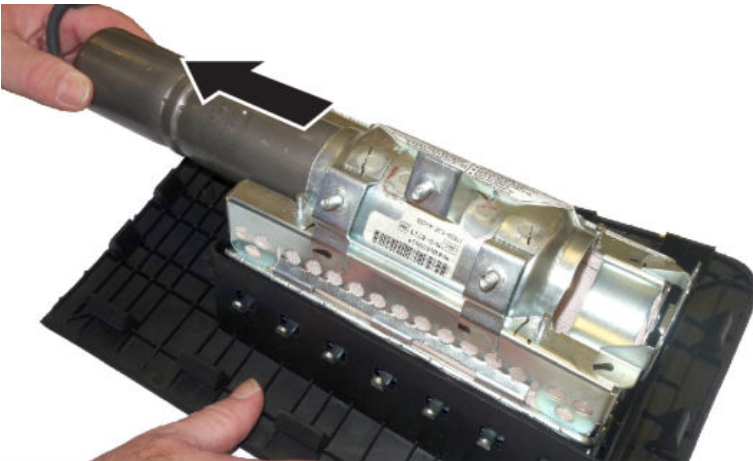
11. Remove the inflator by pushing/pulling it out.
