September 4, 2019

Safety Recall: Takata Front Passenger's Airbag Inflator (Phase 3)

Supersedes 18-002, dated December 7, 2018 to revise the information highlighted in **yellow**.

Replacing the front passenger's airbag inflator

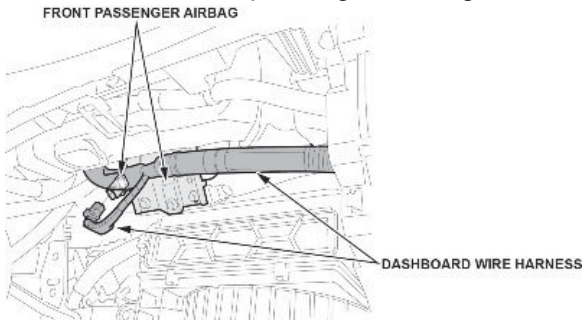
2. Disconnect the battery negative cable and wait at least 3 minutes before continuing.
3. Remove the front passenger's airbag.
 - 3.1. Remove the glove box and the passenger's dashboard trim. Refer to the service information.
 - 3.2. Disconnect the front passenger's airbag 4P connector from the dashboard wire harness.

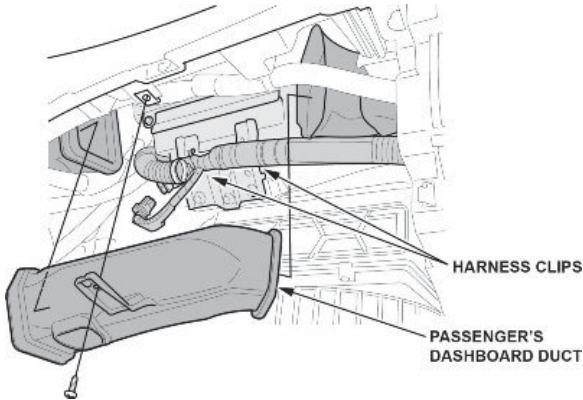
- 3.3. Remove the passenger's dashboard duct, then detach the harness clips.

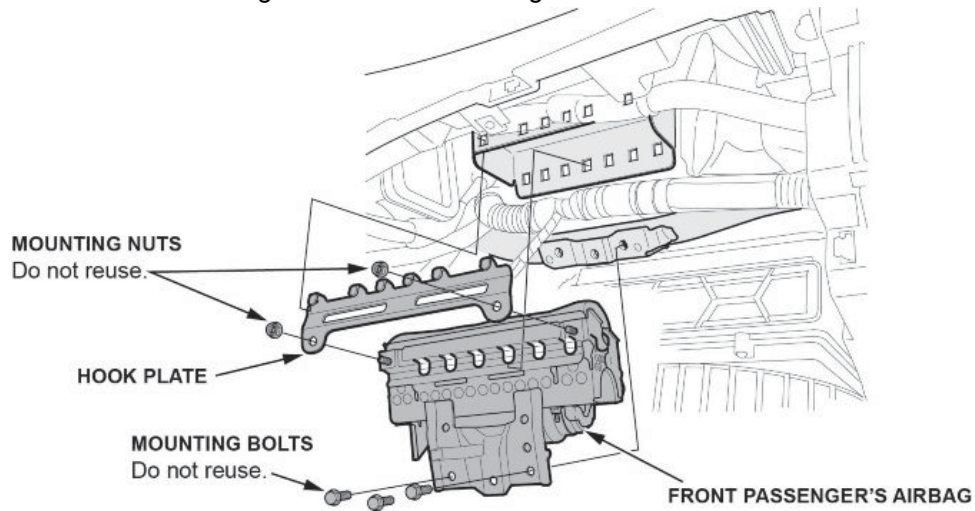
3.4. Remove the mounting nuts and the mounting bolts. Release the hooks of the hook plate and remove it.

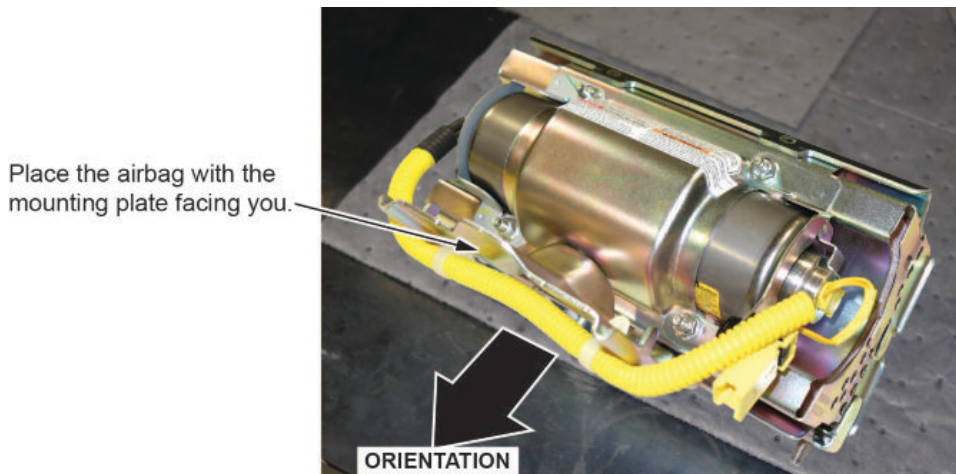
4. Place the airbag, face-down, on a clean shop towel.

- The orientation of the airbag is critical because if the inflator is installed incorrectly, the harness will be too short when you reinstall the airbag.
- The brackets between the various models are similar but may differ from the example shown.

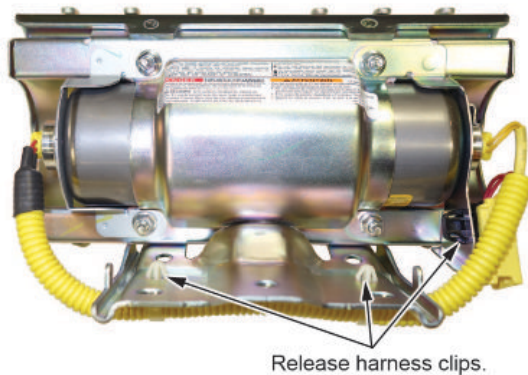
7. Remove the harness from the inflator bracket.

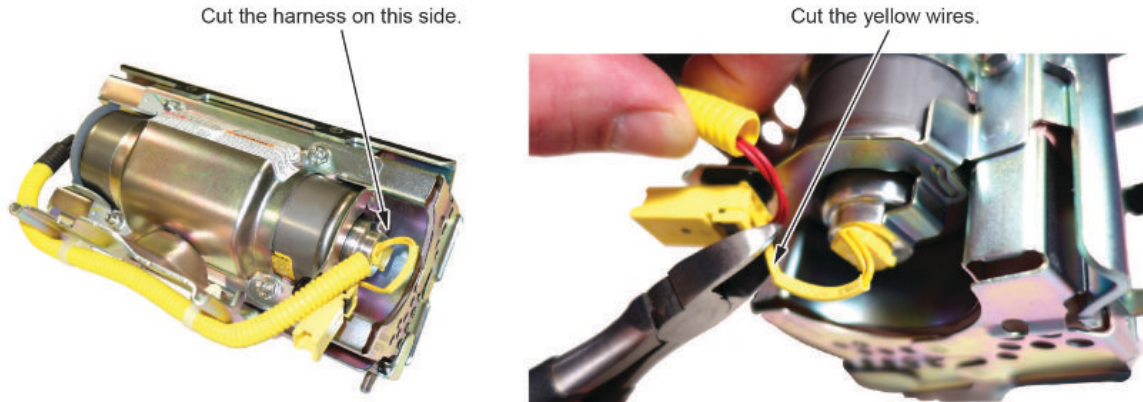
- **You must cut the yellow wires** for inflator removal and short the yellow wires on the inflator side as indicated to prevent accidental deployment.
- **Do not cut the red wires** because the airbag connector shorts these inflator wires.

8.1. Cut the yellow wires as shown.

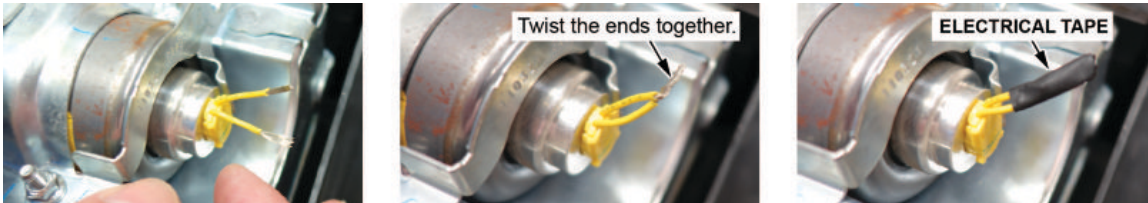
8.2. Strip away about 1 inch of the yellow wire insulation, then twist the wires together.

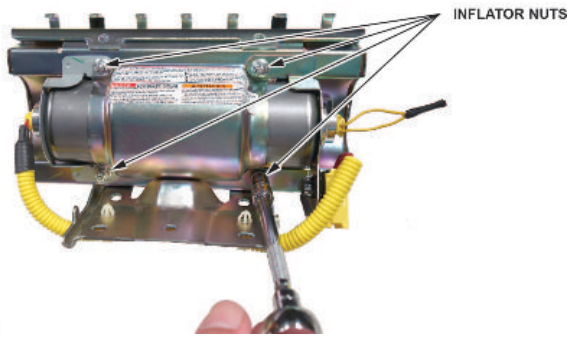
9. Remove the four inflator nuts.

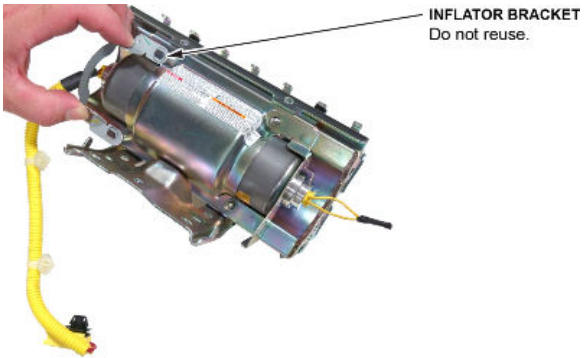
10. Remove the inflator bracket.

- You can only remove one of the brackets, as the other is welded to the airbag housing.
- Do not reuse the bracket; use the new one that came in the inflator kit.

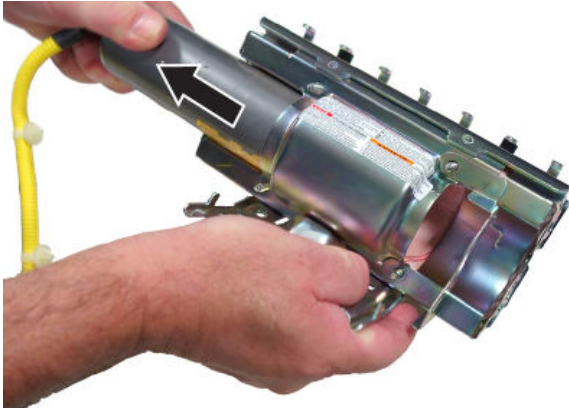
11. Remove the inflator by pulling it out.

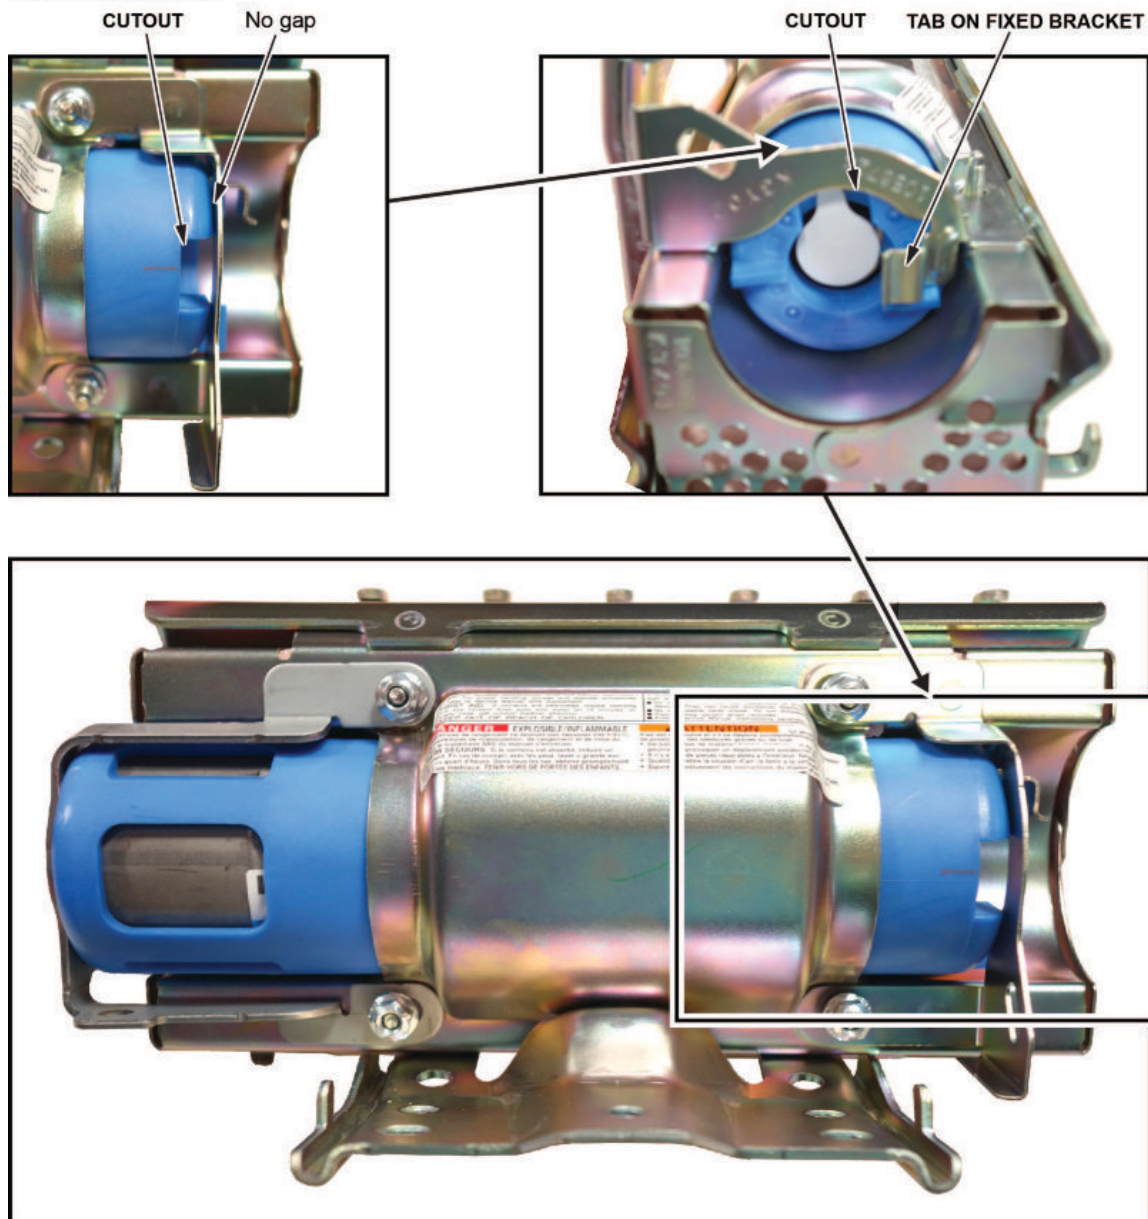
FIXED BRACKET END

- 12.2. Slide the inflator in until the plastic collar contacts the bracket. The two tabs should align with the side of the airbag module and the metal tab as shown. There should be no space or gap between the inflator and bracket.

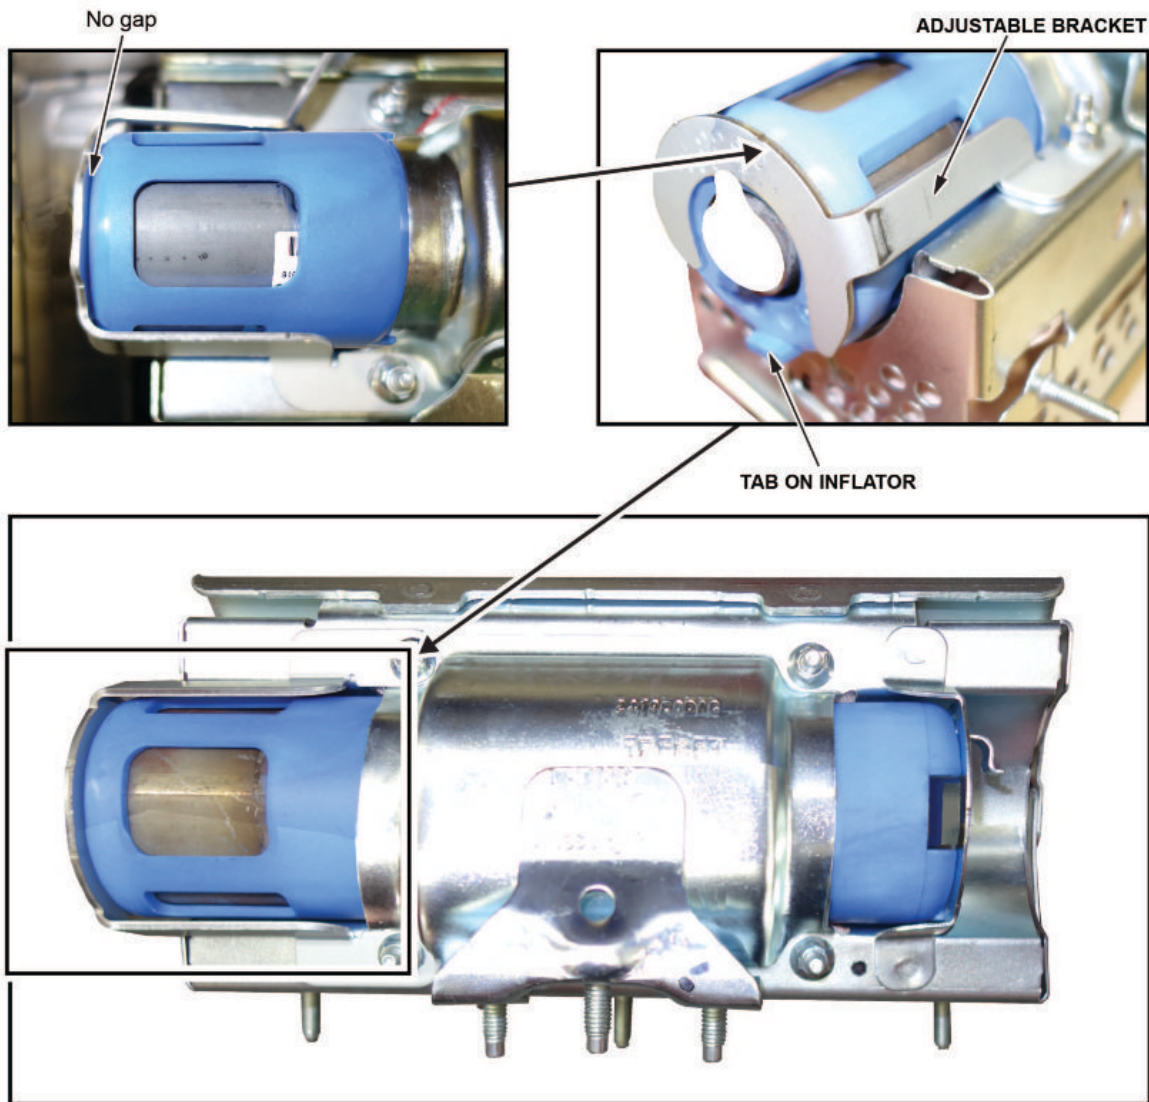
ADJUSTABLE BRACKET END

- 12.3. Install the bracket included in the kit onto the airbag module. Check there is no space or gap between the inflator and bracket by pushing the bracket against the inflator.

The bracket may have a little bit of play before you install the new nuts.

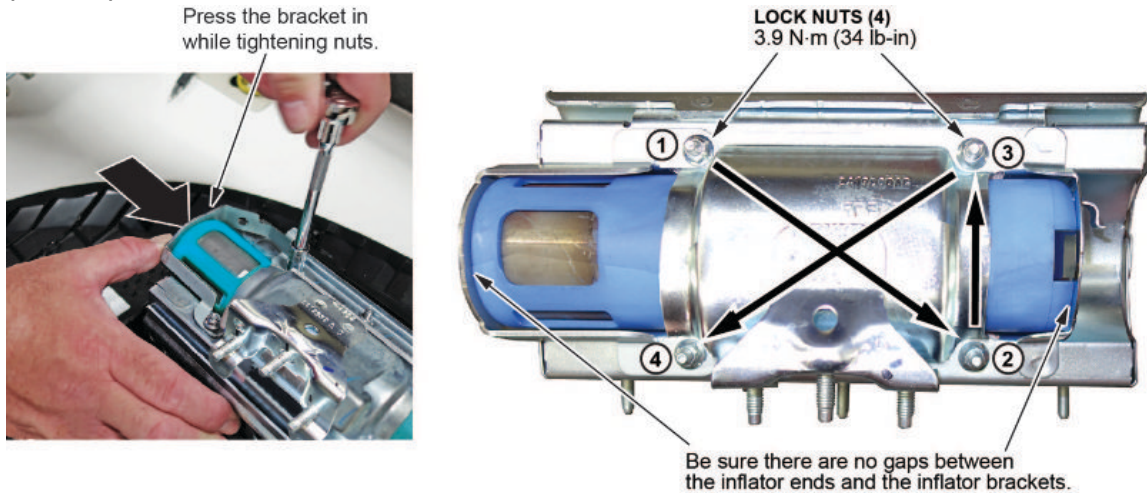
13. Hold the bracket against the inflator, then install the new 5 mm locknuts and torque them in sequence to **3.9 N•m (34 lb-in)** .

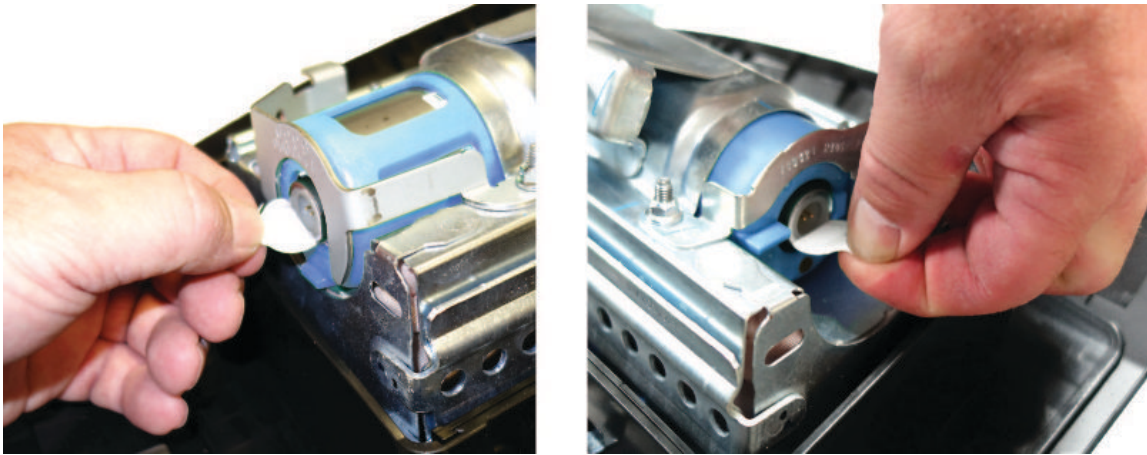
14. Remove the stickers covering the terminals on both sides of the new inflator.

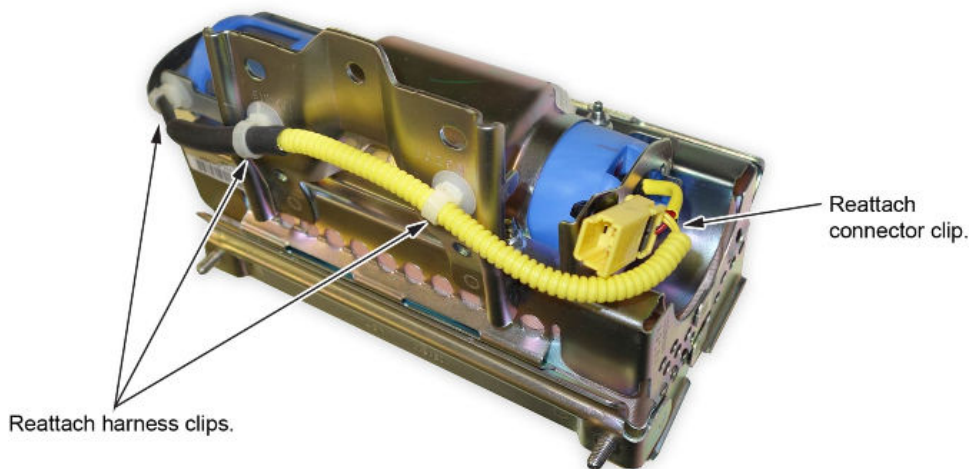
17.1. Attach the connector clip.

17.2. Attach the harness clips onto the inflator bracket. Make sure the harness is securely inserted and that it does not sag.

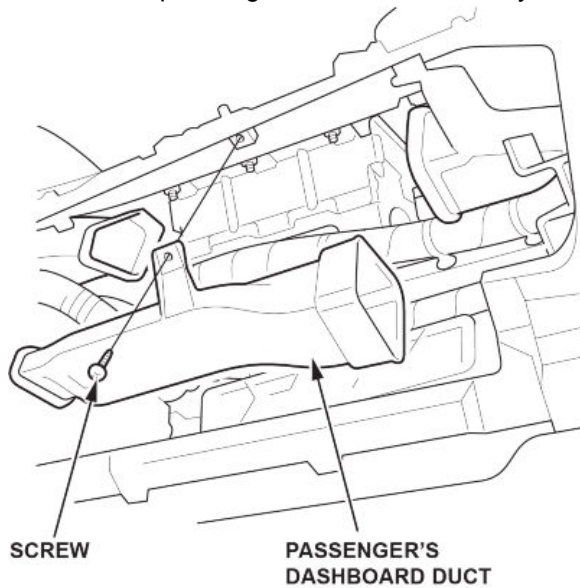
3.3. Remove the passenger's dashboard duct by removing the screw.

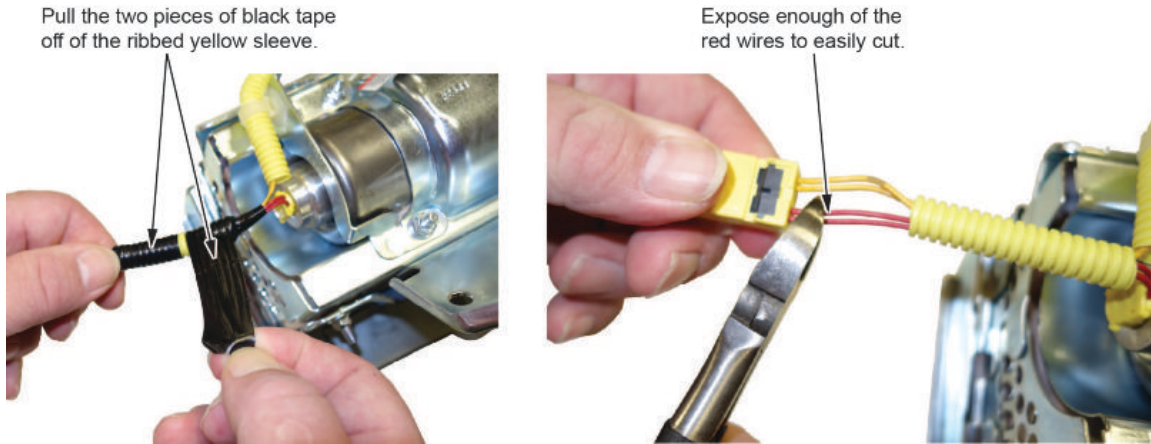
8.1. Cut the red wires as shown.

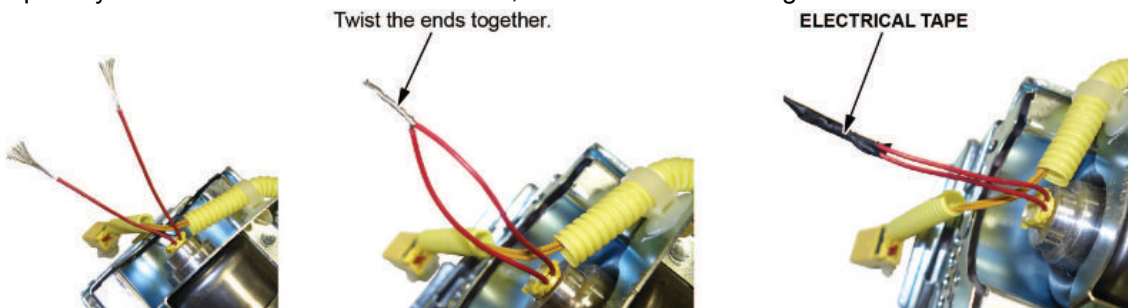
8.2. Strip away about 1 inch of the wire insulation, then twist the wires together.

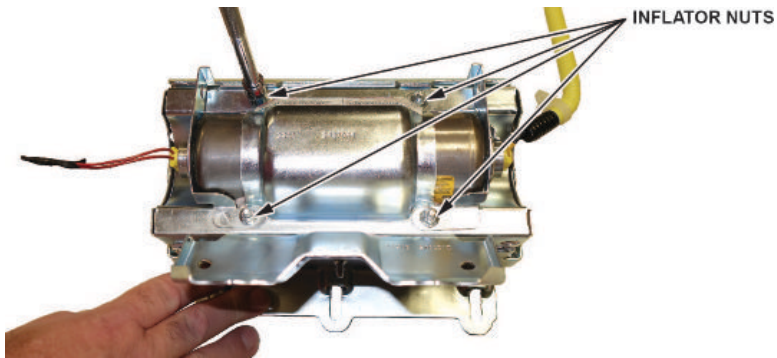
9. Remove the four inflator nuts.

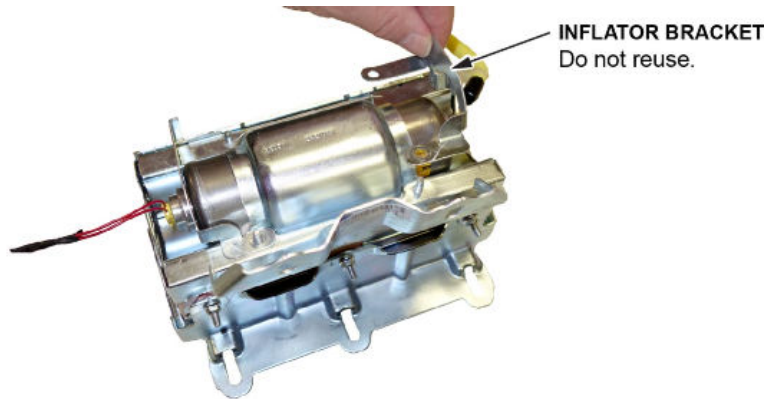
10. Remove the inflator bracket.

- You can only remove one of the brackets, as the other is welded to the airbag housing.
- Do not reuse the bracket; use the new one that came in the inflator kit.

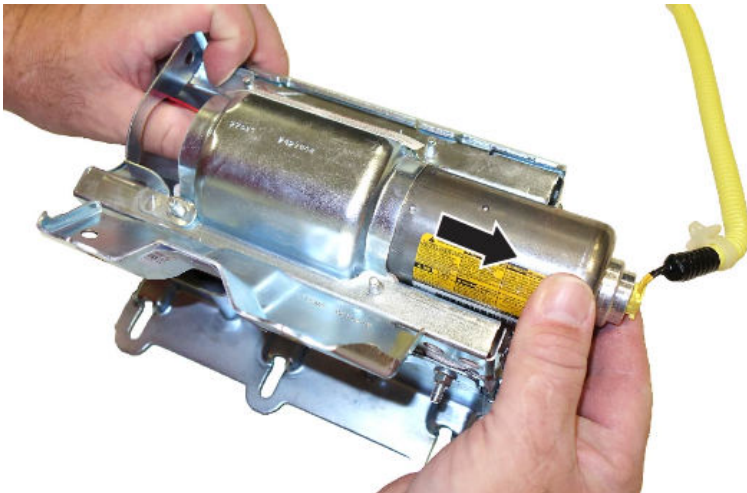
11. Remove the inflator by pulling it out.

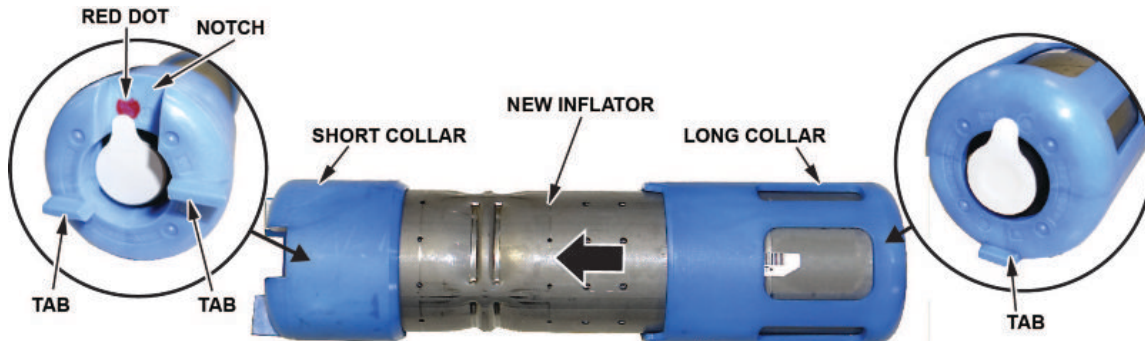
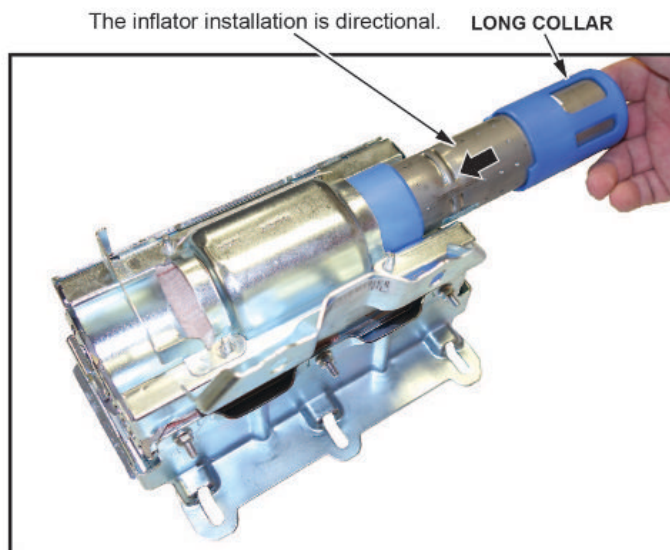
- The V-SMART tool can only validate inflators with slotted end caps. You may receive an inflator with solid end caps. This is the correct part to repair the vehicle, but the V-SMART will fail the validation. **The V-SMART validation must fail a total of three times** before you can have your supervisor override the validation using the **Supervisor Inspection Override**.
- Your supervisor can be a service manager, shop foreman, team leader, etc. **The supervisor must inspect your work** to make sure the replacement inflator was installed correctly. When a supervisor enters his or her information, **the supervisor is signing off that the technician's work was inspected and approved.**

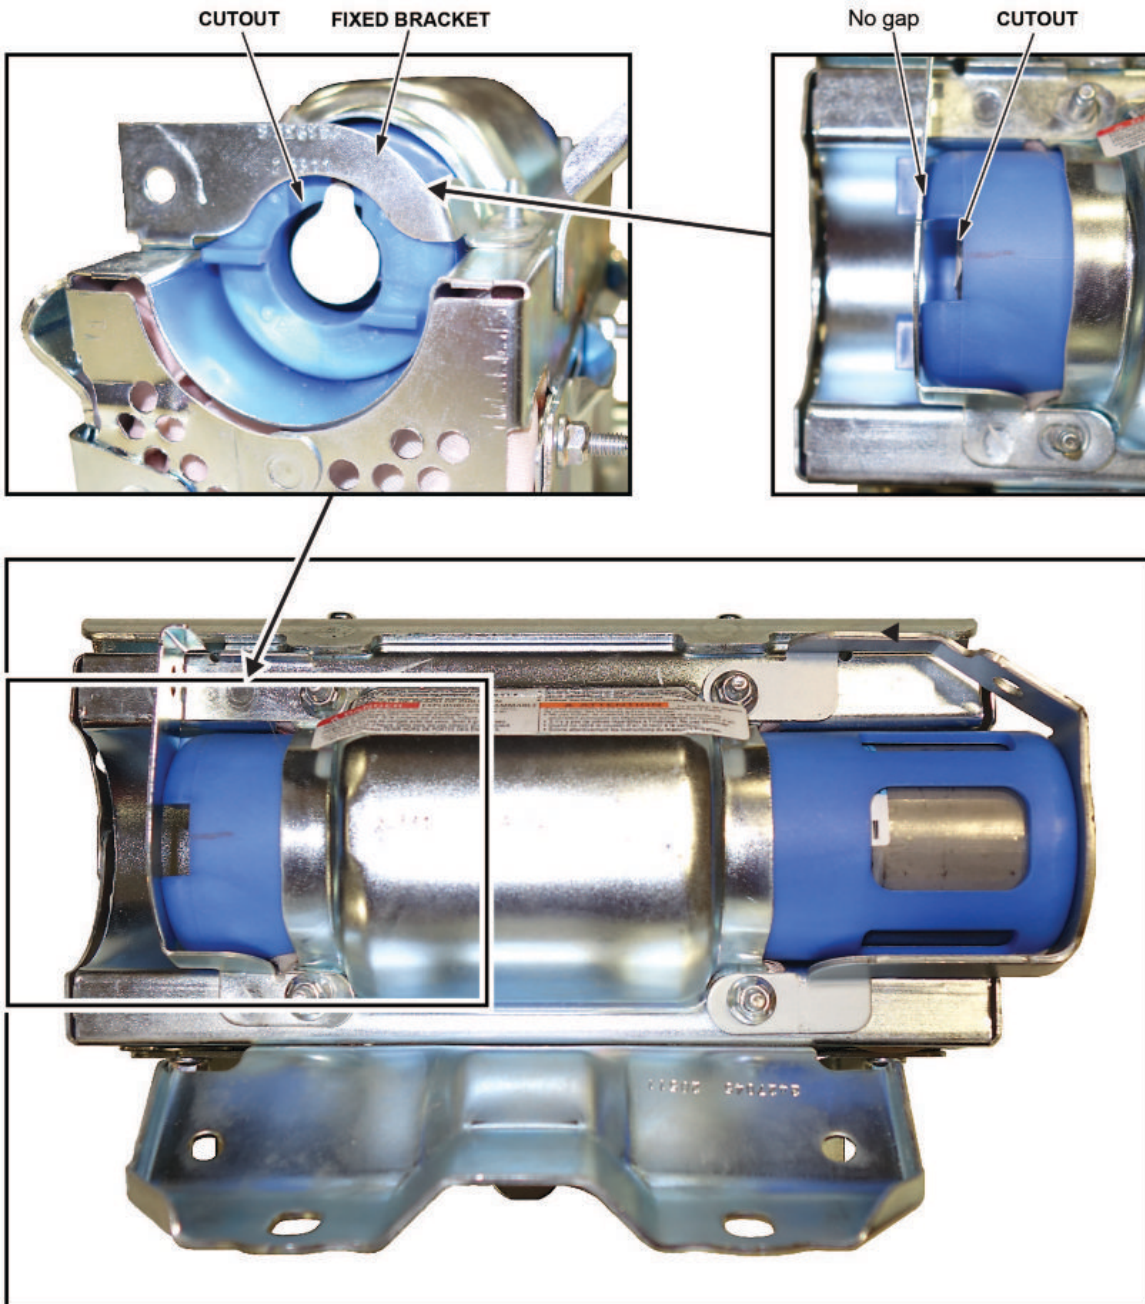
FIXED BRACKET END

- 12.2. Slide the inflator in until the plastic collar contacts the bracket. The two tabs should align with the side of the airbag module and the metal tab as shown. There should be no space or gap between the inflator and bracket.

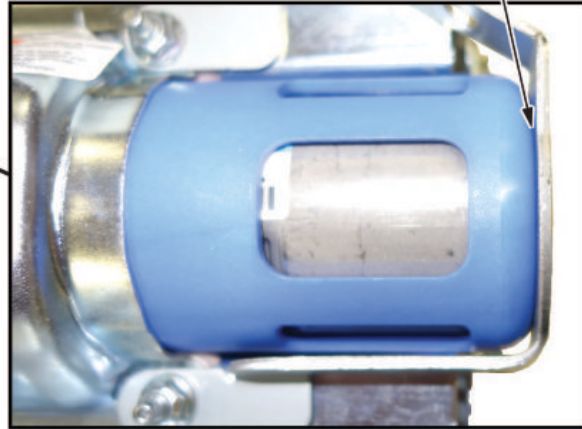
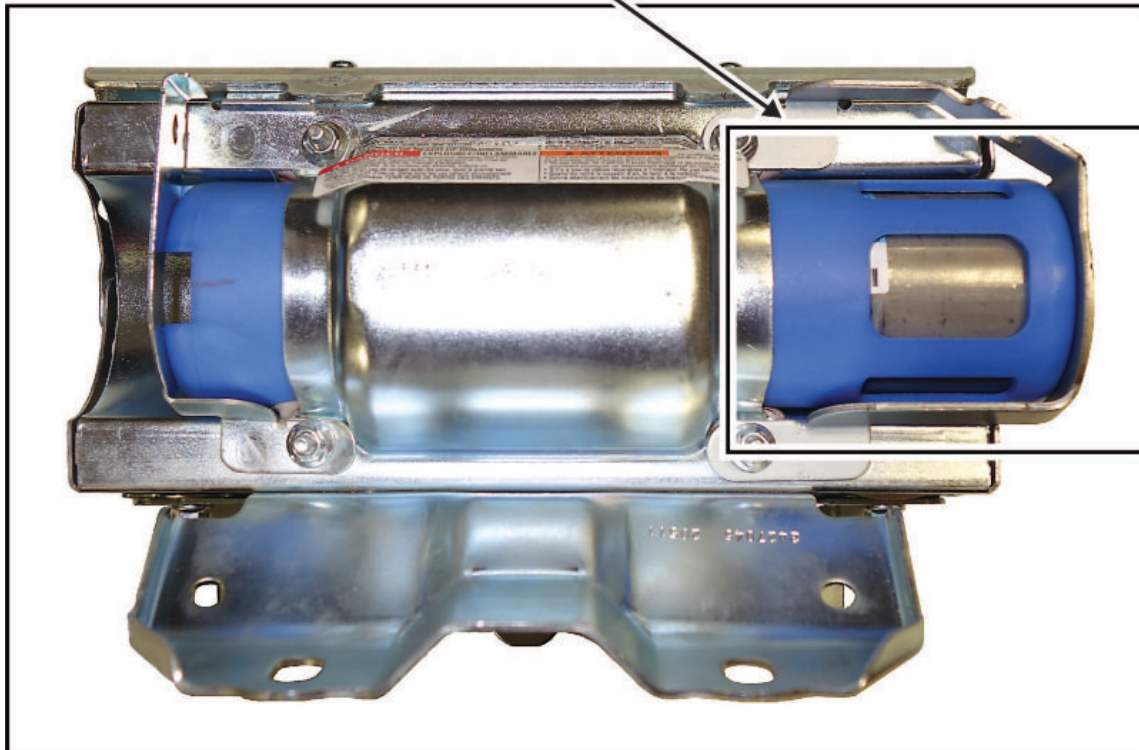
ADJUSTABLE BRACKET

- 12.3. Install the bracket included in the kit onto the airbag module. Check there is no space or gap between the inflator and bracket by pushing the bracket against the inflator.

FLAT SPOT ON PLUG SOCKET

TAB ON BRACKET

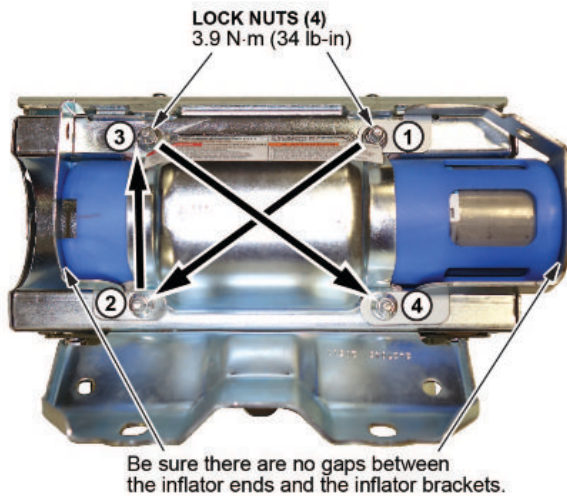
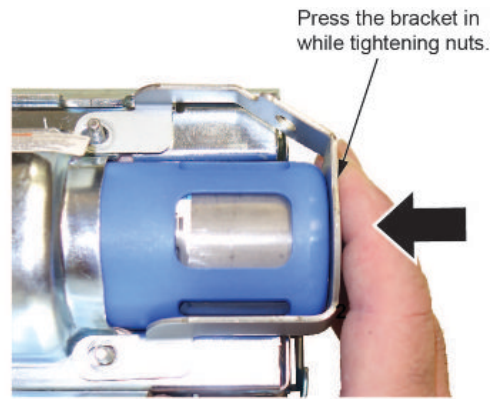
13. Hold the bracket against the inflator, then install the new 5 mm locknuts and torque them in sequence to **3.9 N•m (34 lb-in)** .

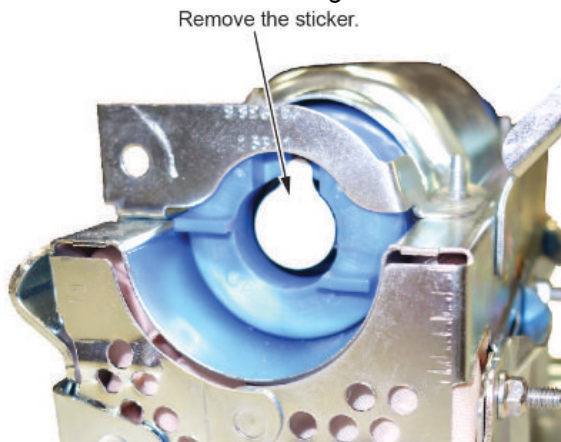
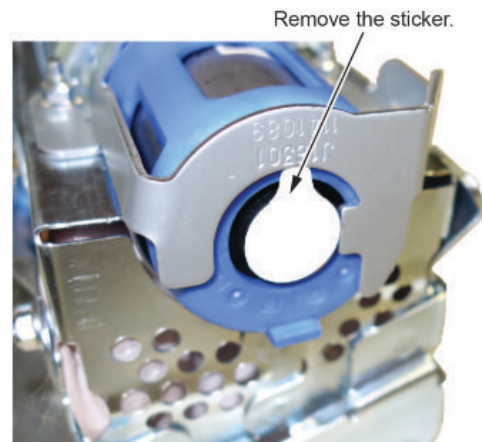
14. Remove the stickers covering the terminals on both sides of the new inflator.

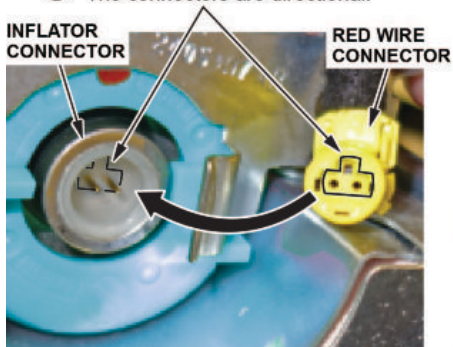
16.2. Connect the red wire connector to the connector on the side with the short plastic collar and red dot. Align the "T" shape in the inflator harness connector with the T-shaped inflator connector, then press the connector into place.

- ① Match up the "T" shape as shown. The connectors are directional.

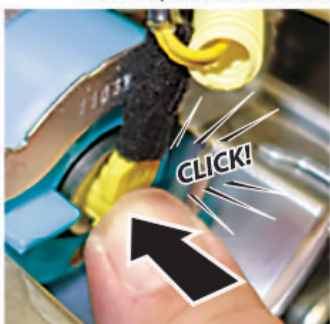
- ② Press the connector into place until it clicks.

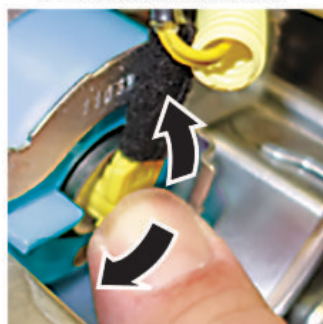
- ③ Wiggle the connector to make sure it's secure.

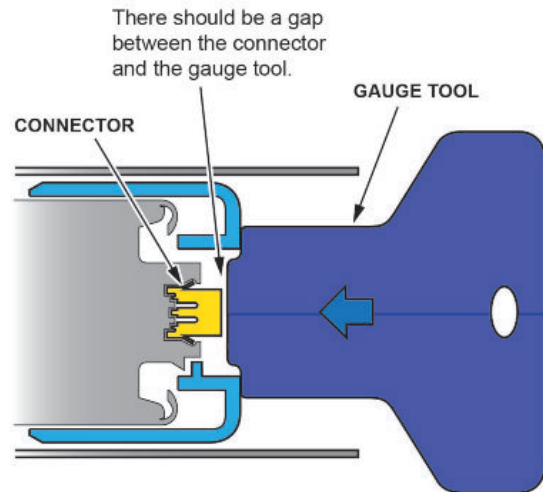
Be sure the connector is fully seated by checking it with the gauge tool.

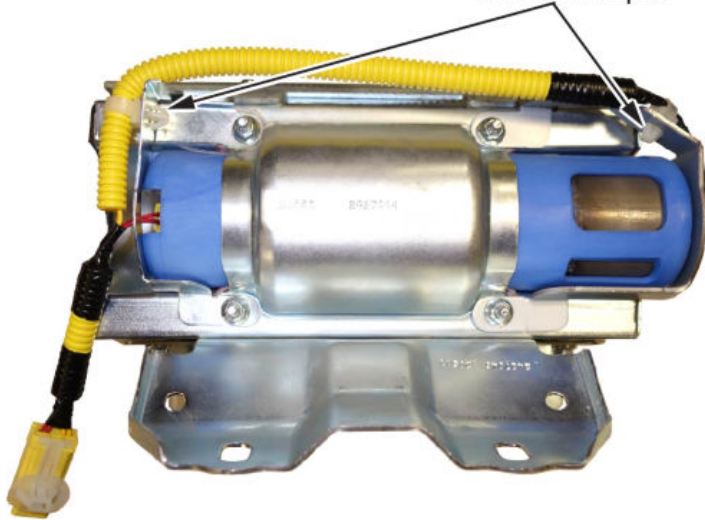
17.1. Connect the harness clips to the bracket.

Reconnect the harness clips.
