# Compliance Recall

## Code: 44N9

<b>Subject</b>	<b>Tire Information Label</b>
<b>Release Date</b>	March 01, 2018
<b>Affected Vehicles</b>	<b>U.S.A. &amp; CANADA: Certain 2014-2015 MY Audi S7, 2016-2018 Audi RS7</b> <i>Check Campaigns/Actions screen in Elsa on the day of repair to verify that a VIN qualifies for repair under this action. Elsa is the <u>only</u> valid campaign inquiry &amp; verification source.</i> <ul style="list-style-type: none"><li>✓ Campaign status must show "open."</li><li>✓ If Elsa shows other open action(s), inform your customer so that the work can also be completed at the same time the vehicle is in the workshop for this campaign.</li></ul>
<b>Problem Description</b>	The tire information label on affected vehicles erroneously lists a combined maximum weight of 1146 lbs/520 kg, rather than the correct combined maximum weight of 992 lbs/450 kg.  If someone were to rely on the incorrect label information, there is a risk of overloading the vehicle.

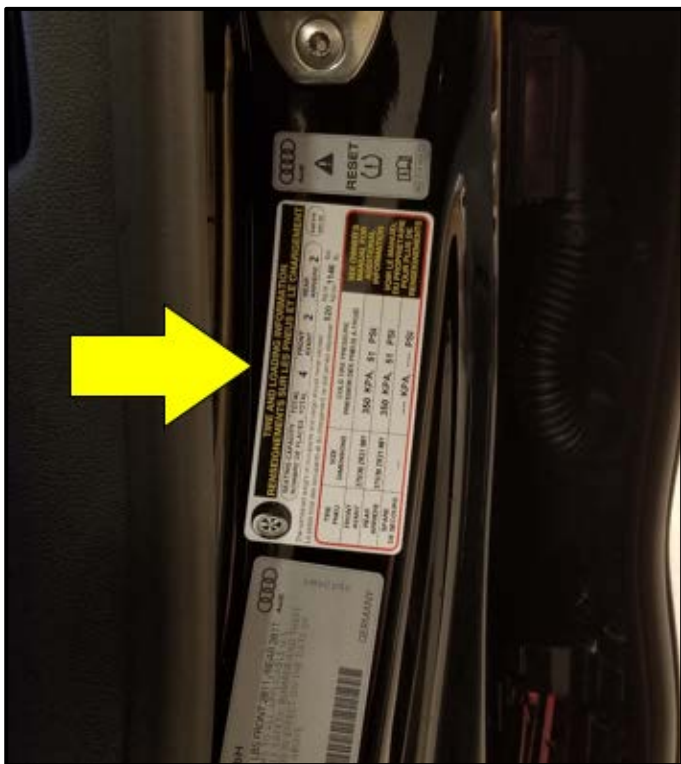
- Open the driver front door.
- Locate the "Tire and Loading Information" label on the B-pillar.
- Clean the surface of the existing label.
- Peel the replacement label off the backing paper.
- Affix the replacement label <arrow> over the existing label.

Ensure the correct label is affixed to the correct vehicle.

- Ensure minimal air bubbles are created when installing the new label.

- The surface of the existing label must be clean, dry, and free from oil residue prior to applying the replacement label.
- The replacement label **MUST** cover the existing label completely.
- Handle the replacement label carefully. Do not touch the adhesive backing.
