Remove "Hopkins Electronic Taillight Converter Harness" from Chassis and Replace with Part # 04101971

1.0	<p align="center">Field Repair Work Instruction Replace "Hopkins" Electronic Taillight Converter Harness (1/2 hour labor allowance @ \$68/hr. + \$5 applicable shop supplies)</p>

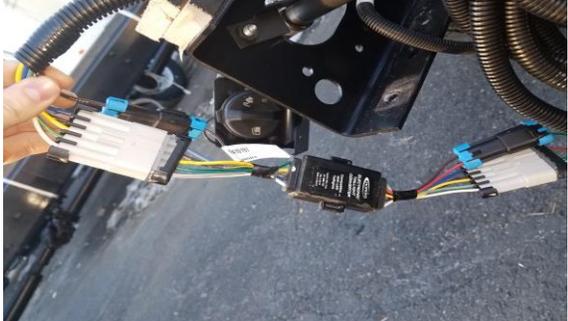
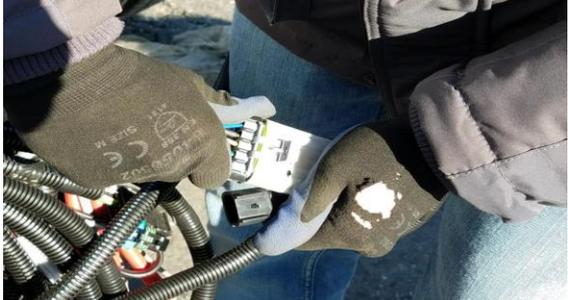
3.0	<p>STEP 2: Removing and Replacing Harnesses</p> <p><u>Part A: Locating the converter Harness</u></p> <p>This part is a small black plastic module with "Hopkins Electronic Taillight Converter" marked on one side.</p> <p>Converter will be a plug n play harness, -identifiable with Metri-Pac connectors at both ends and will be located between the chassis cab and the taillight harness (typically found inside Chassis Frame rail at rear).</p> <p><u>Part B: Replace Converter harness with Morgan supplied harness</u></p> <p>Disconnect Metri-Pac connectors at each end to remove converter harness from vehicle</p> <p>Reconnect Metri-Pac connectors and tug on each connection to ensure a secured fit**</p> <p>Re-secure harness with wire ties to original location</p> <p>Confirm that Lights are operational and compliant to FMVSS-108.</p>
