# Safety Recall **Code: 69Q9**

Subject	TAKATA SDI Driver Frontal Airbag Inflator			
Release Date	June 29, 2018			
<b>Revision Summary</b>	Repair available for criteria T2.			
Affected Vehicles	U.S.A. & CANADA: Certain 2007-2014 MY Volkswagen vehicles equipped with a Takata SDI driver frontal airbag			
	Check Campaigns/Actions screen in Elsa on the day of repair to verify that a VIN qualifies for repair under this action. Elsa is the <u>only</u> valid campaign inquiry & verification source.			
	✓ Campaign status must show "open."			
	<ul> <li>If Elsa shows other open action(s), inform your customer so that the work can also be completed at the same time the vehicle is in the workshop for this campaign.</li> </ul>			
Problem Description	The driver airbag may explode in a crash with airbag deployment. Sharp metal fragments can hit people and cause serious injury or death.			
Corrective Action	Replace the driver frontal airbag inflator with a newly manufactured version. This repair is the <u>final</u> remedy.

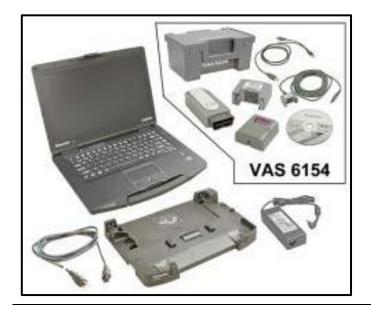
- Ensure ODIS is updated to the latest version. •
- Connect vehicle diagnostic tester. •
- Select Start Diagnosis function and identify • vehicle.
- After identification of control units, Guided Fault • Finding is started automatically.
- Follow the instructions on screen. •

In operating mode Special Functions, Select "Production status documentation part number on the • replacement airbag module/gas generator" <arrow>.

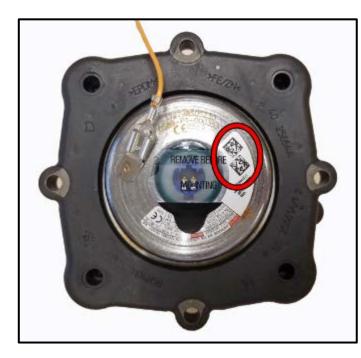
- Place the new inflator on the ESD mat. •
- Scan the data matrix code of the new inflator at a • distance of about 15 cm.

Ensure the correct inflator data matrix code is scanned at this time.								
Crit. Model (model code) Part Number								
N1	Passat (3C)	3C0898201H						
T1	Passat Wagon (3C)	3C0898201J						
N2	Eos (1F) CC (35) Golf/GTI (1K, 5K)	3C8898201B						
T2	Rabbit (1K) Passat (3C)	3C8898201C

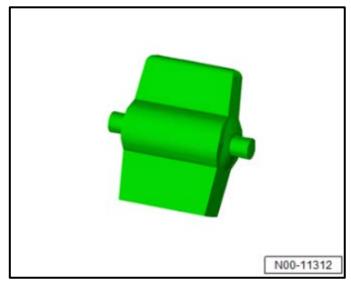
- Disengage connector lock <3> using a small flat bladed screwdriver.
- Remove connector <1> using needle nose pliers. •

- Do not use a screwdriver to pry off connector • <1> or damage to the connector could occur.
- Damage to the airbag connectors will not be covered under this action.
- Remove ground cable <2>.

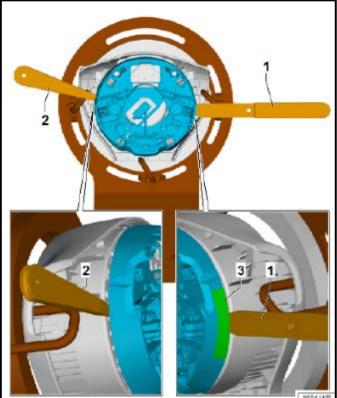
Remove locking pins <arrows> for horn ring with aid of longnose pliers.

- Apply lever -T10571- <1> in shaded area <3>. At • the same time, apply removal wedge -3409- on the other side <2> and lever off horn ring.
- Repeat work steps on other side.

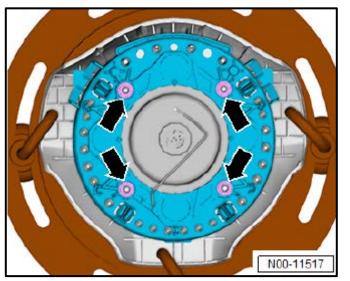
The nuts are self-locking and must be replaced

Fit cover for inflator and tighten 4 nuts <arrows> • to 5 Nm ± 0.4 Nm.

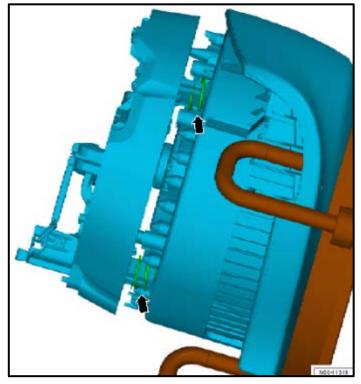
Fit springs <arrows> for horn ring again and allow • to engage audibly.

Position horn ring <arrows> with springs on • securing clips and press firmly in place. Ensure that springs are seated correctly on both sides.

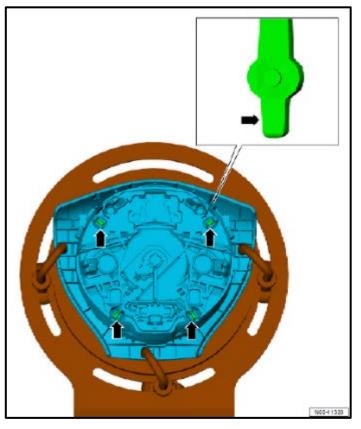
If a pin is damaged or has been lost, it can be replaced with a locking pin from the bag of spares included.

Using long-nose pliers, insert four locking pins in retaining lugs with narrow side facing downwards <arrow in magnification>. Pins must engage audibly.

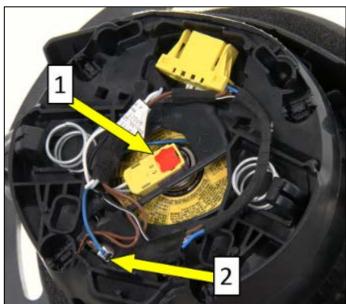
Connect central connector <1> on inflator.

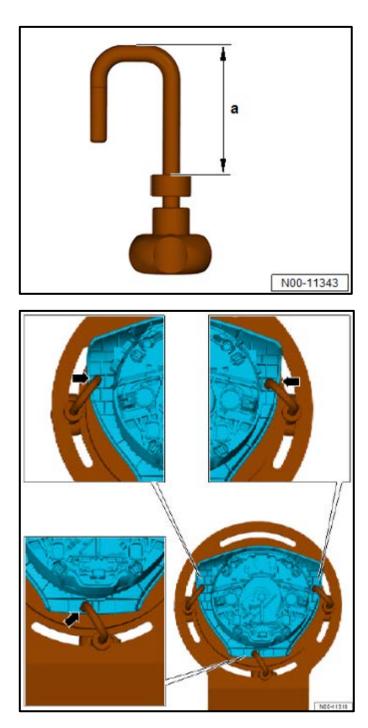
- The three spoke steering wheel has three • mounting points.
- Tighten mounting by hand to prevent damage.
- Adjust three knurled nuts of securing hooks to <dimension a> 50mm.

The clamps must be placed in the positions shown <arrows> to prevent damage to the airbag. Damage to the airbag is not covered under this action.

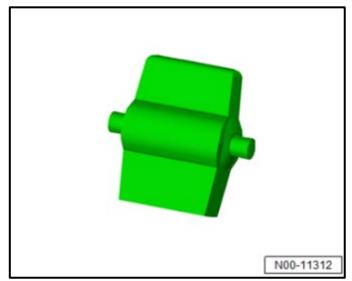
- Disengage connector lock <3> using a small flat bladed screwdriver.
- Remove connector <1> using needle nose pliers. •

- Do not use a screwdriver to pry off connector • <1> or damage to the connector could occur.
- Damage to the airbag connectors will not be covered under this action.
- Remove ground cable <2>.

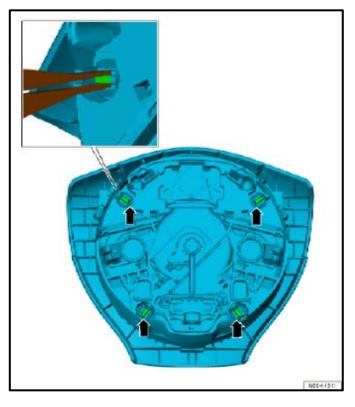
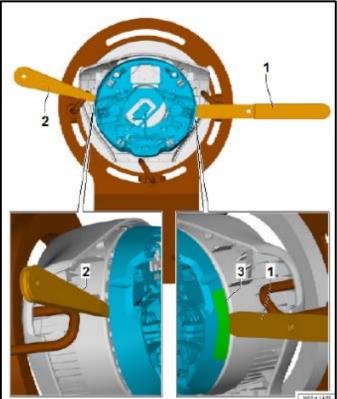
Remove locking pins <arrows> for horn ring with aid of longnose pliers.

- Apply lever -T10571- <1> in shaded area <3>. At • the same time, apply removal wedge -3409- on the other side <2> and lever off horn ring.
- Repeat work steps on other side.

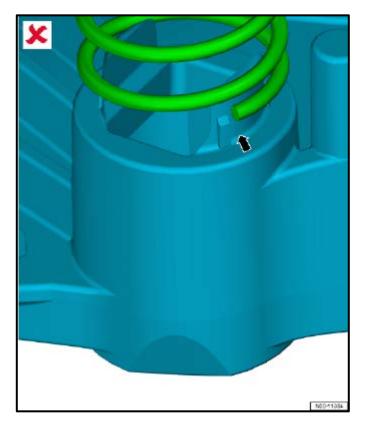
- If one of the springs is damaged or has been lost, • it can be replaced with a spring from the bag of spares included.
- Note the examples shown for reference of proper spring seating.
- Spring seated incorrectly <arrow>. •

Spring seated correctly <arrow>.

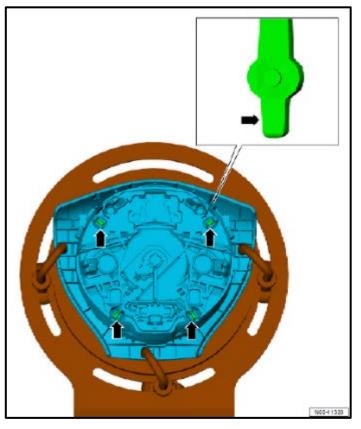
If a pin is damaged or has been lost, it can be replaced with a locking pin from the bag of spares included.

Using long-nose pliers, insert four locking pins in retaining lugs with narrow side facing downwards <arrow in magnification>. Pins must engage audibly.

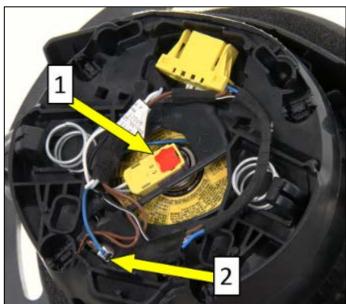
Connect central connector <1> on inflator.

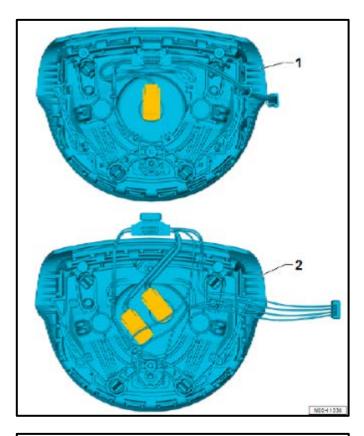
- The four spoke steering wheel has two mounting • points.
- Tighten mounting by hand to prevent damage. •
- Adjust three knurled nuts of securing hooks to <dimension a> 50mm.

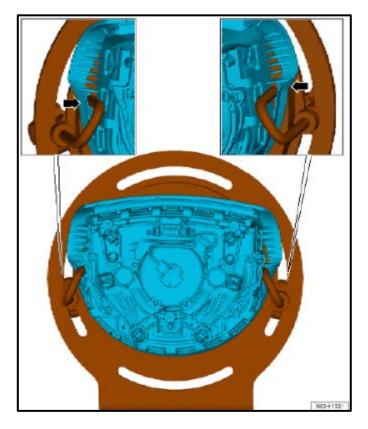
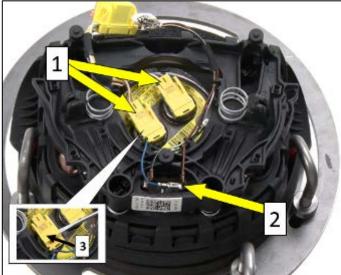
Clamp airbag centrally in airbag support. Securing points on the sides <arrows> and parallel, opposite each other.

The clamps must be placed in the positions shown <arrows> to prevent damage to the airbag. Damage to the airbag is not covered under this action.

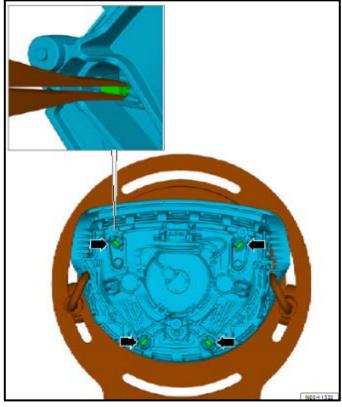
- The locking pins are to be reused. •
- There may be instances in which short locking • pins are fitted. These can be levered out with a small screwdriver.

Remove locking pins <arrows> for horn ring with • aid of longnose pliers.

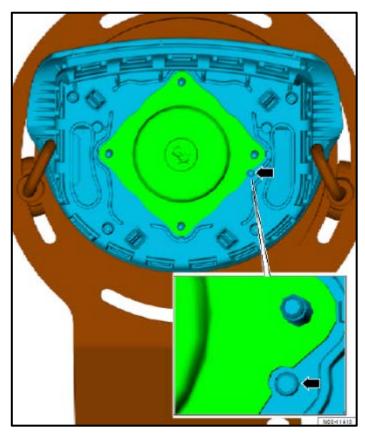
Remove horn ring with springs <arrows>.

- When removing the horn ring, take care that the • springs are not lost as they are not available sepereately.
- **ONE** replacement spring is included in the inflator • kit in the event a spring is lost or damaged.
- If more than one spring is lost, replacement of the • airbag is required. Replacement of the airbag is required if a spring is lost and is not covered under this action.
- Remove and discard nuts <arrows>. •
- Remove the inflator and place in the original packaging.

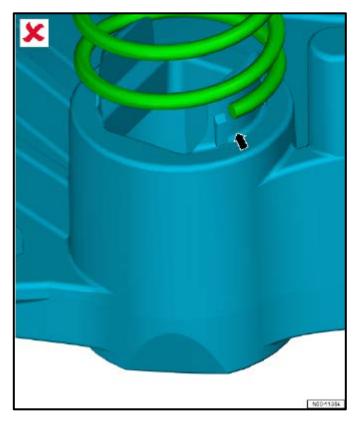
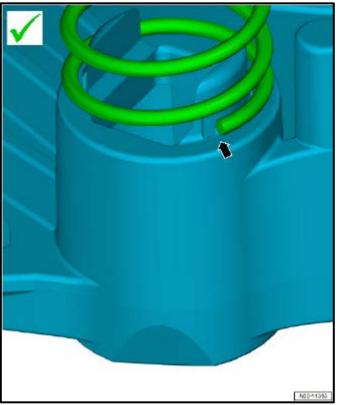
- If one of the springs is damaged or has been lost, • it can be replaced with a spring from the bag of spares included.
- Note the examples shown for reference of proper spring seating.
- Spring seated incorrectly <arrow>. •

Spring seated correctly <arrow>.

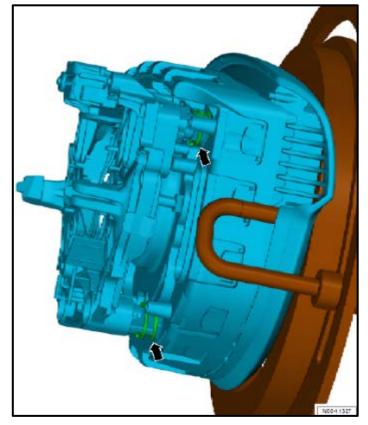
Fit springs <arrows> for horn ring again if necessary.

Position horn ring with springs on securing clips • and press firmly in place. Ensure that springs are seated correctly on both sides <arrows>.

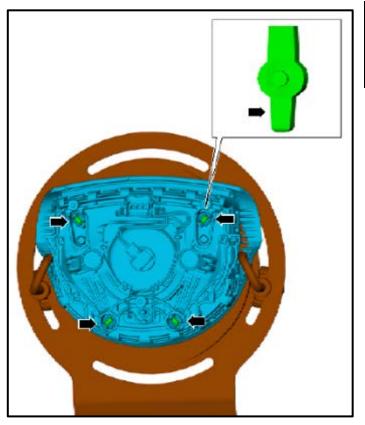
Using long-nose pliers, insert four locking pins in retaining lugs with narrow side facing downwards <arrow in magnification>. Pins must engage audibly.

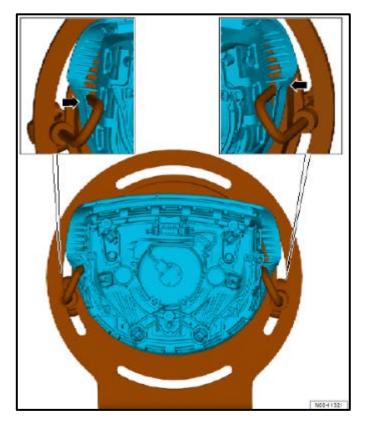
Clamp airbag centrally in airbag support. Securing points on the sides <arrows> and parallel, opposite each other.

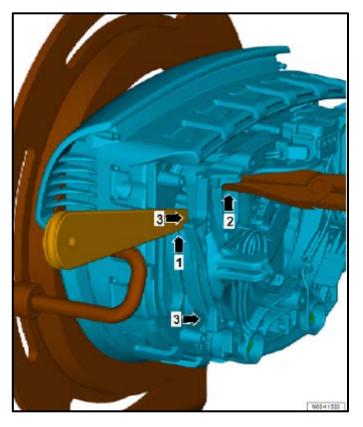
Remove locking pins <arrows> for horn ring with • aid of longnose pliers.

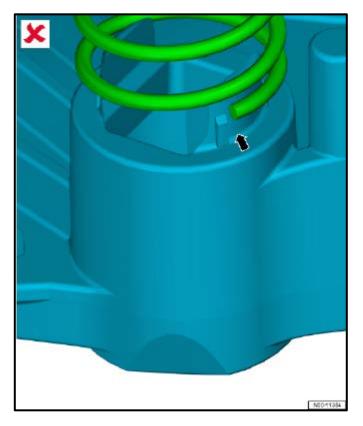
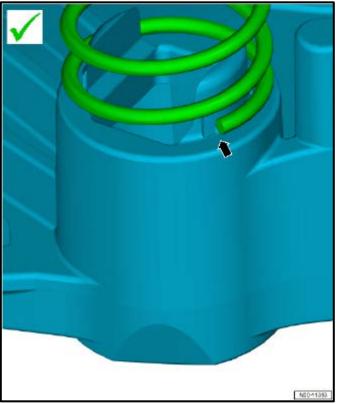
- If one of the springs is damaged or has been lost, • it can be replaced with a spring from the bag of spares included.
- Note the examples shown for reference of proper spring seating.
- Spring seated incorrectly <arrow>. •

Spring seated correctly <arrow>.

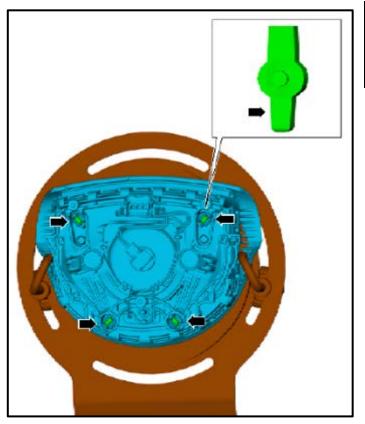
• Using long-nose pliers, insert four locking pins in retaining lugs with narrow side facing downwards <arrow in magnification>. Pins must engage audibly.

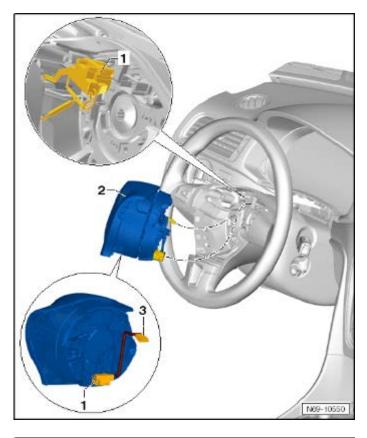
- The battery must be disconnected before • installing the airbag back into the vehicle.
- Before handling pyrotechnic components (for example, disconnecting the connector), the person handling it must "discharge static electricity". This can be done by touching the door striker, for example.
- Connect the connector <1>. The connector must click into place during this.
- Press the connector lock on the connector <1>.
- Connect the connector <3> (if equipped).
- Insert the airbag unit <2> into the steering wheel but do not press on it.

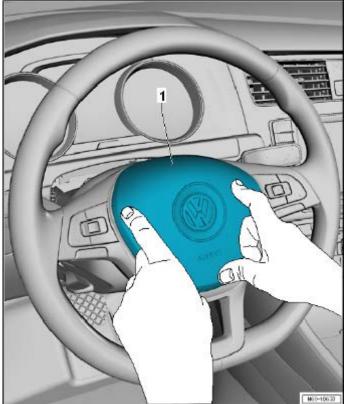
- Press on the edge of the airbag unit <1> with both hands until it locks into place.
- Gently pull on the airbag unit to make sure the airbag unit is secured correctly at all three attachment points in the steering wheel.

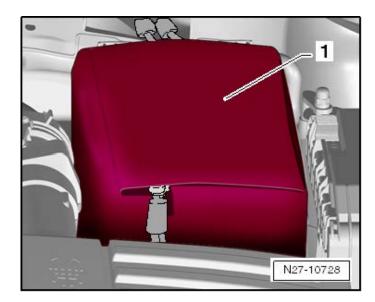
- Close the cover <1>.
- Cycle the ignition off and back on. •
- Bring driver seat to an upright position. •
- Store previously recorded radio presets (if • necessary).
- Set clock to local time. •
- Activate the power window regulator one-touch • up/down function.
- Check the DTC memories of all the control units • and erase under-voltage faults if necessary.
- After completing repairs, verify the horn is operational.
