TECHNICAL INSTRUCTIONS

SAFETY RECALL J0K

VACUUM PUMP

**CERTAIN 2018 Toyota Highlander
2017 Toyota Sienna**

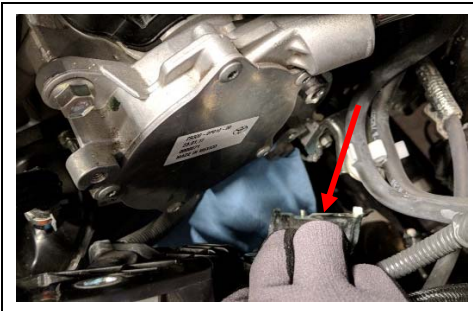
- 4. REMOVE THE VACUUM PUMP**
 - a. Pull back on wiring harness to gain access to the 3 vacuum pump bolts as shown in the picture.

Note: Place shop towel underneath pump to catch any oil during pump removal.
