July 2018  
FL771AB  
NHTSA #18V-300  
Transport Canada #2018-245

## **Subject: Freightliner Cascadia Steering Wheel Airbag Fasteners**

**Models Affected: Specific Cascadia vehicles manufactured December 19, 2017, through April 12, 2018, and equipped with an optional steering wheel airbag.**

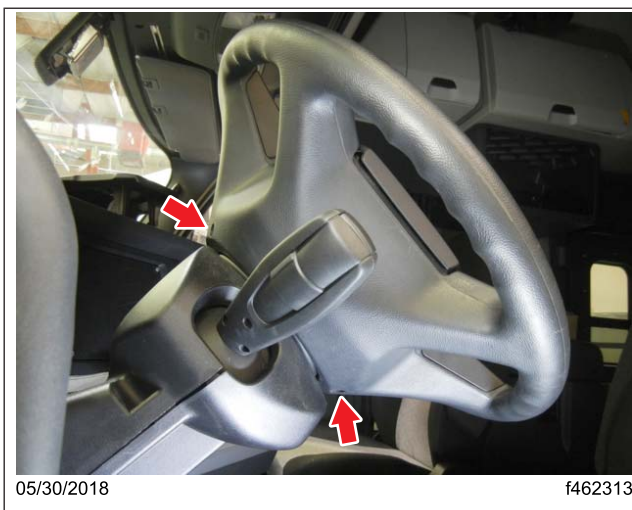
1. Check the base label (Form WAR259) for a completion sticker for FL771 (Form WAR260) indicating this work has been completed. The base label is usually located on the passenger-side door, about 12 inches (30 cm) below the door latch. If a completion sticker is present, no work is needed. If a completion sticker is not present, proceed to the next step.
2. Park the vehicle on a level surface, shut down the engine, and set the parking brake. Chock the tires.
3. Turn the steering wheel 90 degrees to access the airbag retainer screws. See [Fig. 1](#).

**Fig. 1, Locations of the airbag Retainer Screws with the Steering Wheel Turned 90 Degrees**

4. Tighten the two airbag retainer screws 44 to 53 lbf-in (500 to 600 N-cm).
  - **FL771A:** If one or both airbag retainer screws are missing, replace them. See [Table 1](#) for the part number.
  - **FL771B:** If one or both airbag retainer screws are missing, replace the steering wheel. This is expected to be rare. Submit a pre-approval request for steering wheel replacement.
5. Clean a spot on the base label (Form WAR259). Write the campaign number, FL771, on a blank red completion sticker (Form WAR260) to indicate the work has been completed and attach it to the base label.
