# **SERVICE PROCEDURE**

18508

**SUBJECT: SAFETY RECALL**  
**Emergency Window Release Latch on certain IC Bus® CE Series school bus models built 15 March 2017 thru 22 January 2018 with feature code 0510140.**

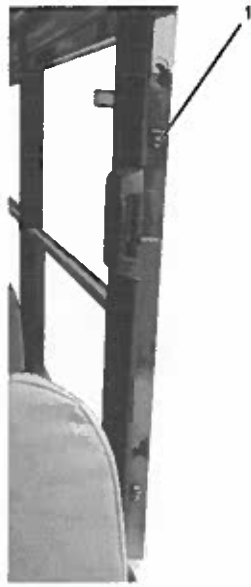
**Figure 2. Upper Tab**

1. Upper tab

6. Locate upper tab (Figure 2, Item 1).

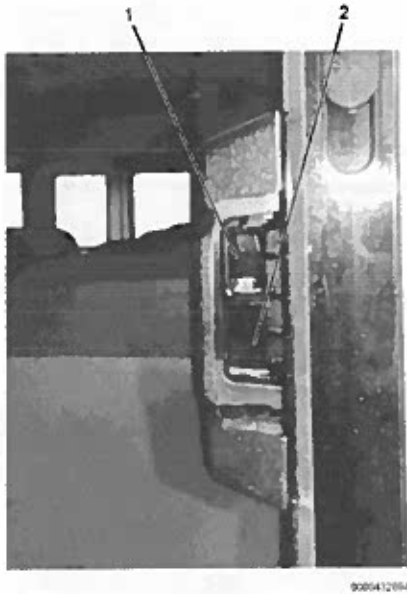
**Figure 4. Handle Catch**

1. Recessed surface
2. Slide

9. Locate handle catch.
10. Using WD-40 Specialist, apply lubricant to recessed surfaces above and below slide (Figure 4, Items 1 & 2).
11. To allow lubricant to penetrate mechanism, move slide up and down repeatedly.
12. Move slide down. Slide must be in down position in order for window to close completely.
13. Grasp emergency exit lift handle and pull window closed.
14. Push emergency exit lift handle to lock window.
15. Open, close, and lock window twice to ensure mechanisms are working freely.
16. Repeat Steps 5 through 15 for each side emergency window.
17. Remove wheel chocks.

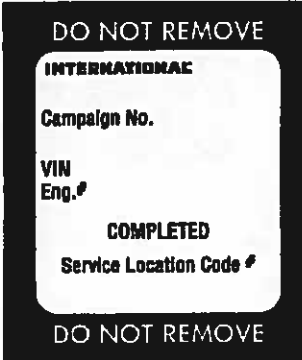
Each vehicle corrected in accordance with this campaign must be marked with a CTS-1075 Campaign Identification Label.

Complete the label and attach on a clean surface next to the vehicle identification number (VIN) plate.
