July 2018
FL772A-K
NHTSA #18V-353 (Non-School Bus)
NHTSA #18V-352 (School Bus)
Transport Canada #2018-285 (Non-School Bus)
Transport Canada #2018-284 (School Bus)
REVISED NOTICE

Subject: Brake Caliper Mounting Bolts

Models Affected: Specific Freightliner Business Class M2, Cascadia, Columbia, 108SD, and 114SD vehicles; Western Star 4700, 4900, and 5700 vehicles; Freightliner Custom Chassis B2, S2C, S2G, XB and XC chassis; and Thomas Built Buses Saf-T Liner C2, EFX, and HDX buses manufactured January 3, 2017, through October 31, 2017, and equipped with air disc brakes

On certain vehicles, insufficiently torqued caliper mounting bolts may not provide adequate clamping force between the brake caliper and brake anchor plate, potentially resulting in reduced brake effectiveness, which could lead to a crash.

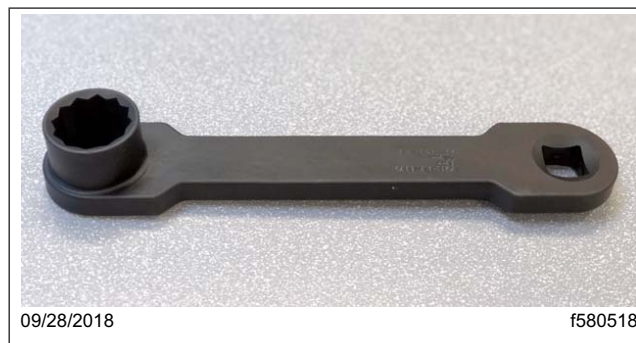
Fig. 1, DDC DSNCHA018005 30mm Air Disc Brake Caliper Brake Bolt Torque Adaptor

5. Set a torque wrench to 350 lbf-ft (475 N·m) and tighten the caliper mounting bolts. If they do not turn, go to step 13. If they turn, go to step 6. Due to limited caliper bolt access, it may be necessary to use tool DDC DSNCHA018005 referenced in tool letter 18TL18. If the tool is needed, use tool DDC DSNCHA018005 only and no other tools. See [Fig. 1](#). For torque specifications, see [Table 4](#) for a 47 in (119 cm) long wrench.

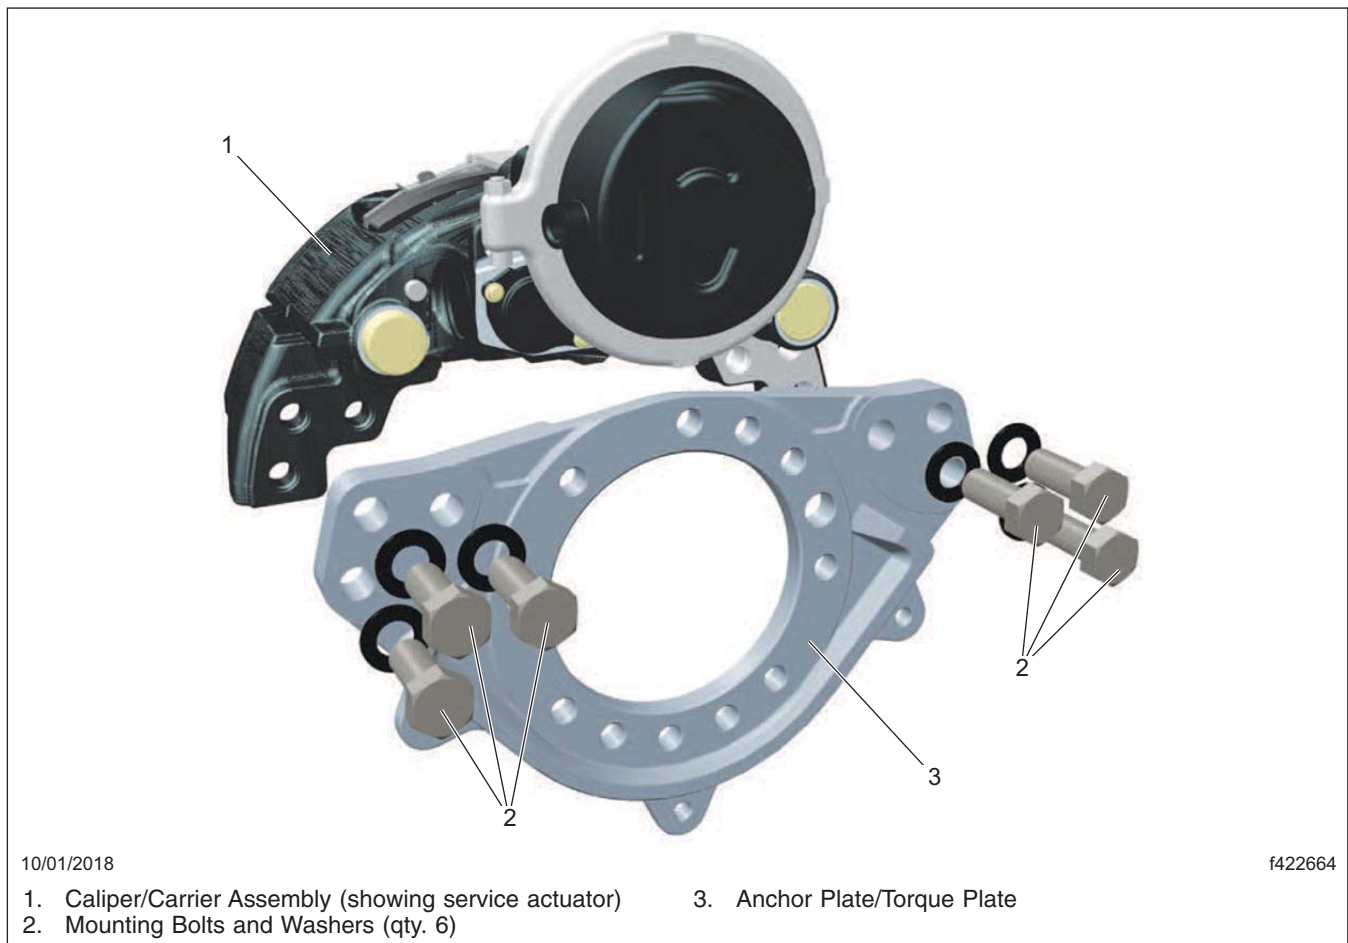
Fig. 2, Bendix Axial Mounted Caliper

9. Align each caliper/carrier assembly with the rotor by pushing the caliper against the shelf on the torque plate, then install the caliper/carrier assembly using new caliper mounting bolts. See [Fig. 2](#).

10. Tighten the carrier mounting bolts in two steps as follows.
 - 10.1 Start on one side of the caliper and tighten all three bolts 40 ± 20 lbf·ft (54 ± 27 N·m), beginning with the inner-most bolt and moving to the outer-most bolt. Then tighten the three bolts on the other side of the caliper 40 ± 20 lbf·ft (54 ± 27 N·m), beginning with the inner-most bolt and moving to the outer-most bolt. See [Fig. 3](#).
 - 10.2 Repeat this process, increasing the torque value to 375 ± 25 lbf·ft (508 ± 34 N·m). If tool DDC DSN-CHA018005 referenced in tool letter 18TL18 is used, see [Table 5](#) for torque specifications.

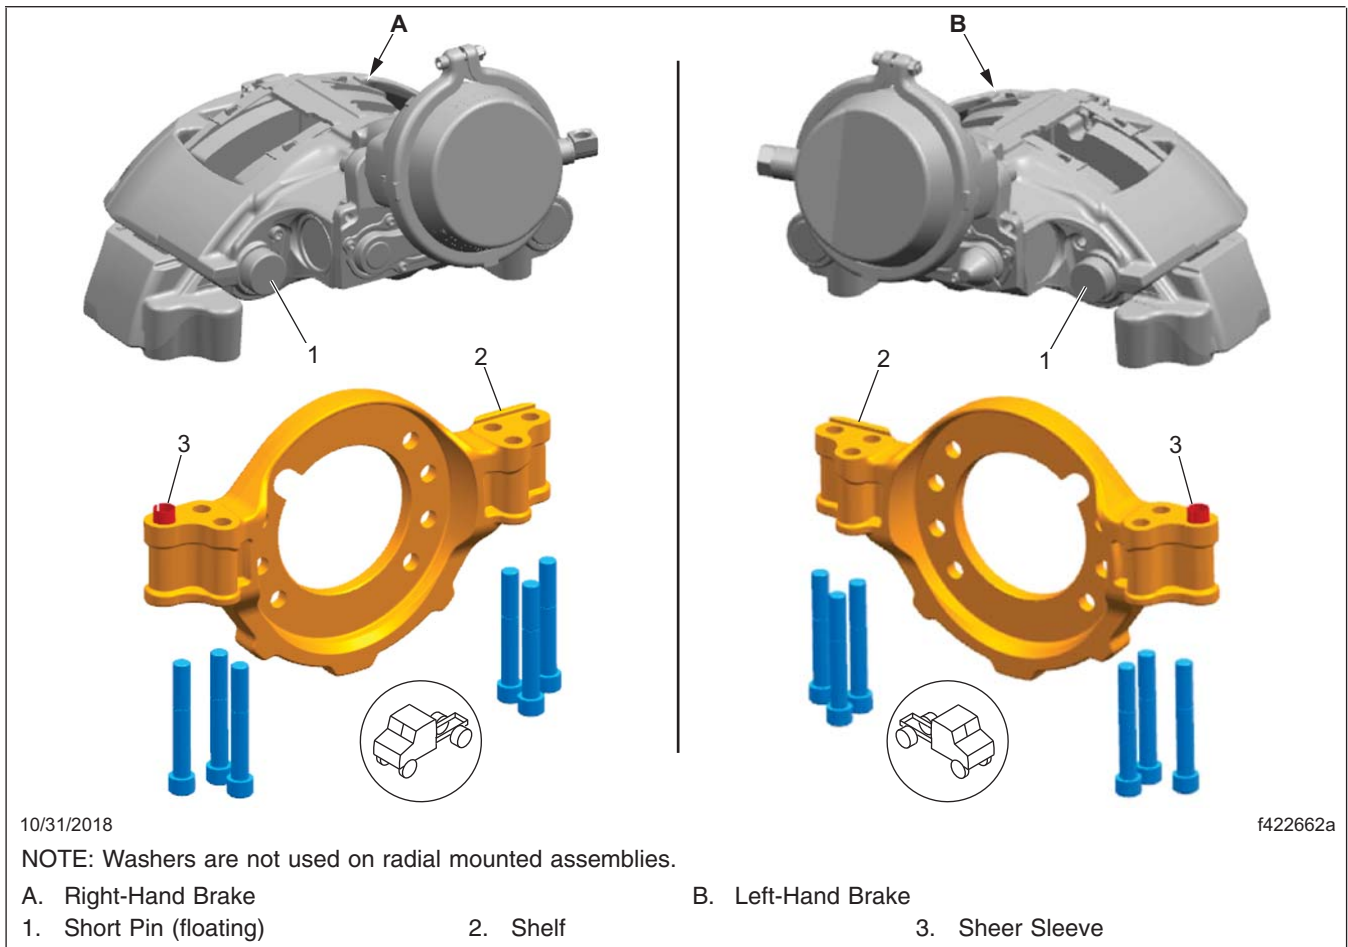
Fig. 4, Bendix Radial Mounted Caliper

- Align each caliper/carrier assembly with the rotor by pushing the fixed pin side of the caliper against the shelf on the torque plate, then install the caliper/carrier assembly using new caliper mounting bolts. See [Fig. 4](#).

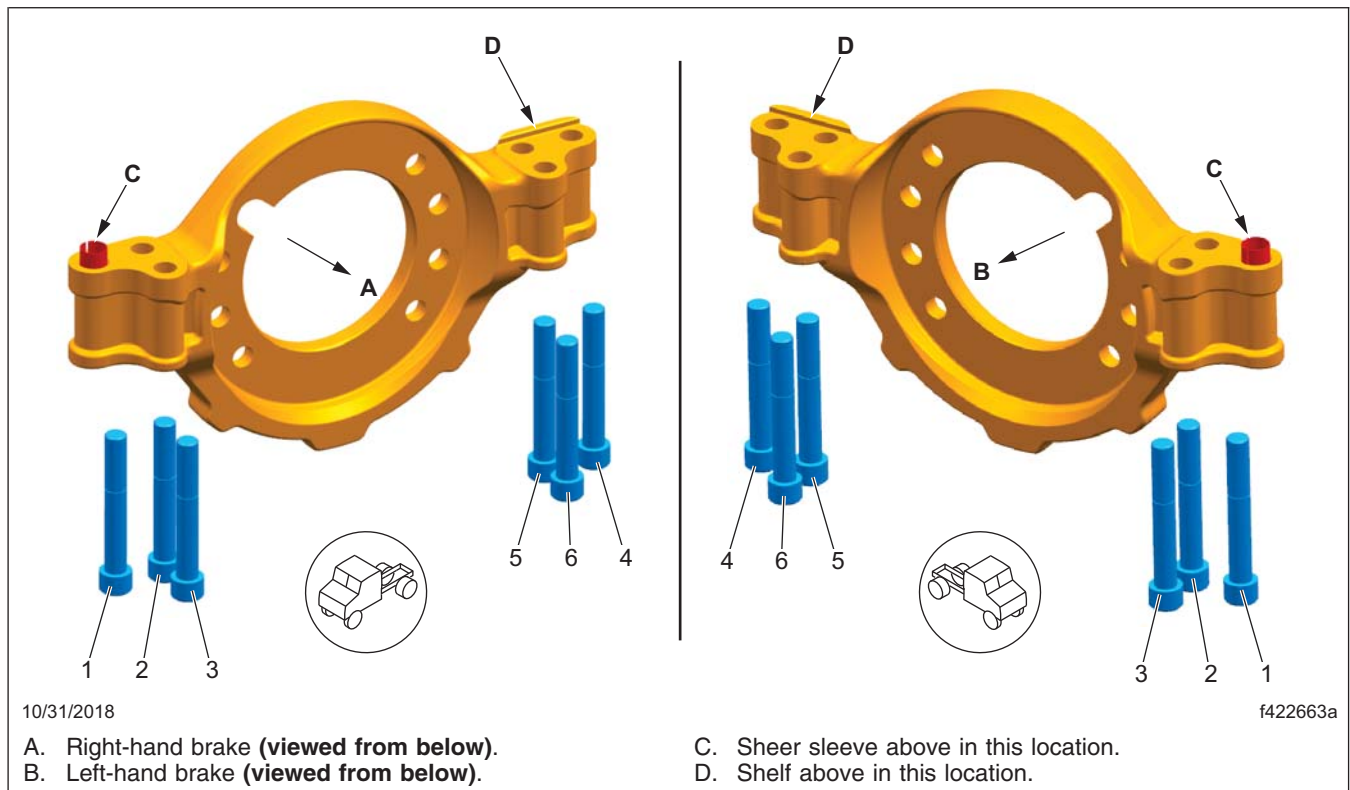
Fig. 5, Tightening Pattern (viewed from below), Bendix Radial Mounted Caliper

10.1 Initially tighten all six bolts 45 ± 5 lbf-ft (61 ± 7 N-m). Slide the caliper inboard and outboard, through the center of the chamber or brake. The caliper must have a minimum of 20 mm of travel. If the brake assembly does not move, or requires more than 40 pounds of force to move, the caliper has a binding issue. File a WSC ticket for instructions.

10.2 Perform a final tightening spec of 225 ± 22.5 lbf-ft (305 ± 31 N-m). Slide the caliper inboard and outboard, through the center of the chamber or brake. The caliper must have a minimum of 20 mm of travel. If the brake assembly does not move, or requires more than 40 pounds of force to move, the caliper has a binding issue. File a WSC ticket for instructions.

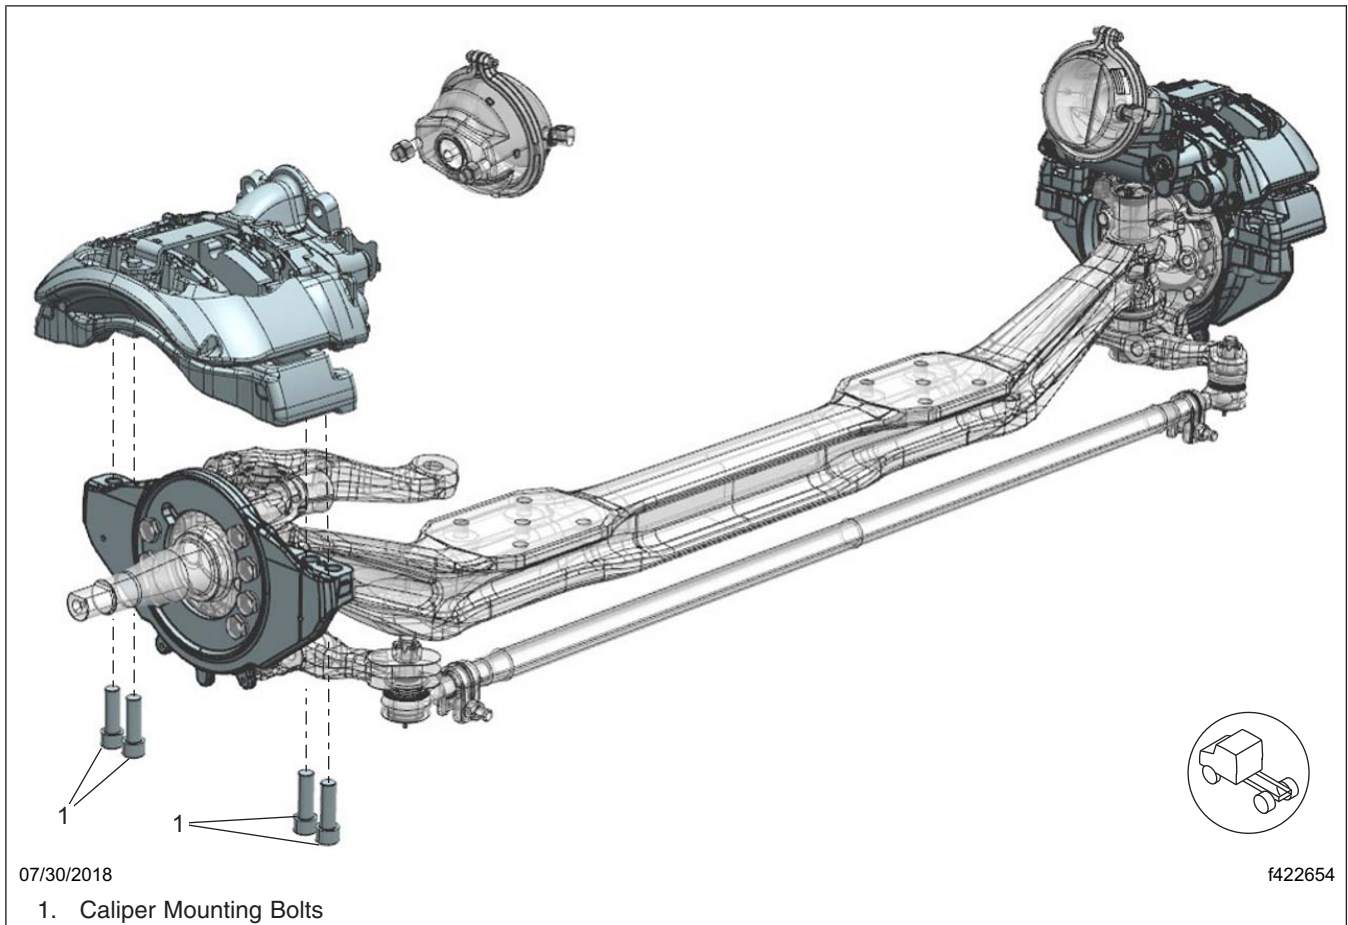
Fig. 7, Meritor Radial Mounted Caliper

9. Align each caliper/carrier assembly with the rotor by pushing the fixed pin side of the caliper against the shelf on the torque plate, then install the caliper/carrier assembly using new caliper mounting bolts. See [Fig. 7](#) and [Fig. 8](#).

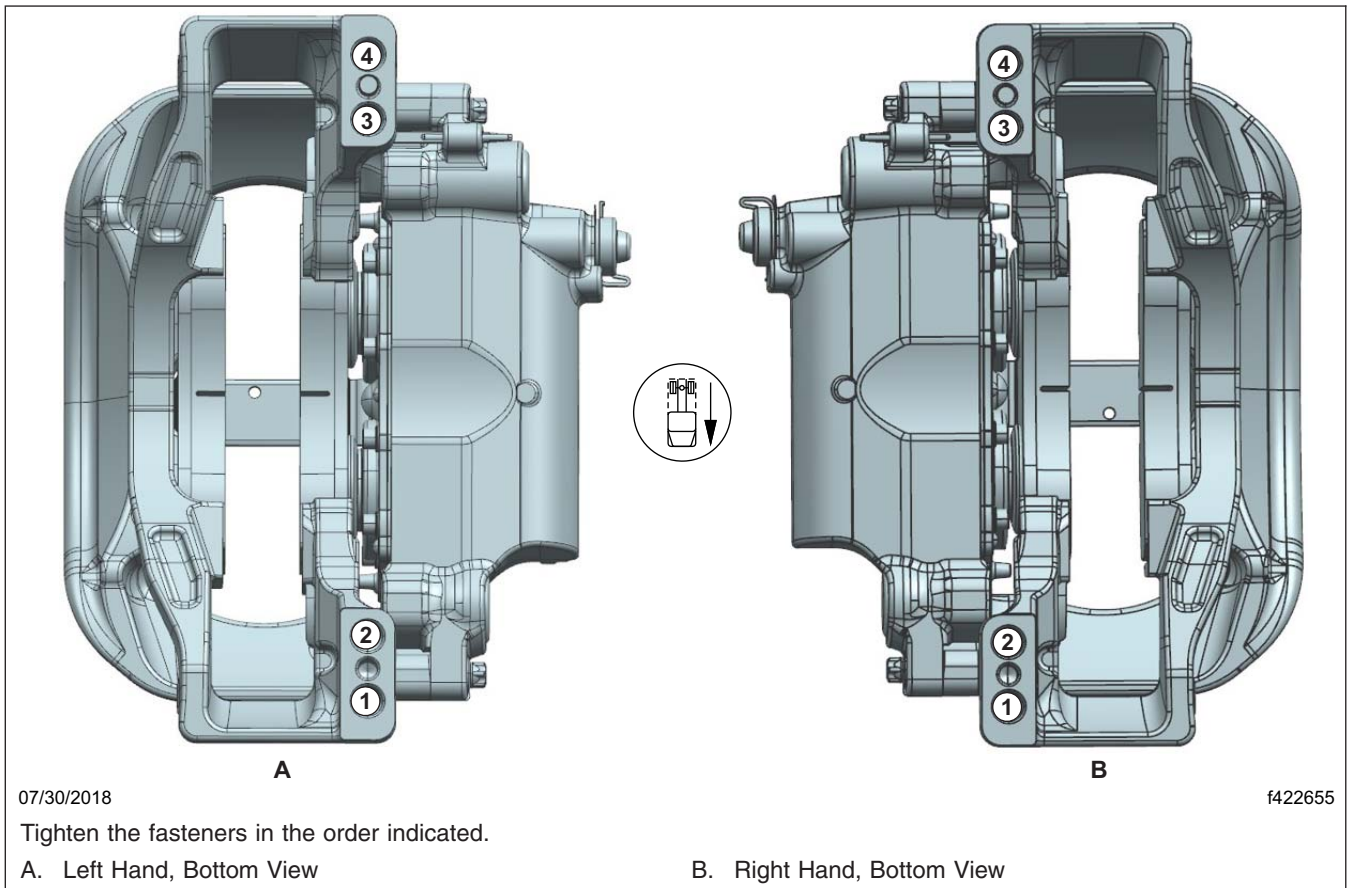
Fig. 8, Tightening Pattern, Meritor Caliper

NOTE: The tightening pattern will always start on the short (floating) pin side, with the bolt that passes through the shear sleeve.

10. Tighten the carrier mounting bolts in two steps, using the pattern shown in **Fig. 8**.
 - 10.1 Initially tighten all bolts 45 ± 5 lbf-ft (61 ± 7 N-m). Slide the caliper inboard and outboard, through the center of the chamber or brake. The caliper must have a minimum of 20 mm of travel. If the brake assembly does not move, or requires more than 40 pounds of force to move, the caliper has a binding issue. File a WSC ticket for instructions.
 - 10.2 Perform a final tightening spec of 400 ± 50 lbf-ft (542 ± 68 N-m). Slide the caliper inboard and outboard, through the center of the chamber or brake. The caliper must have a minimum of 20 mm of travel. If the brake assembly does not move, or requires more than 40 pounds of force to move, the caliper has a binding issue. File a WSC ticket for instructions.

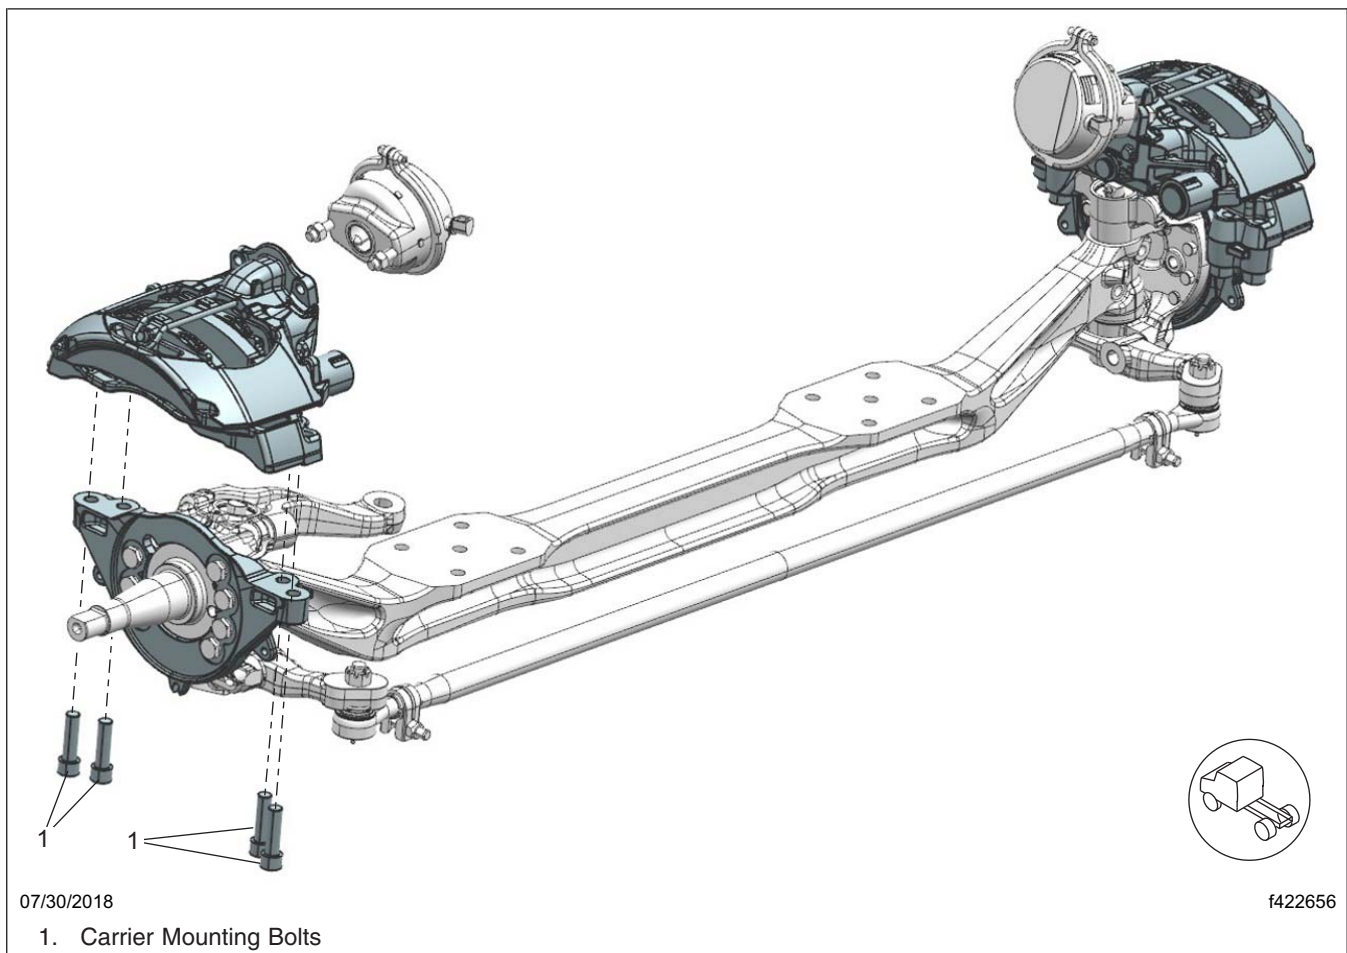
9. Align each caliper/carrier assembly with the rotor by pushing the fixed pin side of the caliper against the shelf on the torque plate, then install the caliper/carrier assembly using new caliper mounting bolts. See [Fig. 9](#) and [Fig. 10](#).

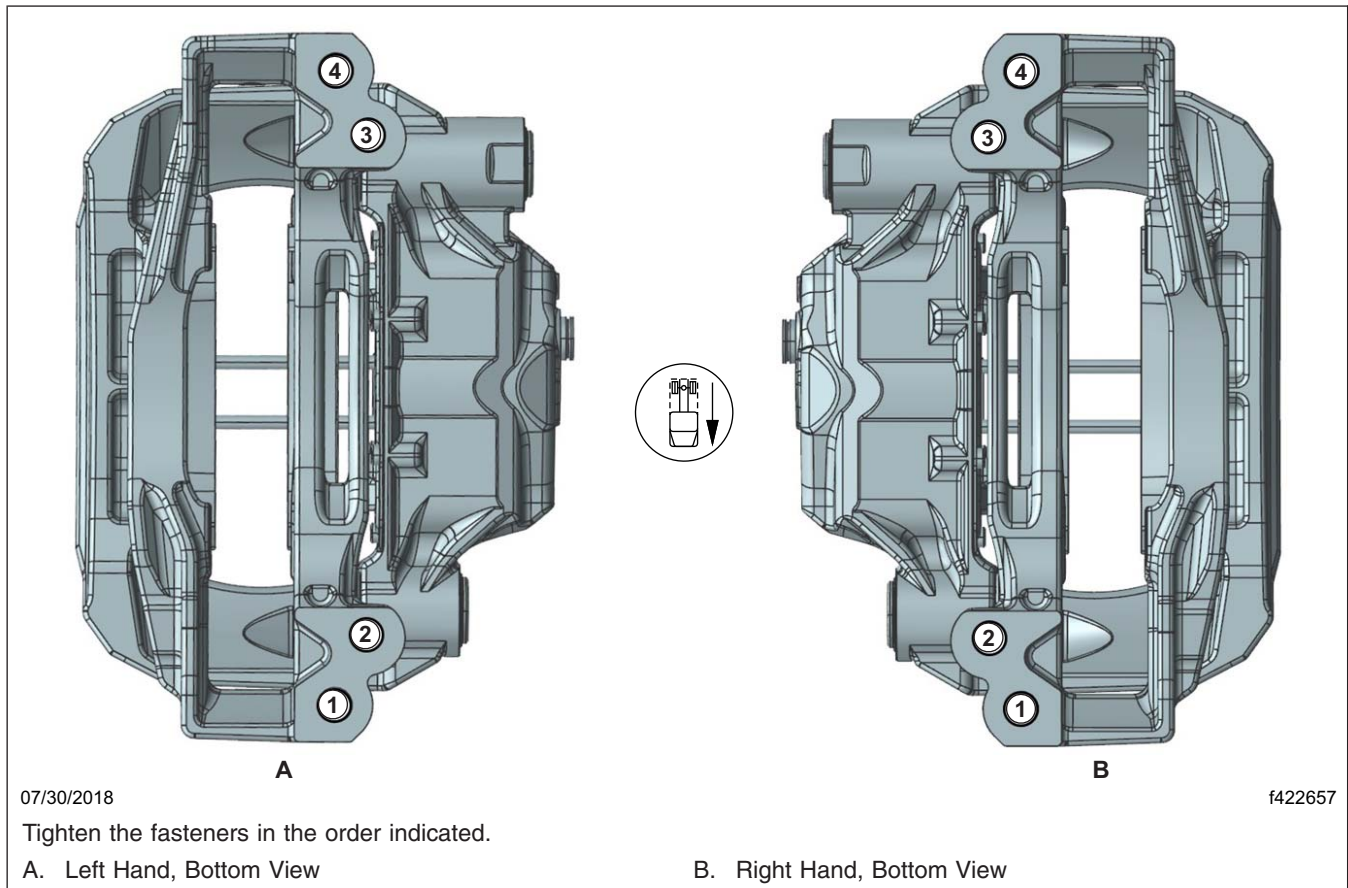
Fig. 10, Wabco Maxxus Radial Mounted Caliper Tightening Pattern

NOTE: The tightening pattern will always start on the short (floating) pin side, with the bolt that passes through the shear sleeve.

10. Tighten the carrier mounting bolts in two steps, using the pattern shown in **Fig. 10**.
 - 10.1 Initially tighten all bolts 45 ± 5 lbf·ft (61 ± 7 N·m). Slide the caliper inboard and outboard, through the center of the chamber or brake. The caliper must have a minimum of 20 mm of travel. If the brake assembly does not move, or requires more than 40 pounds of force to move, the caliper has a binding issue. File a WSC ticket for instructions.
 - 10.2 Perform a final tightening spec of 295 ± 22 lbf·ft (400 ± 30 N·m). Slide the caliper inboard and outboard, through the center of the chamber or brake. The caliper must have a minimum of 20 mm of travel. If the brake assembly does not move, or requires more than 40 pounds of force to move, the caliper has a binding issue. File a WSC ticket for instructions.

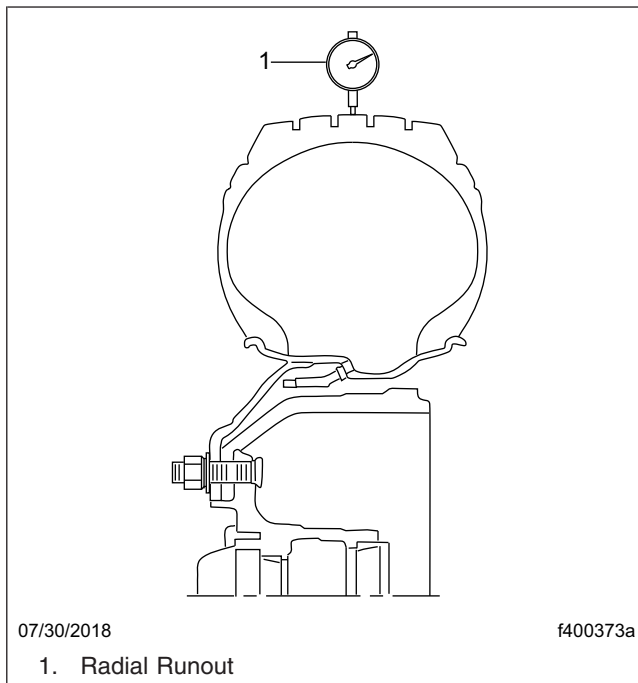
Fig. 11, Radial Runout Check for Tires

- Beginning with the right-front wheel, use a tire runout gauge to check the radial runout. See **Fig. 11**. Write down the measurement for later use to avoid vibration complaints.
- Mark the two studs closest to the valve stem as shown in **Fig. 12**, for proper wheel assembly location when reinstalling the wheel assembly on the hub.
