Revision 1 September 2018

Dealer Service Instructions for:

# Safety Recall U74 / NHTSA 18V- 486 Tailgate Latch

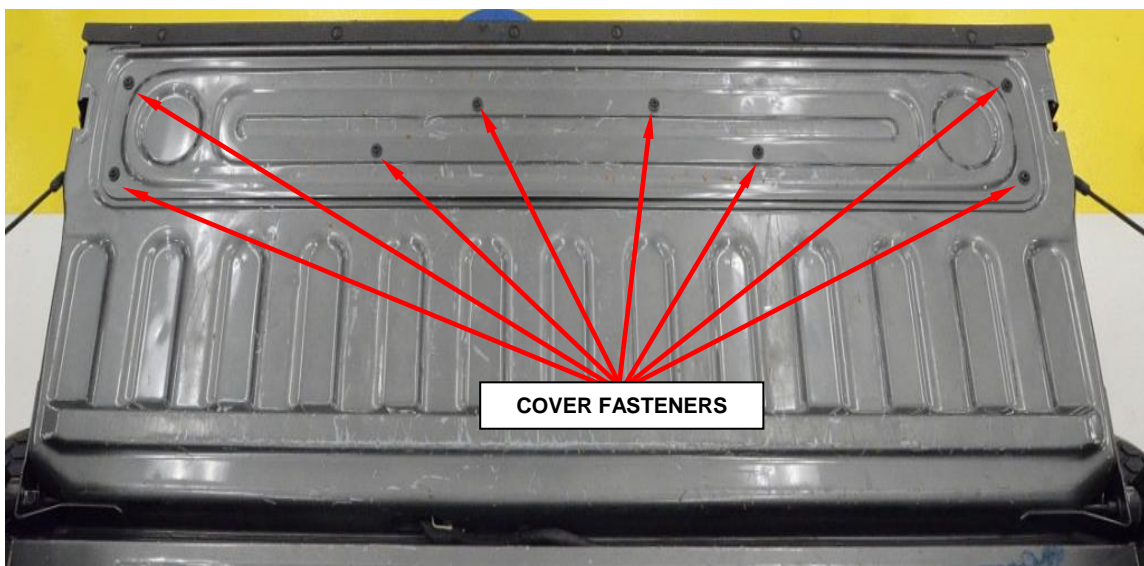
**Figure 1 – Tailgate Cover**

1. Open the tailgate.
2. If equipped with a tailgate liner, remove the screws and remove the tailgate liner.
3. Remove the fasteners that secure the tailgate cover to the inside of the tailgate and remove the cover (Figure 1).
