XC40 Brake Pedal rivet check

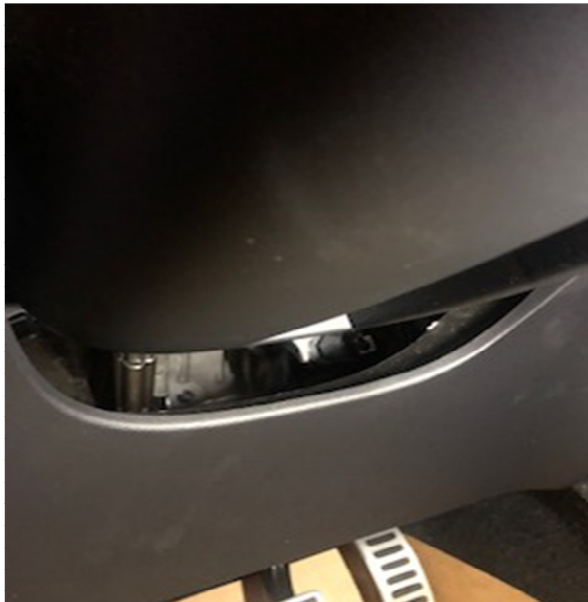
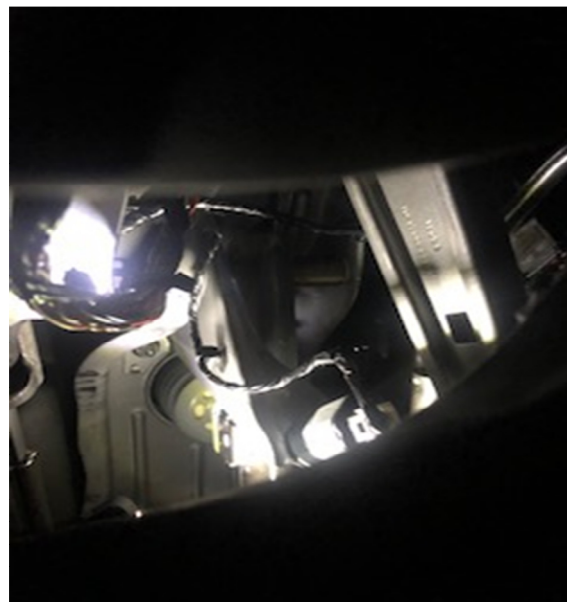
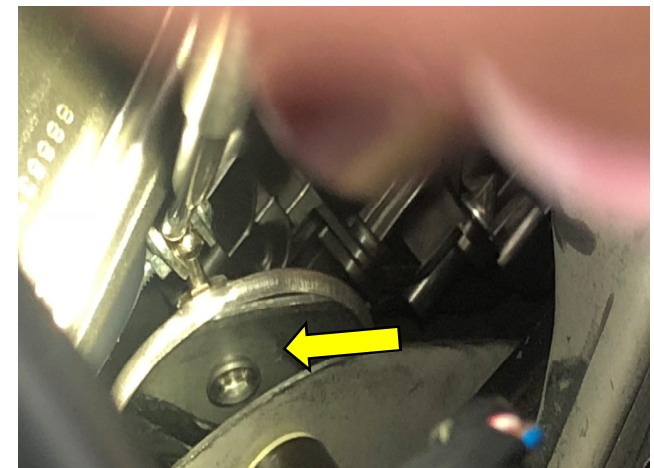
**Visual inspection  
with mirror**

Steering column pulled up

Looking through the column area Looking into the mirror at rivet

Check whether a solid flange is existing  
on both sides, (1 occasional crack on  
rivets are judged OK)

Check both sides of brake box with mirror for visual inspection

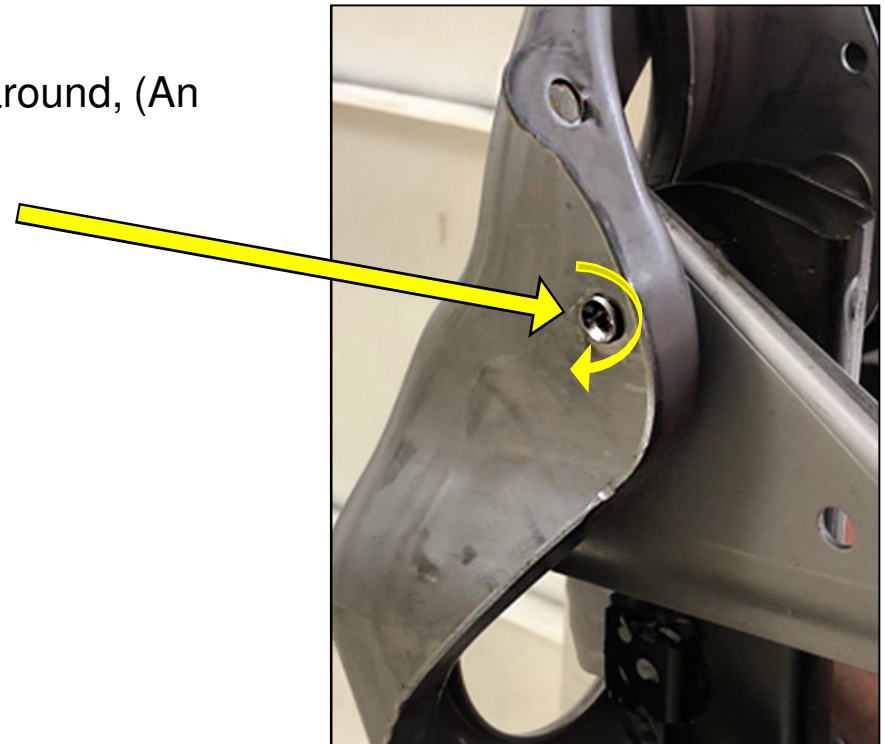
- Look at the perimeter for each rivet, both sides.
- Make sure that there is a solid flange all the way around, (An occasional crack is judged OK)
- Look at the inside for a circular shape

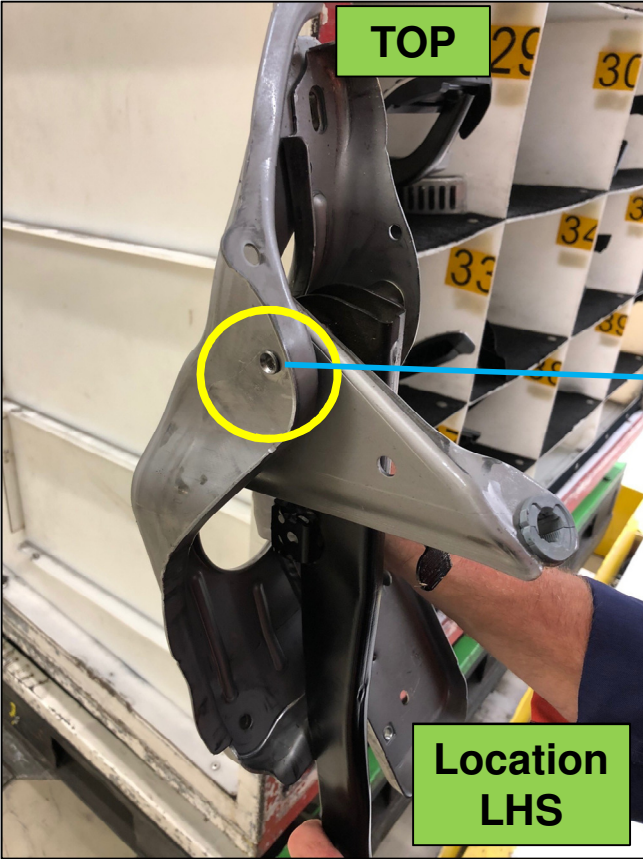
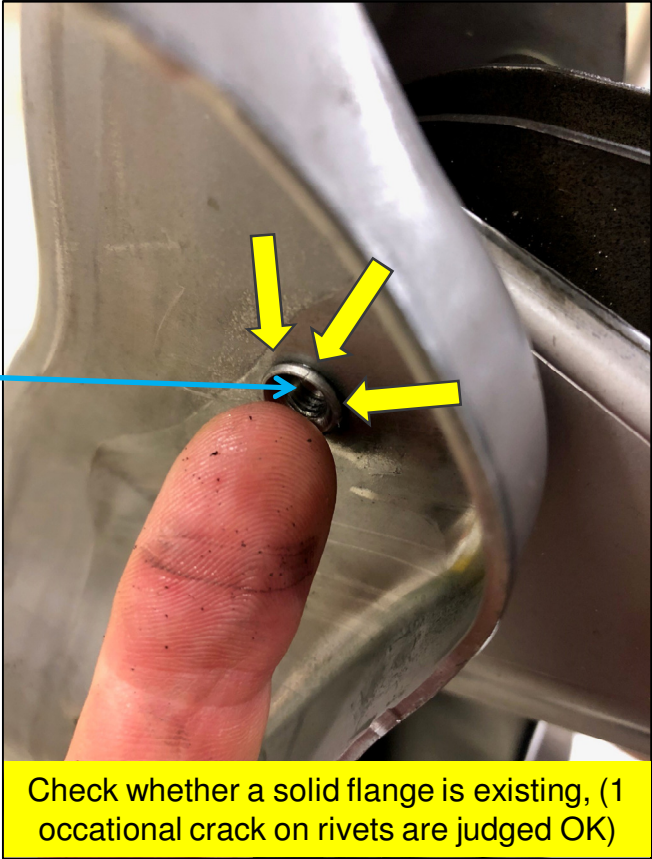
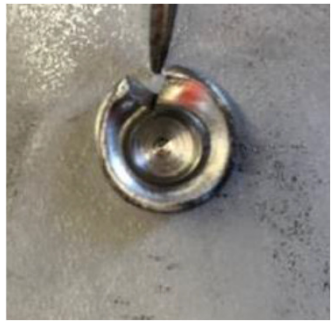
Orientation view

OK  
Rivet with 1 crack

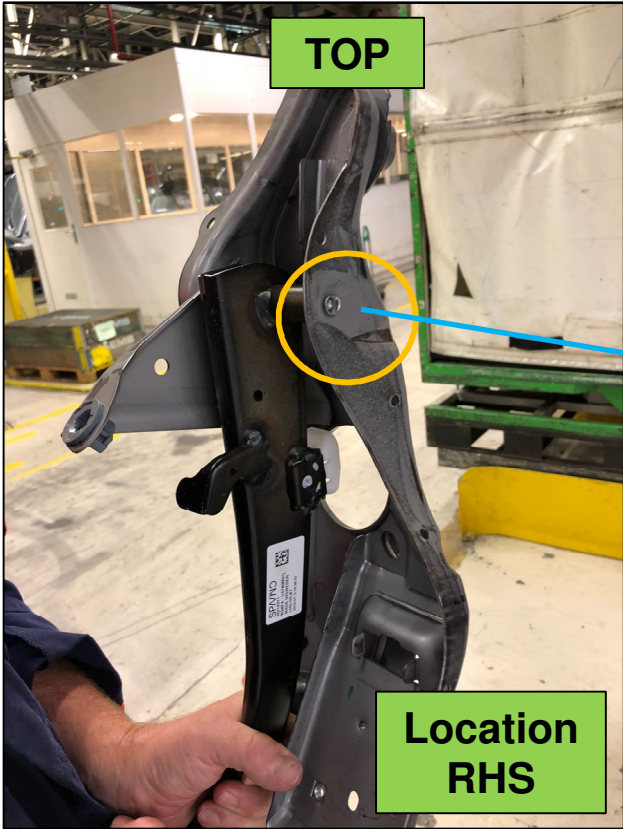
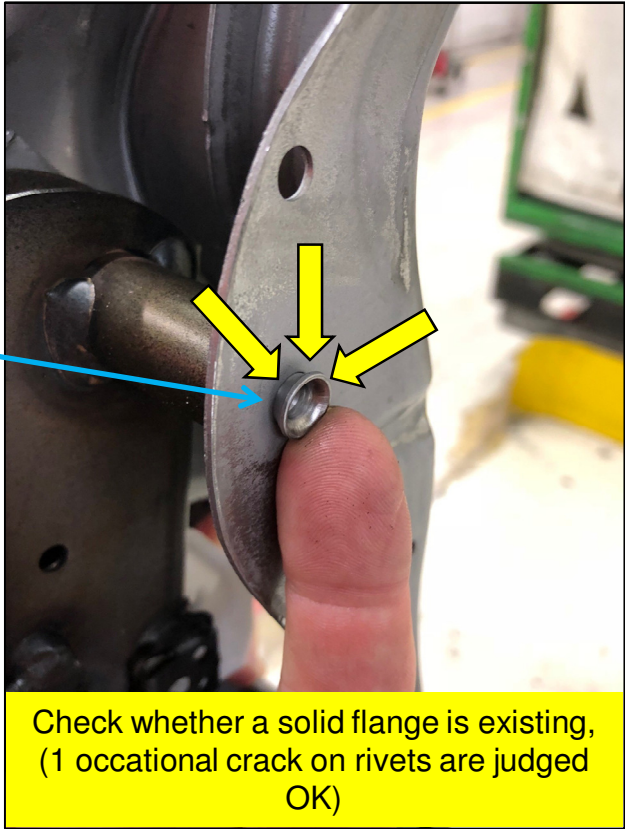
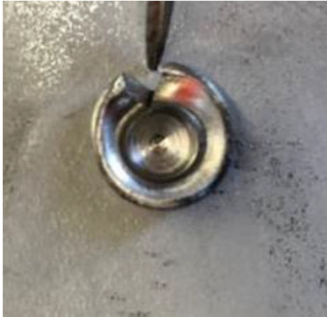
Orientation view

OK  
Rivet with 1 crack

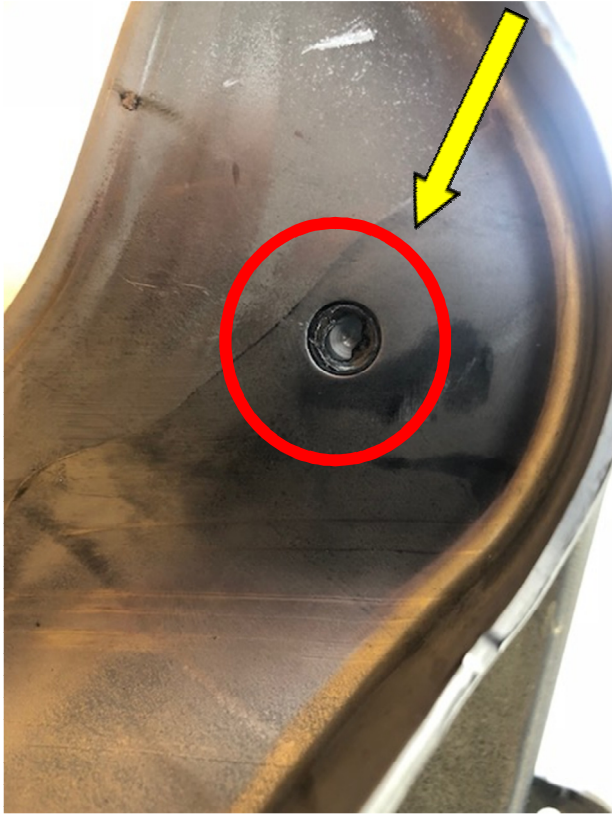
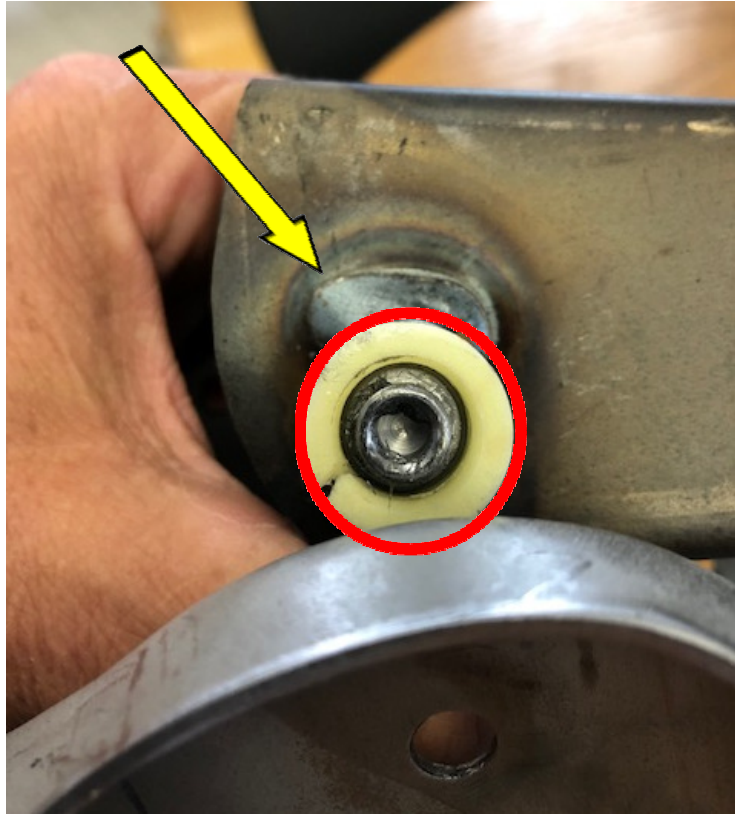
NOK

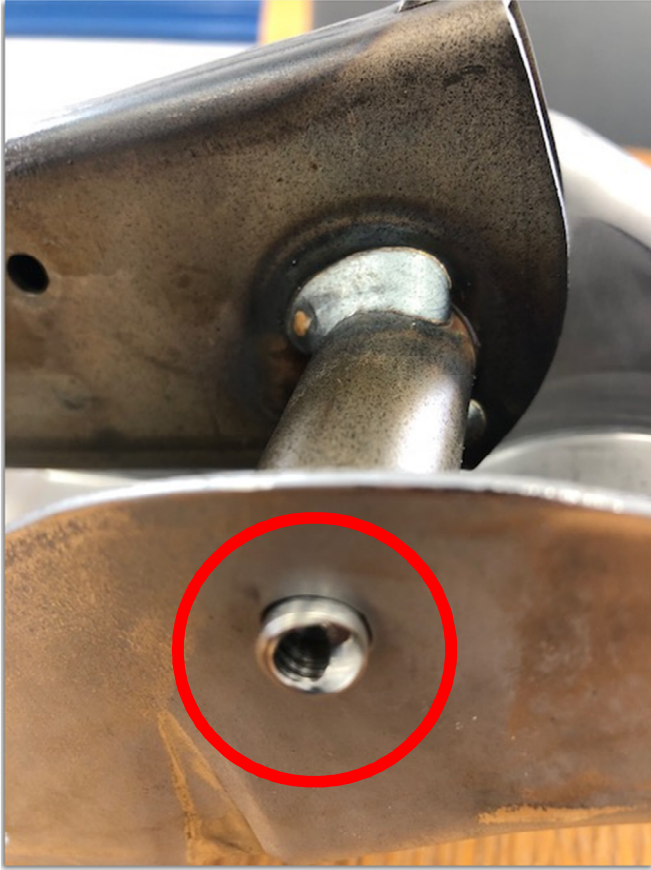
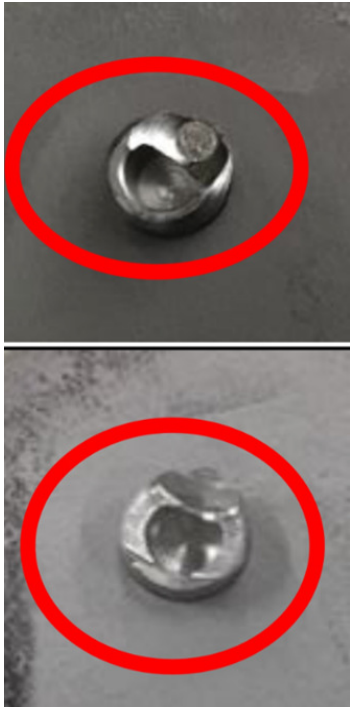
NOK
