## TRAIL KING Industries, Inc.

Inspect aluminum cross-members above each fixed axle suspension. All cracks will need to be evaluated by Trail King customer service to determine repair.

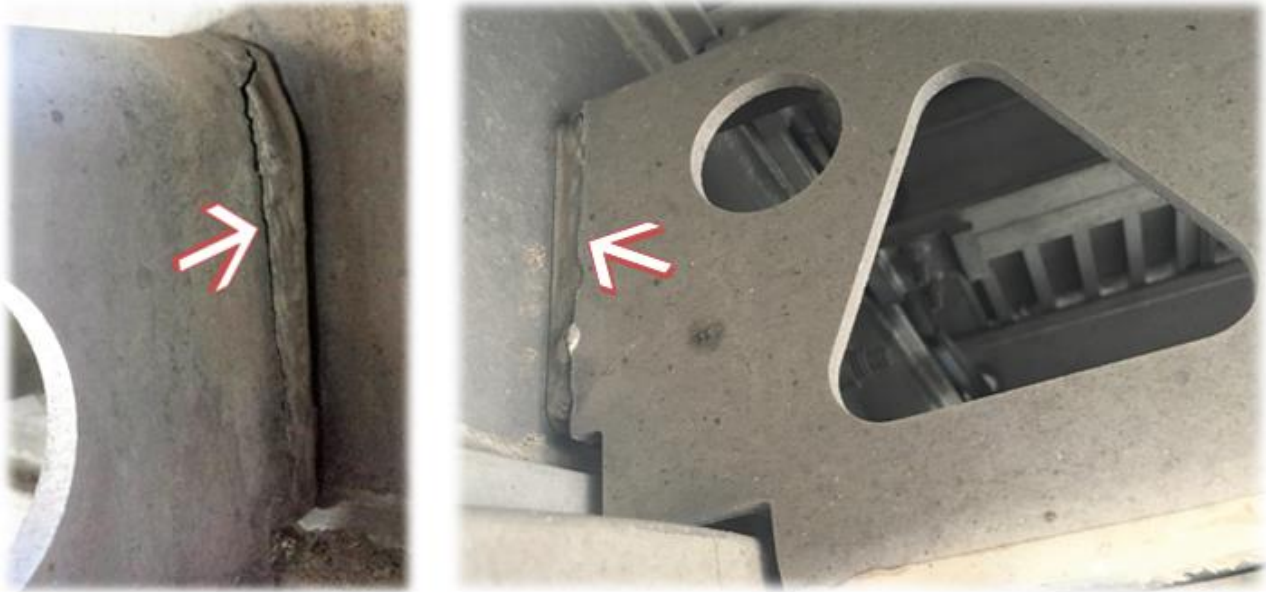
- The pictures below shows possible cracking on the aluminum cross-members along the inside of the main beam webs.
