Service Bulletin

18-099

Safety Recall: Front Passenger's Airbag Inflator Can Be Over-Pressurized (Phase 4)

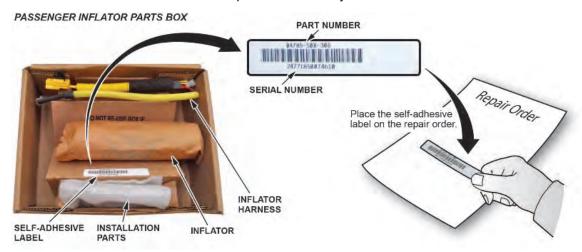
6. Peel the label located inside the inflator box from its backing and attach it to the RO. For the warranty claim to be paid, the **replacement inflator part number that you received** must be included in the warranty claim.

- The replacement part number is printed on the top part of the label and the serial number is printed on the bottom. Make sure you attach the label to the RO and give it to the warranty clerk.
- There may also be a colored sticker located in the kit, ignore it because it is not used.
- Not all inflator kits have a label included. In those cases, write the serial number and part number from the side
 of the inflator box on the RO. The part number always starts with 047.

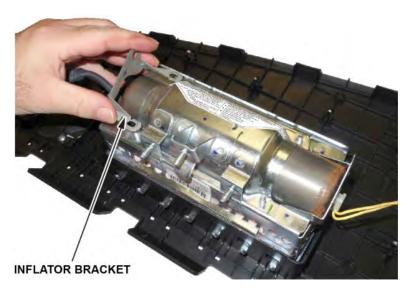
10. Remove the inflator bracket.

You can only remove one of the brackets, as the other is welded to the airbag housing.

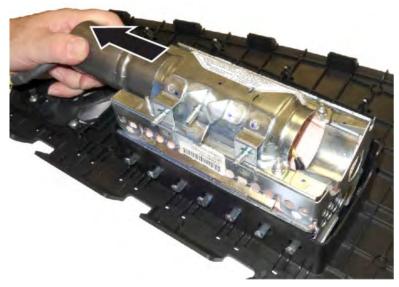
11. Remove the inflator by pushing/pulling it out.

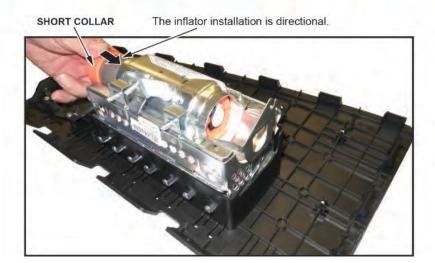
12.2. Collars on this inflator are orange. One side of the inflator has a longer collar, a tab, a plastic cutout, and a small flat spot on the connector. The other side of the inflator has a shorter collar, two tabs, and a red dot.

Make sure you insert the end with the longer collar into the airbag first.

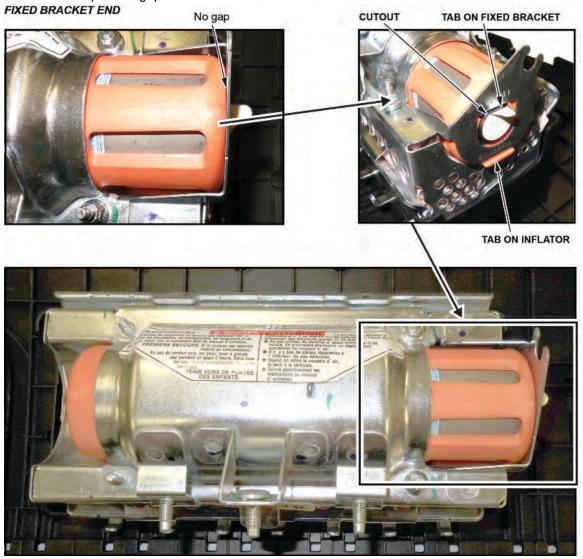
12.3. Slide the inflator in until the plastic cutout and the small flat spot align with the tab on the bracket. There should be no space or gap between the inflator and bracket.

FIXED BRACKET END

No gap

CUTOUT

TAB ON FIXED BRACKET

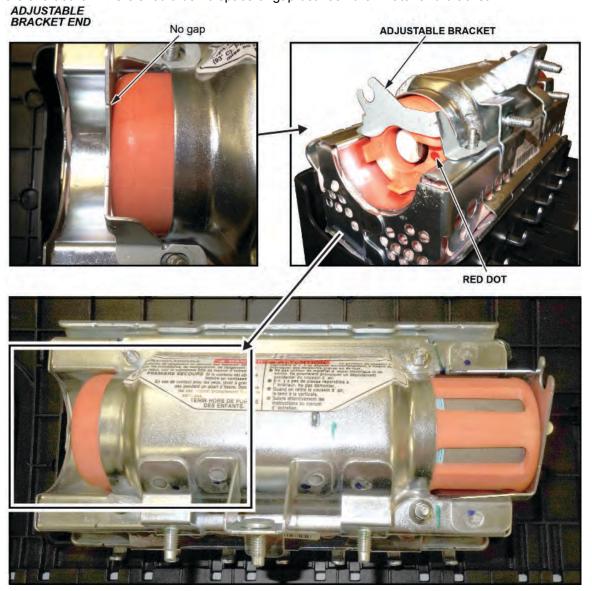
12.4. Install the bracket included in the kit onto the airbag module. There should be a red dot visible on the end of the short collar. There should be no space or gap between the inflator and bracket.

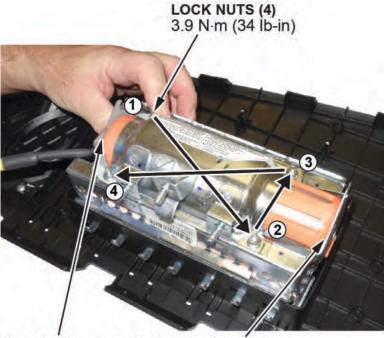
13. Install four new 5 mm locknuts and torque them in sequence to 3.9 Nom (34 lb-in) .

Be sure there are no gaps between the inflator ends and the inflator brackets

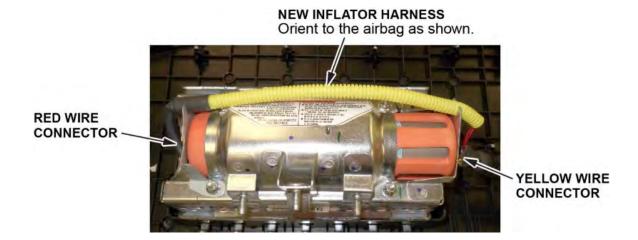
- 14. Remove the stickers covering the terminals on both sides of the new inflator.
- 15. Install the new inflator harness.
 - 15.1. Make sure the airbag and harness are aligned as shown.

- Make sure you have the orientation correct as shown below. If you connect the harness incorrectly, the harness cannot be removed, and you will not be able to reinstall the airbag because the harness will be too short.
- Connect the red wire connector to the short collar side of the inflator with the red dot.

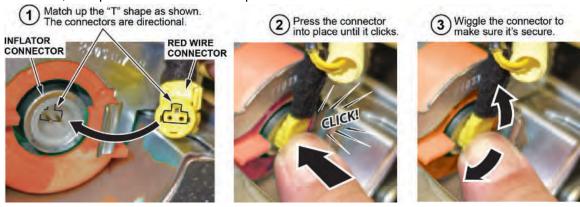
15.2. Connect the two connectors. Align the "T" shape in the inflator harness connector with the T-shaped inflator connector, then press the connector into place.

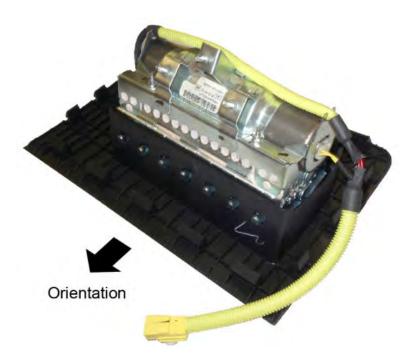
- 4. Place the airbag, face-down, on a clean shop towel.

The orientation of the airbag is critical because if the inflator is installed incorrectly, the harness will be too short when you reinstall the airbag.

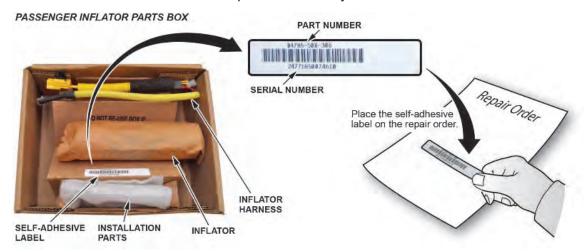
6. Peel the label located inside the inflator box from its backing and attach it to the RO. For the warranty claim to be paid, the **replacement inflator part number that you received** must be included in the warranty claim.

- The replacement part number is printed on the top part of the label and the serial number is printed on the bottom. Make sure you attach the label to the RO and give it to the warranty clerk.
- There may also be a colored sticker located in the kit, ignore it because it is not used.
- Not all inflator kits have a label included. In those cases, write the serial number and part number from the side of the inflator box on the RO. The part number always starts with 047.

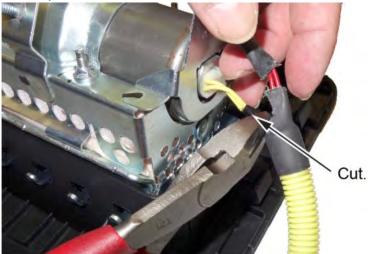
8.1. Cut the yellow wires as shown.

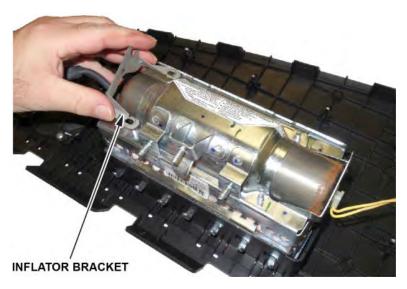
10. Remove the inflator bracket.

You can only remove one of the brackets, as the other is welded to the airbag housing.

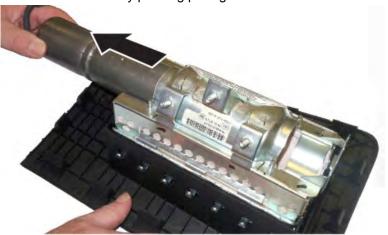
11. Remove the inflator by pushing/pulling it out.

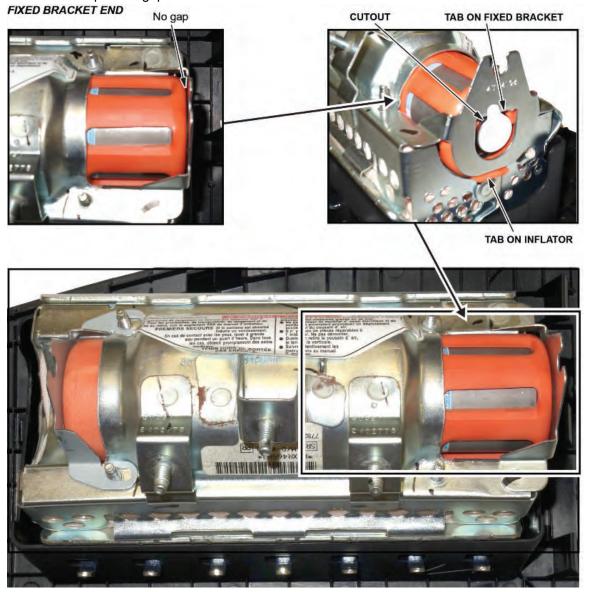
12.3. Slide the inflator in until the plastic cutout and the small flat spot align with the tab on the bracket. There should be no space or gap between the inflator and bracket.

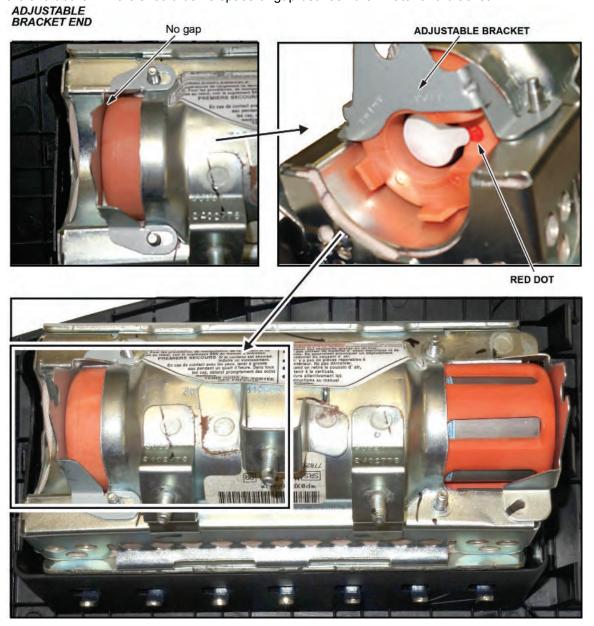
12.4. Install the bracket included in the kit onto the airbag module. There should be a red dot visible on the end of the short collar. There should be no space or gap between the inflator and bracket.

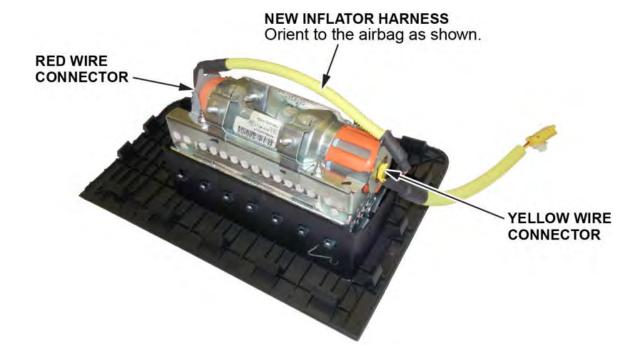
- 14. Remove the stickers covering the terminals on both sides of the new inflator.
- 15. Install the new inflator harness.
 - 15.1. Make sure the airbag and harness are aligned as shown.

- Make sure you have the orientation correct as shown below. If you connect the harness incorrectly, the harness cannot be removed, and you will not be able to reinstall the airbag because the harness will be too short.
- Connect the red wire connector to the short collar side of the inflator with the red dot.

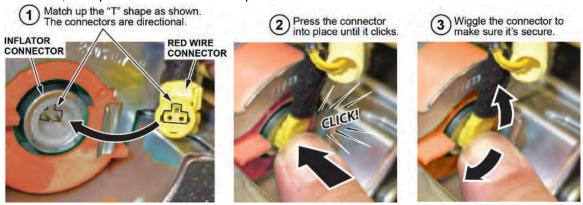
15.2. Connect the two connectors. Align the "T" shape in the inflator harness connector with the T-shaped inflator connector, then press the connector into place.

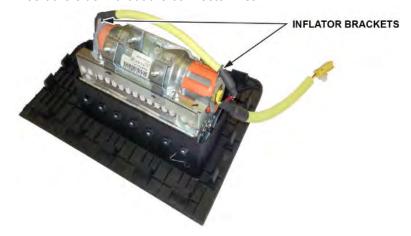
- 16. Connect the harness to the inflator brackets.
 - 16.1. Insert the side without the connector first.
