## Thor Motor Coach Recall Repair Supplemental Instructions

Recall #	18V-741 2018-561		
Description/Title:	Refer LP Hose Routing SUPPLEMENTAL INSTRUCTIONS		
Affected Product Line(s):	Certain MY 2018 & 2019 Chateau, Four Winds, & Freedom Elite motorhomes		
Service Campaign #:	RC000162	Released Date:	1/18/2019

#### Supplemental Repair Code for LP Hose Replacement-

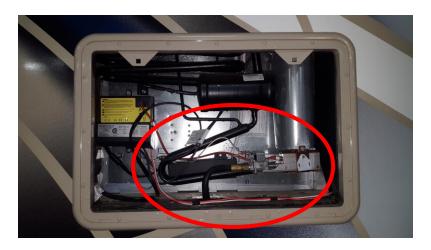
2. Unhook LP hose from valve in thru access door.

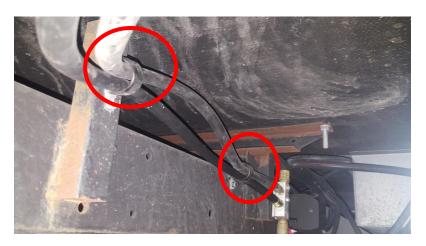
3. Find routing of LP hose under motorhome and unhook other end from propane manifold. P-clamps may need to be removed during process for easier replacement of hose. (NOTE- routing of LP hose will vary based on floor plan on motorhome)

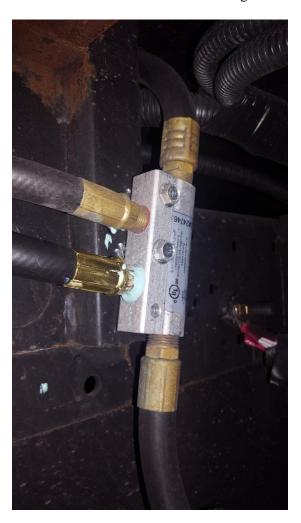
- 3. Once original LP hose is removed, replace with new one according to list on page 1.
- 4. Use a thread sealant when connecting LP hose to manifold.

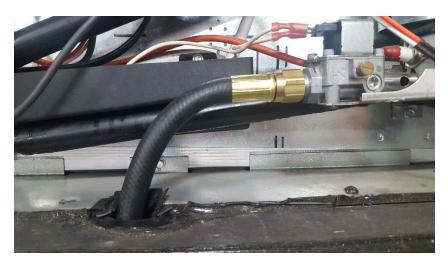
6. Re-route LP hose up through grommet on refer cabinet floor.

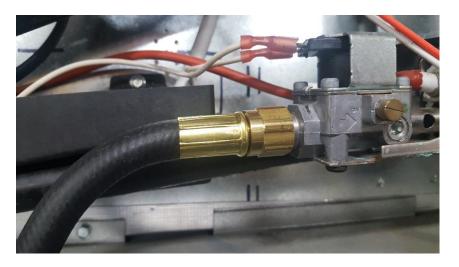
7. Attach hose and tighten onto valve. A second wrench will be needed to hold valve in place as to not turn or kink the replacement LP hose.
