February 2019
FL799A
NHTSA #18V-742
Transport Canada #18-575
REVISED NOTICE

Subject: Honeywell Brake Light Pressure Switches

Models Affected: Specific Freightliner Cascadia vehicles manufactured March 8, 2016, through June 30, 2017.

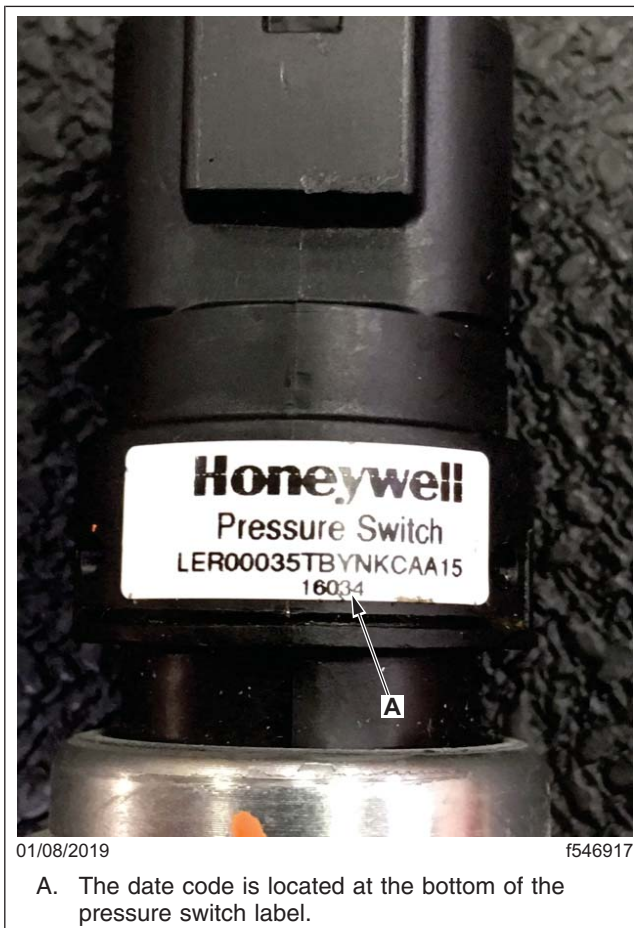
Fig. 2, Brake Light Pressure Switch Date Code

5. Before installing the new pressure switch, inspect the date code at the bottom of pressure switch label. See [Fig. 2](#). The date code format is YYDDD. For example: June 30, 2017 is formatted as 17181.

If the date code is 16001 through 17181, DO NOT install on the vehicle. Submit a PAR to return it to the PDC.

If the date code is outside this range, continue with the next step.

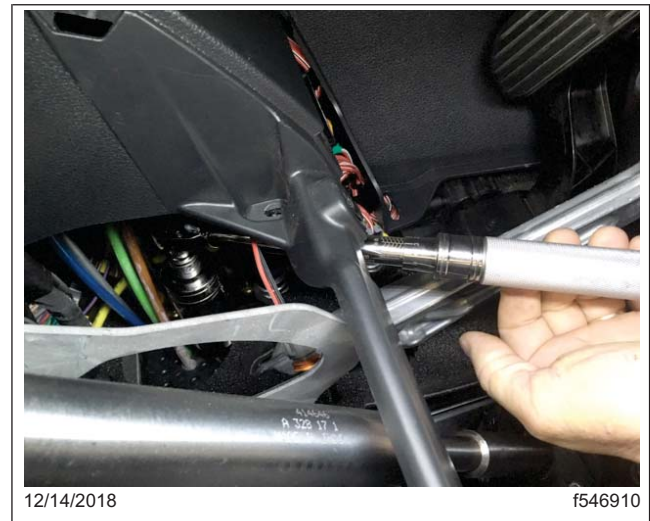
Fig. 3, Tightening the Brake Light Pressure Switch

6. Install the new pressure switch. Torque the switch 7 to 9 lbf-ft (9.5 to 12 N·m). See [Fig. 3](#).
