Technical BULLETIN

SAFETY RECALL

CERTAIN 2015 ~ 2018 YZF-R3 MODELS FACTORY MODIFICATION CAMPAIGN – Radiator Hose Leaking

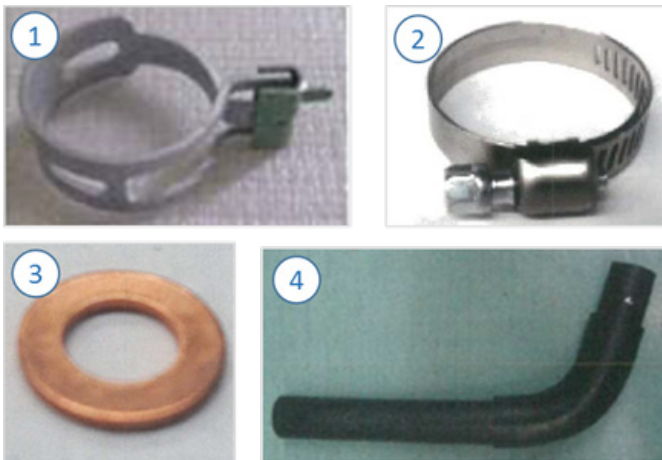
KIT CONTENTS

No.	Part Name	Part Number	Quantity
1	Clip (1WD1)	90467-250A1-00	1
2	Hose Clamp Assy (1WD1)	90450-28001-00	1
3	Gasket (KT) (SX4, T105, YP125)	90430-06014-00	1
4	Hose 3 (1WD1)	1WD-E2578-00-00	1
