**TECHNICAL INSTRUCTIONS
FOR
SAFETY RECALL JLI/JLJ/JLK
FRONT PASSENGER AIRBAG INFLATOR REPLACEMENT
CERTAIN 2006 – 2012 MY IS 250/350 and 2008 – 2009 MY IS F**

Update 02/20/2020

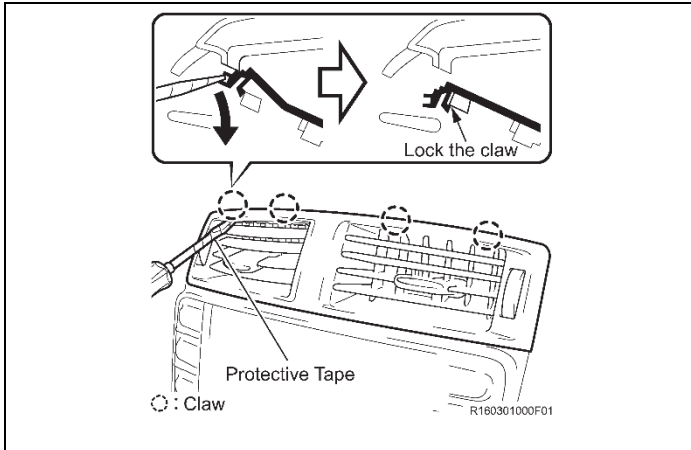
Removing the No. 3 air register

Remove any peripheral parts on left and right side of the register to allow access to the back of the register.

Wrap the tip of a screwdriver with tape.

Lock the 4 claws inside the register as shown.

NOTE: Do not use a molding removal tool to remove the register it could be damaged.

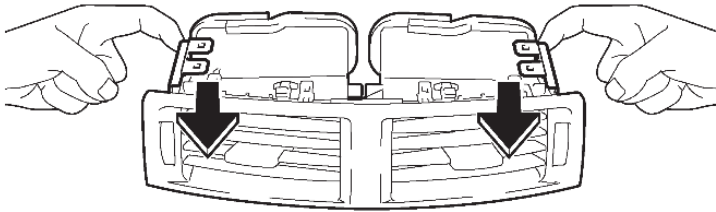
OK Push from the back side

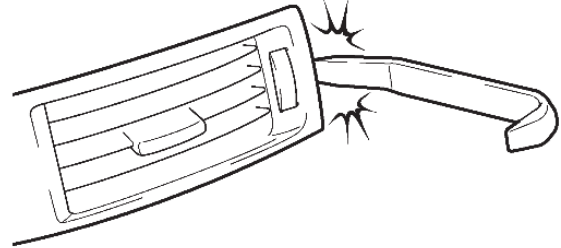
NG Pry from the front side

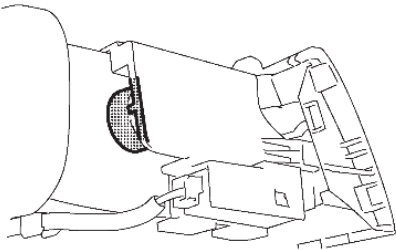
Using your finger on the left side push out at the point shown to disengage the 4 claws.

Back side of part manufactured before August 2008:

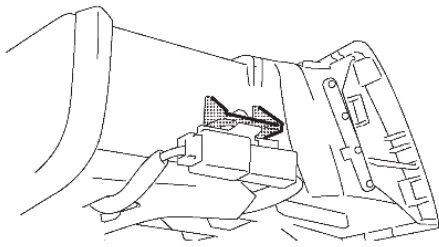
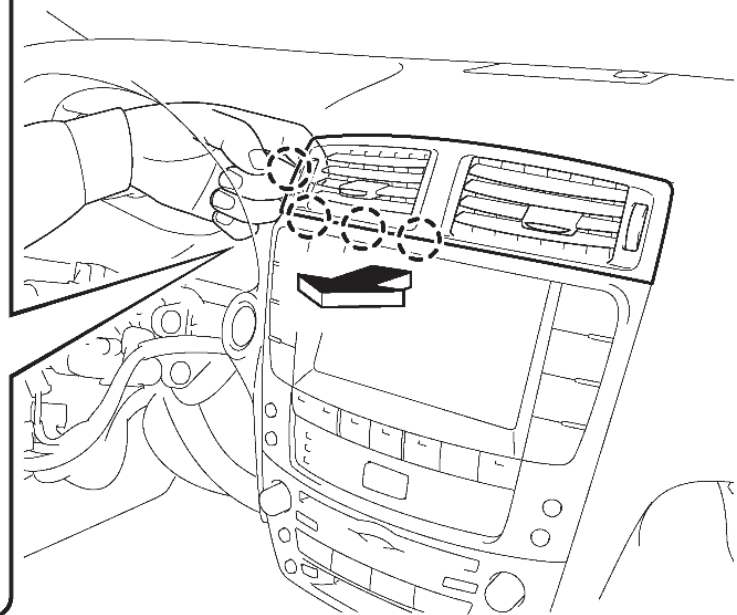
Back side of the part manufactured after August 2008:

Using your finger on the right side push out at the point shown to disengage the 3 claws and remove the register from the instrument panel.

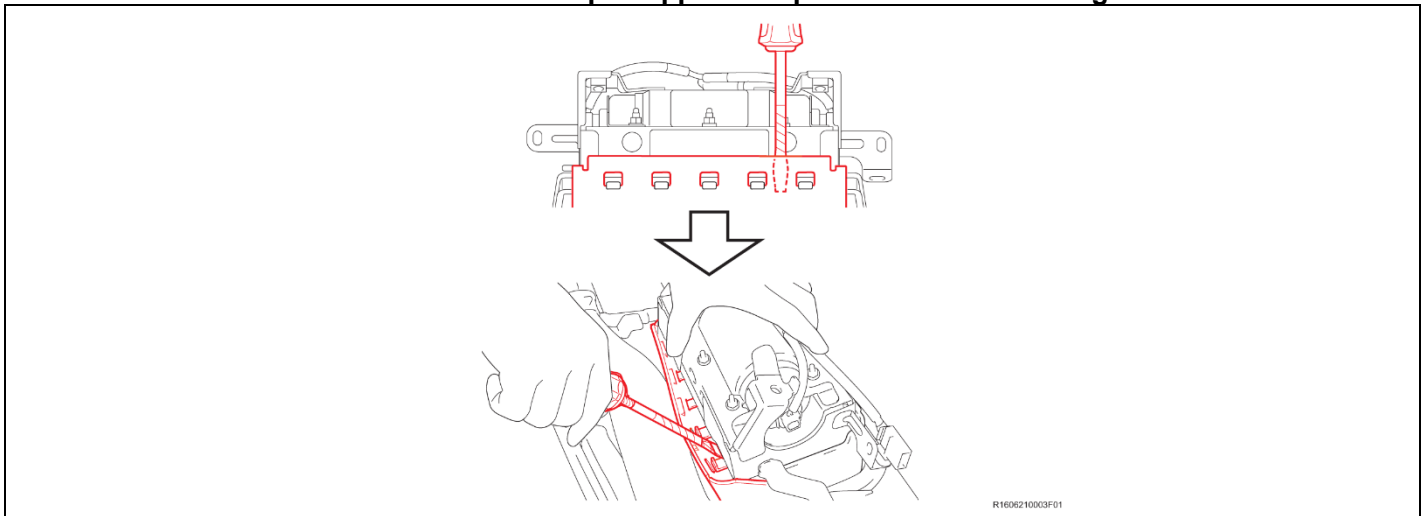
- c) Remove the 4 bolts, disengage the straps, and then remove the airbag assembly.

NOTE: Use a screwdriver with the tip wrapped in tape to remove the airbag from the dash.

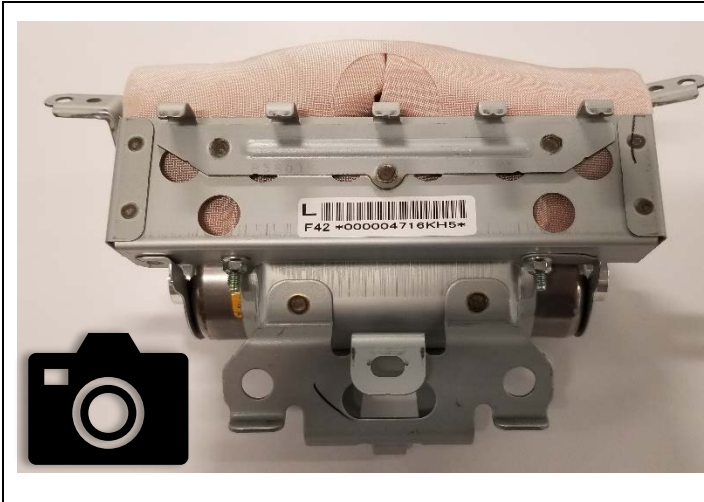
1. TAKE A PICTURE OF THE AIRBAG ASSEMBLY SERIAL NUMBER

- a) Take a picture of the airbag assembly serial number exactly like the image to the left.
- b) Email the picture to Quality_Compliance@toyota.com for review.

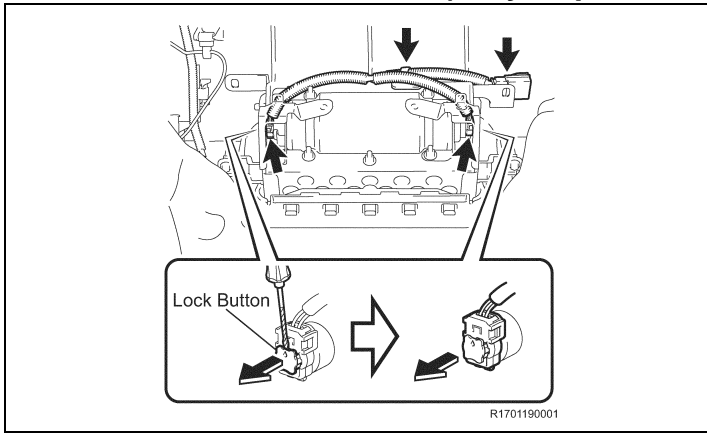
- a) Using a screwdriver to release the lock button of the connector.
- b) Disconnect the 2 connectors.
- c) Disengage the 2 clamps.

NOTE: The removed instrument panel wire will not be reused.

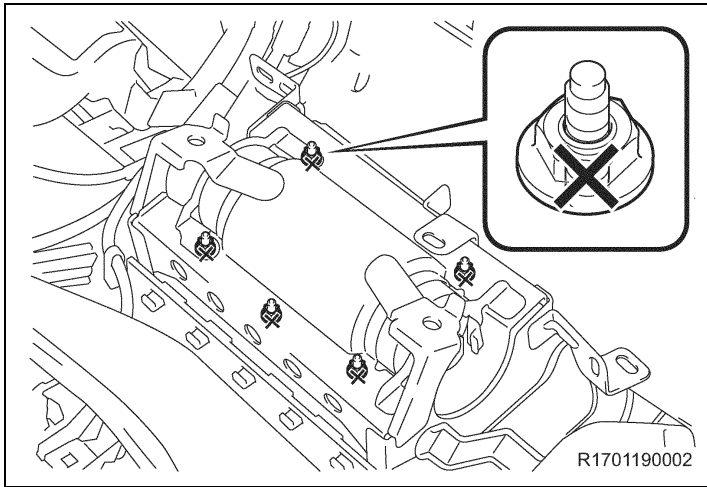
- d) Mark the 5 self locking nuts to prevent reuse.

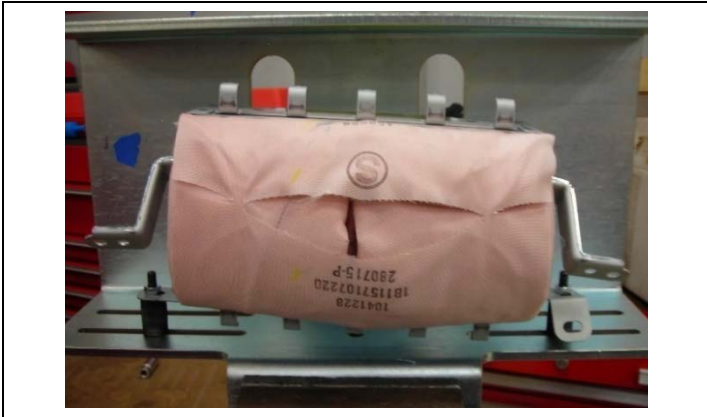
f) Mount the airbag to the mounting bracket as shown.

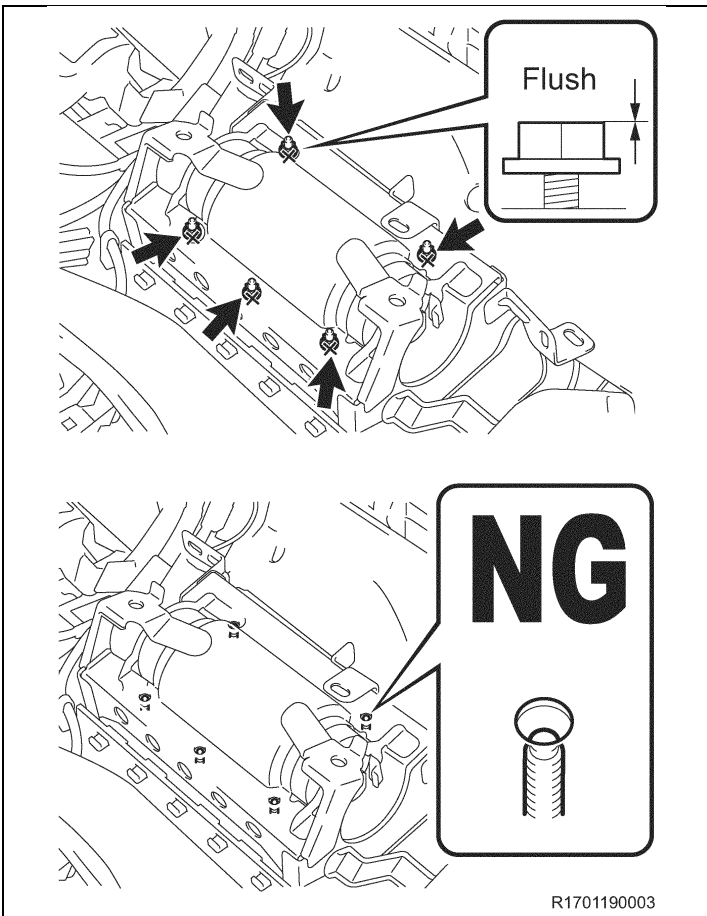
g) Loosen the 5 nuts until each nut is flush with the top of the stud as shown.

NOTE: You may need to slide the airbag to the left or right to access the middle nut. DO NOT use power tools to remove the nuts.

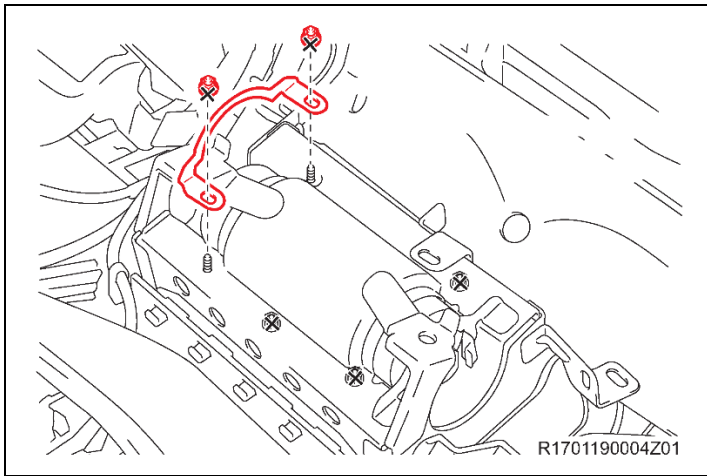
- h) Loosen and discard the 2 nuts on the end where the positioning plate is removeable.
- i) Remove and discard the plate.

DO NOT use power tools.

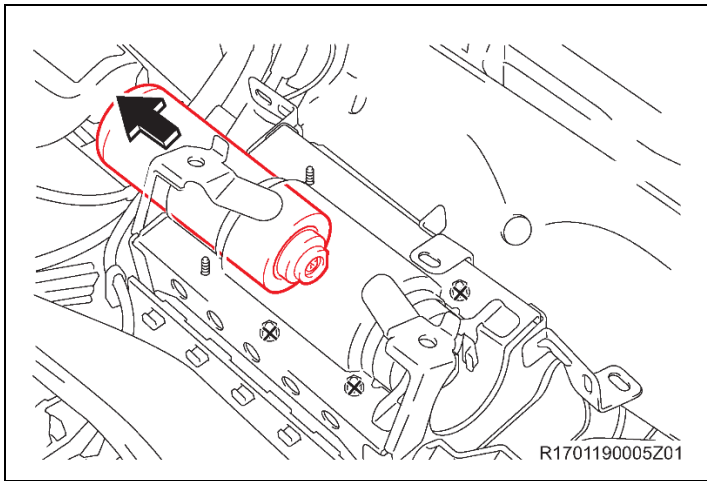
- j) Remove the inflator.

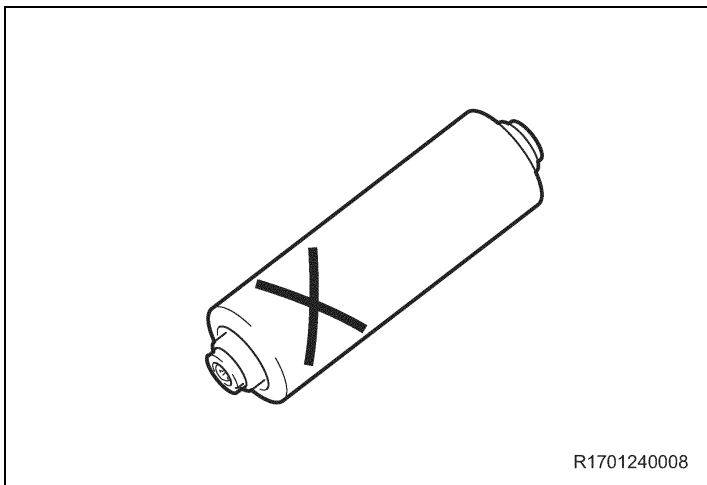
- k) Mark the old inflator so it is not reused.
- NOTE: Return the old inflator to the parts department for recovery.**

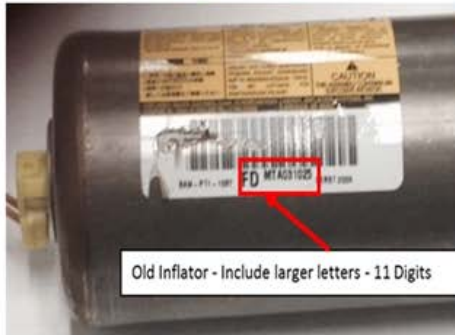
The Inflator serial code is an 11 digit code on the Inflator can. It can be found with a bar code on removing the Inflator can from the Airbag Assembly unit.

The first two characters of the Original Inflator Serial code will be from [AA, AB, AJ, FD or JD].

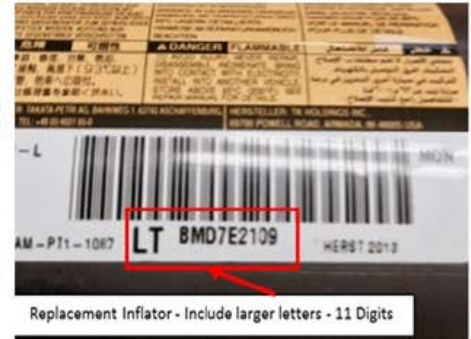
The first two characters of the Replacement Inflator Serial code will be either 'LT' or 'LR'.

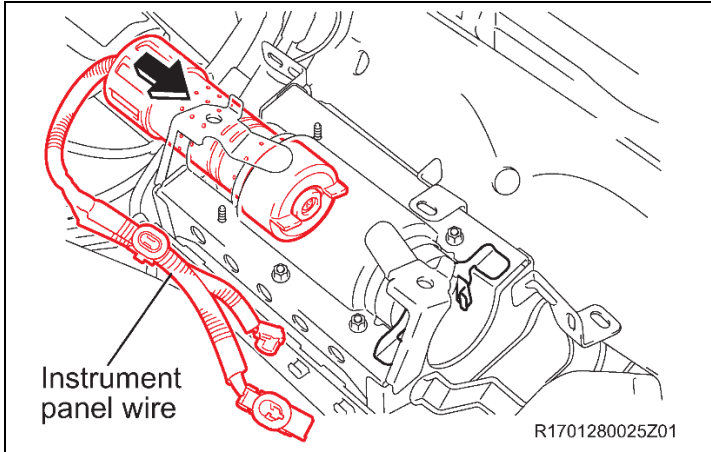
1. **INSTALL THE NEW INFLATOR**
 - a) Install the new inflator as shown.

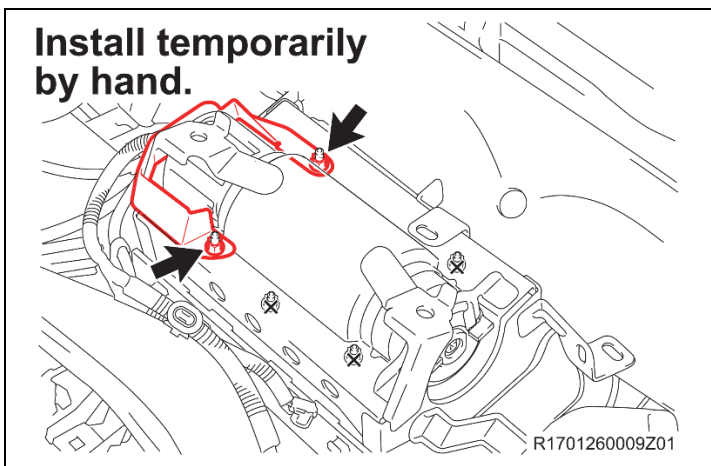
- e) Install the **NEW** positioner plate.
- f) Temporarily install 2 **NEW** nuts.

**Install temporarily
by hand.**

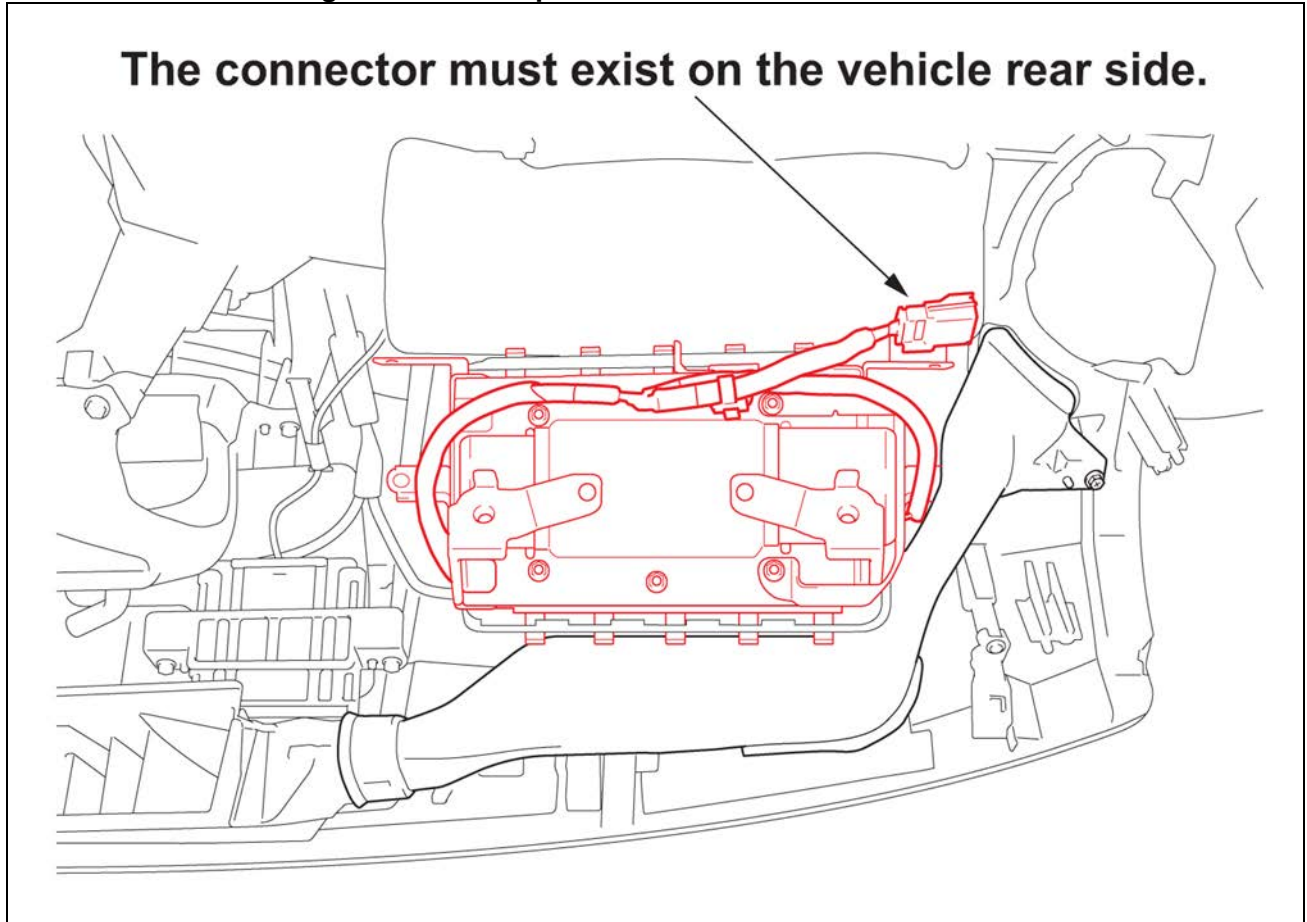
NOTE: Ensure the airbag connectors is positioned as shown

- b) Install the 2 screws and the heater to register duct.
- c) Install the 3 screws and the side defroster nozzle.
