TECHNICAL INSTRUCTIONS
FOR
SAFETY RECALL JLI/JLJ/JLK
FRONT PASSENGER AIRBAG INFLATOR MODULE
CERTAIN 2002 – 2010 MODEL YEAR SC 430

UPDATE 10/17/2019

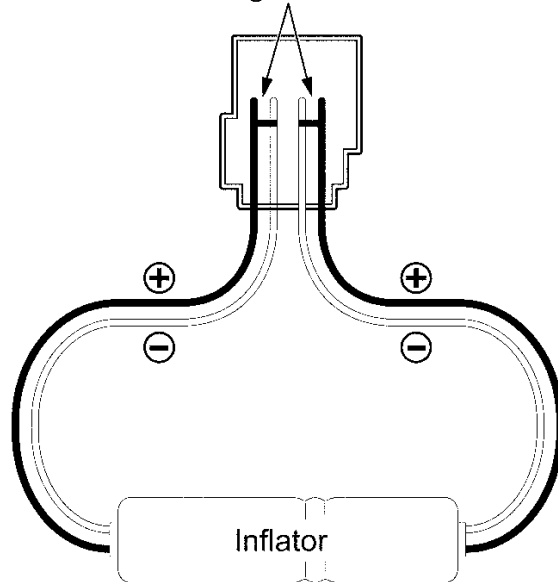
Short circuiting on both sides.

The connector of the inflator module contains a short circuiting mechanism to eliminate voltage variances when the connector (1) is disconnected. To allow for the replacement of the inflator module, a new short circuit (2) **MUST** be created before cutting the wires (3) and removing the inflator. The following steps **MUST** be followed exactly as described to ensure the work is completed correctly and safely.

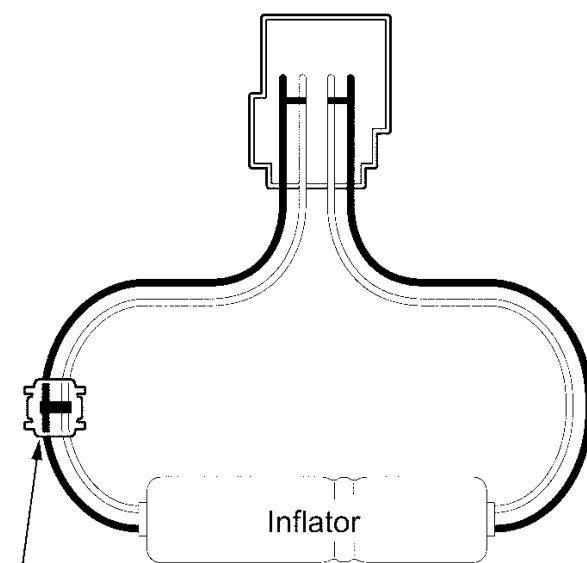
(2)

Create new short circuit using electro tap.

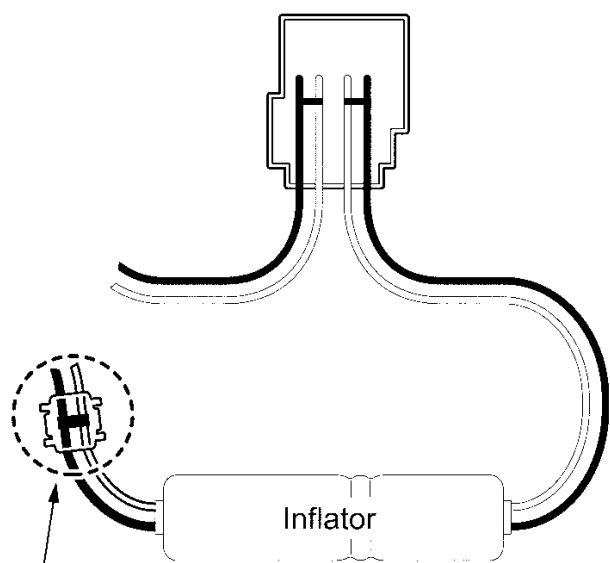
(3)

Short circuiting is maintained even after cutting harness.

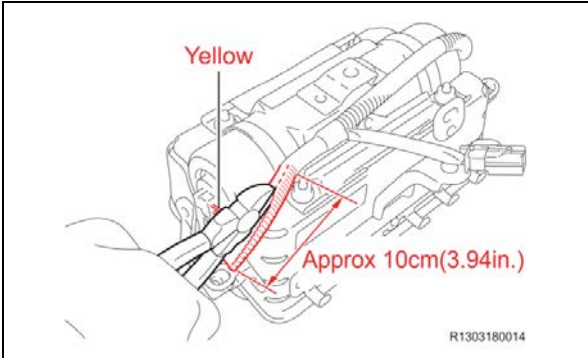
a) Disengage the harness clamp.

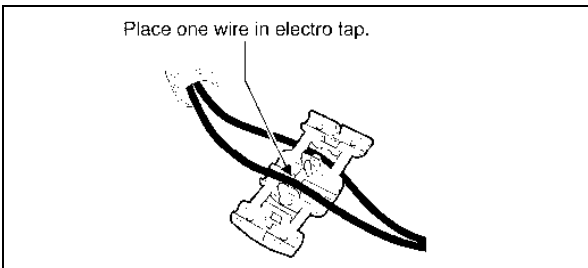
c) Cut off the tab of the electro tap shown in the illustration.

STOP This tab **MUST** be removed to ensure a good short.

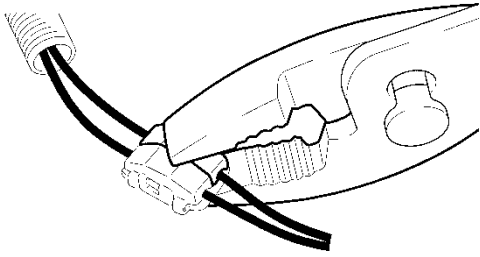
b) Fold and pinch the half of the electro tap with the wire and use pliers to lock the electro tap.

Lock the other wire.

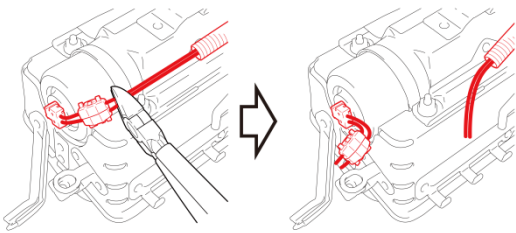
OK

Cut at opposite side to inflator

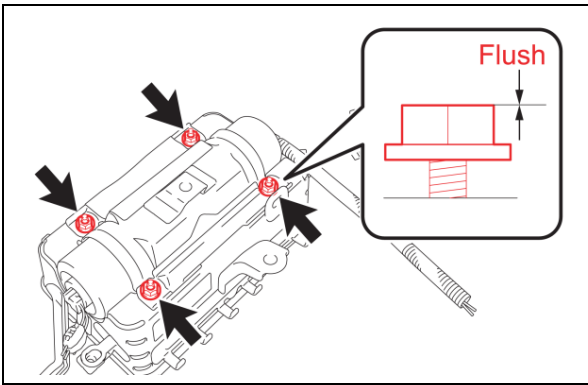
- a) Use the access holes in the bracket to loosen the 4 nuts.

- **DO NOT** use power tools.
- **DO NOT** remove the nuts or the bag may fall out of the airbag assembly.

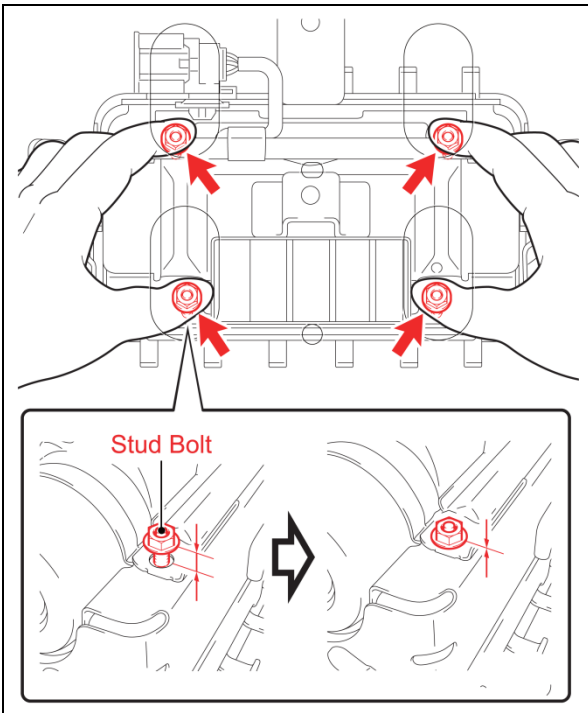
- b) Loosen the nuts until they are flush with the studs.
 - c) Use a marker to mark the nuts as they are not to be reused.
- NOTE: *DO NOT* reuse the old nuts, new nuts *MUST* be used.**

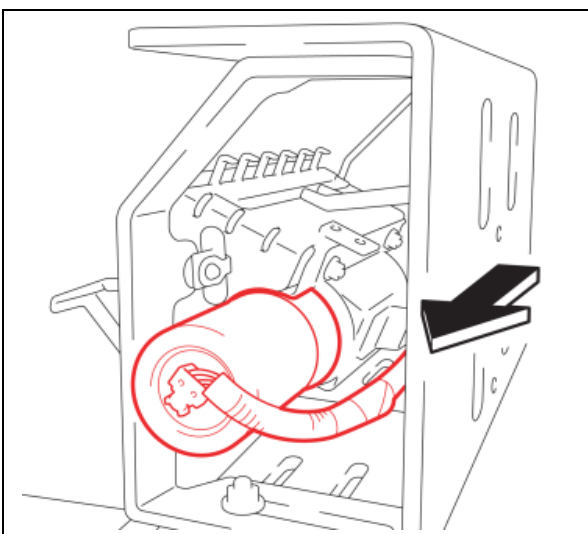
- a) Gently push in the 4 studs until the nuts contact the airbag case to allow for inflator removal.

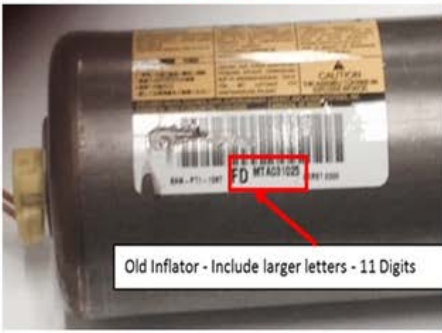
Original Inflator

Old Inflator - Include larger letters - 11 Digits

How to Identify the Inflator serial code on the Original and Replacement Inflator can?

The Inflator serial code is an **11 digit code** on the Inflator can. It can be found with a bar code on removing the Inflator can from the Airbag Assembly unit.

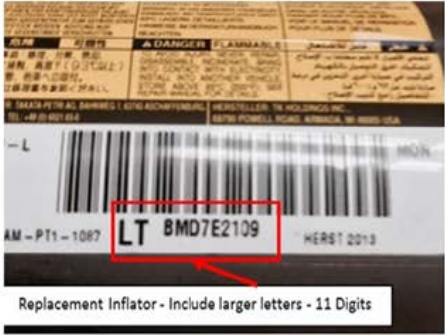
The first two characters of the **Replacement Inflator Serial code** will be either 'LT' or 'LR'.

Replacement Inflator - Include larger letters - 11 Digits

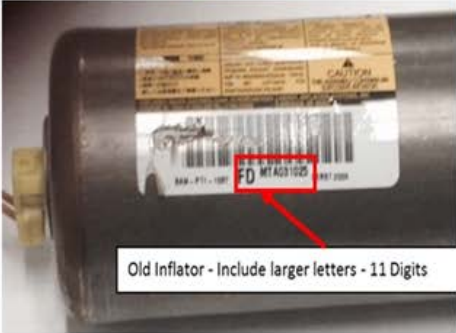
Original Inflator

Old Inflator - Include larger letters - 11 Digits

How to Identify the Inflator serial code on the Original and Replacement Inflator can?

The Inflator serial code is an **11 digit code** on the Inflator can. It can be found with a bar code on removing the Inflator can from the Airbag Assembly unit.

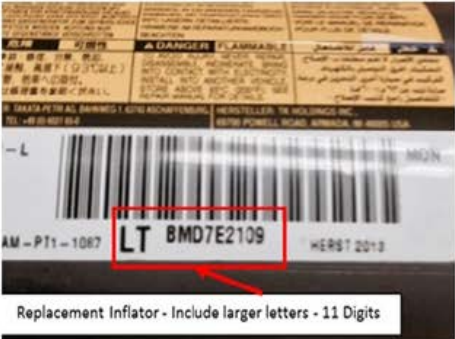
Replacement Inflator - Include larger letters - 11 Digits

The first two characters of the **Replacement Inflator Serial code** will be either 'LT' or 'LR'.

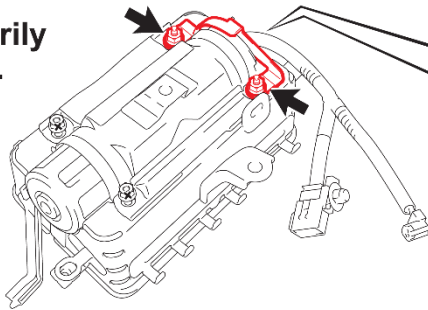
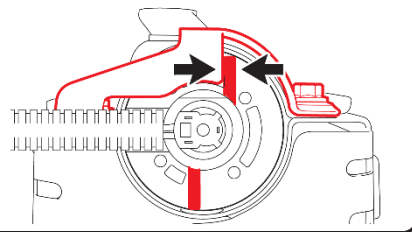
- Remove the 2 old nuts on the harness connected side.
- Store the removed nuts in a separate container.
- Match the flat part of a **NEW** position determining plate of the harness connected side with the projecting part of the inflator.
- Temporarily install 2 **NEW** nuts and position determining plate by hand on the stud bolts.

If the flat surfaces are not aligned with each other, the orientation of the inflator could be displaced, causing the airbag to fail in deployment.

Install temporarily by hand.

Flats are aligned.

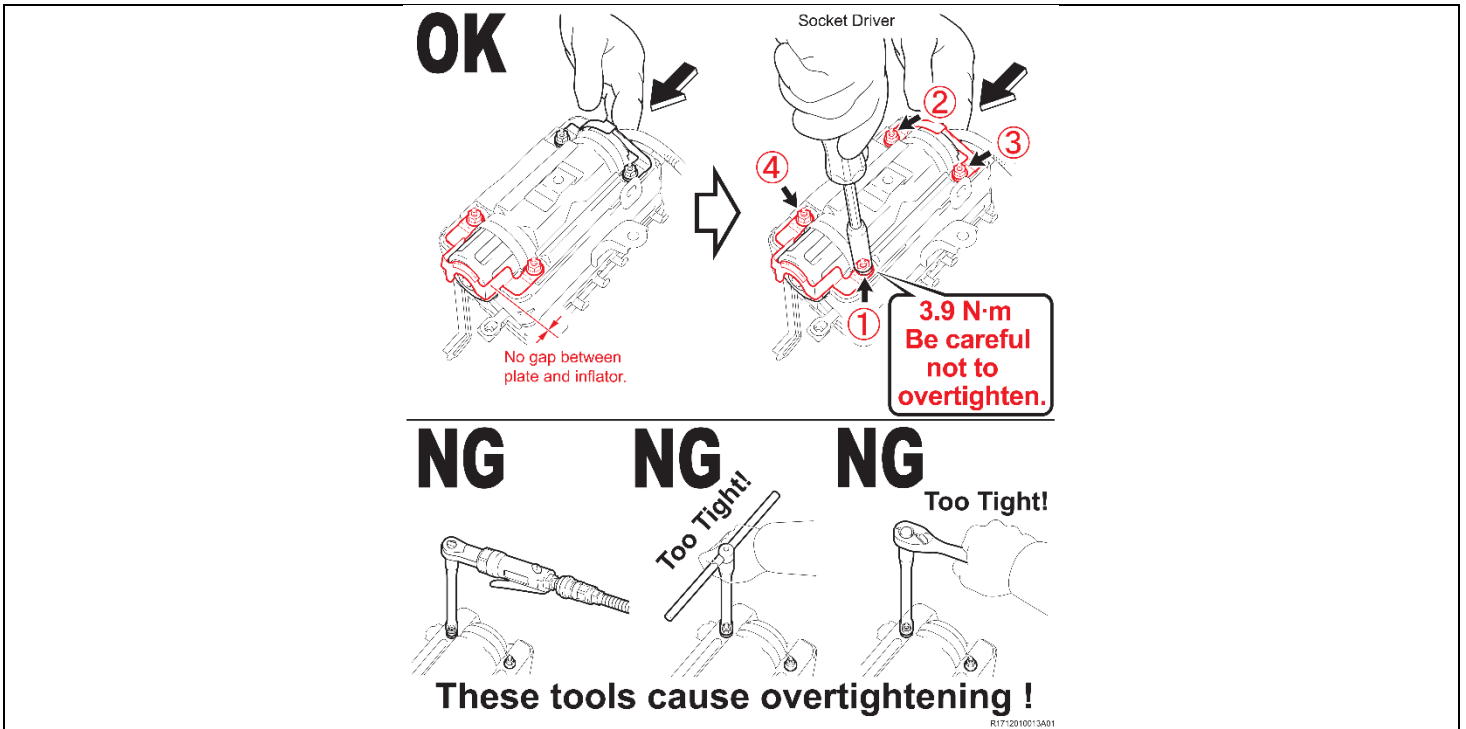
- k) Push the inflator towards the position determining plate of the harness unconnected side to eliminate any gap.

If any gap exists, the aligned flats may move apart, resulting in failure in normal deployment of the airbag.

The tightening torque is low (3.9 N-m). Use of an air ratchet wrench or tightening strongly with a T-handle wrench or a ratchet handle may cause deformation of the stud bolt.

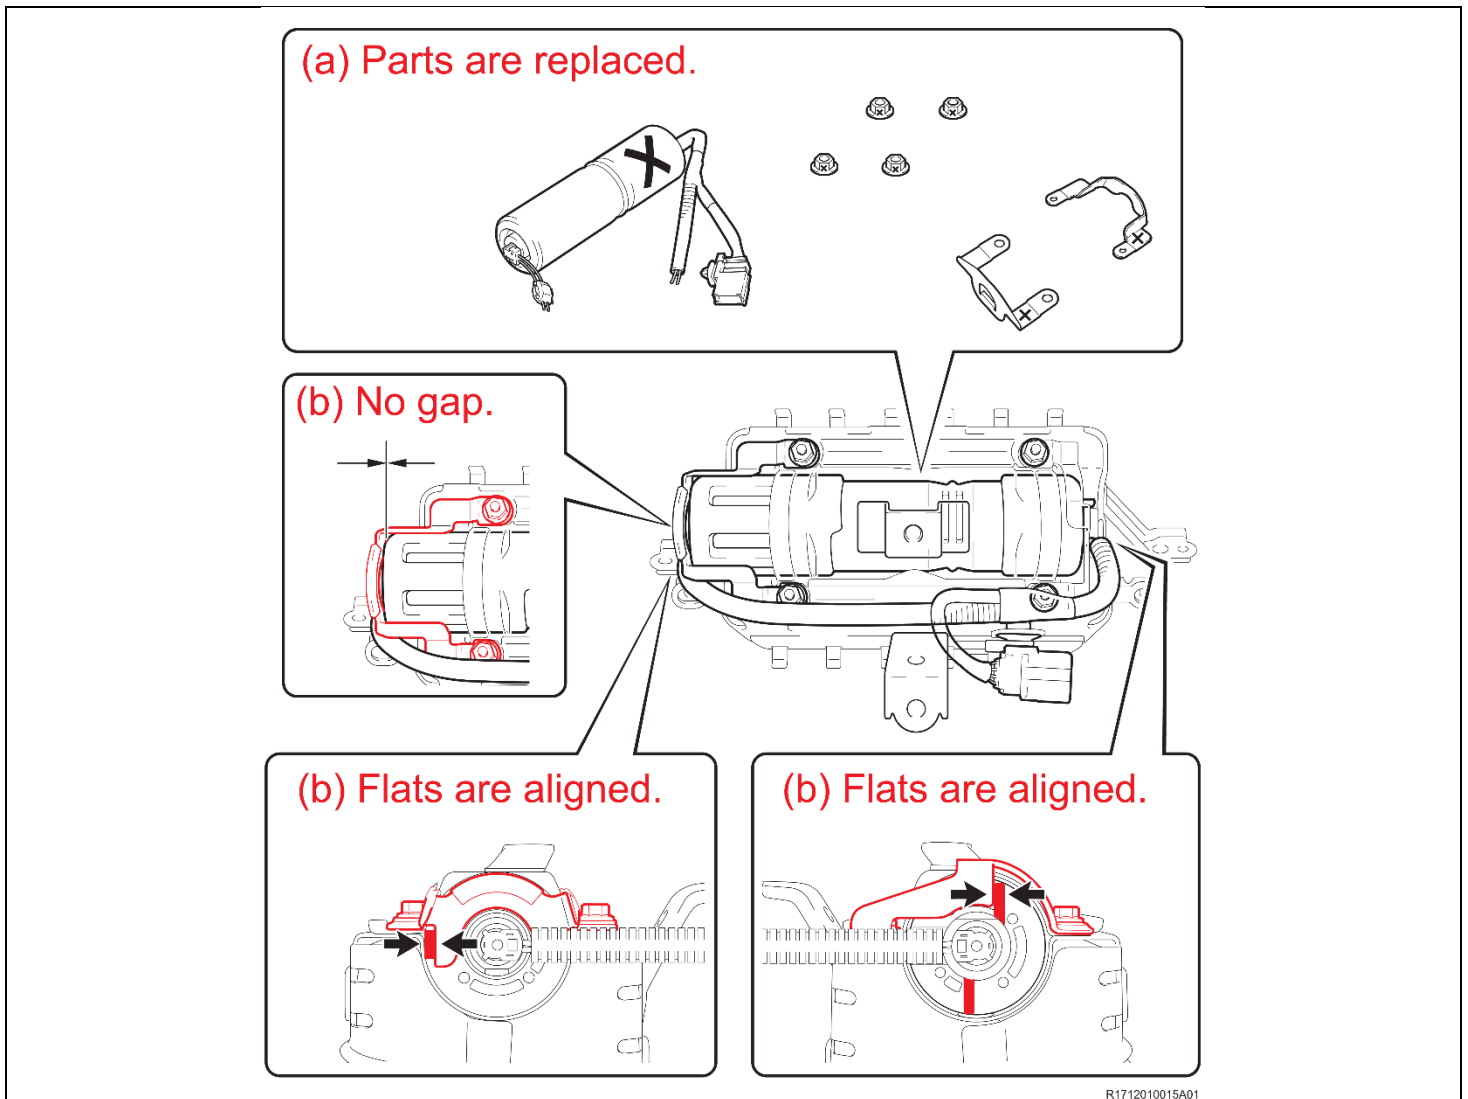
- a) Check that the inflator, plates and 4 nuts are replaced.
- b) Check that positions of the inflator and the position determining plate are correct. (The flats should be aligned and there should be no gap.)
