TECHNICAL INSTRUCTIONS
FOR
SAFETY RECALL J0A, J0B, J0C
FRONT PASSENGER AIRBAG “MODULE” REPLACEMENT ONLY

CERTAIN 2005 – 2008 MODEL YEAR MATRIX

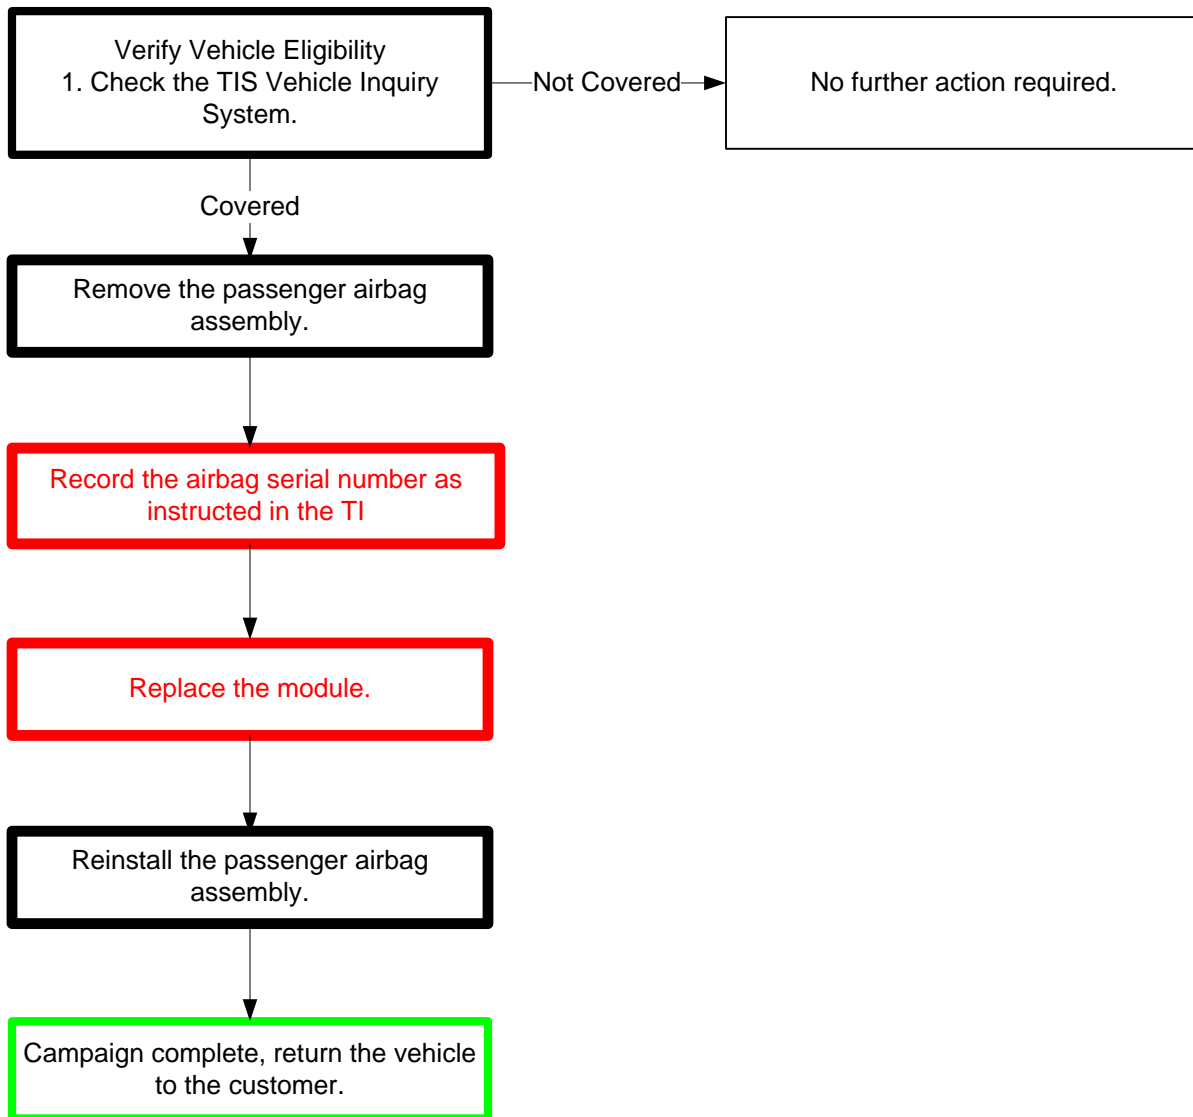
I. OPERATION FLOW CHART

The flow chart is for reference only. **DO NOT** use it in place of the full technical instructions. Follow **ALL** steps as outlined in the full technical instructions to confirm the campaign is completed correctly.

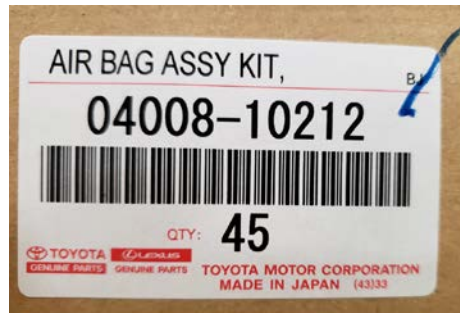
Dealers should discontinue the installation of the parts listed below for the recalls, customer pay repairs AND over-the-counter sales (if applicable) unless they have a mark on the label.

Make sure the parts box has a check mark as seen in the image above

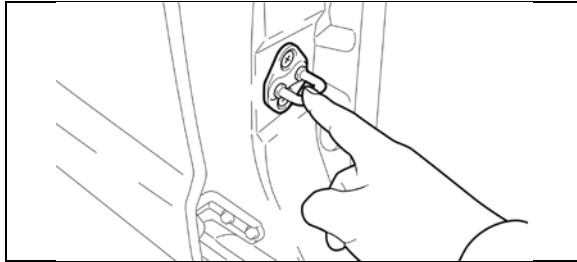
1. ELIMINATE STATIC ELECTRICITY

- a) Before starting work and periodically while working on the vehicle, touch a metallic part of the vehicle to discharge static electricity in the body.

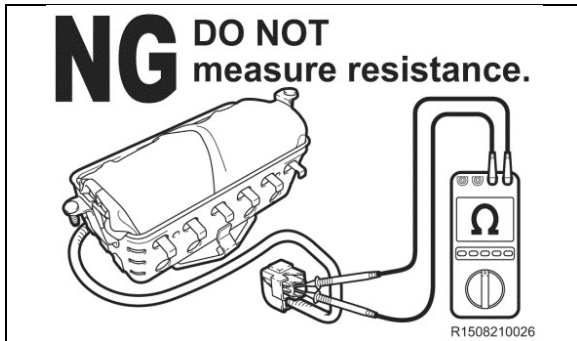
2. DO NOT MEASURE RESISTANCE

- a) **DO NOT** measure resistance of airbag components, this may cause accidental activation.

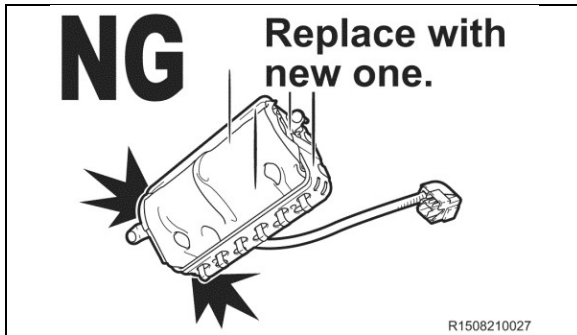
3. HANDLE THE AIRBAG CAREFULLY

- a) If an inflator is dropped, replace it with a **NEW** inflator.

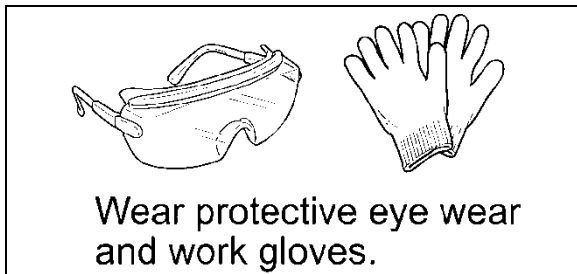
4. WEAR PROTECTIVE EQUIPMENT

- a) Always wear appropriate protective equipment when working on the SRS.

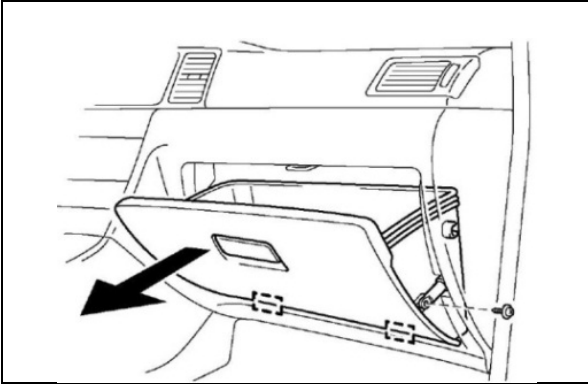
1. REMOVE THE GLOVE BOX

- a) Open the glove box door.
- b) Press in on both sides of the door and swing it down to remove it from the vehicle.

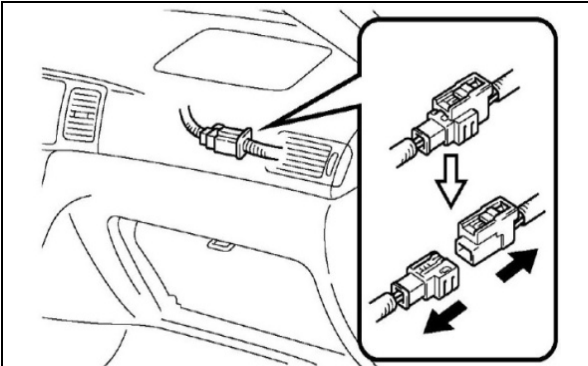
2. REMOVE THE AIRBAG ASSEMBLY

- a) Disconnect the negative battery cable.

- Wait at least 90 seconds after disconnecting the cable from the negative battery terminal to prevent airbag and seat belt pre-tensioner deployment.
- Follow all precautions as outlined on TIS before servicing the SRS system.

- b) Disconnect the airbag connector.
- c) Remove the 2 nuts and release the 6 clips.
- d) Remove the airbag assembly.

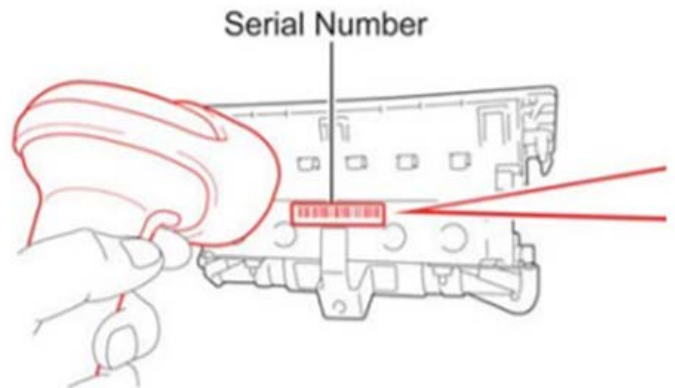
<table><tr><th data-bbox="841 254 1557 310">AIRBAG SERIAL NUMBER IDENTIFICATION</th></tr><tr><td data-bbox="841 310 1557 474"><ul style="list-style-type: none">• The airbag serial number is ALWAYS the 12 DIGITS located BETWEEN the asterisks.• The 3 digits before the asterisk ARE NOT part of the serial number, and SHOULD NOT be entered or an inaccurate response may be returned.</td></tr></table>

The **AIRBAG ASSEMBLY** serial number and the **INFLATOR** serial number are **DIFFERENT**. The **AIRBAG ASSEMBLY** serial number **MUST** be recorded prior to replacement.

If the airbag serial number and barcode are not legible or are not present, check the box in the application indicating the serial number is not legible and continue with the repair.

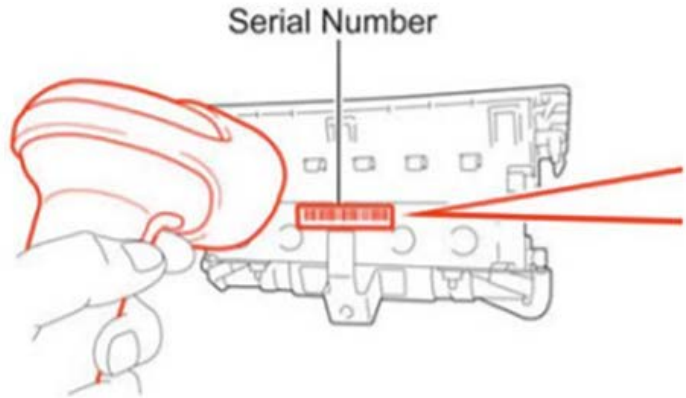
* Serial Number of New Airbag Assembly:

* Re-confirm the Serial Number of New Airbag Assembly:

The new **AIRBAG ASSEMBLY** serial number **MUST** be recorded prior to reinstallation to track the airbag assembly to the vehicle.

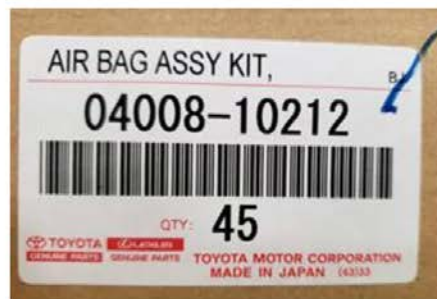
NOTE: This serial number 123456789123 is not recognized. This part should be returned to Toyota **UNLESS there is a mark on the label** (shown below). If there is a mark on the label submit a picture of the airbag assembly and a job aid to quality_compliance@toyota.com and await further instructions.

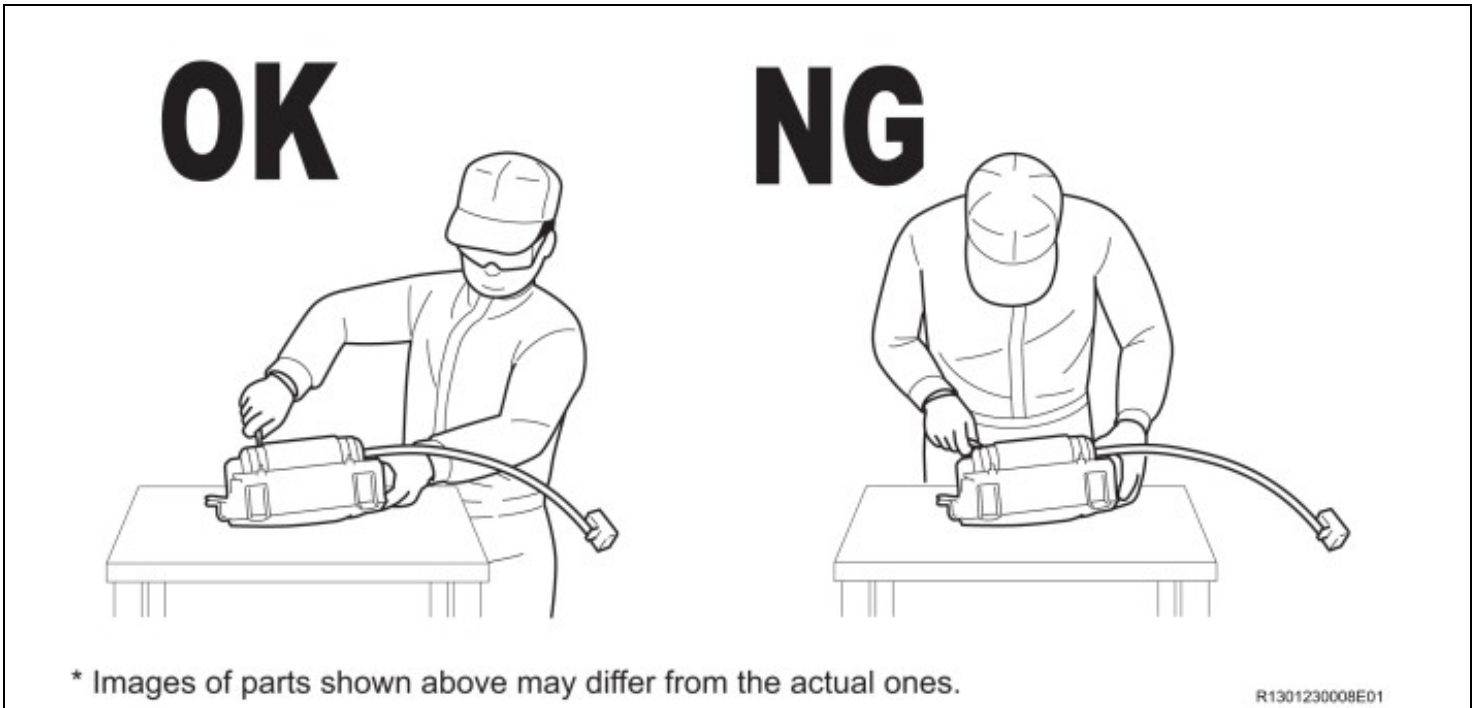
1. WORKING WITH AIRBAG

- Carefully place the airbag on the bench inflator side up.

NOTE: Place clean sheet(s) of paper on the bench to protect the airbag.

- Avoid standing directly over the inflator.

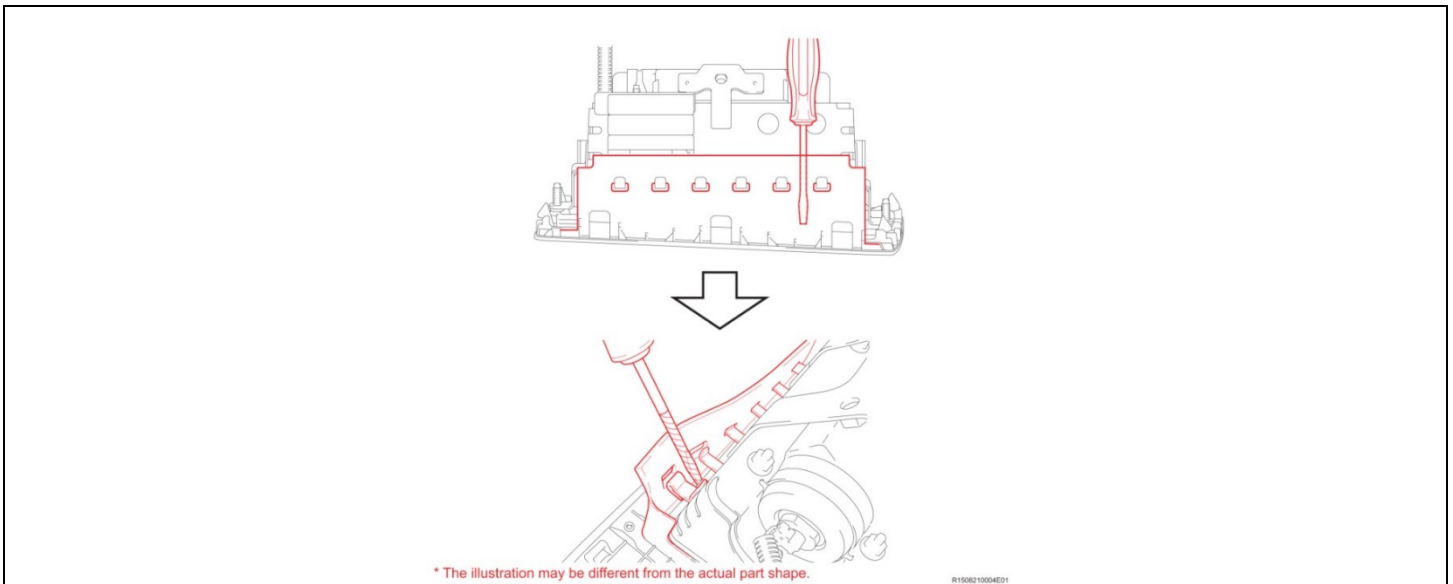
3. REMOVE THE COVER

- a) Gently insert the screwdriver between the airbag door and module and disengage the claws holding the door to the module. Please refer to the video below.

- b) After all the claws have been disengaged separate the module from the door.
- c) Mark the old module so it is not reused.
- d) Inspect the door for damage to the mounting slots.

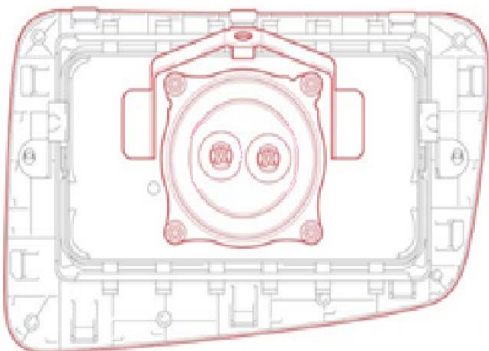
Take care not to mistake the mounting direction.

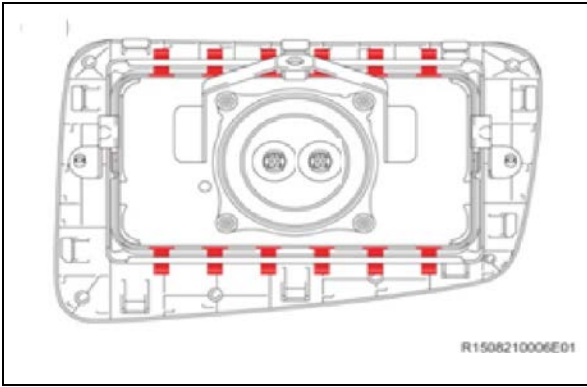
4. INSTALL THE NEW MODULE

- a) Carefully slide the new module into the airbag door.

NOTE: Mounting direction.

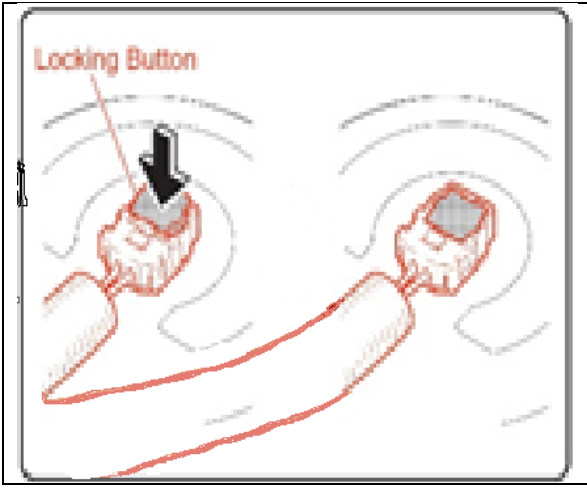
b) Reengage the tangs of the module into the door using the screwdriver with the shaft wrapped in tape.

c) Connect the new harness to the new module.
d) Press the lock tab down.
