TECHNICAL INSTRUCTIONS

SAFETY RECALL JLI/JLJ/JLK

FRONT PASSENGER AIRBAG INFLATOR MODULE

CERTAIN 2002 – 2005 MODEL YEAR SC 430

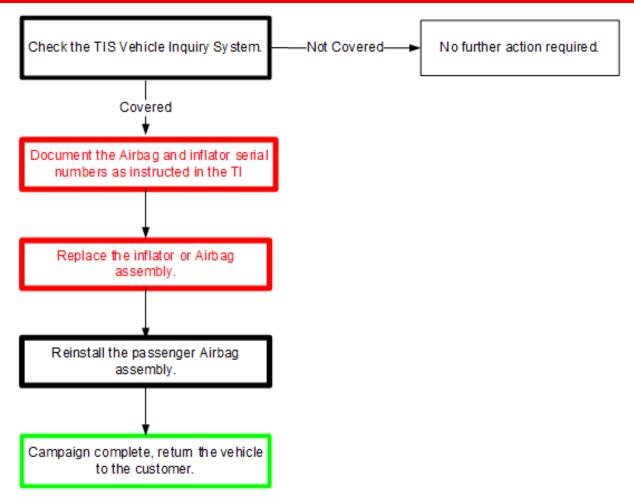
I. OPERATION FLOW CHART

The flow chart is for reference only. *DO NOT* use it in place of the full technical instructions. Follow *ALL* steps as outlined in the full technical instructions to confirm the campaign is completed correctly.

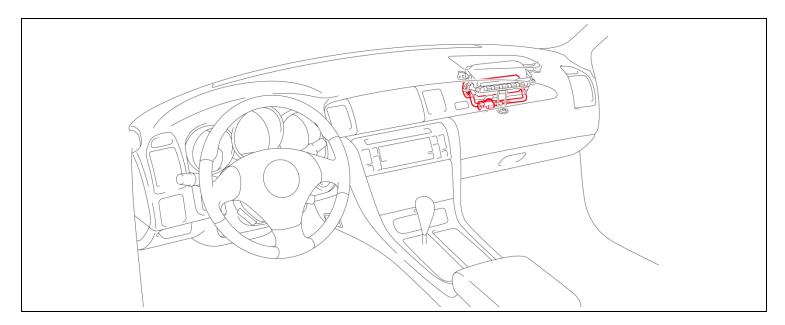
The subject vehicles are equipped with front passenger airbag inflators produced by Takata. The propellant in these inflators may degrade after prolonged exposure to high absolute humidity and fluctuating high temperatures. Degraded propellant can cause the inflator to explode during airbag deployment. In the event of an inflator explosion, metal fragments could pass through the airbag cushion material, striking the vehicle occupants, and result in serious injury or death.

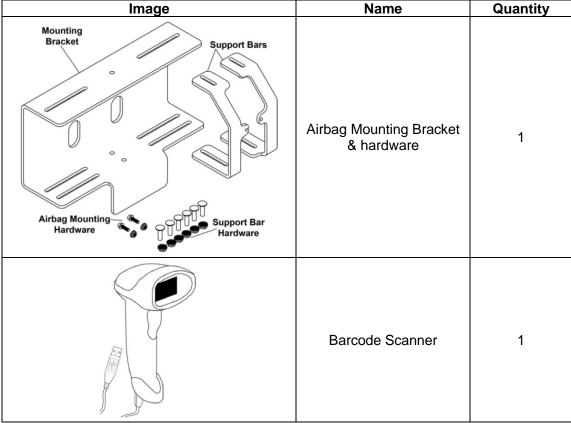
- Torque wrench • •
- **Electrical Tape** • Zip Tie
- Techstream
- ELG CAMPAIGN TOOLS These tools where previously provided to the dealership for campaign DLC and will be used for campaign ELG. These tools are required when performing this repair.

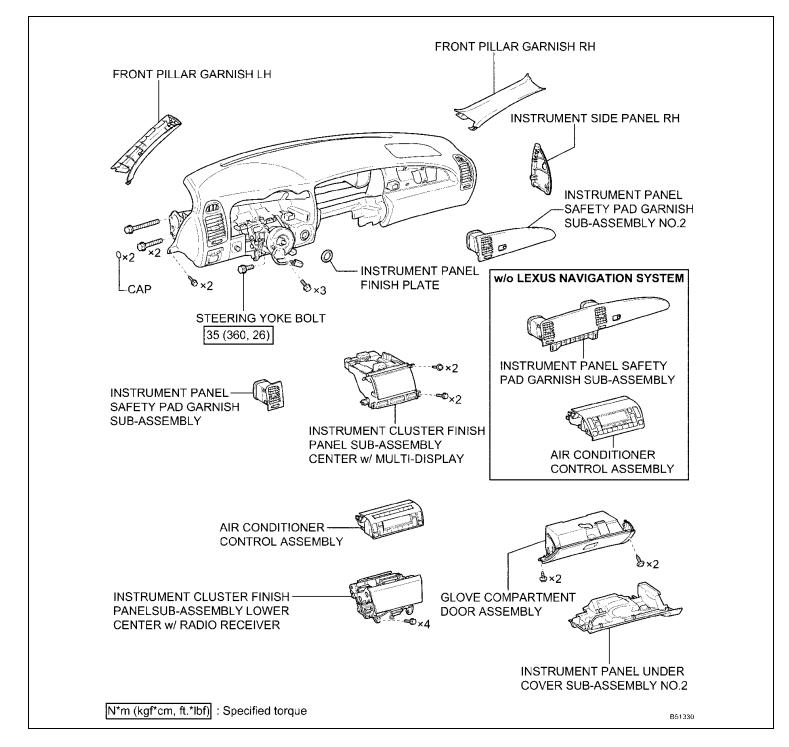
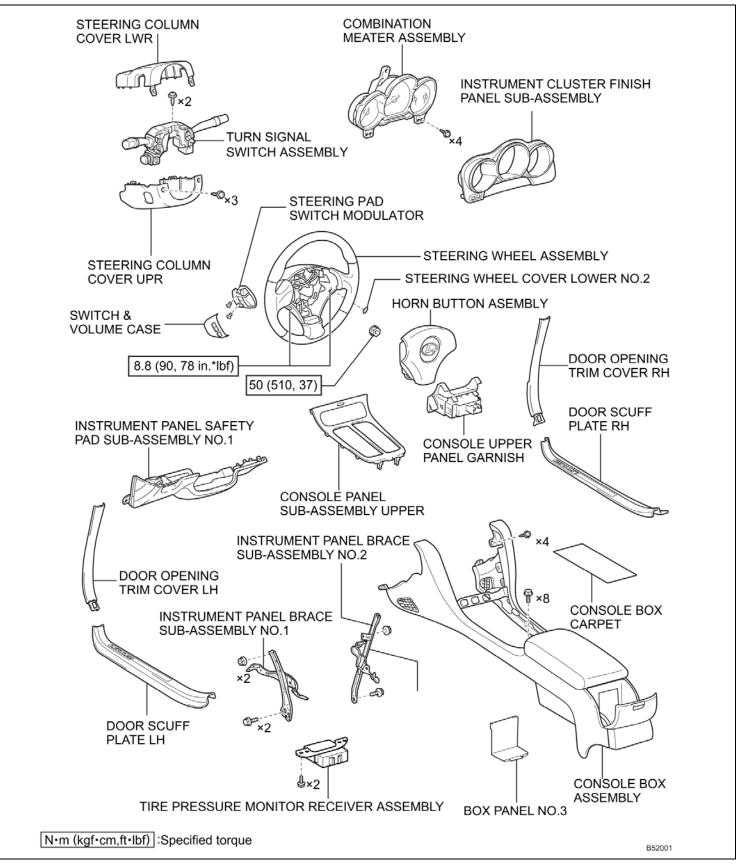
2. REMOVE THE INSTRUMENT PANEL SAFETY PAD SUB-ASSEMBLY

a) Refer to TIS for removal instructions 2002-2005 MY

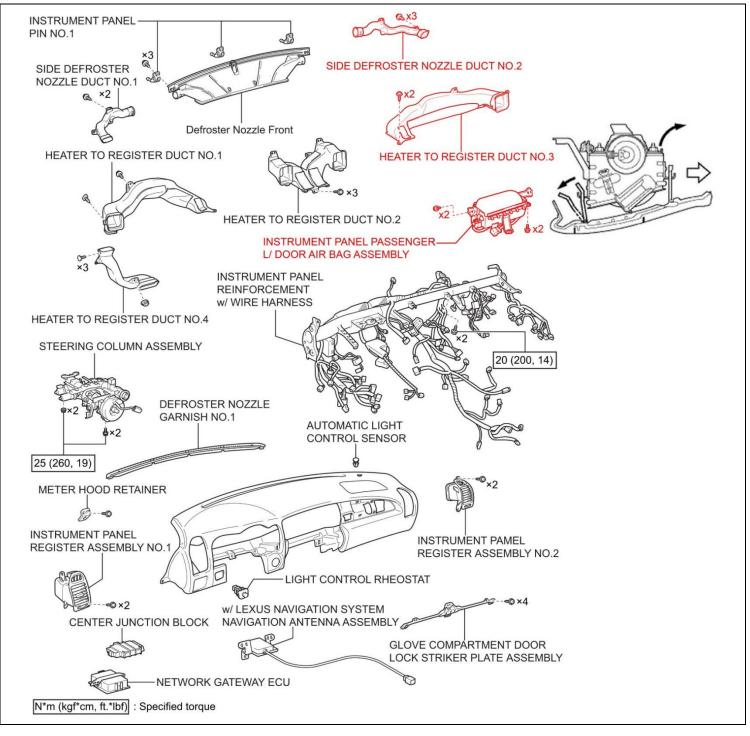
3. REMOVE THE AIRBAG FROM THE INSTRUMENT PANEL

- a) Remove the 3 screws and the side defroster nozzle.
- b) Remove the 2 screws and the heater to register duct.
- c) Remove the 4 bolts, disengage the straps, and then remove the airbag assembly.

NOTE: Only remove the components highlighted in red; there is NO NEED to remove any other components.

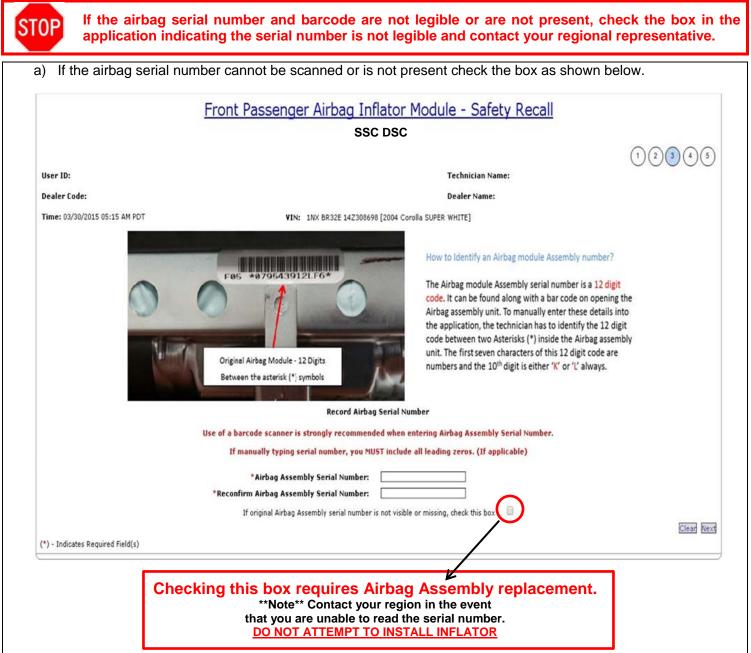
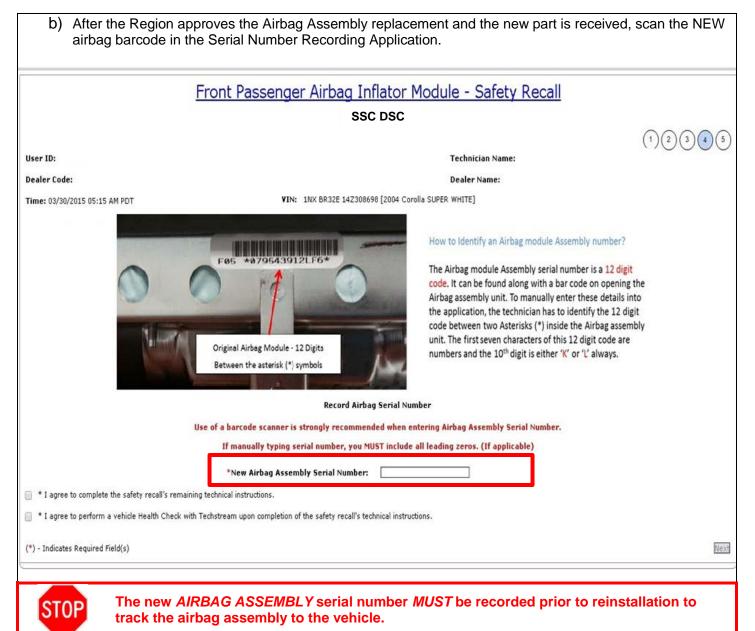
AIRBAG SERIAL NUMBER IS MISSING OR IS UNREADABLE

TOP The AIRBAG ASSEMBLY serial number and the INFLATOR serial number are DIFFERENT. The AIRBAG ASSEMBLY serial number MUST be recorded prior to replacement.

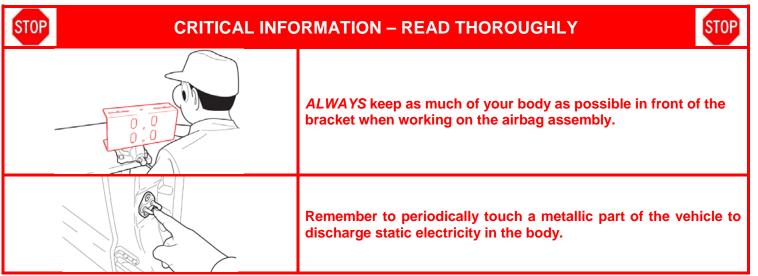
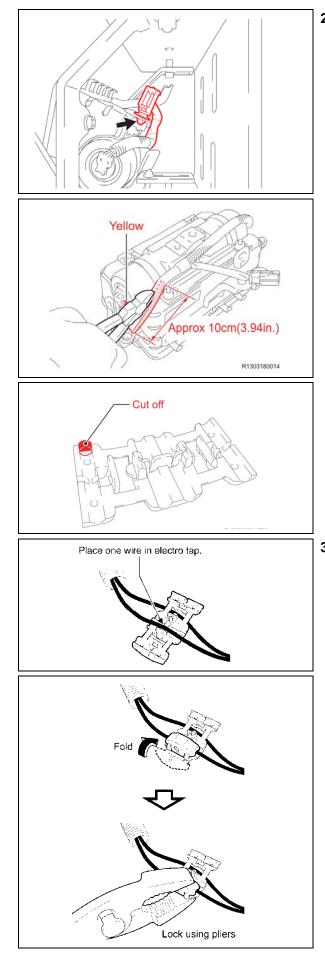
1. MOUNT THE AIRBAG IN THE MOUNTING BRACKET

a) Position the airbag so that the airbag weld-nuts are between the support bars and mounting bracket and install the bolts.

- b) Position the support bars at an angle as shown in the illustration.
- c) Confirm the center airbag bracket is facing up.

NOTE: The position of the support bars is critical to create clearance for the removal of the inflator.

- d) Position the airbag so that all four nuts can be removed through the access holes.
- e) Tighten the nuts holding the support bars to the mounting bracket.
- f) Confirm the following:
 - Mounting bracket is secure in the vise.
 - Airbag is secure in the support bars.
 - Support bars are secure on the mounting bracket using 1 bolt/nut at the top of each support bar and 2 nuts/bolts at the bottom of each support bar.

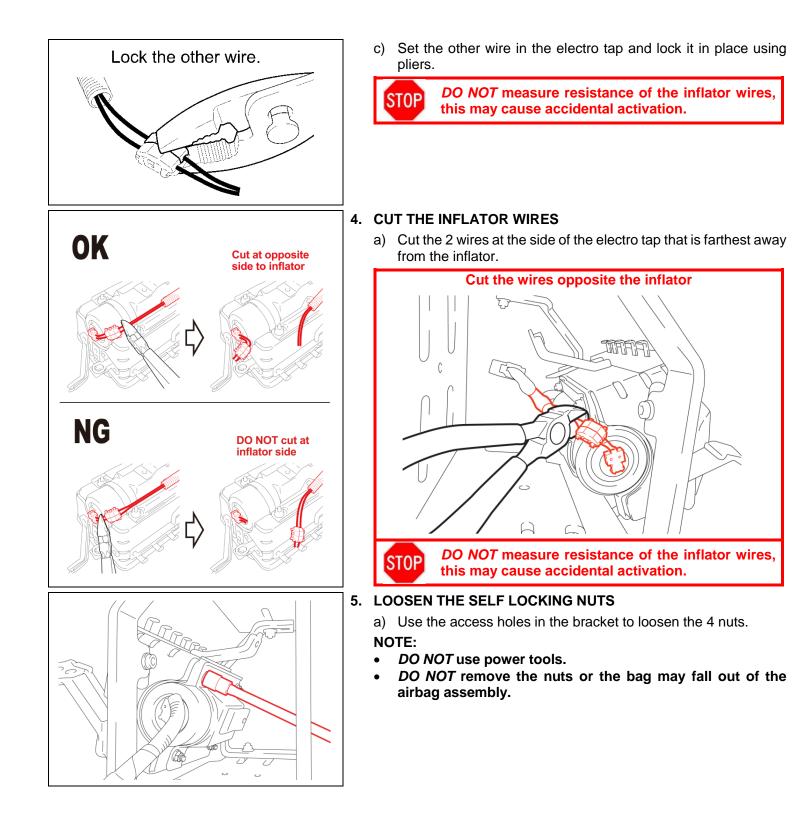
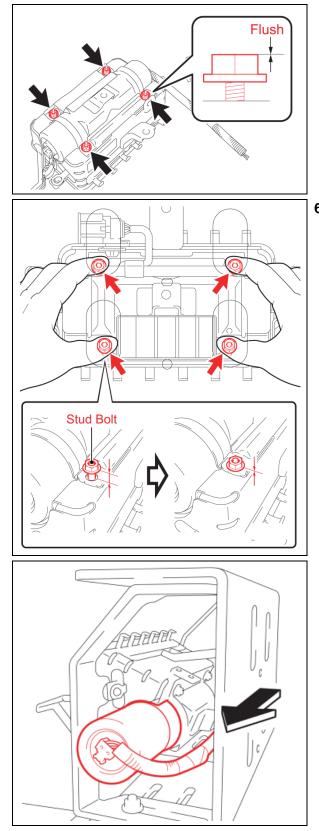
- 3. CREATE A NEW SHORT CIRCUIT IN THE INFLATOR HARNESS
 - a) Place one wire in the electro tap as shown in the illustration.
 - b) Fold and pinch the half of the electro tap with the wire and use pliers to lock the electro tap.

- DO NOT work on both wires at the same time to avoid errors.
- Pliers *MUST* be used to confirm the electro tap is firmly locked in place.

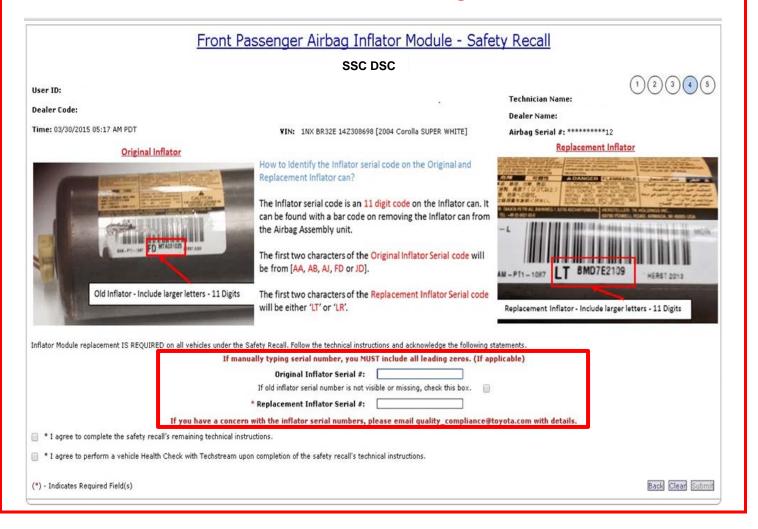
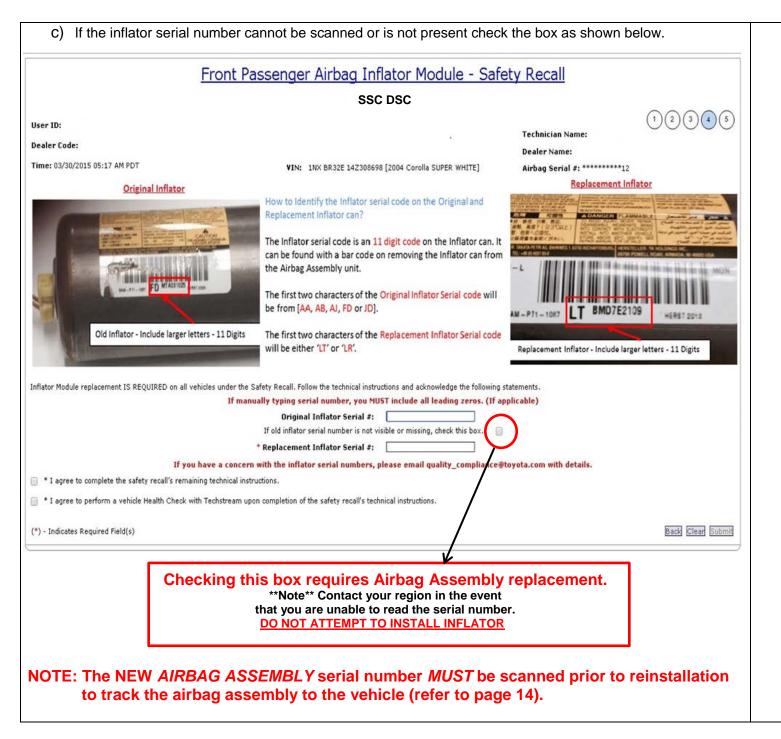
ATTENTION: This information is **CRITICAL**

- It is used to confirm the correct inflator is removed from the vehicle.
- It is recorded by TMS to trace the return parts shipment.
- It is used to track the new inflator that is being installed in the vehicle.

- d) Confirm agreement by checking the two boxes.
- e) Record the Warranty Authorization # to be included in the warranty claim.
- f) Place the old inflator in the parts box and take it immediately to the parts department.

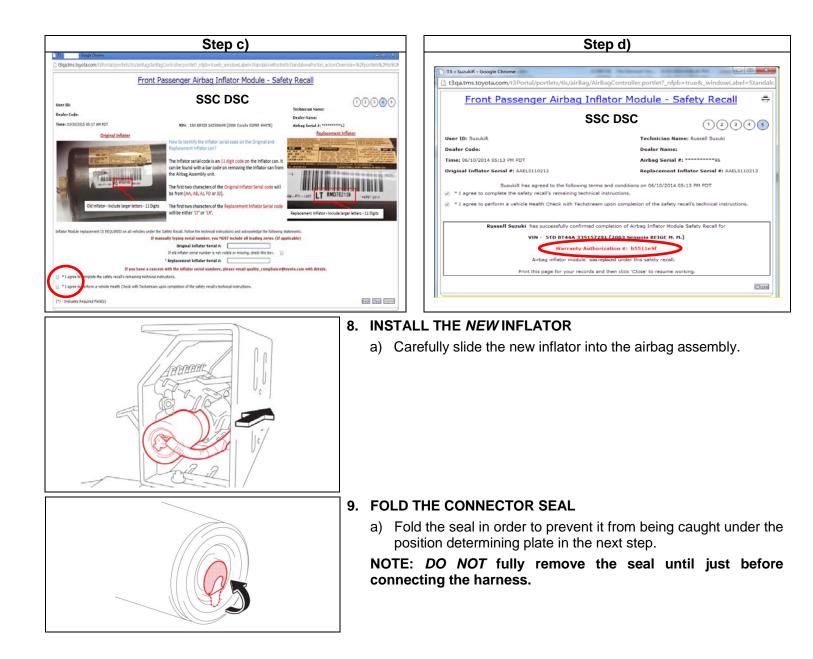
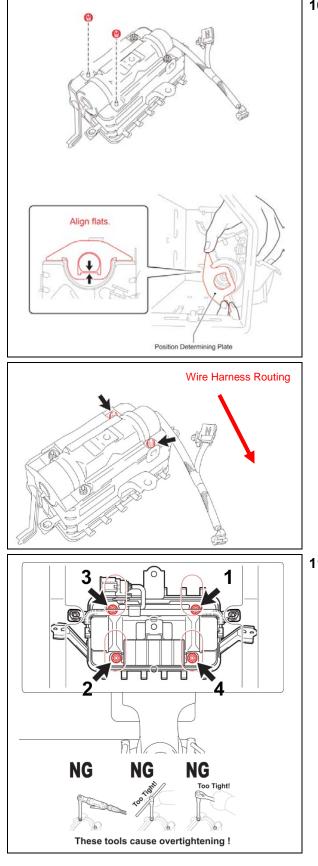
10. INSTALL THE *NEW* SELF LOCKING NUTS AND POSITION DETERMINING PLATE

- a) Remove the 2 old nuts.
- b) Install the position determining plate and install the 2 *NEW* nuts by hand. They will be torqued on a later step.

The position determining plate can only be installed on one side in one position, confirm the plate is aligned correctly.

- c) Remove the 2 old nuts.
- d) Install the 2 **NEW** nuts by hand. They will be torqued on the next step.

Ensure the position of the new wire harness matches the illustration. If the wire harness is not oriented correctly, the connector will not line up with the retaining bracket. DO NOT use this inflator if the harness is not correctly routed.

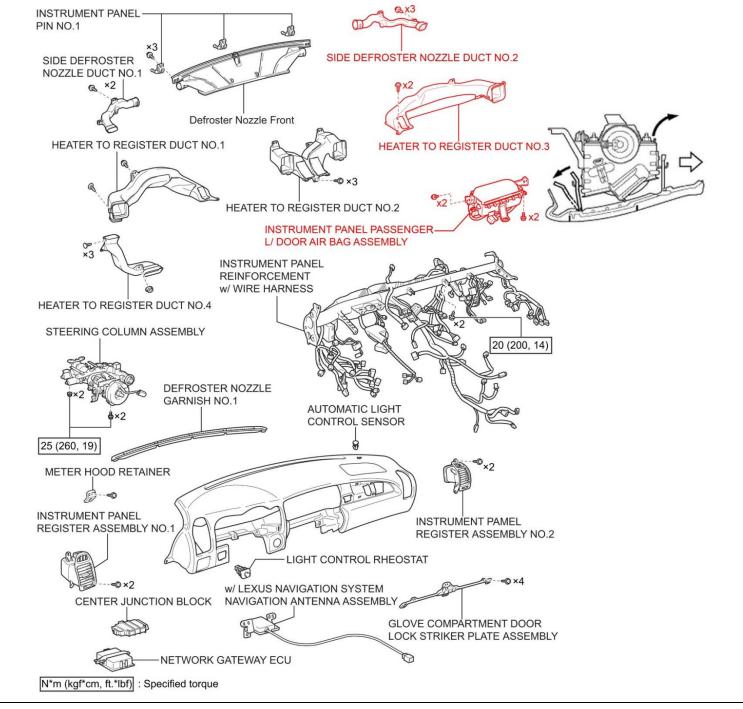
1. REINSTALL THE AIRBAG ASSEMBLY IN THE INSTRUMENT PANEL

- a) Position the airbag assembly in the instrument panel, engage the straps, and then install the 4 bolts.
- b) Install the 2 screws and the heater to register duct.
- c) Install the 3 screws and the side defroster nozzle.
